SUBJECT: **Briefing** – Washington Suburban Sanitary Commission (WSSC) – Chevy Chase Lake Water Main Break

**Forensic Results of 60-inch PCCP Water
Main Failure in Chevy Chase**

September 9, 2013

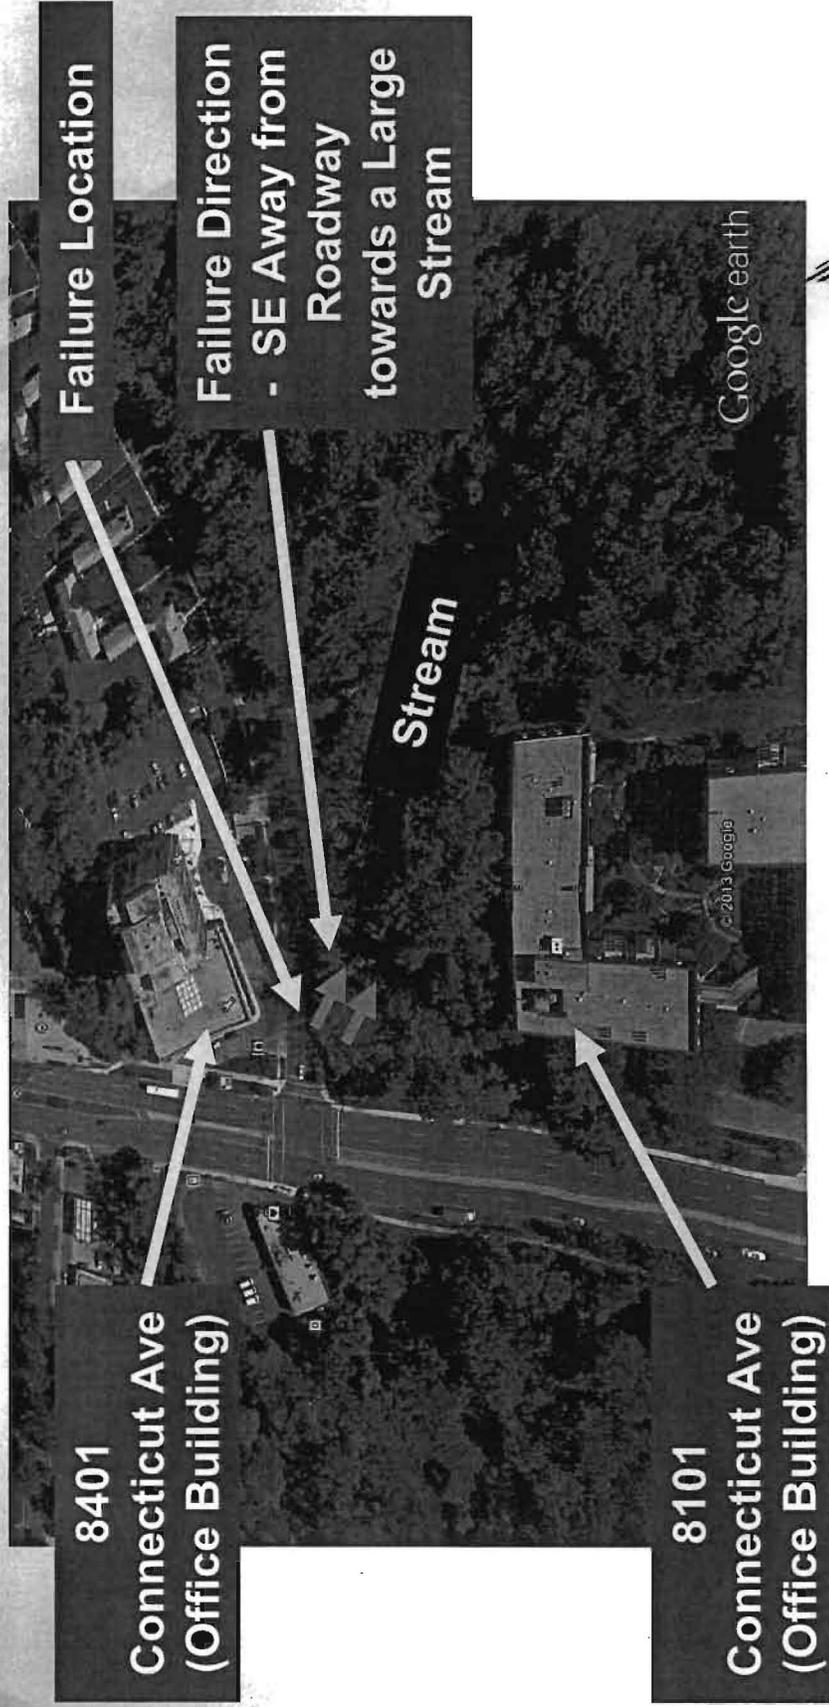
Failure Site Conditions

- 60-inch Water Main Failed on March 18, 2013, Reported Approx. 8:00 P.M.
- Failure Site is Located along Chevy Chase Lake Drive Near the Intersection of Connecticut Avenue in Chevy Chase.
- Estimated Loss of 60 Million Gallons of Potable Water.
- Failure Direction was Away from the Roadway in the South Embankment of Chevy Chase Lake Drive and Caused a Large Crater Approximately 90 Feet in Length and 45 Feet Wide.
- The Water Flowed into a Large Stream which Helped to Minimize Flooding and Further Damage.

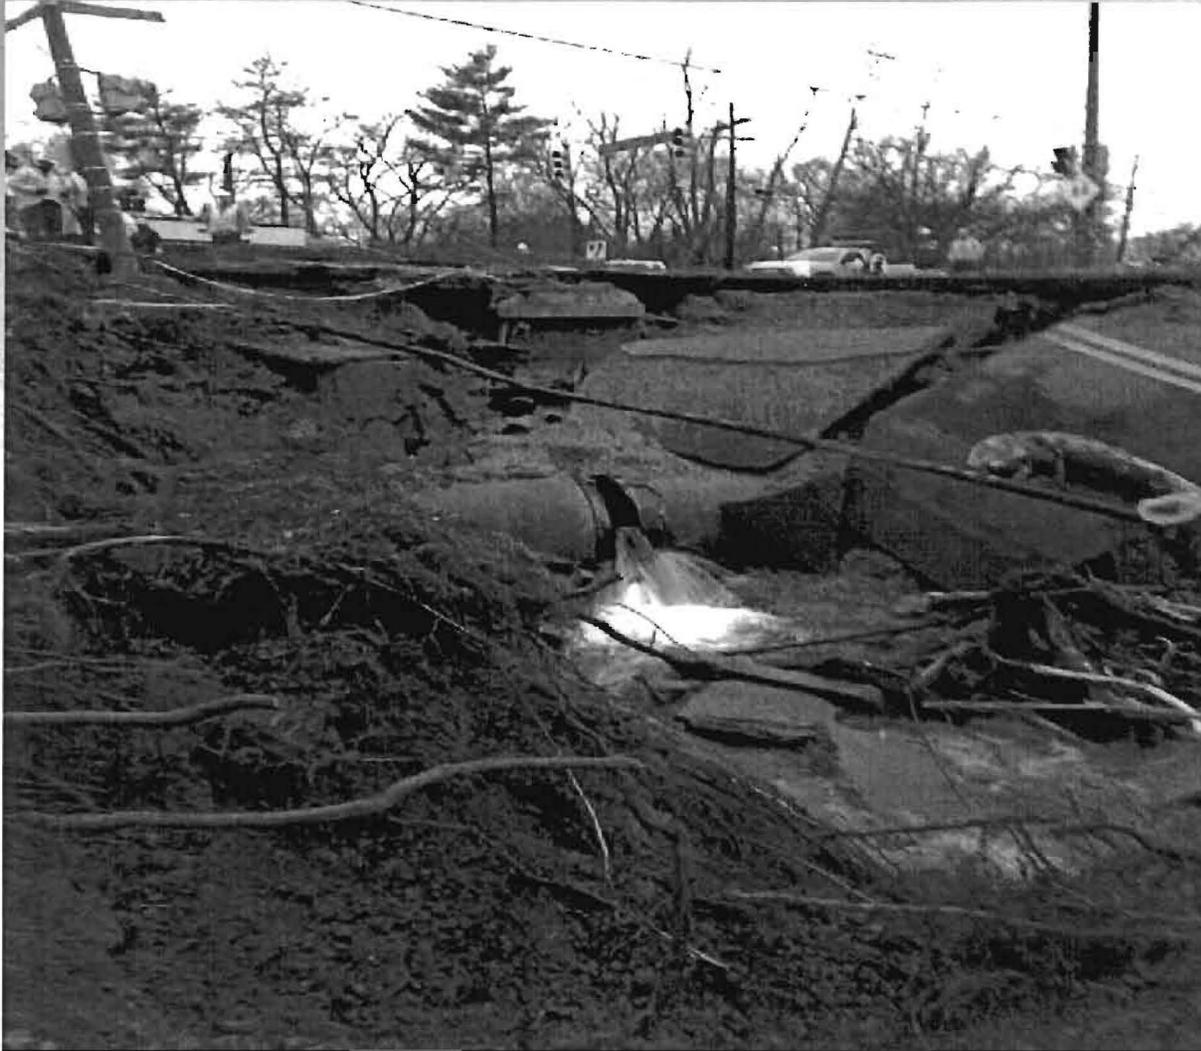
60-Inch PCCP Failure - Chevy Chase

54/60-inch Water Main
Runs Approximately
Parallel to Connecticut
Avenue – Large Sections
of the Asphalt Pavement
from Chevy Chase Lake
Drive Were Damaged
and 24-Inch Valve Vault
Exposed.

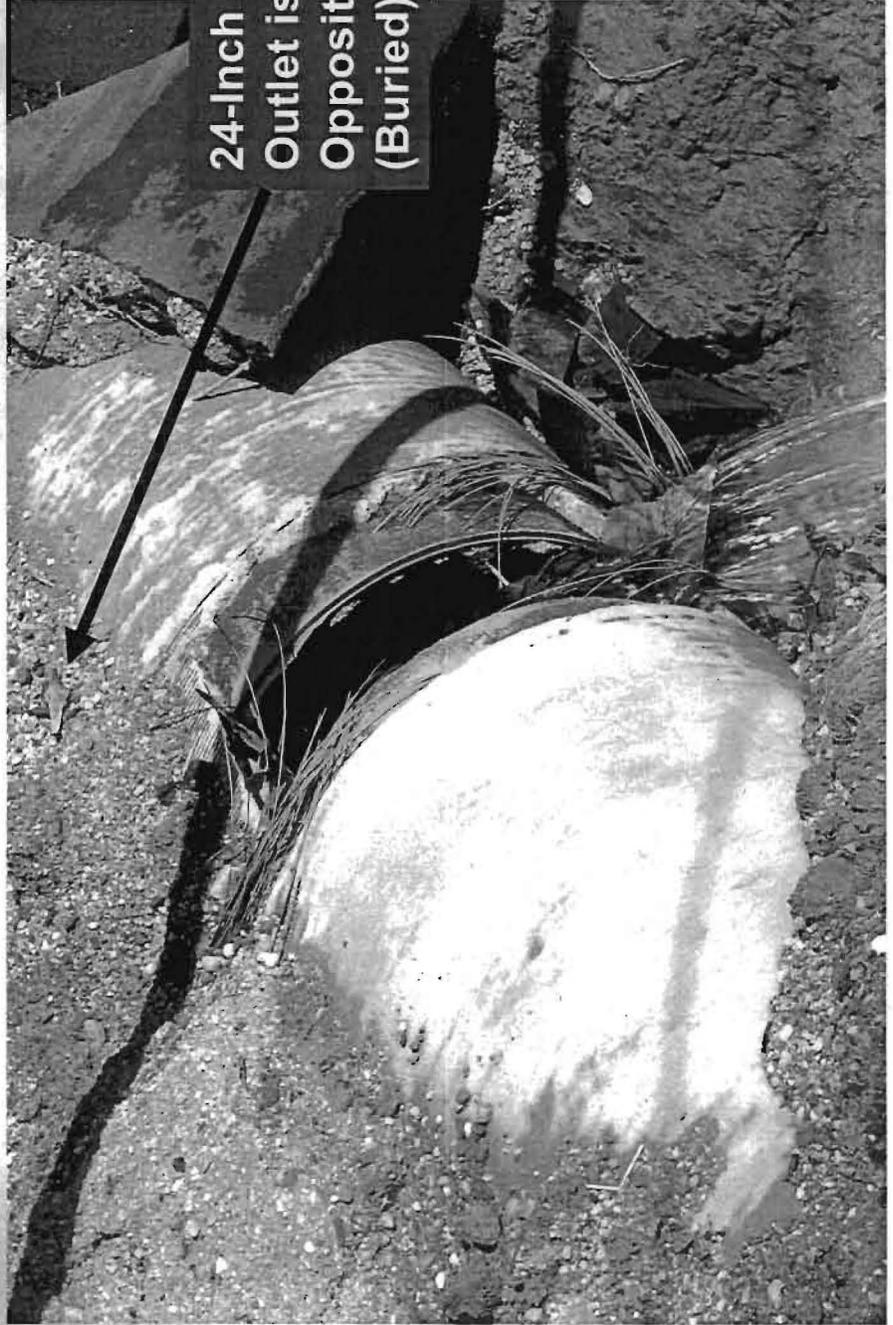
Failed 60-Inch - Rupture Side

Close-up Following Main Shutdown

24-Inch Factory Installed
Outlet is Located on the
Opposite Side of Pipe
(Buried)

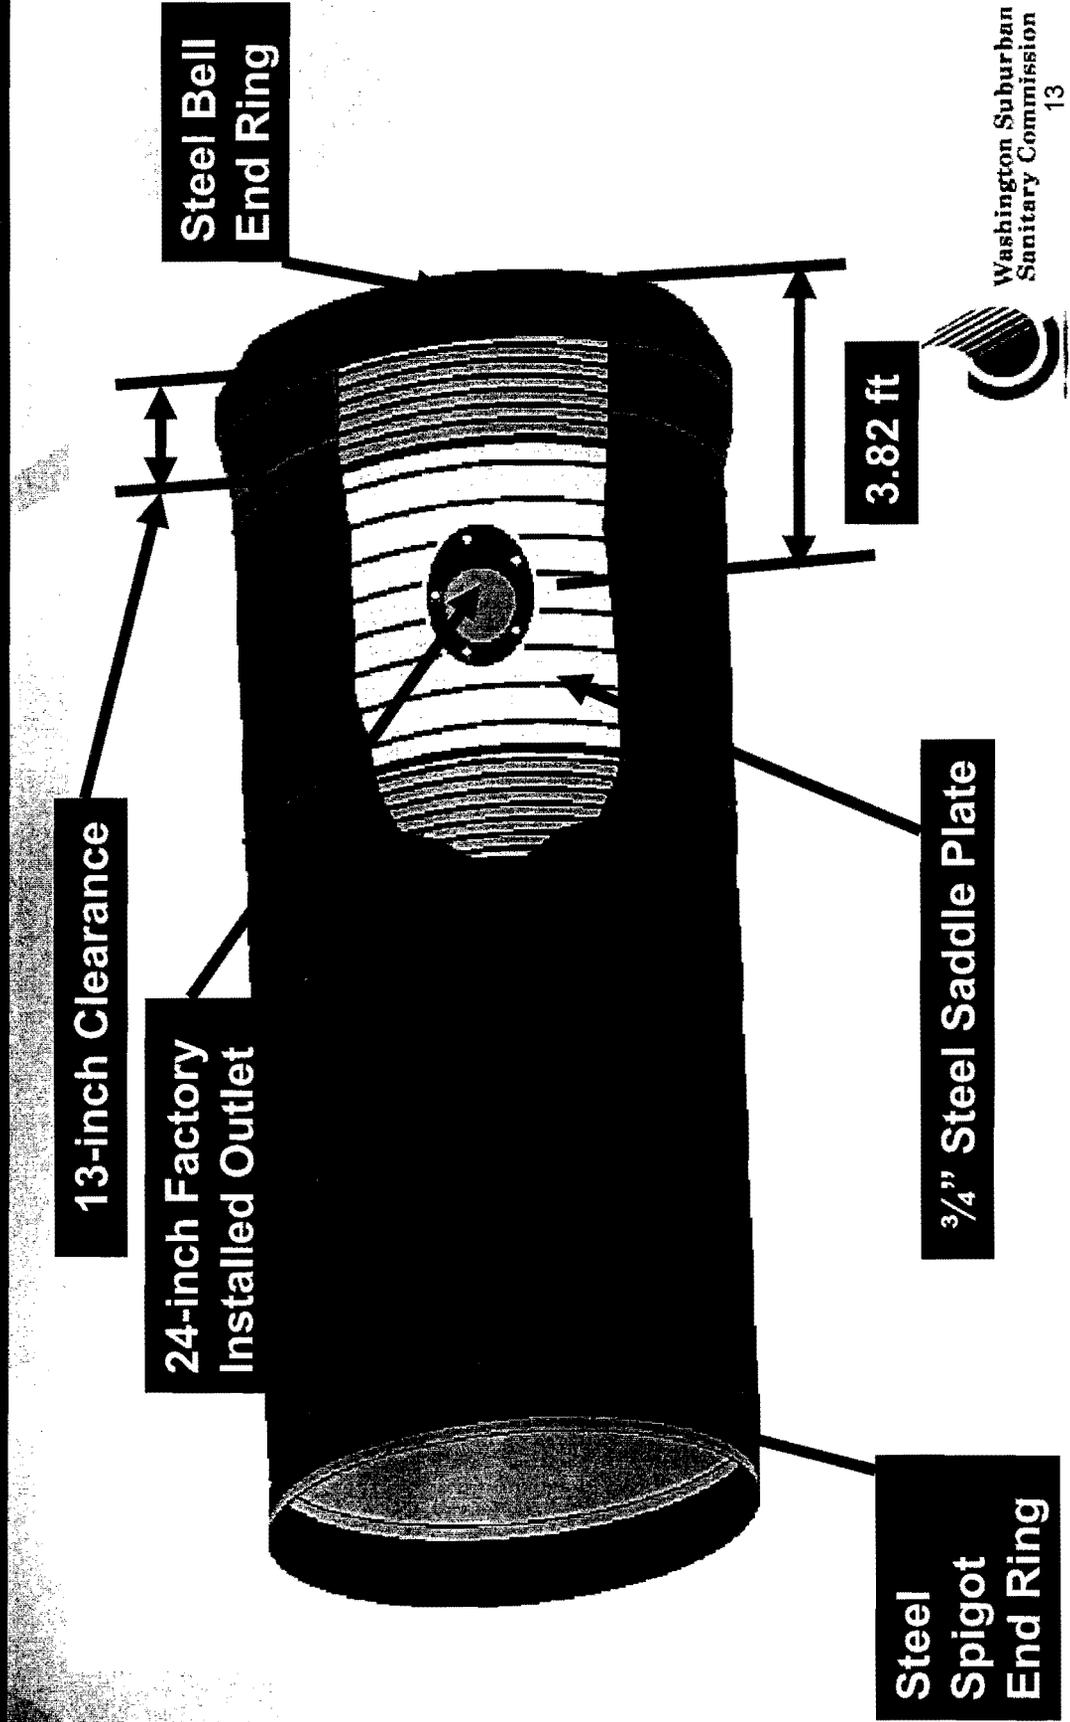
Failed Outlet Pipe Design

- 20 Foot Section of 60-inch Diameter SP-12 Embedded Cylinder Pre-stressed Concrete Cylinder Pipe (PCCP).
- The Water Main was 35 Years Old, Constructed in 1978.
- Failed Pipe had 24-inch Factory Installed Outlet Centered 3.82 Feet From Face of Bell End with a 13-inch Clearance from the Steel Saddle Plate to Steel Bell End Ring.
- Pipe Was Manufactured by the Interpace Corporation at the Perryman Maryland Plant in 1977 with Class IV Wire, Known to be Most Problematic.

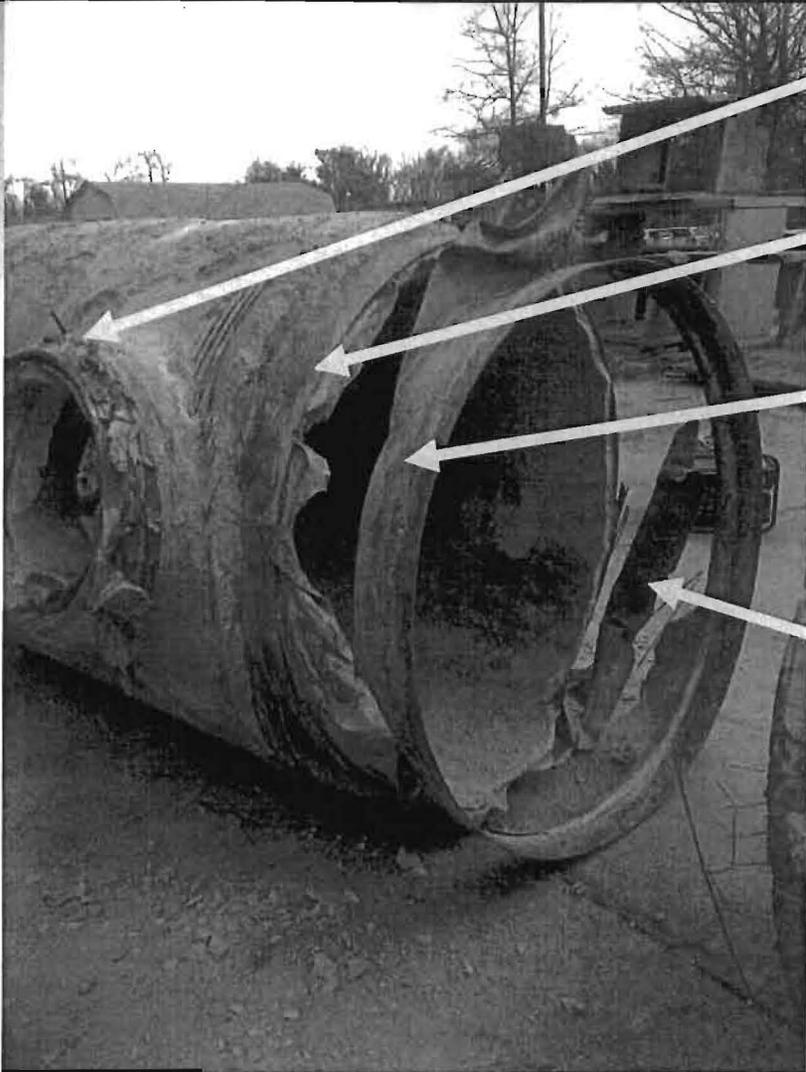
Failed 60-Inch Pipe

Failure Occurred in the Area
Between the Steel Saddle Plate
and the Steel Bell End Ring on the
Opposite Side of the Pipe
From the Outlet

- 1) Inadequate Wire Pre-stress Found Between the Steel Saddle Plate Used to Attach the Factory Installed Outlet and the Steel Bell End Ring Compromised the Composite Structure of the Pipe Section;
- 2) A Slow Leak From the Gasket at the Bell End;
- 3) Chemically and Physically Weakened Pipe Joint Mortar Caused by the Leaking Potable Water (More Corrosive To Steel) Allowed Water to Enter the End of the Compromised Composite Structure and to Corrode the Wires and Steel Cylinder;

- Identify and Map Similar Pipe Sections in Mains 48-inch and Larger – This Task is Complete and a Total of 234 Similar Pipe Sections with Outlets Have Been Identified.
- Perform a Study Prior to the Start of the FY'14 PCCP Inspection Program to Investigate All PCCP Condition Assessment Technologies Both Existing and Emerging to Evaluate Techniques to Identify Defects in the Area Between the Steel Saddle Plate and the End Ring for Pipe Sections with a Factory Installed Outlet if the Area Between These Components is Two (2) Feet or Less.
- Utilize the Techniques Found in the FY'14 PCCP Inspection Program and Excavate Suspect Outlet Pipes to Validate the Results. Continue Research to Identify Nature and Extent of the Problem.
- Repair All Sections of PCCP with Outlets that are Found Suspect.

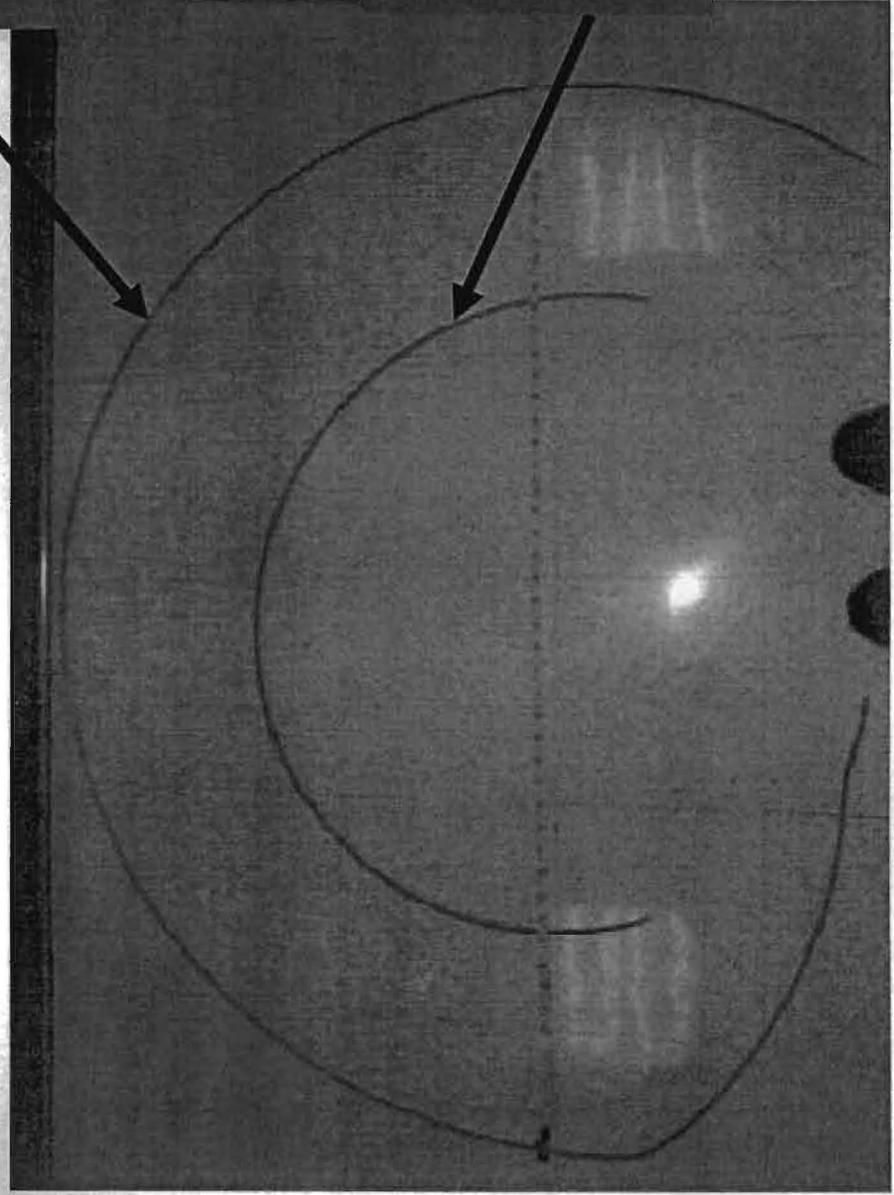
First Contributing Cause – Lack of Adequate Pre-Stress at Failed End of Pipe

4' - 8" Diameter –
Pre-Stressed Wire
Hoop From Spigot
End – Adequate
Pre-Stress

2' - 8" Diameter –
Pre-Stressed Wire
Hoop From Bell
(Failed) End –
Inadequate Pre-
Stress

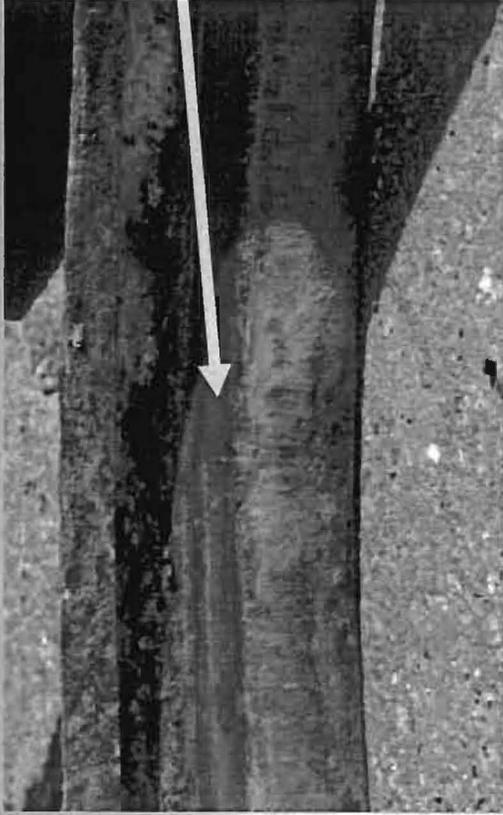
Second Contributing Cause – Slow Leak at Bell (Failure) End

Dark Gray Color Shows Smooth Consistent Gasket Seal Impression on Interior of Bell End Joint Ring

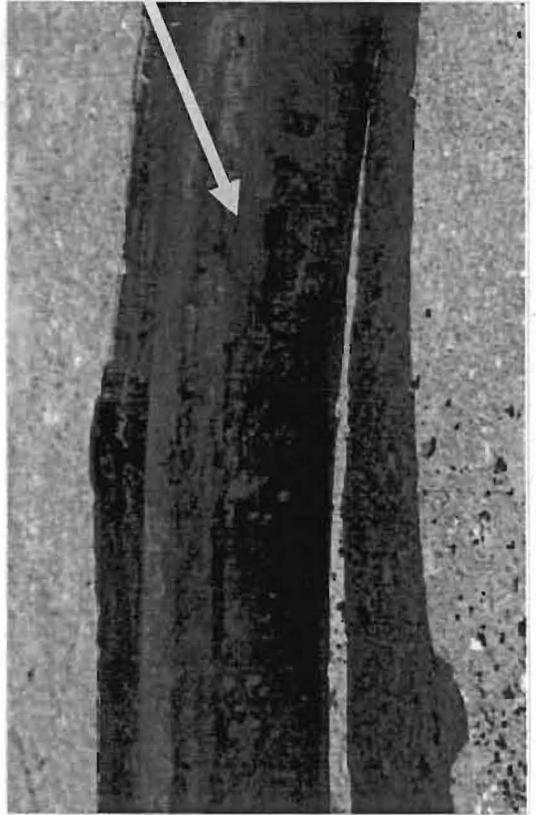
Corrosion Patterns Across 2' - 6" Length of Interior of Bell End Joint Ring at Pipe Invert Indicate the Lack of a Good Seal

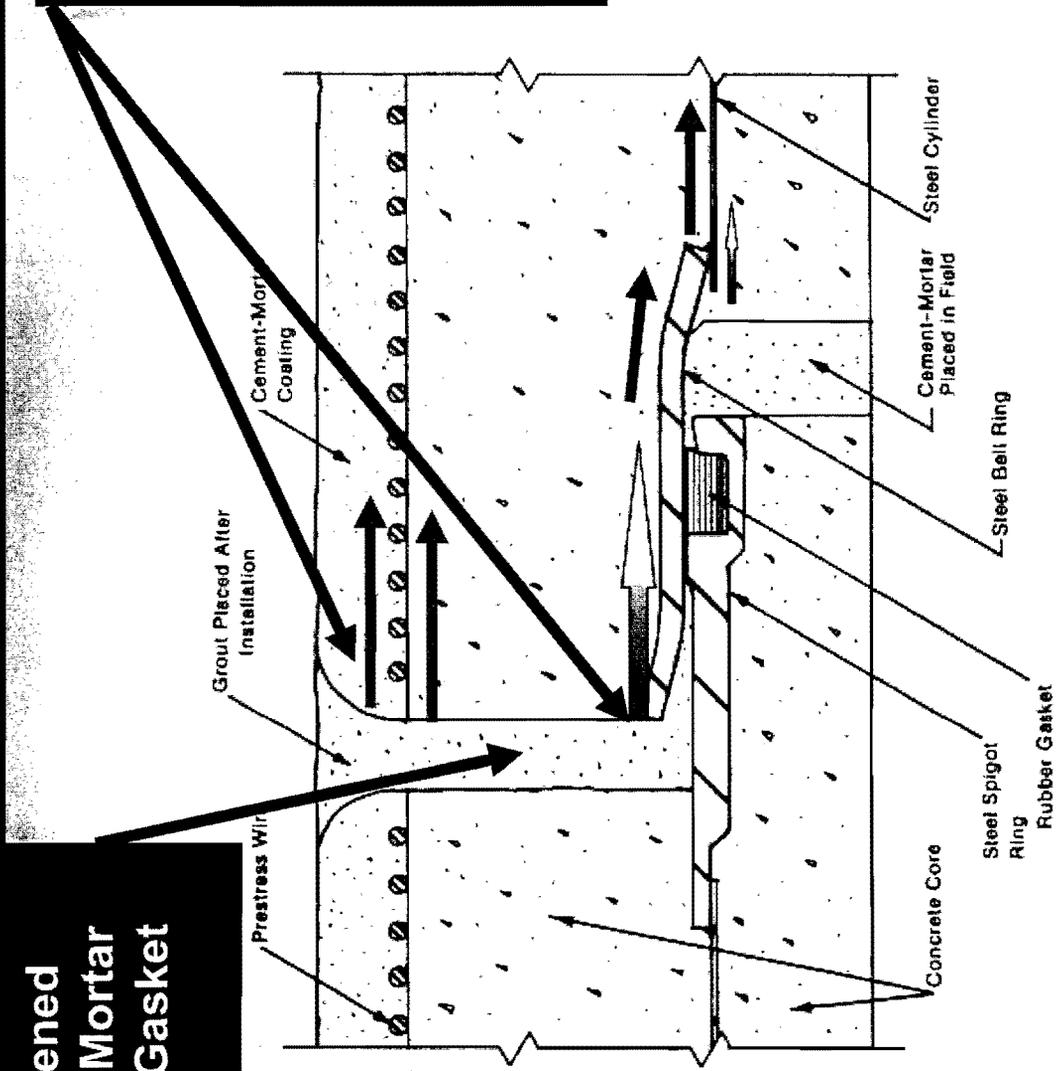
Third Contributing Cause – Weakened Joint Mortar From Leak

Weakened Joint Mortar from Gasket Leak

Potable Water (More Corrosive to Steel) Entered End of Compromised Pipe Section Due to Lack of Adequate Pre-Stress and Corroded Steel Cylinder and Steel Wire
