Hollywood Branch Stream Restoration

Preliminary Assessment Report_ Revised
January 2009

30% Concept Design Report
June 2009

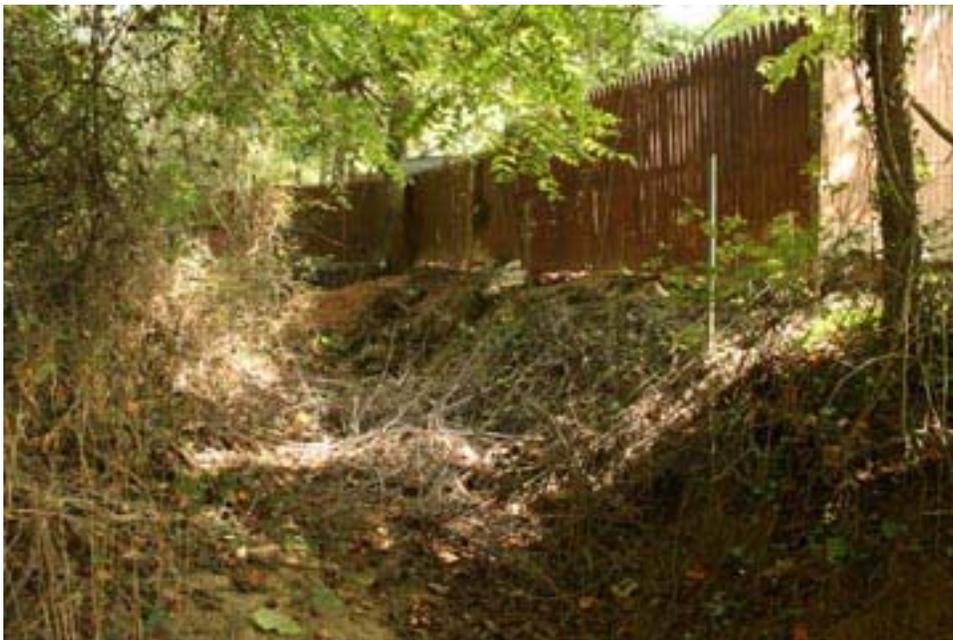
Fig. 5 – Emergency spillway channel eroding into rear of yards

The results of the field assessment indicate that although Reach 1 is stable approximately 100 linear feet of the 225 linear feet of the spillway channel is unstable. The poor conditions along the spillway channel make it a source of sediment to downstream reaches and present a long term maintenance issue for the adjacent residences. Table 1.3 summarizes the stream conditions along Reach 1.

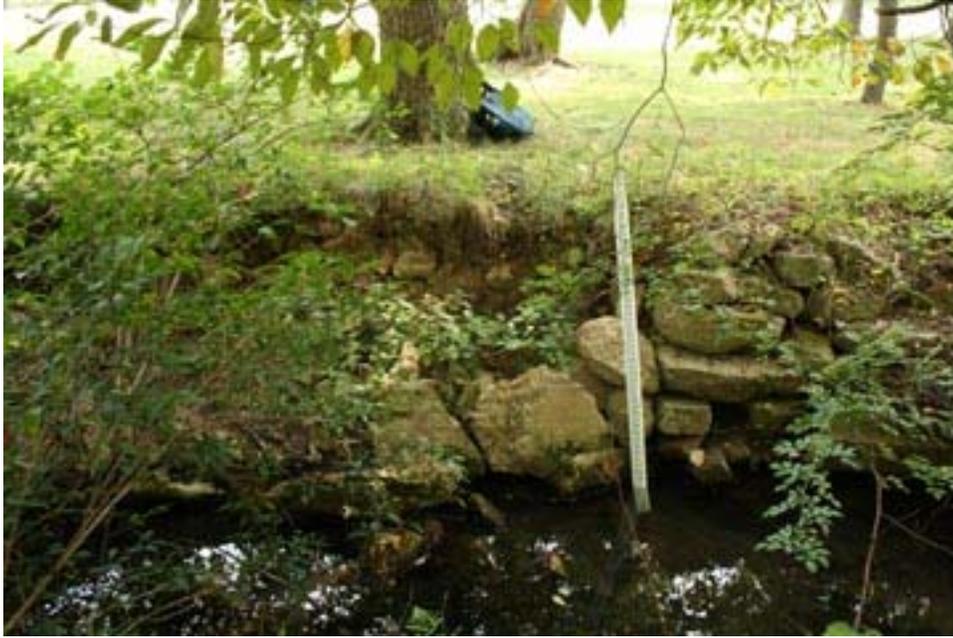
Fig. 6 – Stacked concrete wall collapsing at upstream end of Reach 2

The results of the field assessment indicate that 50 linear feet (11.8%) of the total 422 linear feet of channel along Reach 2 is unstable. The localized bank erosion along the upper section of the reach is a source of sediment to downstream reaches. Table 1.4 summarizes the stream conditions along Reach 2.

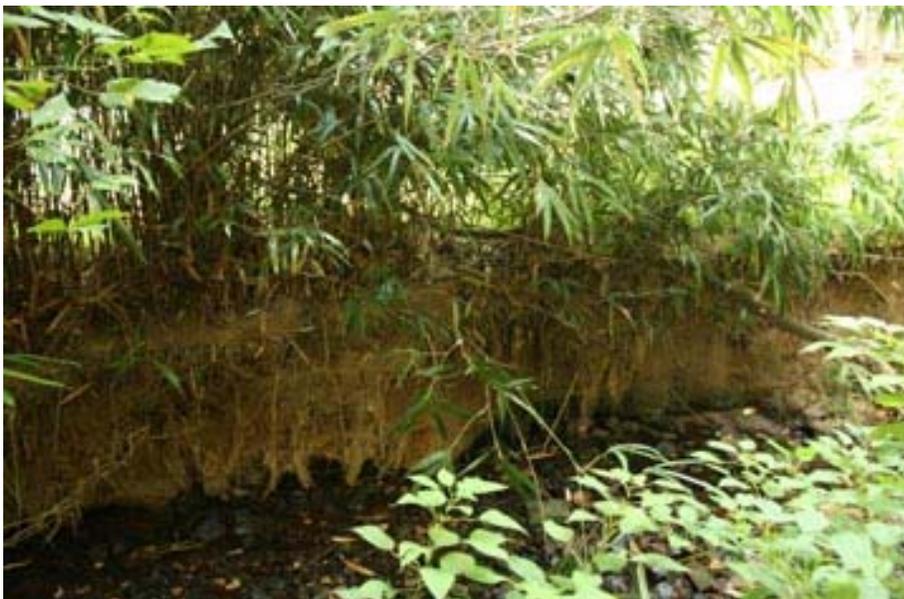
Figs. 8 and 9 – Eroding banks along upstream section of Reach 3

The results of the field assessment indicate that 60 linear feet (30%) of the total 200 linear feet of channel along Reach 3 is unstable. The poor conditions along the actively eroding section of the reach are a source of sediment to downstream reaches. Table 1.5 summarizes the stream conditions along Reach 3.

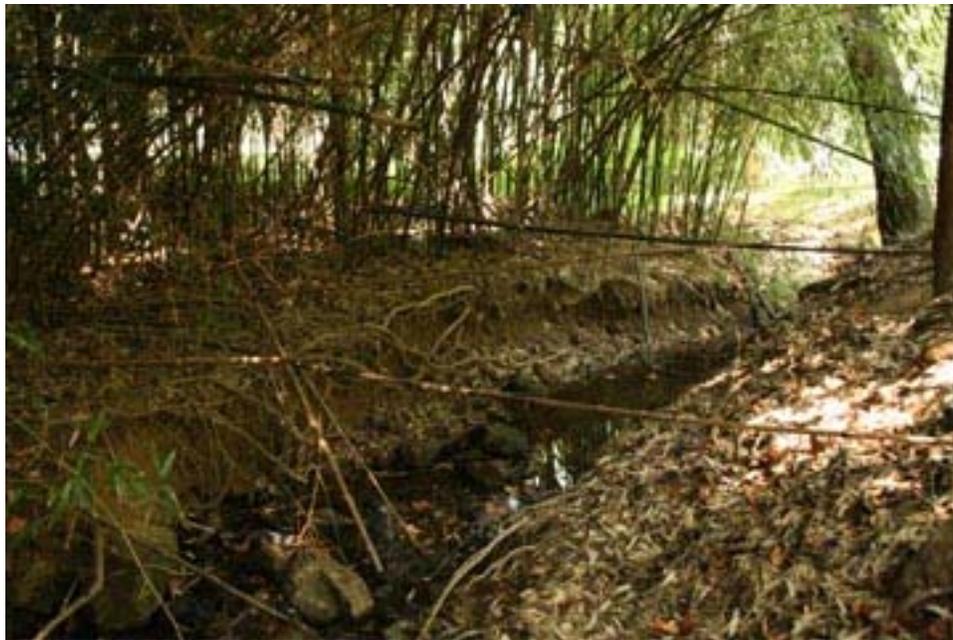
Figs. 10 and 11 – Eroding banks at upstream end of Reach 4.2
Note: Dense stand of bamboo along right bank

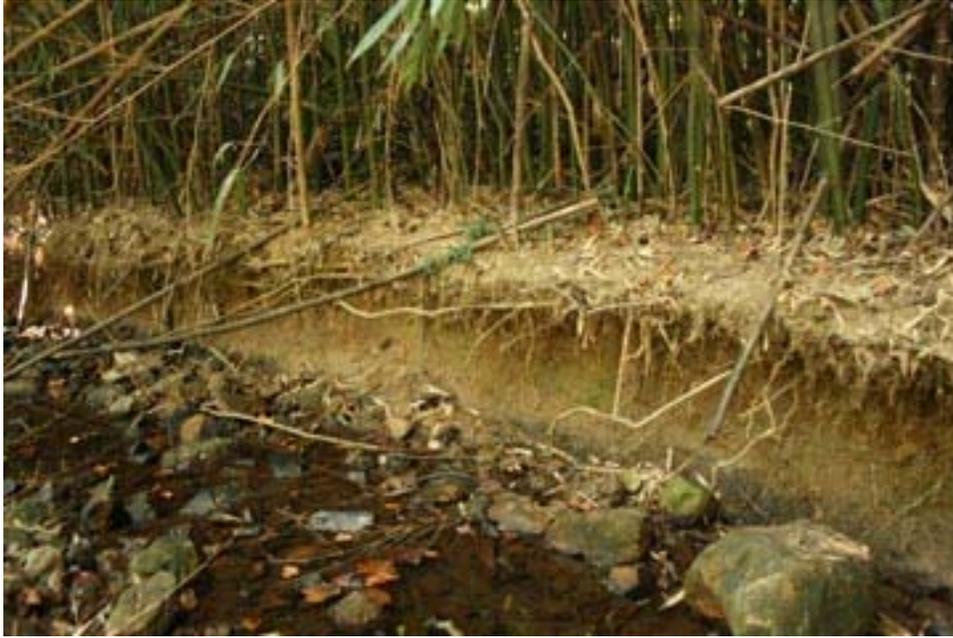
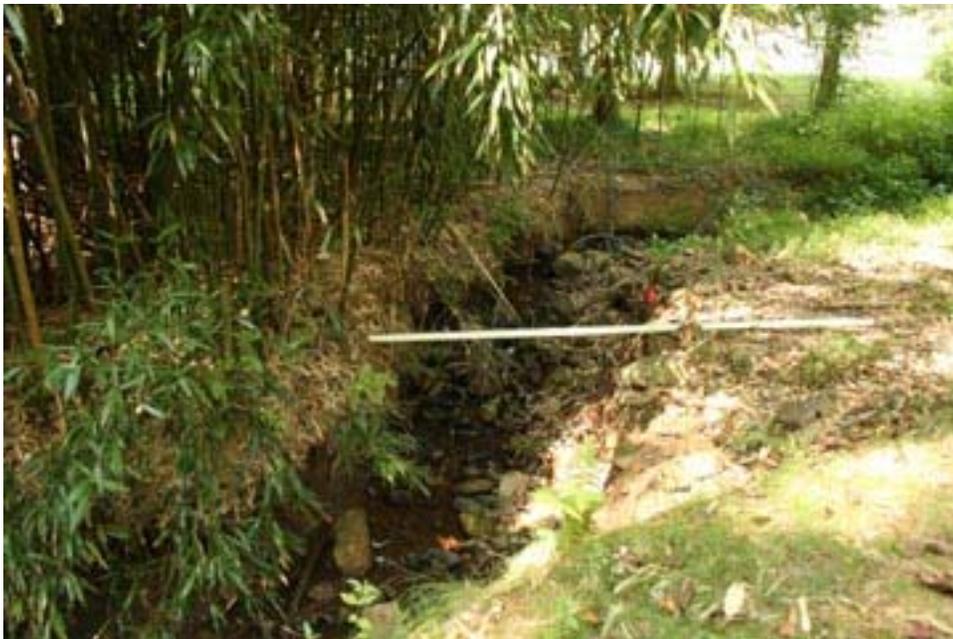
Fig. 12 – Head-cut migrating upstream through Reach 4.2

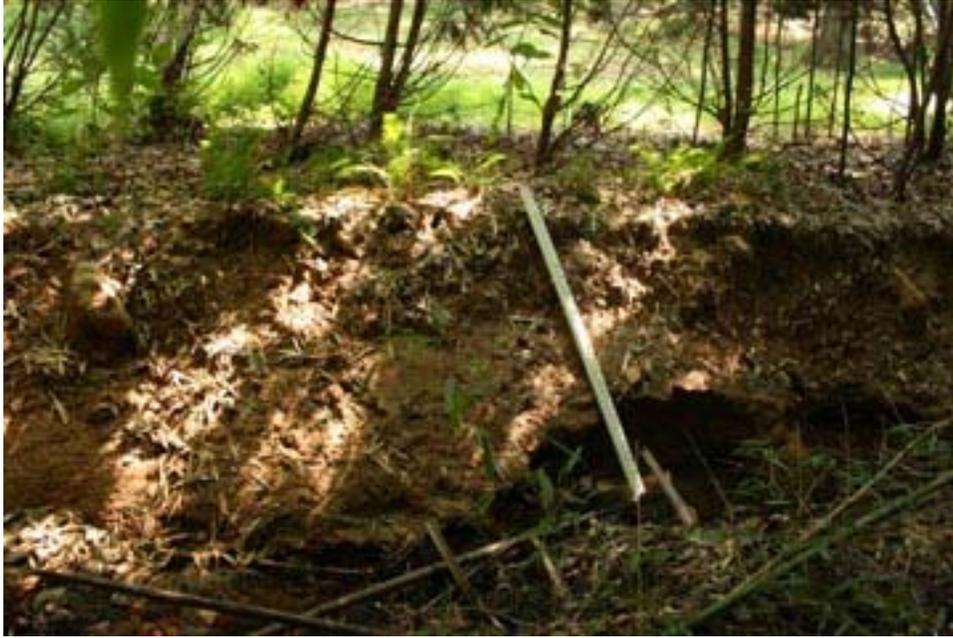
Fig. 13 – Eroding bank at downstream end of Reach 4.2

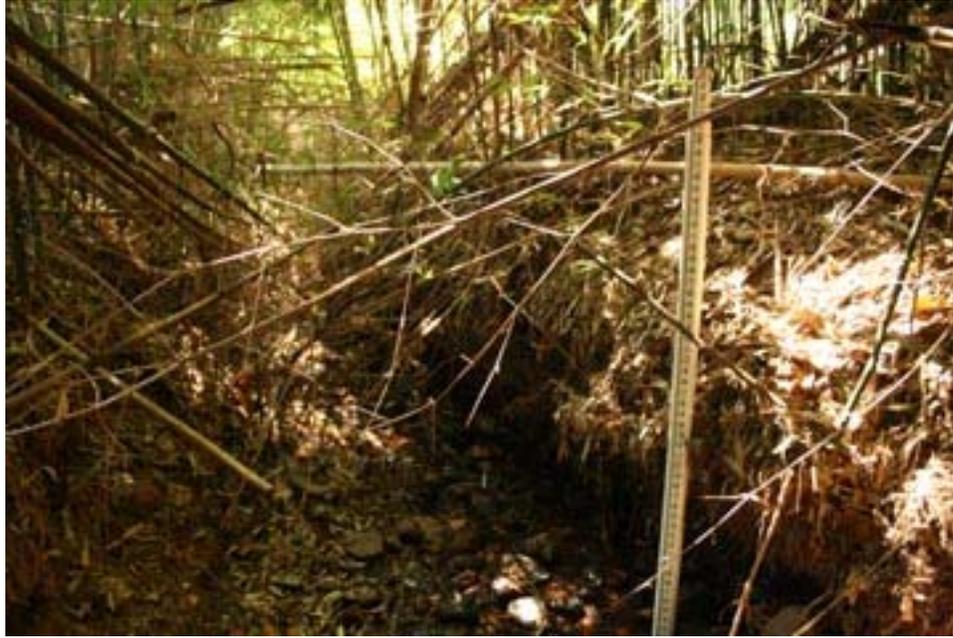
Fig. 15 – Deeply incised channel at downstream end of Reach 4.4

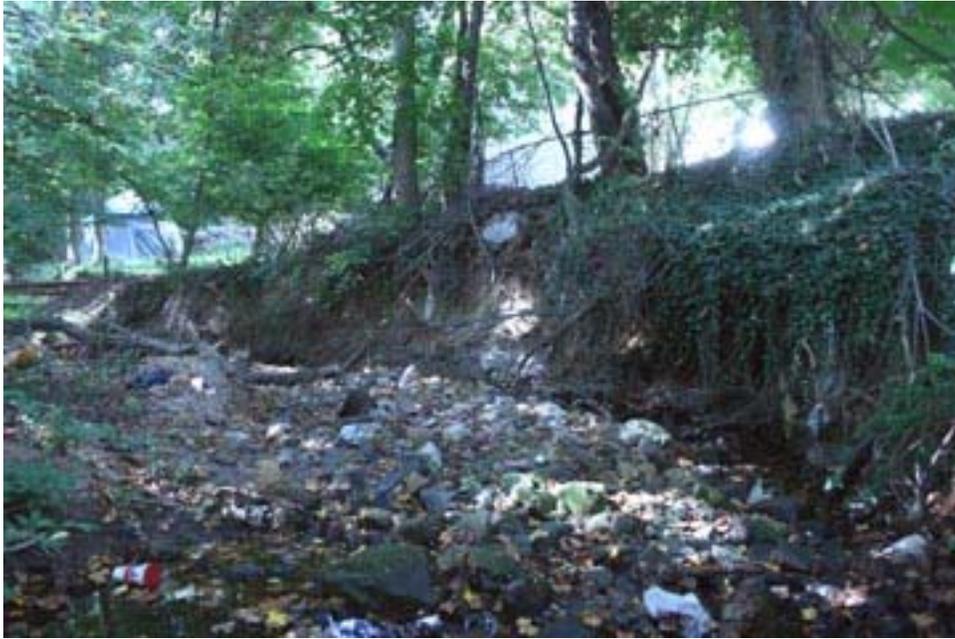
Figs. 16 and 17 – Eroding bank at upstream end of Reach 5.1

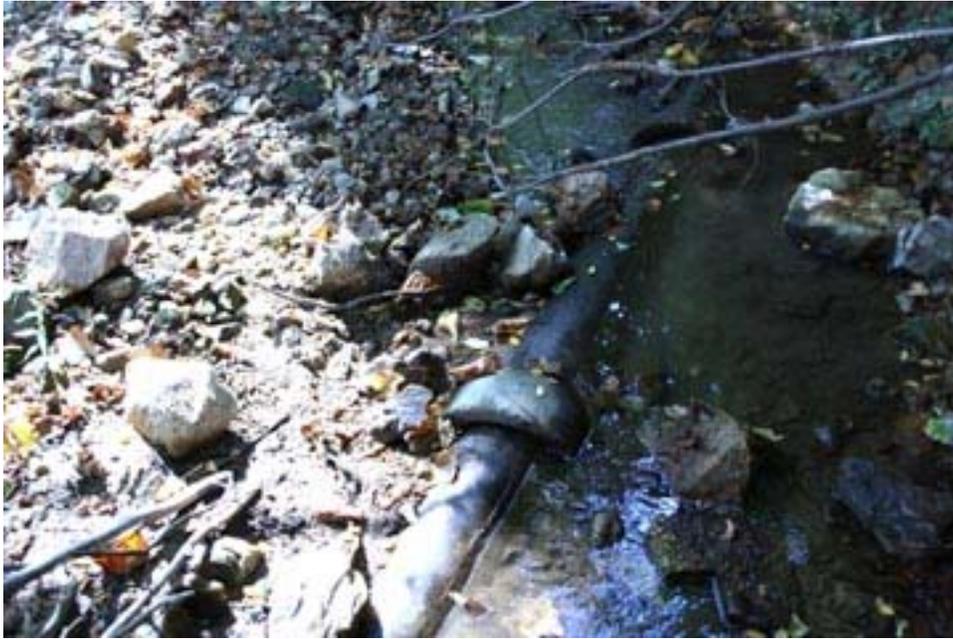
Fig. 18 – Exposed sanitary sewer in upper Reach 5.1

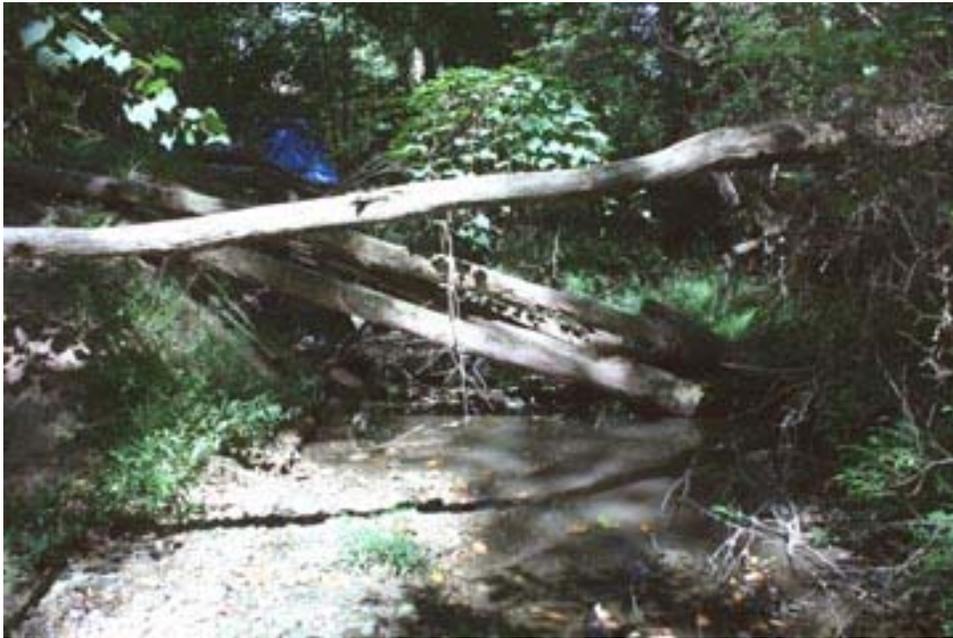
Fig. 19 – Debris jam middle section of Reach 5.1

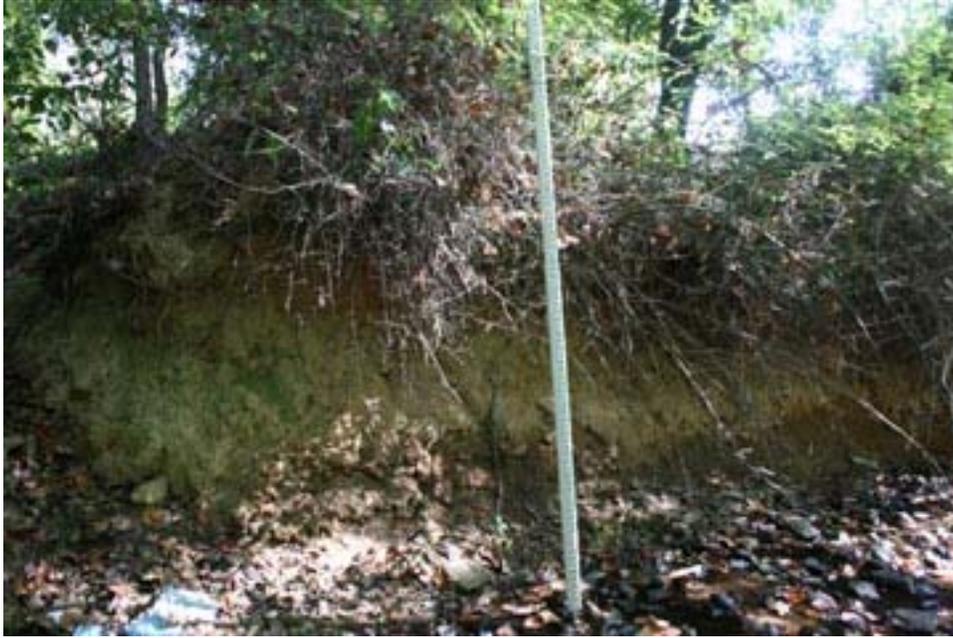
Fig. 20 – Eroding bank upstream end of Reach 5.1

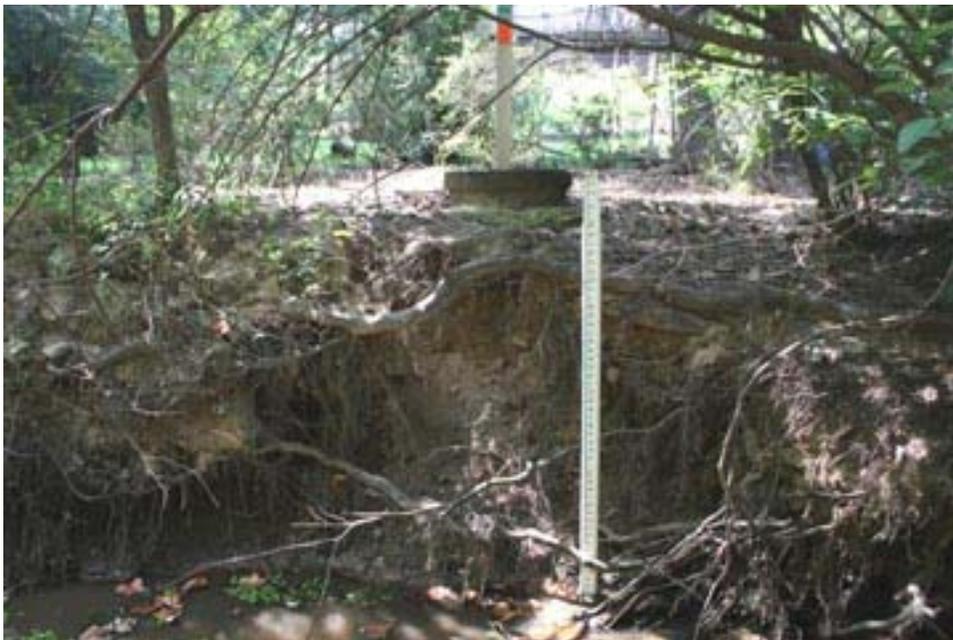
Fig. 21 – Eroding bank adjacent to sanitary sewer manhole middle section of Reach 5.3

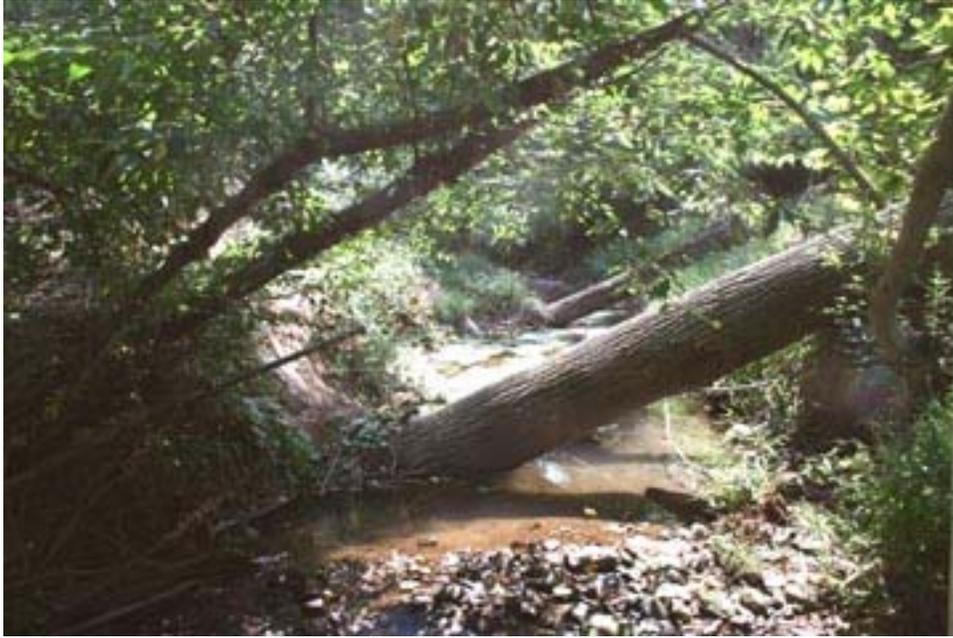
Fig. 22 – Eroding banks with trees collapsing into channel at downstream end of Reach 5.3

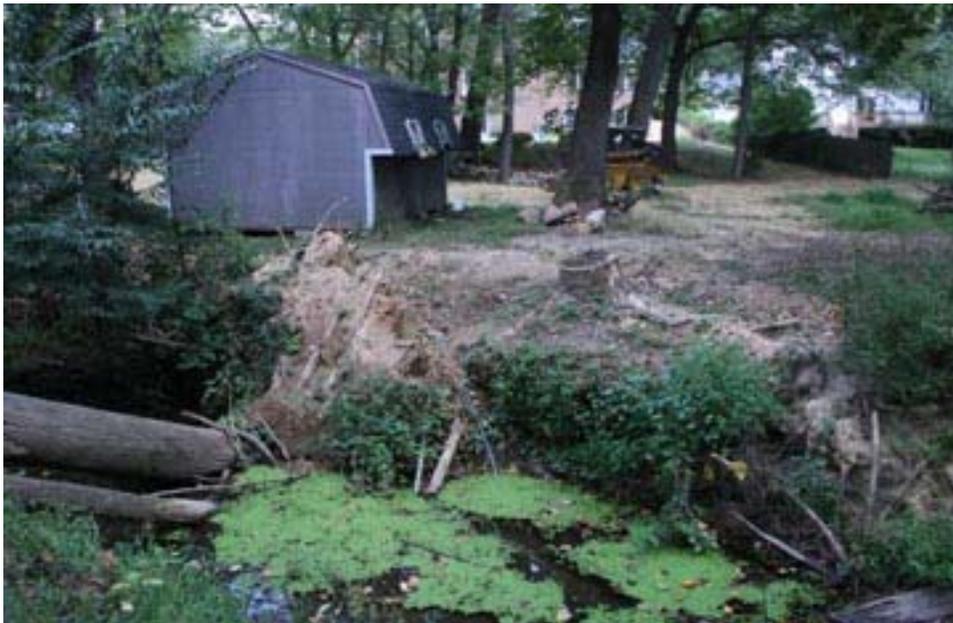
Fig. 23 – Failing bank and collapsed tree adjacent to shed at downstream end of Reach 5.3

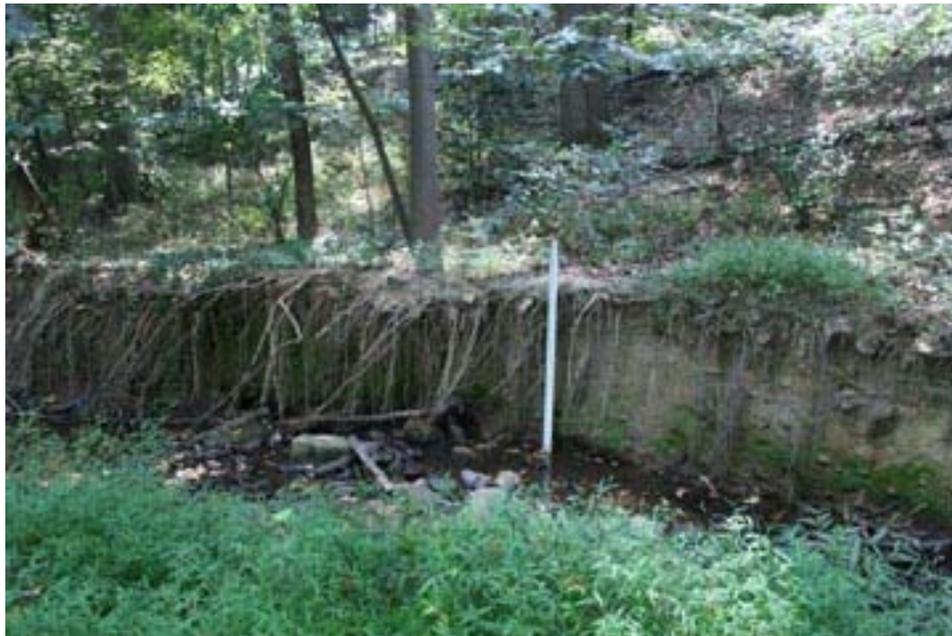
Fig. 24 – Bank erosion in upper section of Reach 6.1

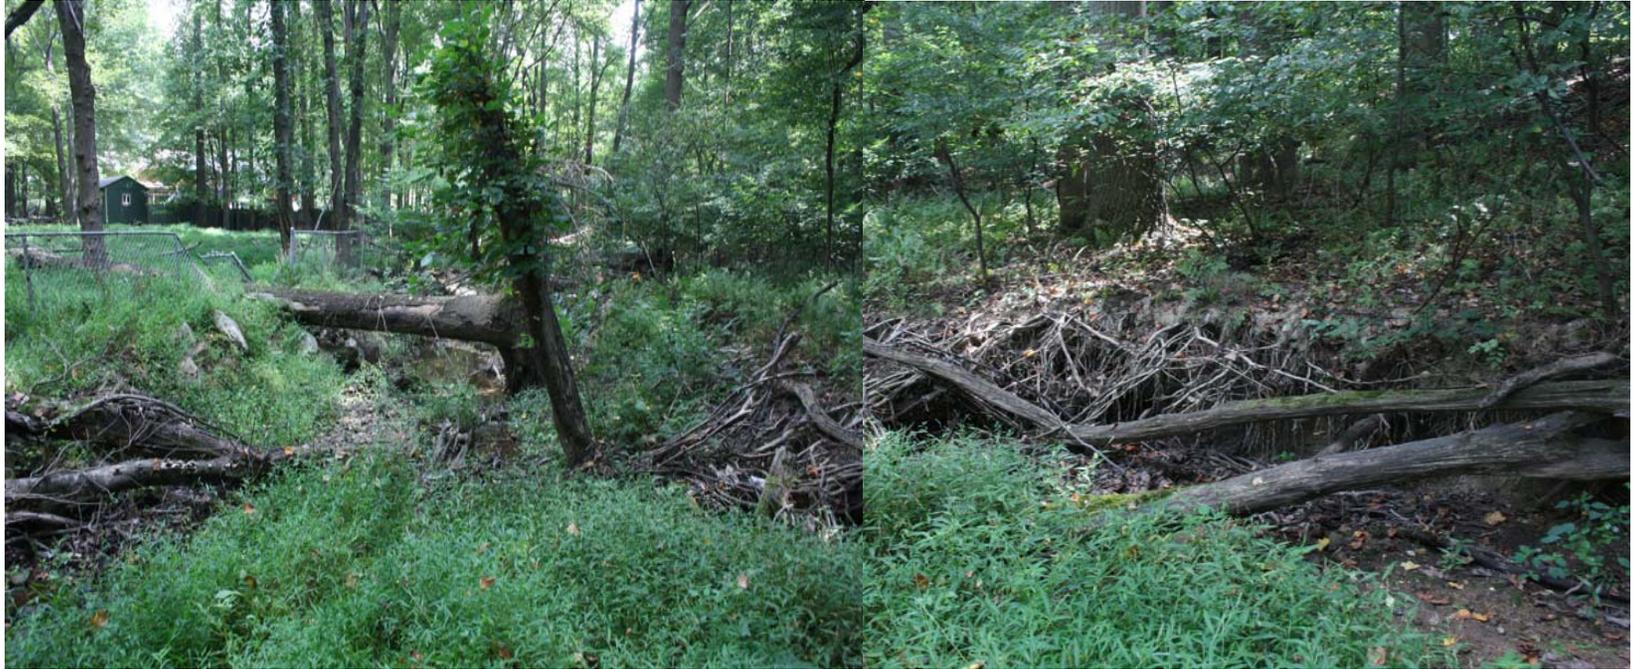
Fig. 25 – Split channel, large debris jam, and aggradation in upper section of Reach 6.1

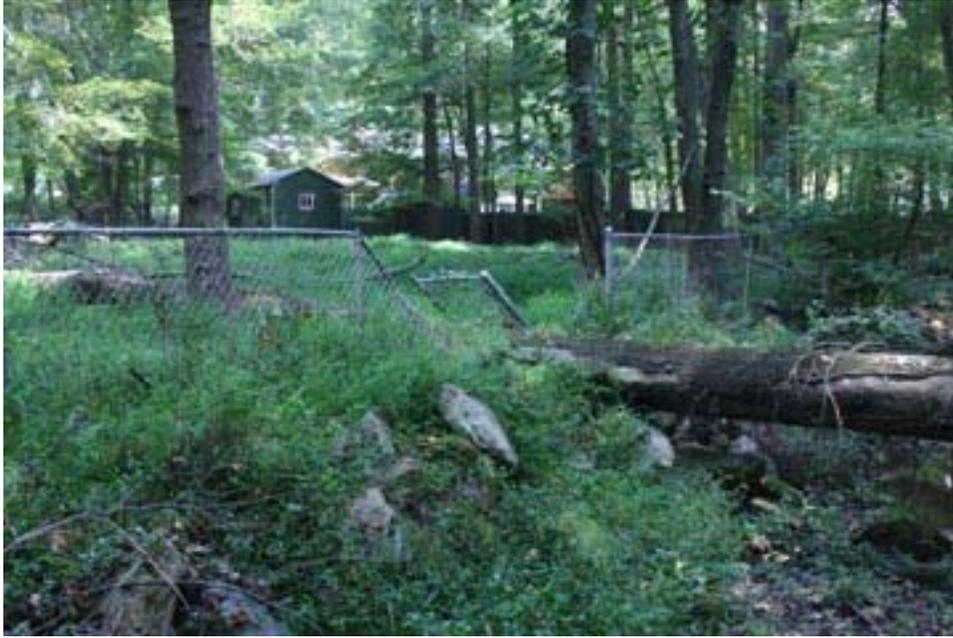
Figs. 26 and 27 – Collapsed trees and damaged fences in upper section of Reach 6.1

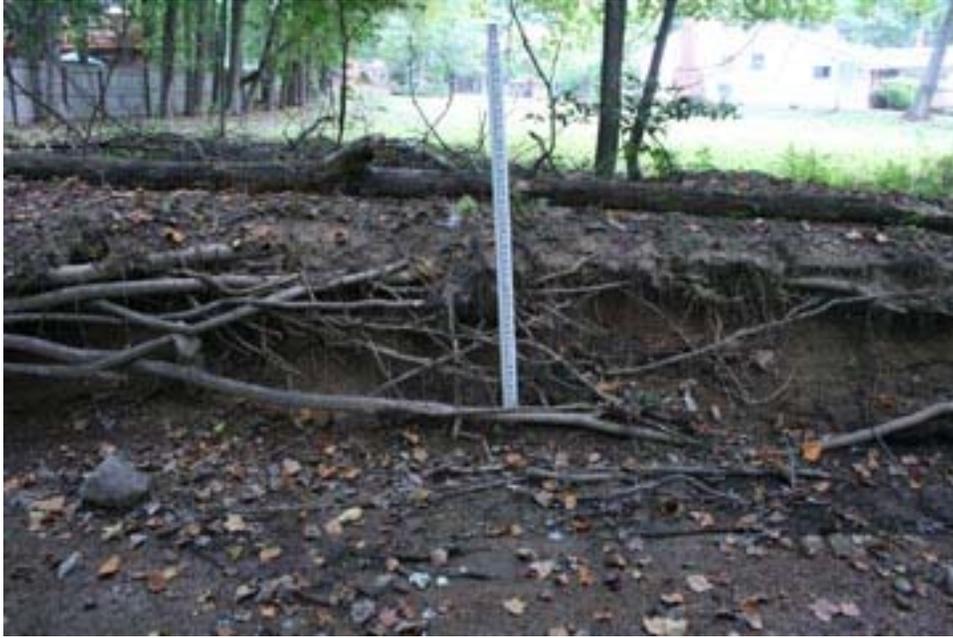
Fig. 28 – Bank erosion along lower section of Reach 6.1

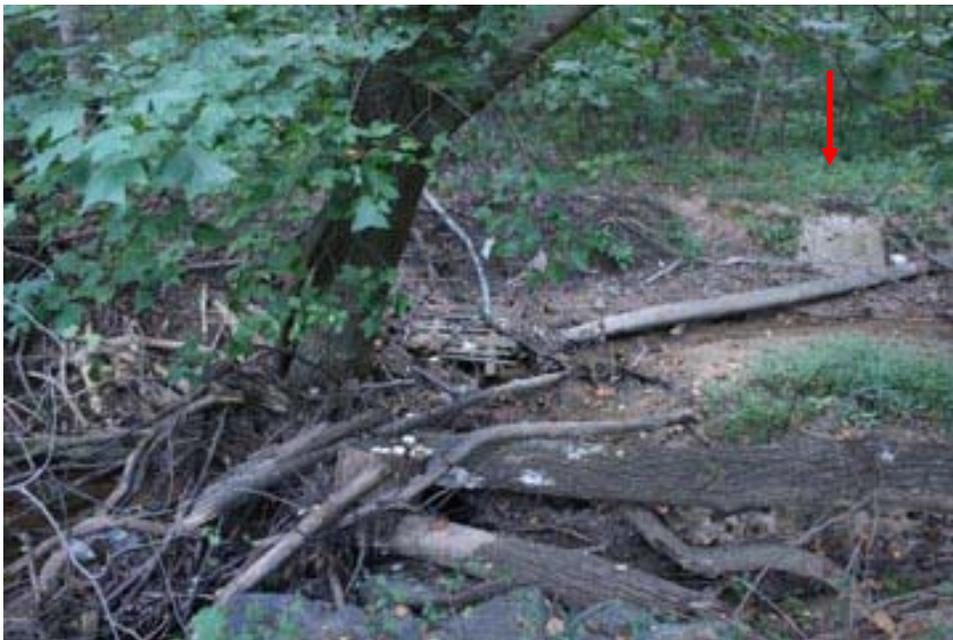
Fig. 29 – Debris jam, aggradation and exposed sanitary sewer manhole

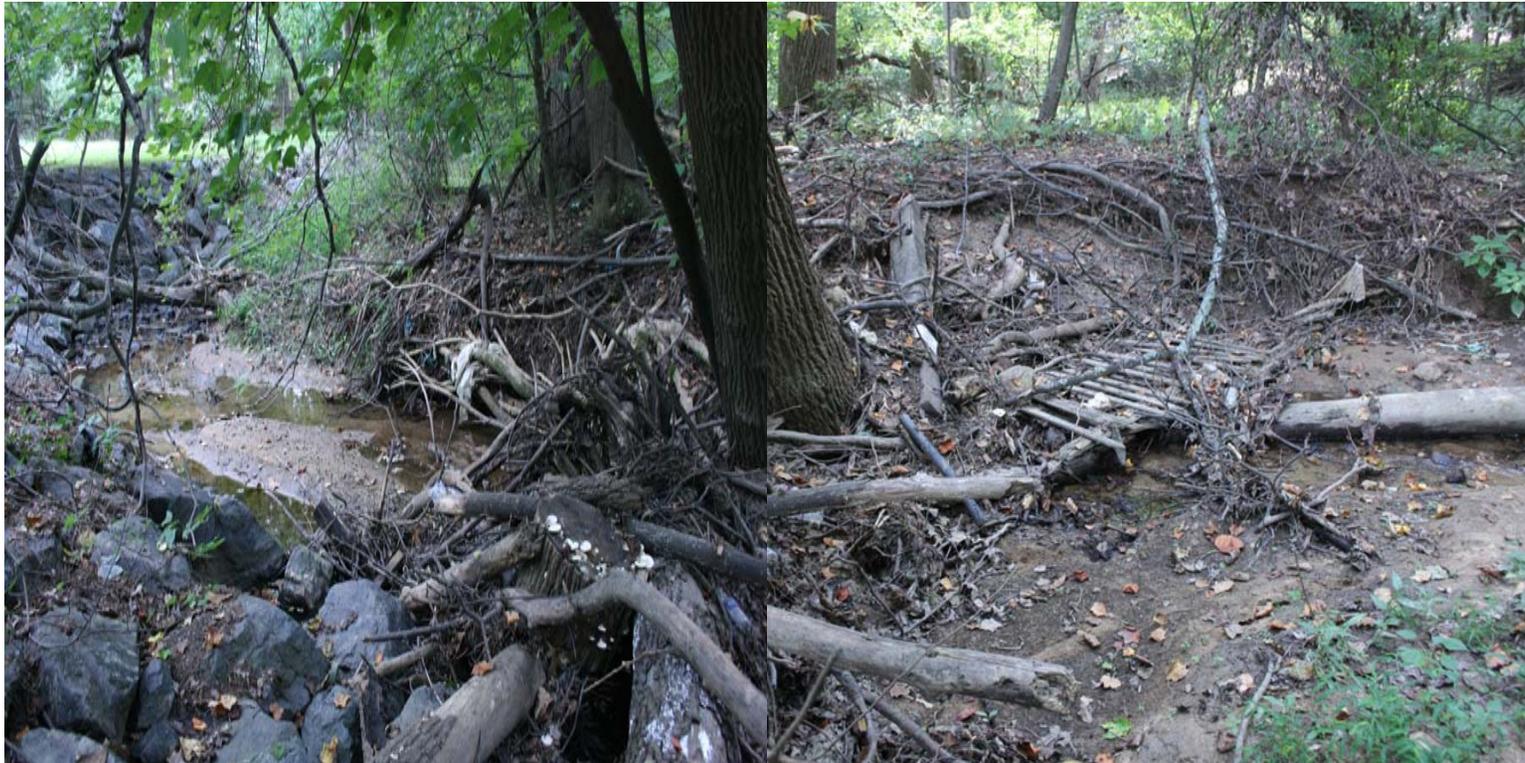
Fig. 30 – Debris jam at knick-point at downstream end of Reach 6.1. Note aggradation upstream and significant drop in bed elevation into Reach 6.2

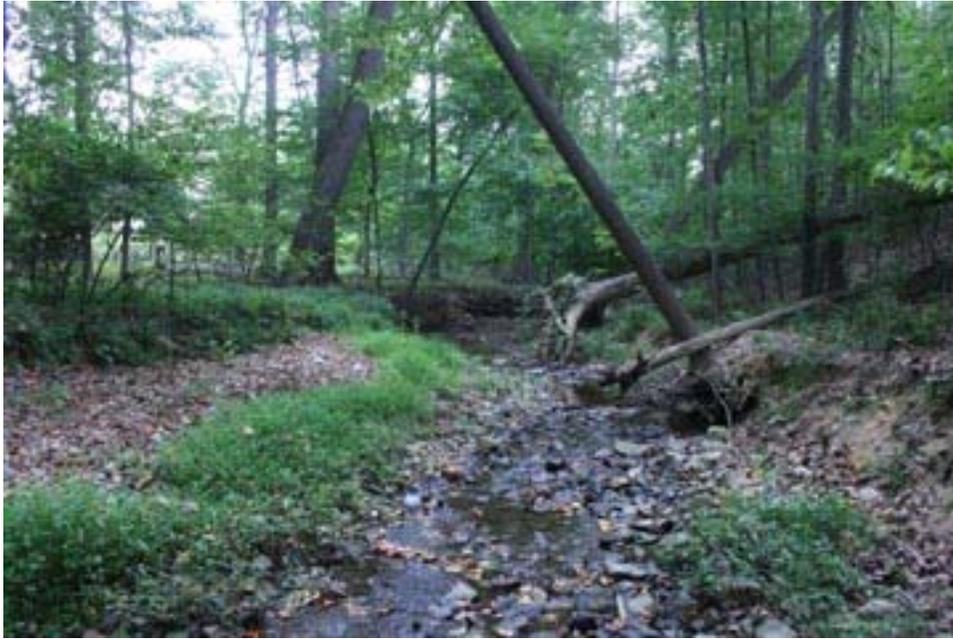
Fig 31 – Falling trees along upper section of Reach 6.3.

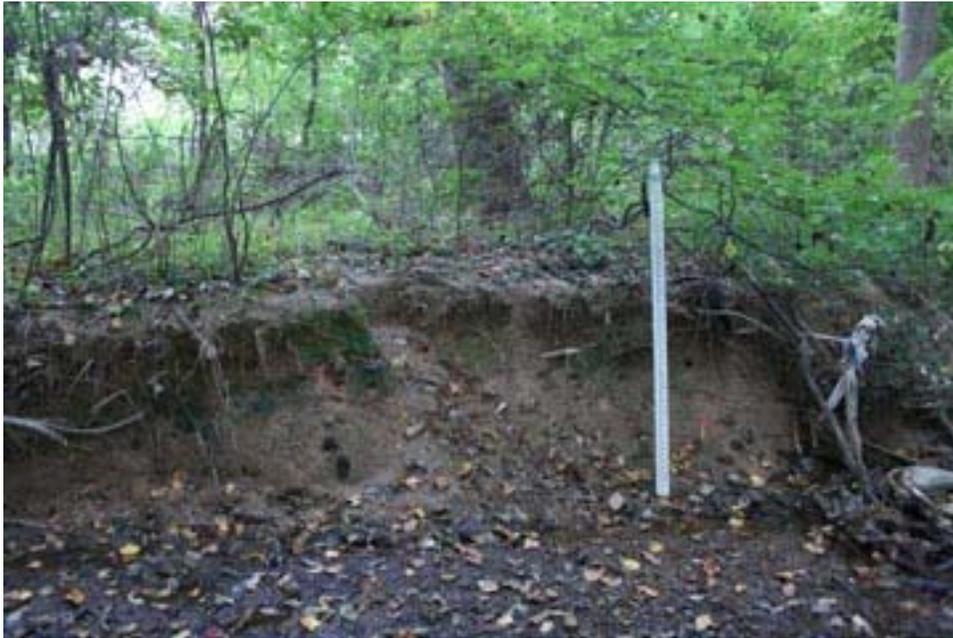
Fig 32 – Bank erosion along middle section of Reach 6.3.

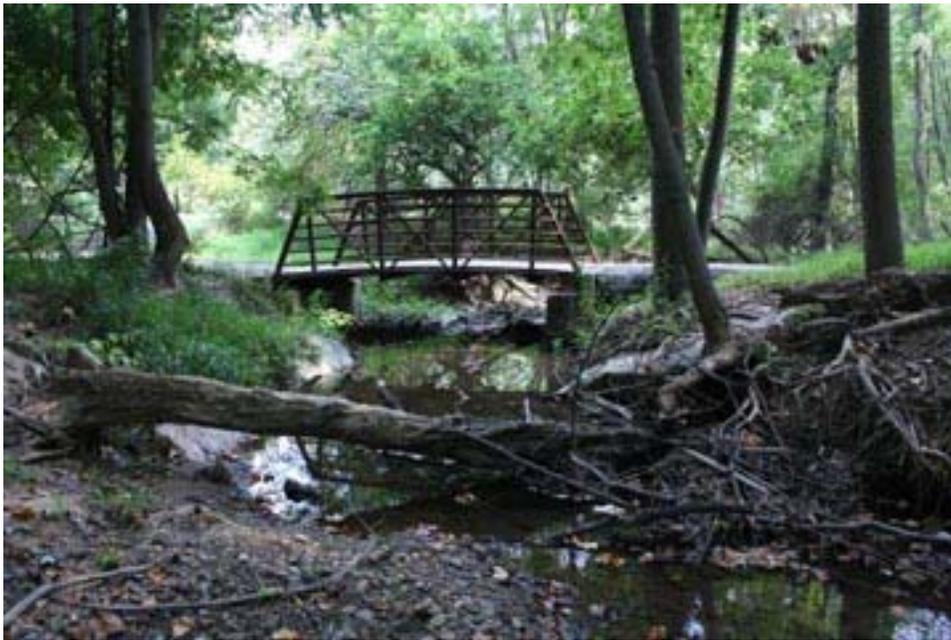
Fig 34 – Debris jam upstream of footbridge at downstream end of Reach 6.3.

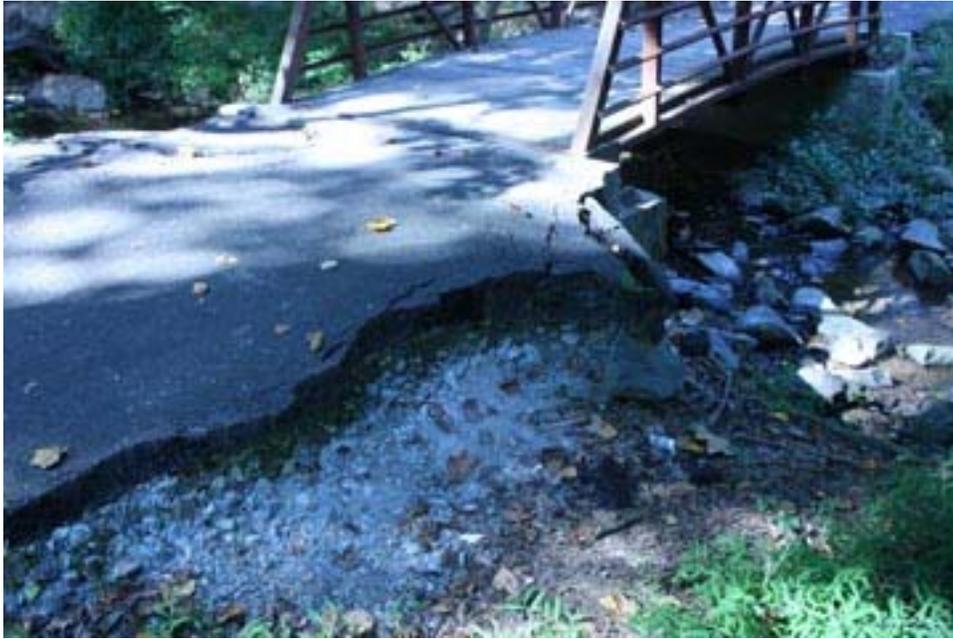
Fig. 35 – Trail at footbridge by storm flow overtopping streambanks

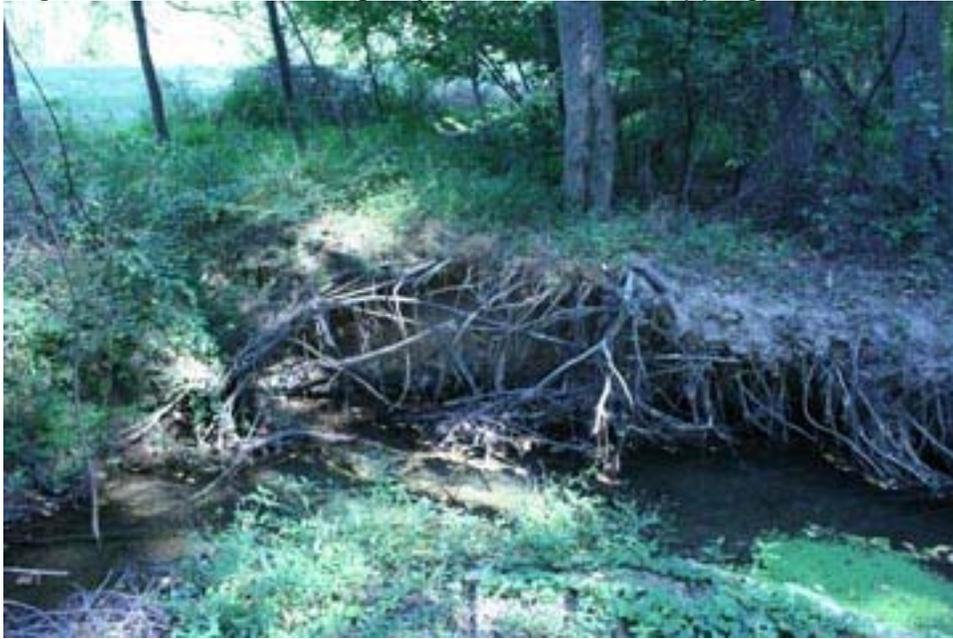
Figs. 36 and 37 – Bank erosion along upper section of Reach 7

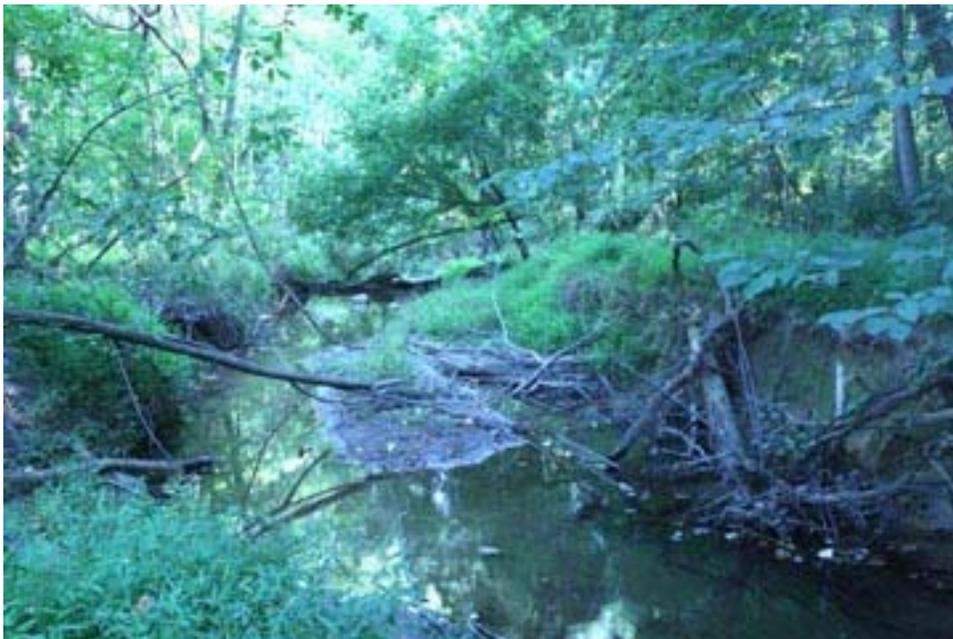
Fig 38 – Bank erosion, debris jam, and aggradation along upper section of Reach 7

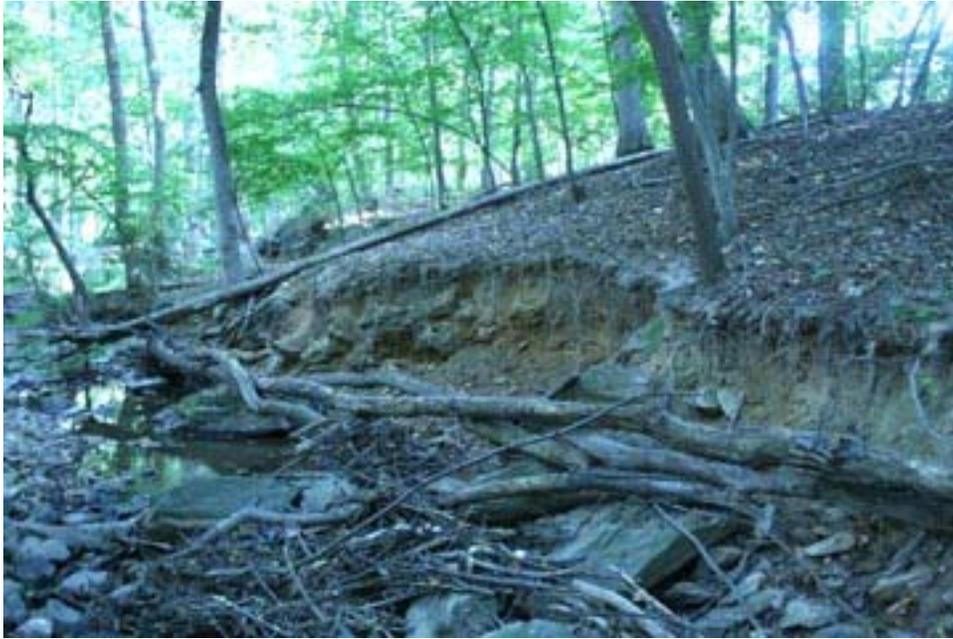
Fig 41 – Bank erosion and debris jams along high terrace in middle section of Reach 7

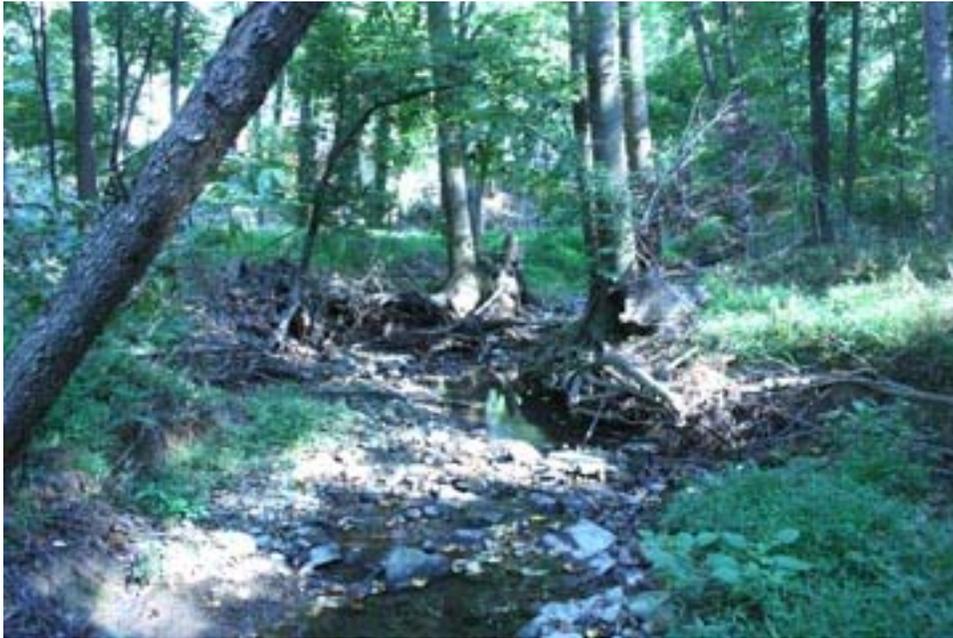
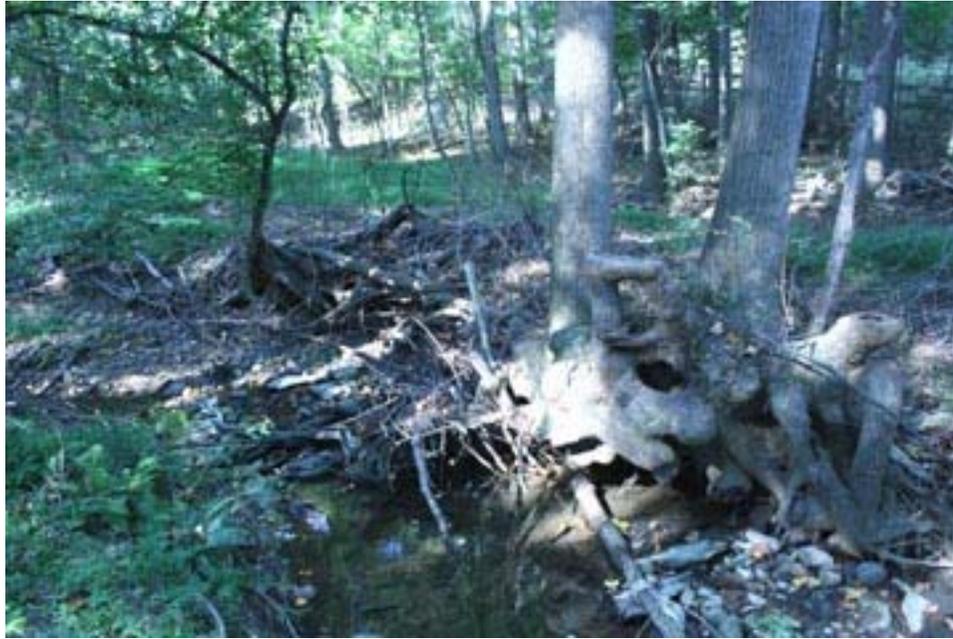
Figs 42 and 43 – Severely undercut trees, debris jams and lateral bars along lower section of Reach 7

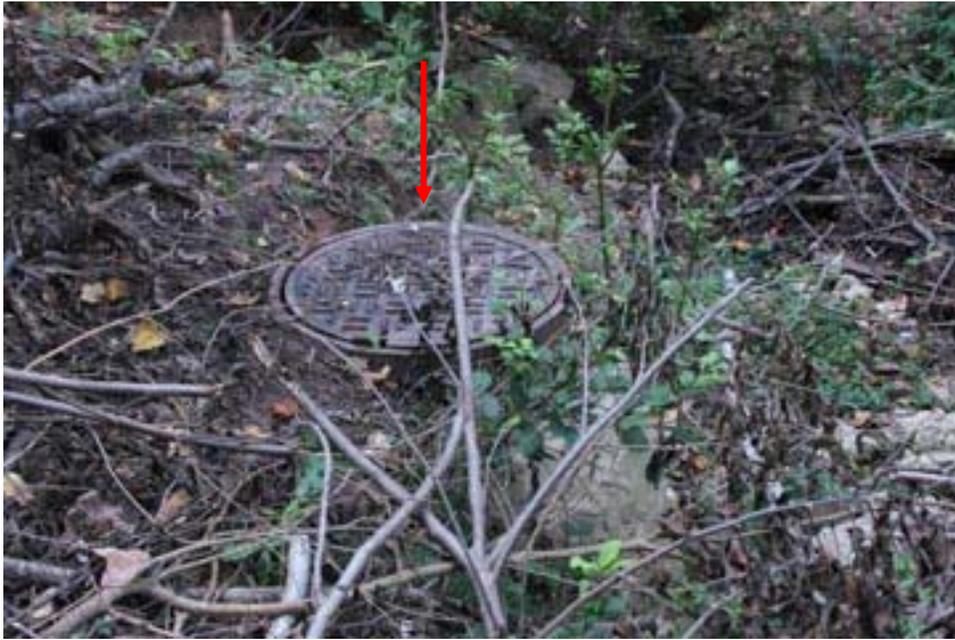
Fig. 47 – Exposed sanitary sewer manhole

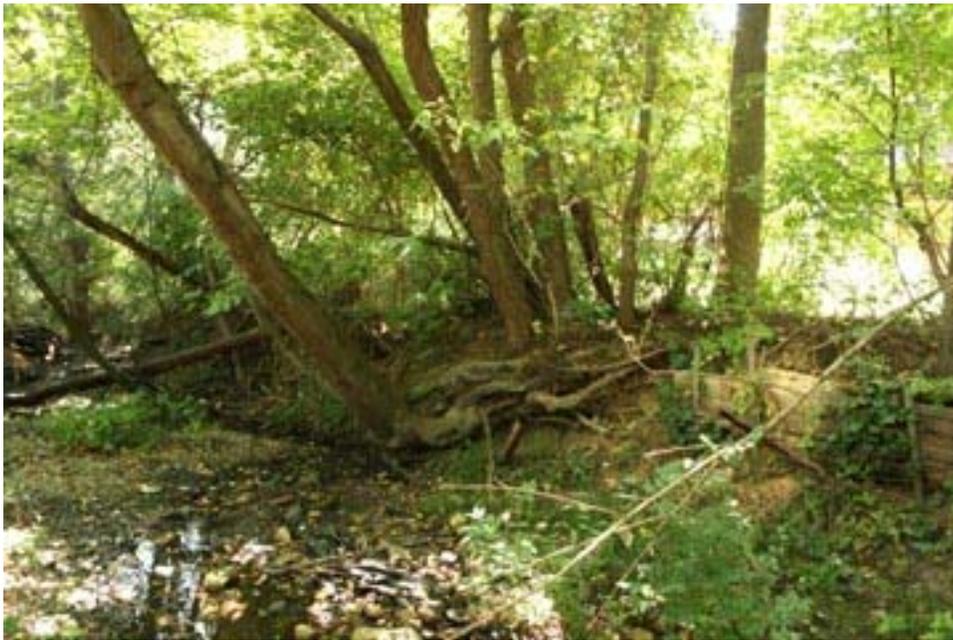
Figs. 51 and 52 – Eroding banks, failing retaining wall, mid-channel bars along upstream end of Tributary 3.1

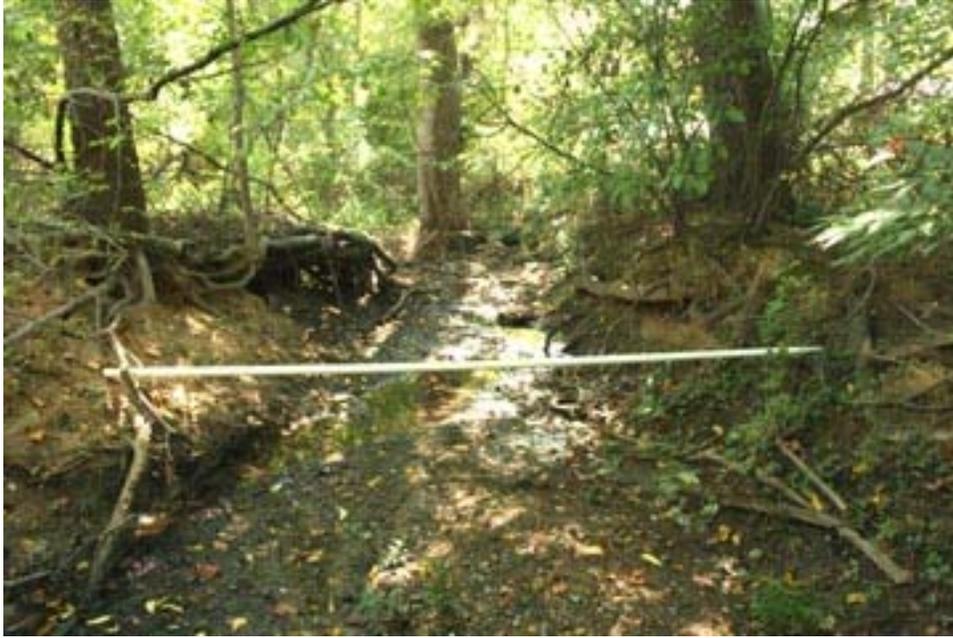
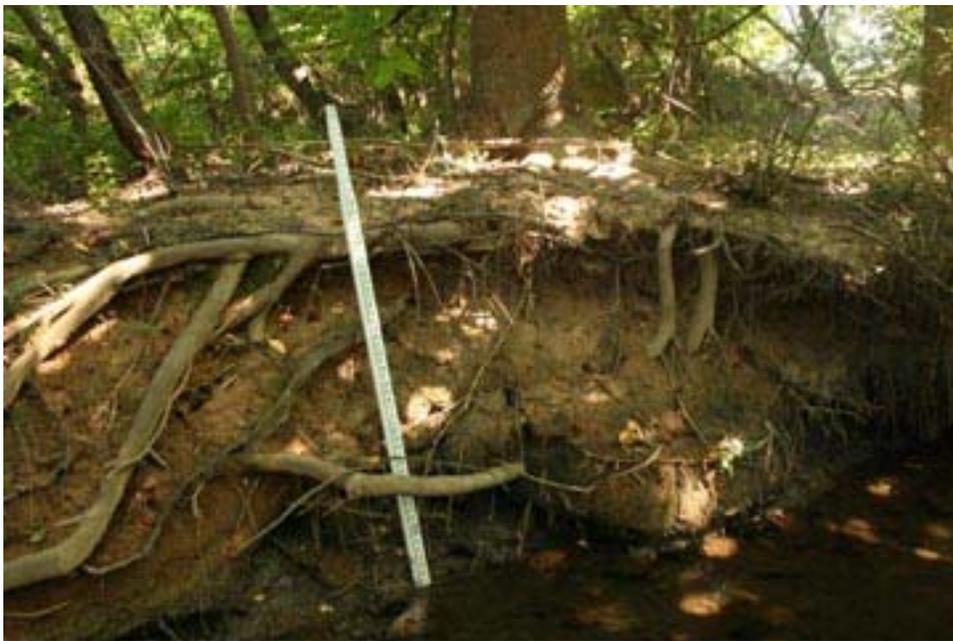
Figs. 53 and 54 – Eroding banks, debris jams, split channel, and aggradation along middle section of Tributary 3.1

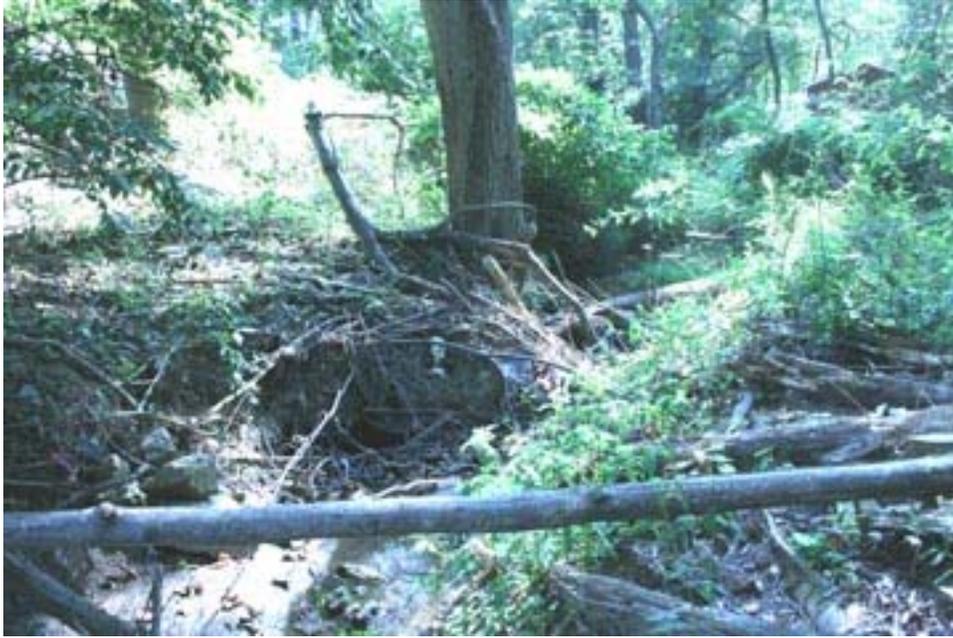
Figs. 55 and 56 – Head-cut at upstream end of Tributary 3.3
Note – debris jam and aggradation upstream of head-cut
