Hollywood Branch Stream Restoration

Preliminary Assessment Report_ Revised
January 2009

30% Concept Design Report
June 2009

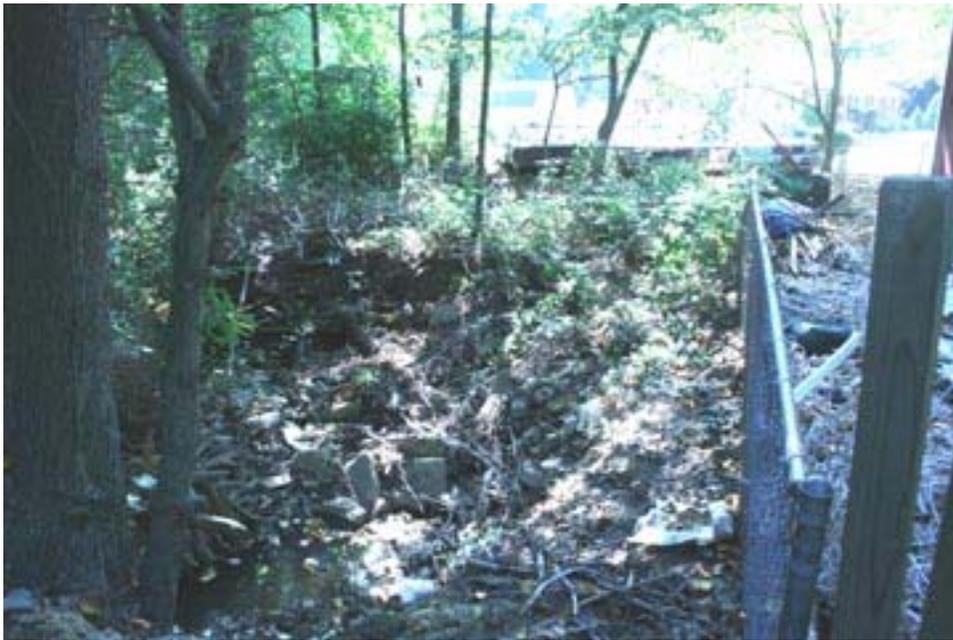
Fig. 57 – Deeply incised channel along Tributary 3.3 with active bank erosion adjacent to structure and fence. Note - debris and rubble dumped into channel by landowner attempting to stabilize bank

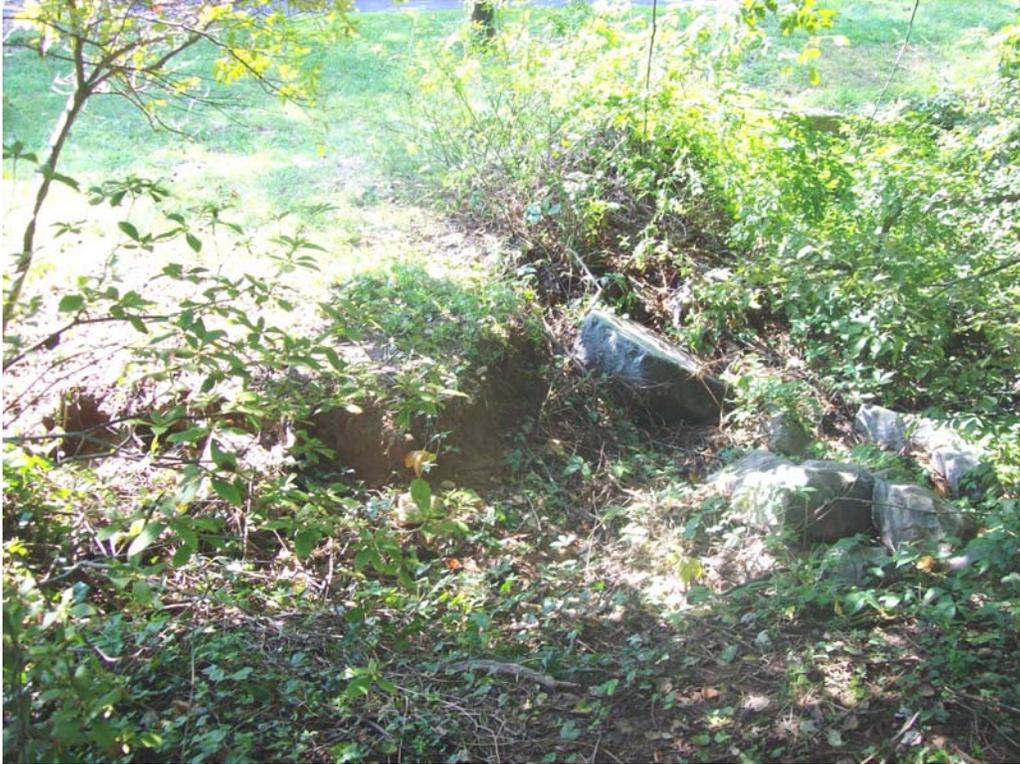
Figure 1.1 Nickpoint upstream of Copley Lane culvert.

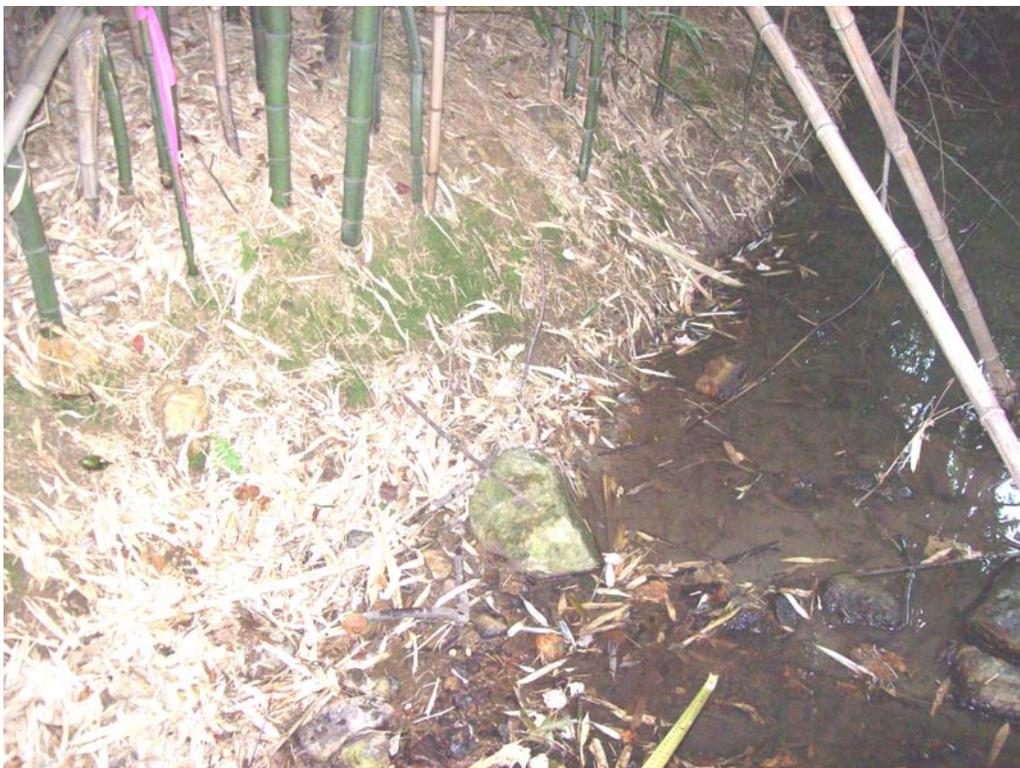
Figure 4.2.1 Small pipe perpendicular to flow at cross section 4.4.

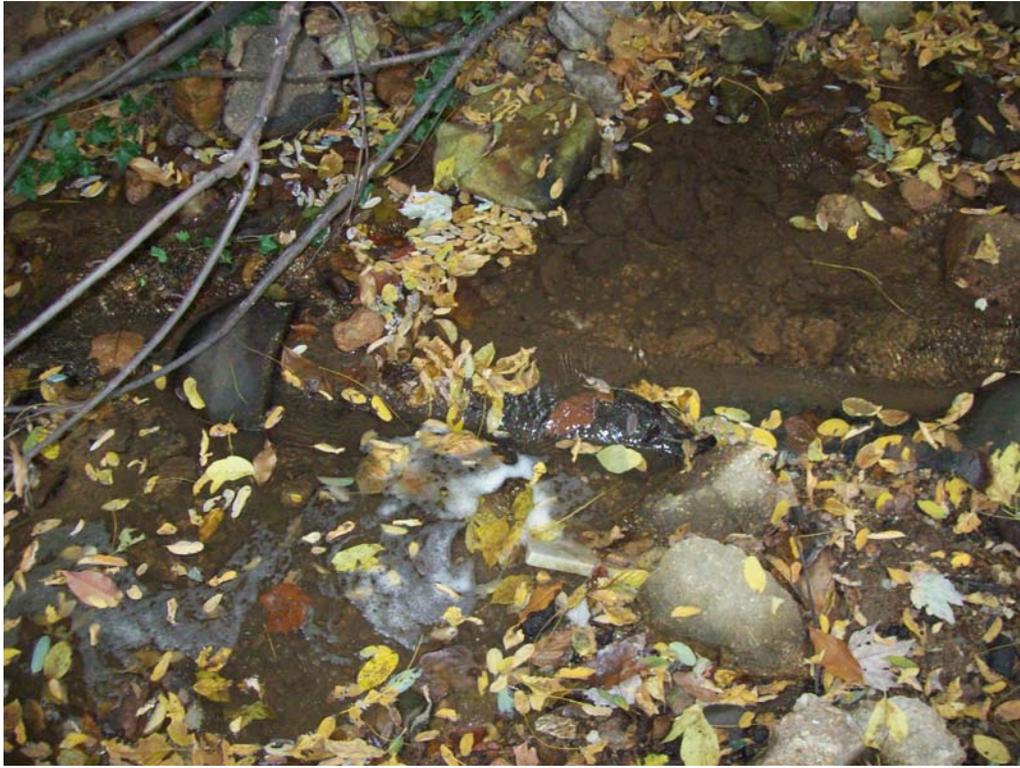
Figure 5.1.1 Exposed 8" sewer line near cross section 5.1

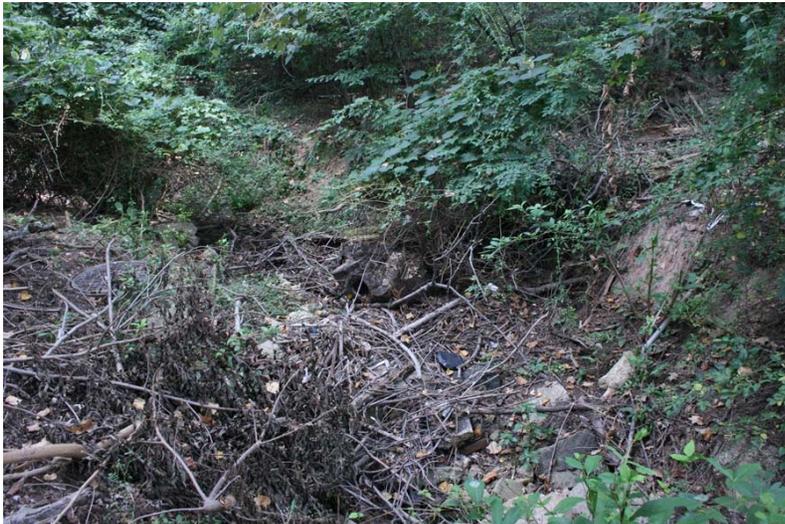
Figure 5.1.2(c) Degraded earth channel.

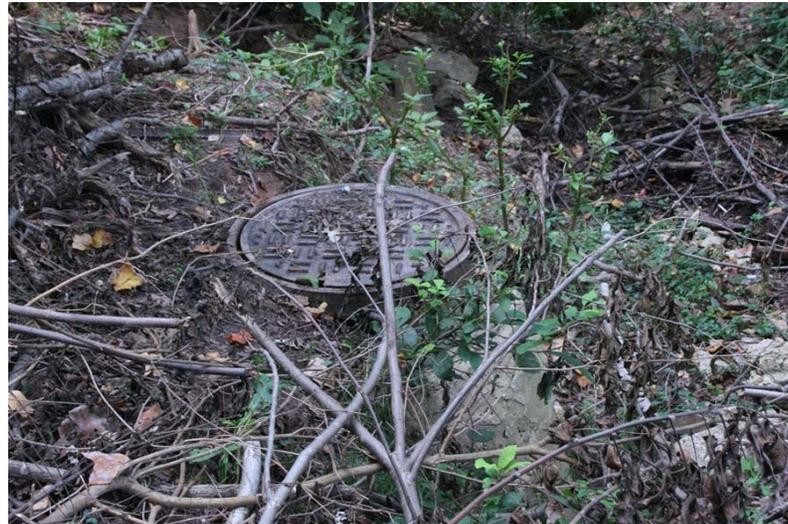
Figure 5.1.2(d) Exposed sewer manhole.

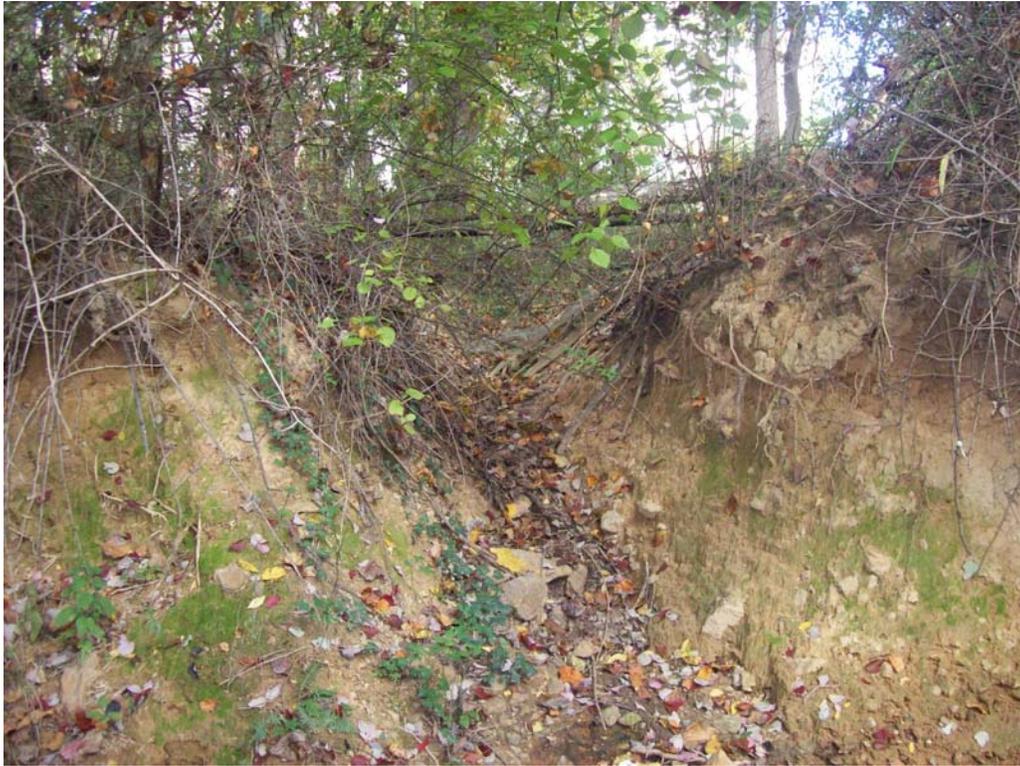
Figure 5.1.3(a) Erosion channel as viewed upstream.

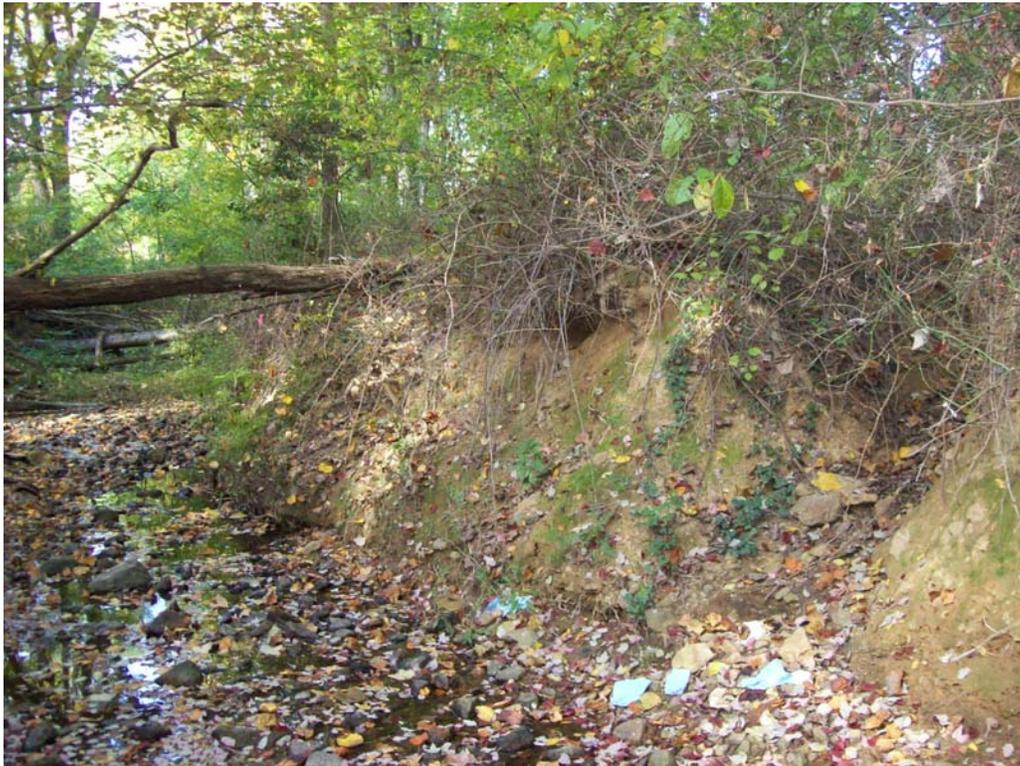
Figure 5.1.4(b) Erosion channel junction with Hollywood Branch (upstream view).

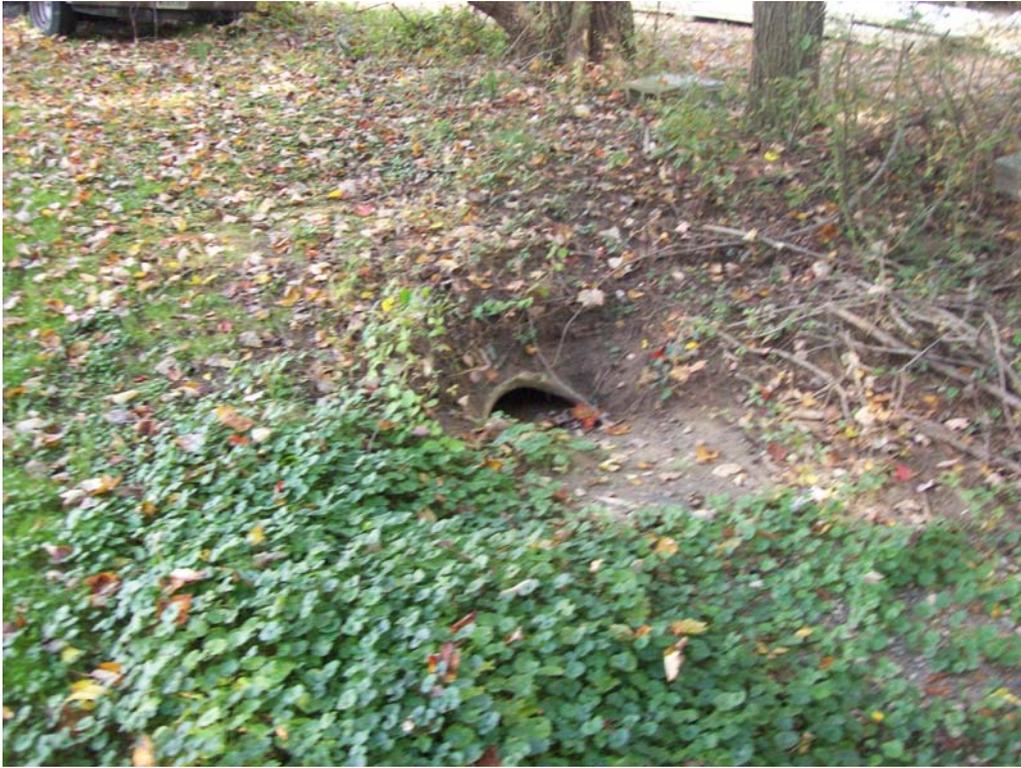
Figure 5.3.1(a) Half-full Anderson St. storm drain outfall.

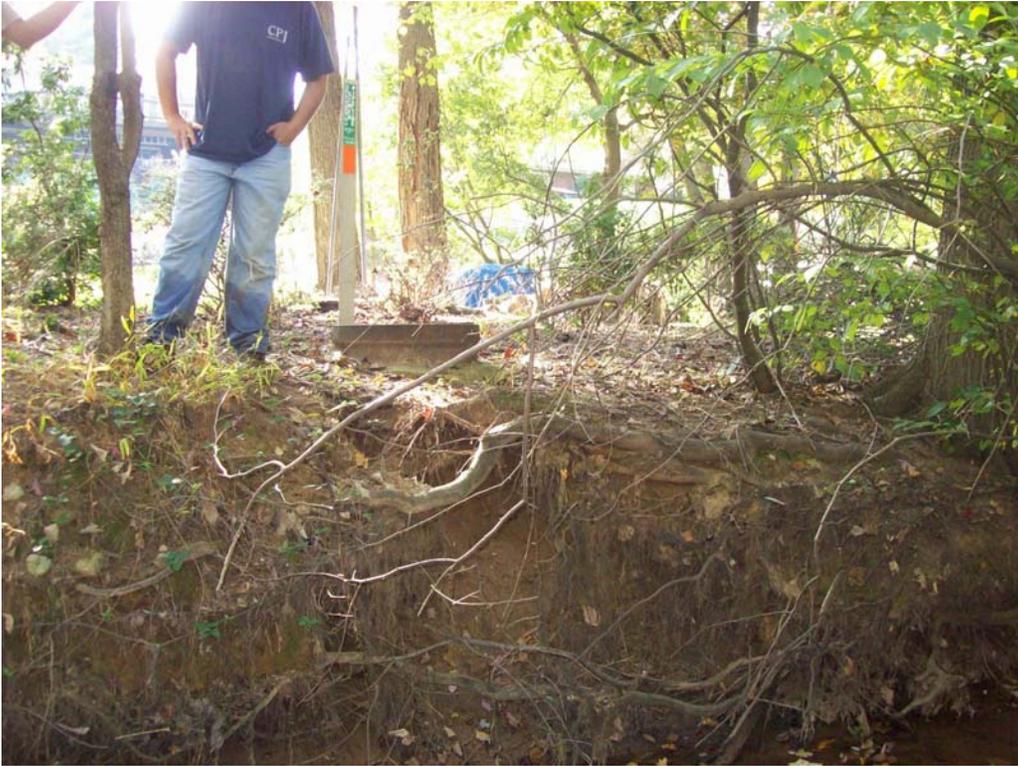
Figure 5.3.2 Sewer manhole almost exposed downstream of cross section 5.7.

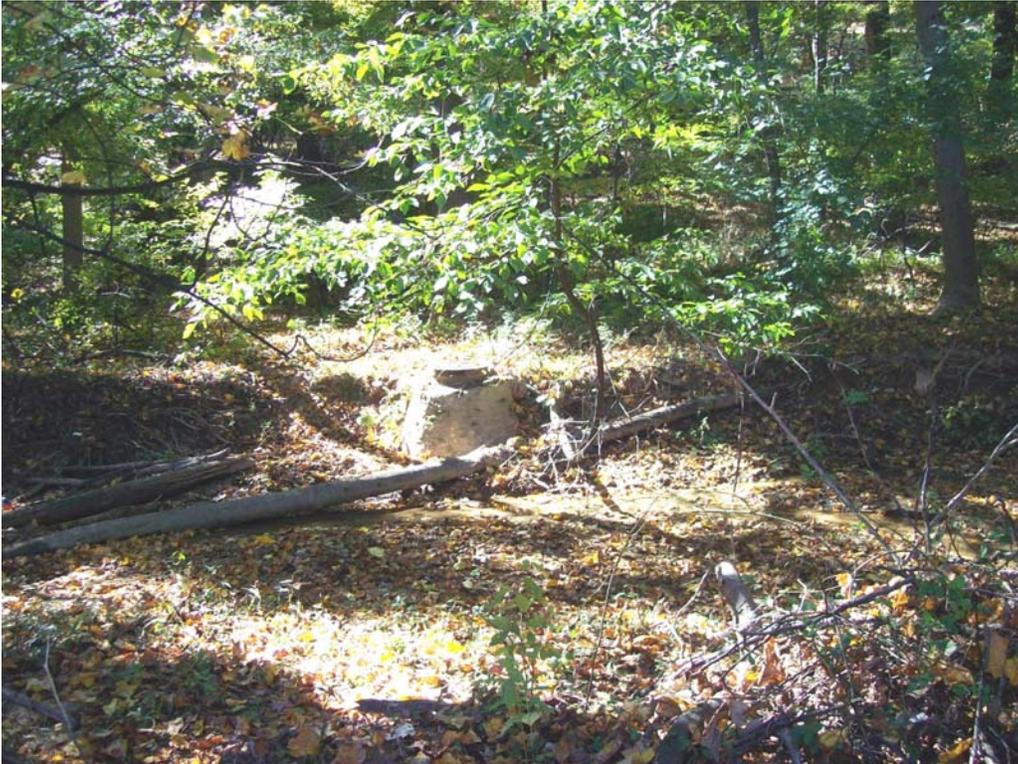
Figure 6.1.1 Exposed sewer manhole across from last residence on Anderson St.

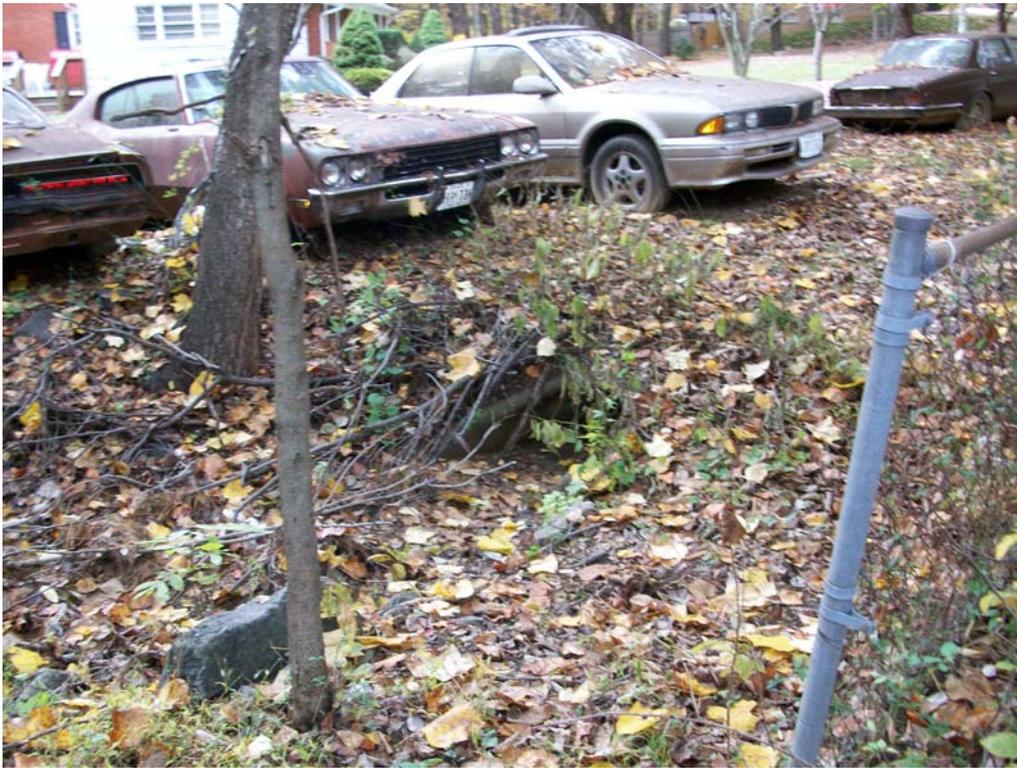
The storm drain from Burkart Bea Kay Drive in section 3 of Tributary 3 has impeding sediment in its apron; see Figure Trib 3.3.1(a). The outfall storm drain flow is causing erosion and a high grade near the junction with Hollywood Branch; see the unstable rip rap in Figure Trib. 3.3.1(b).

Figure Trib. 3.3.1(a) Storm drain on Burkart Bea Kay Drive.

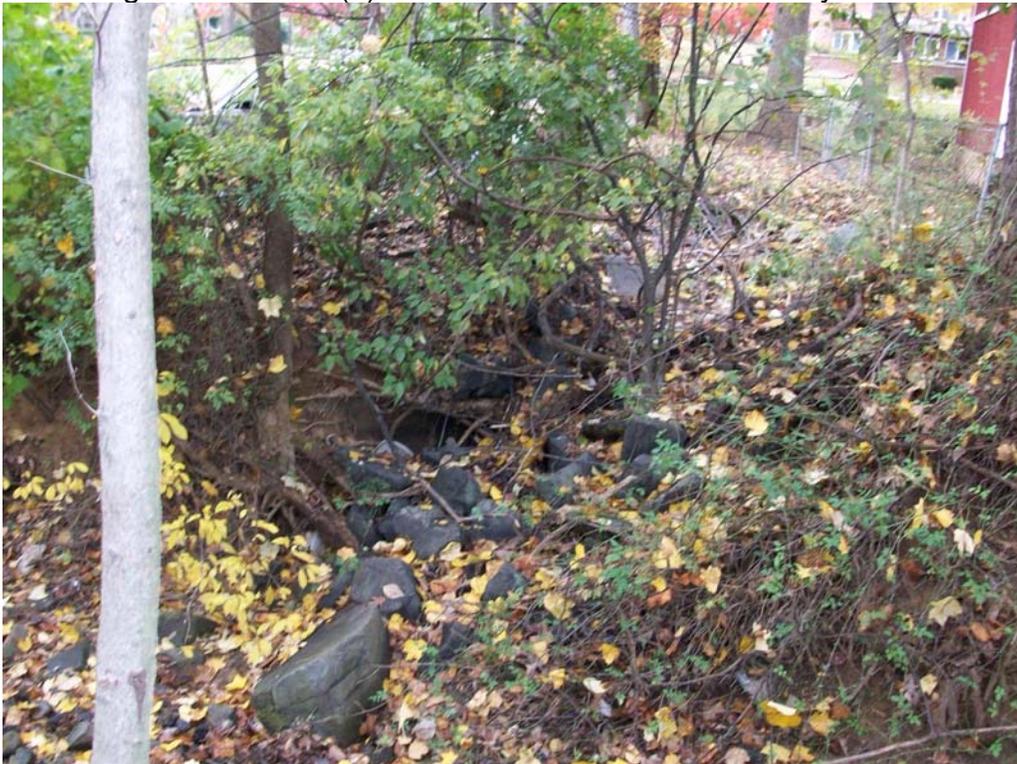
Figure Trib. 3.3.1(b) Unstable rip rap near Hollywood Branch junction.
