# Cabin John Creek Watershed

## 3.16 Lower Booze Creek Stream Restoration

### 3.16.1 Introduction

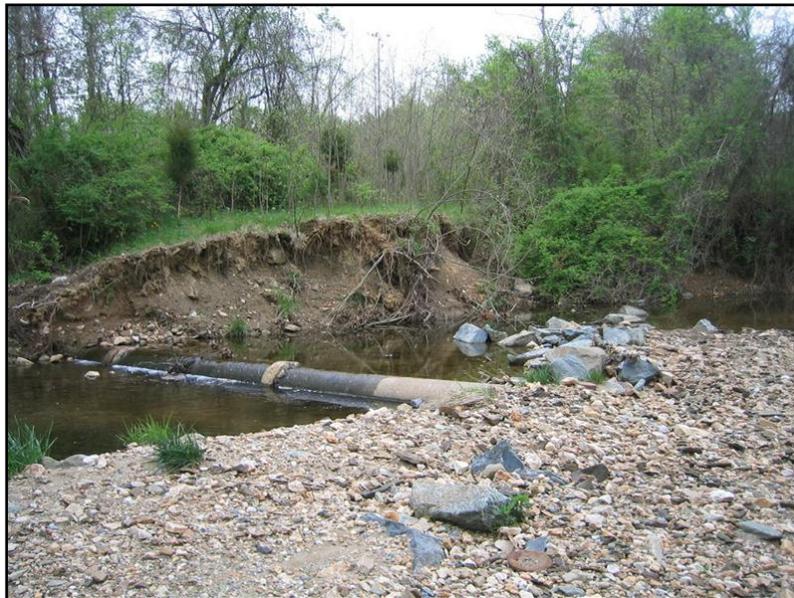
In 2003, the Lower Booze Creek was identified by the Department of Environmental Protection (DEP) as being a priority for stream restoration. The stream within the project site was severely eroded, had exposed sewer lines and manhole risers, and had a sparsely vegetated riparian zone (*Figure 3.16.1*). The design for this project includes stabilizing the stream banks, cleaning and protecting the sewer infrastructure, improving the instream habitat for stream biota, and planting riparian vegetation. Construction of this project is scheduled for 2012. This is a pre-restoration report; it describes the project goals, pre-restoration monitoring plan, and the results of the monitoring performed to establish baseline conditions at this site.

*Figure 3.16.1 – Lower Booze Creek Stream Prior to Restoration (2007)*

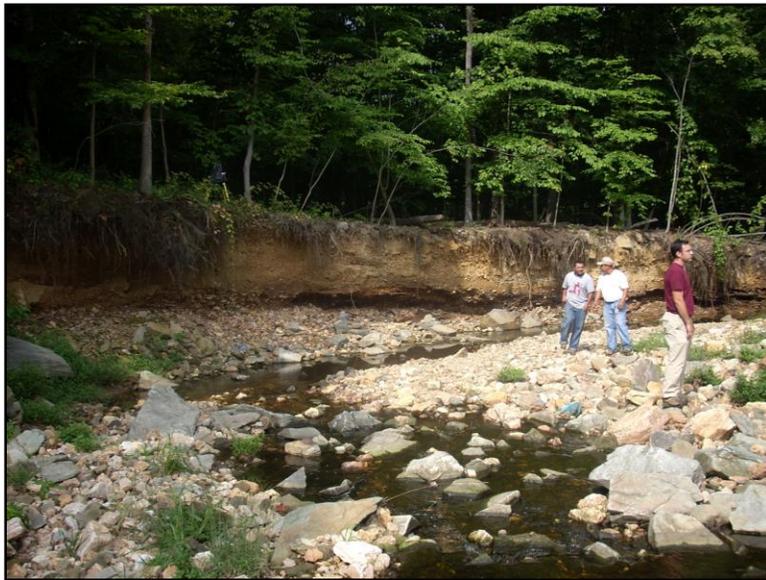
The Booze Creek tributary exhibited widespread, severe bank erosion with many vertical banks exceeding 6-8 feet in height (**Figure 3.16.2**).

***Figure 3.16.2 – Severe Streambank Erosion along Lower Booze Creek, Prior to Restoration (2007)***

Boulder rocks will be installed at the toe of the streambank slopes to help stabilize the area of the stream channel subject to the greatest erosive or “shear” stress. The slopes above the reinforced toe will be graded back to create new floodplain terraces and will be planted with native trees and shrubs to further stabilize the streambanks. The project will attempt to save undercut streambank trees with supportive “rock packing”. More seriously damaged trees will be flush cut, allowing the root systems to remain in the bank for stabilization. To increase and enhance the riparian habitat and stream buffer, approximately 2,400 live stakes, 2,400 tubelings, 1,500 shrubs, and 950 trees are scheduled to be planted after the in-stream portion of the project is complete.

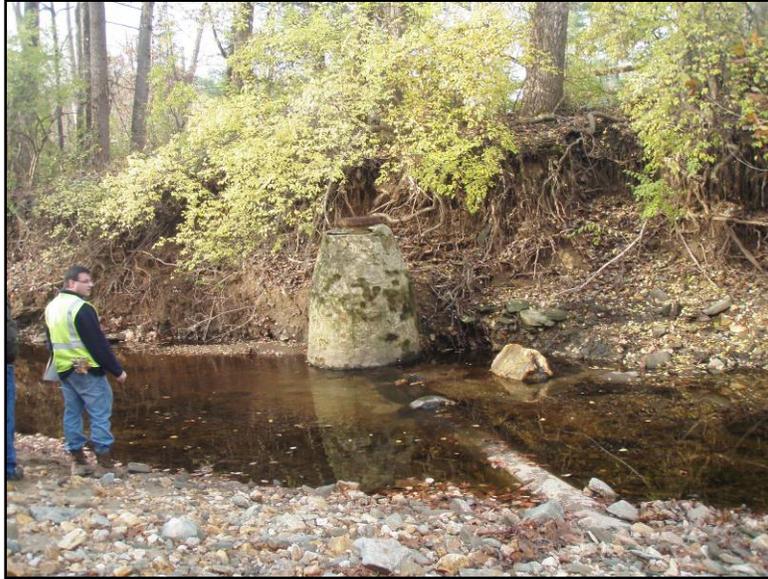
Numerous sewer lines and manhole risers have been exposed by scour and were in danger of being severely damaged by continued erosion (**Figure 3.16.3**).

***Figure 3.16.3 – Exposed Sewer Line and Manhole Riser in Lower Booze Creek, Prior to Restoration (2010)***

Montgomery County is working closely with the Washington Suburban Sanitary Commission (WSSC) to protect buried sewer lines with channel grade controls and divert stream water flow away from exposed manholes. The WSSC will use the County’s temporary construction access to clean and reline existing sewer lines, further protecting sewer infrastructure. Additionally, WSSC will replace an exposed water main located downstream of River Road.

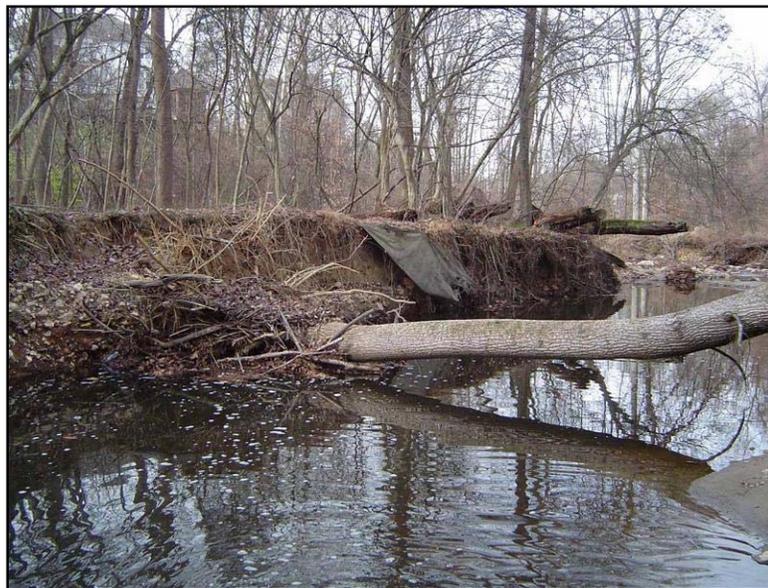
Many trees were being undercut and falling into the stream resulting in debris jams and additional localized bank erosion (***Figure 3.16.4***).

***Figure 3.16.4 – Undermined Tree, Debris Jam, and Streambank Erosion along Lower Booze Creek, Prior to Restoration (2004)***

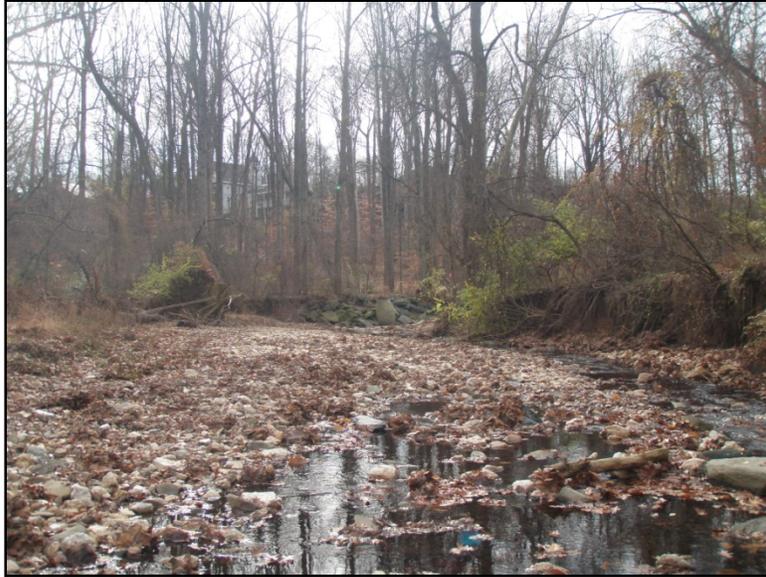
The stream appeared to be somewhat over-widened resulting in poor sediment transport, sediment deposition, lateral erosion, and the loss of habitat features (***Figure 3.16.5***).

***Figure 3.16.5 – Over-widened Stream Channel in Lower Booze Creek, Prior to Restoration (2010)***

The Booze Creek project will use in-stream restoration techniques and reforestation to help stabilize streambanks and enhance riparian habitat. The proposed instream structures include rock and log vanes, which will direct water away from unstable stream banks, create downstream scour pools, and provide stable and suitable habitat for fish. Rock cross vanes will also function as grade control structures, which will slow the erosive process of stream down-cutting. Root wad revetments are instream structures that are proposed to help stabilize streambanks, create scour holes, and provide overhead cover for fish.
