# Anacostia River

# Paint Branch

## 3.5 Hollywood Branch Stream Restoration Project

The more specific restoration goals are presented below in **Table 3.5.1**, along with the monitoring performed to characterize pre-restoration conditions, and when and where monitoring has occurred or is planned to occur following restoration. This is a pre-construction monitoring report and summarizes the pre-restoration conditions within the Hollywood Branch Stream Restoration Project area.

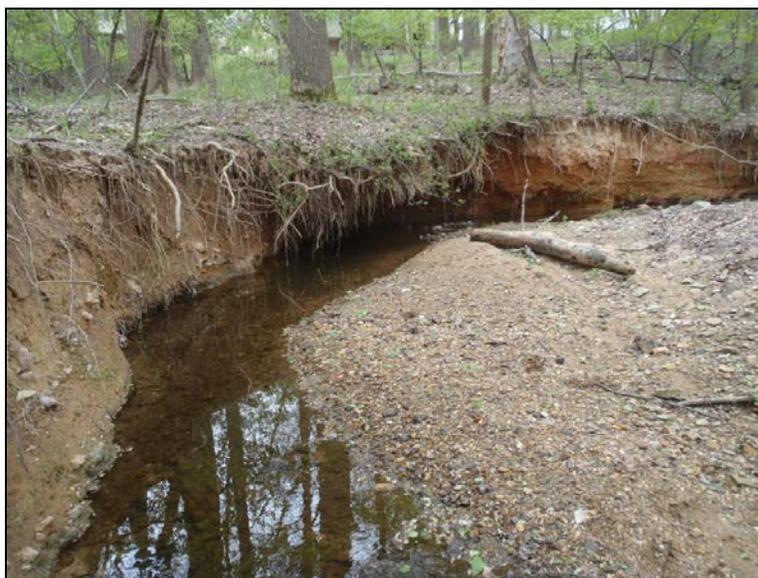
*Figure 3.5.2 – Hollywood Branch Pre-Restoration (2012)*

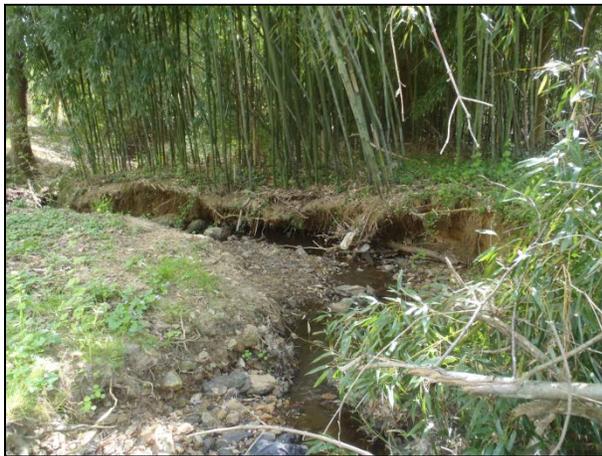
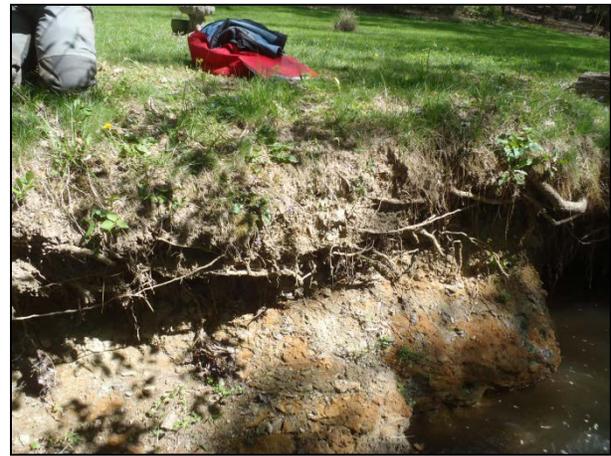
In general, the existing riparian conditions in the upper half of the project (on private property) is mostly manicured lawn with scattered trees, while the lower half is located within stream valley parkland and has forested riparian conditions. Not surprisingly, the most significant streambank erosion occurs through the private property portion where there is little to no streambank protection (*Figures 3.5.3 – 3.5.5*).

**Figure 3.5.3 – Hollywood Branch Pre-Restoration (2012), examples of streambank erosion and invasive bamboo within study reach 4, between Midland Road and Randolph Road.**

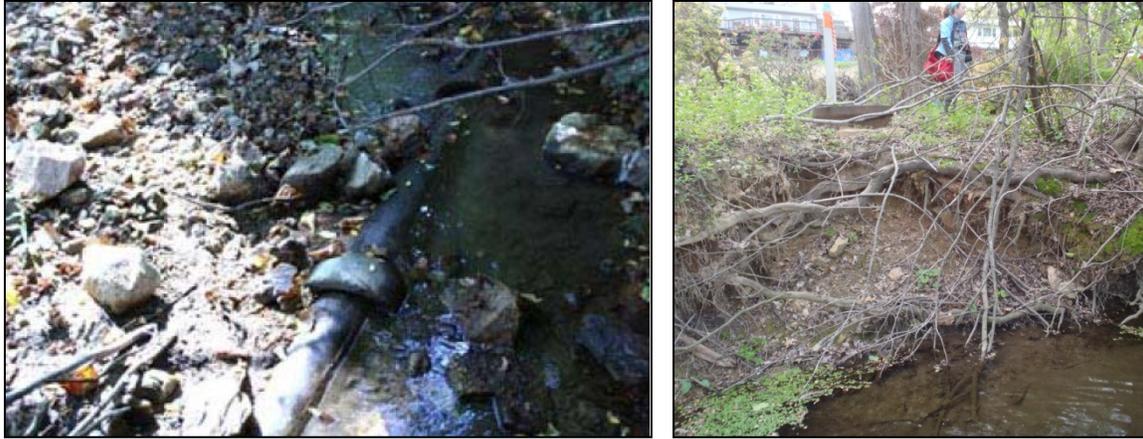
***Figure 3.5.4 – Hollywood Branch exposed sanitary sewer (left) and eroding streambank adjacent to sanitary sewer manhole (right) within study reach 5, just below Randolph Road, prior to restoration (2009)***

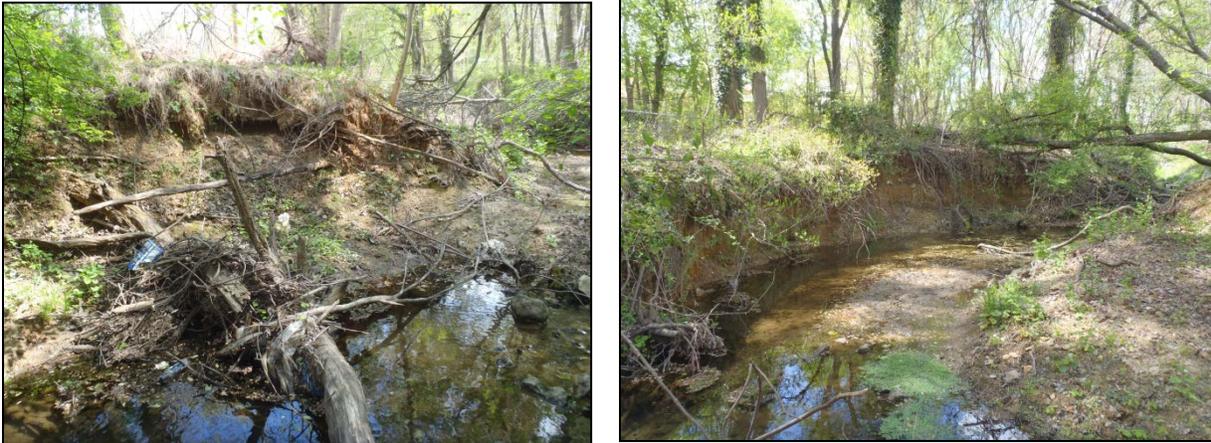
***Figure 3.5.5 – Hollywood Branch pre-restoration (2012) examples of streambank erosion within study reach 5 downstream of Randolph Road***

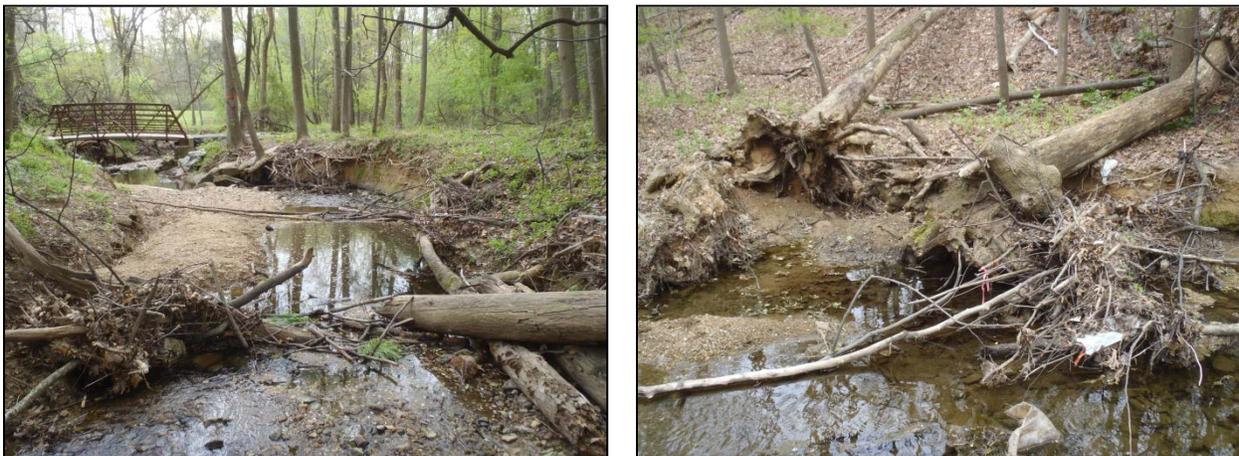
***Figure 3.5.6 – Hollywood Branch pre-restoration (2012) examples of sediment deposition, debris jams, active streambank erosion, and failing streambanks with collapsed trees, within study reach 6, on parkland downstream of Randolph Road, just upstream of pedestrian bridge***

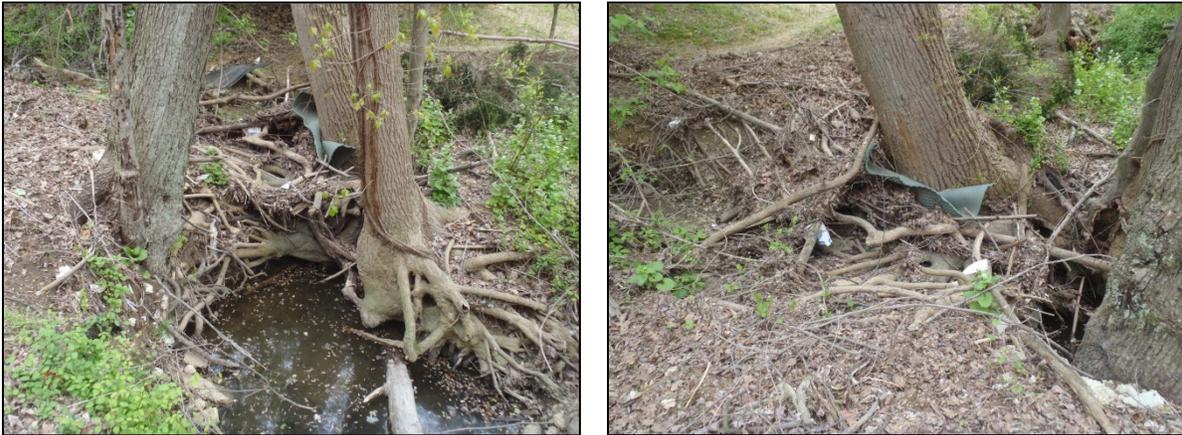
**Figure 3.5.7 – Hollywood Branch pre-restoration (2012) small tributary (study reach 7), showing head-cut with debris jam and aggradation upstream. Tree roots are temporarily holding elevations in place.**
