3.18 Little Falls III Mall Tributary Stream Restoration

3.18.1 Introduction

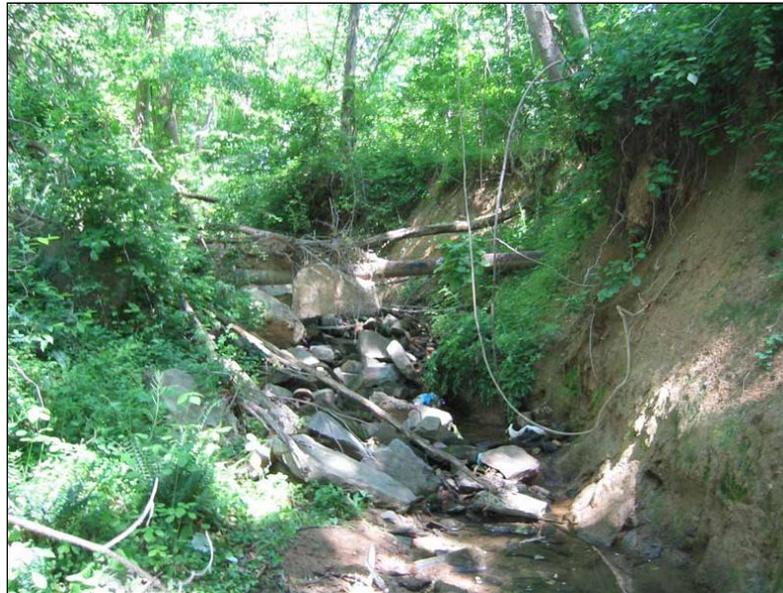
Figure 3.18.1 – Little Falls III Mall Tributary Pre-Restoration in 2005

The majority of drainage into the Little Falls Mall Tributary comes from the Shops at Summers Place where the stormwater flows into a "U" shaped concrete channel. The lower section of the concrete channel is undermined and has fallen apart, causing severe stream erosion. Immediately below the failing concrete channel, there is extreme channel down-cutting. On average, the streambank height within the project area was nine feet, with very minimal vegetation for streambank protection. An exposed, leaking sewer line was found toward the upper end of the project limits. Stream erosion was further increased by five storm drain outfalls that had minimal outfall channel protection.

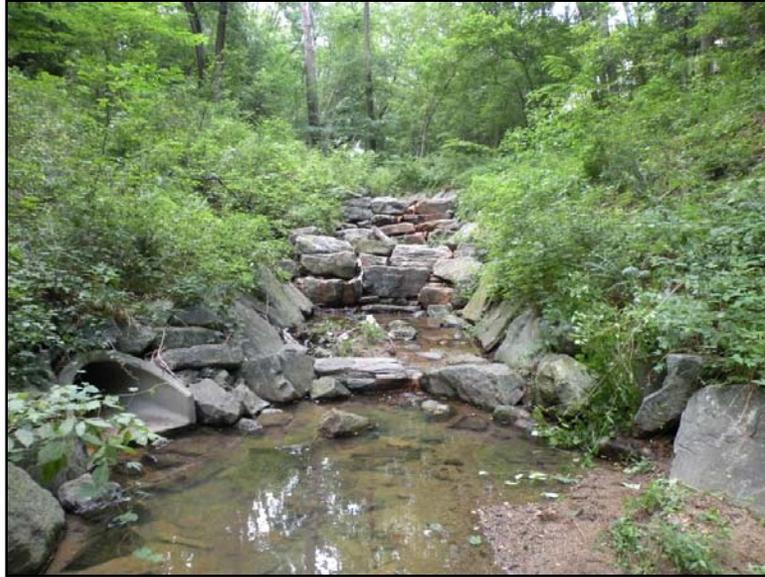
Figure 3.18.2 – Little Falls III Mall Tributary Post- Restoration in 2009

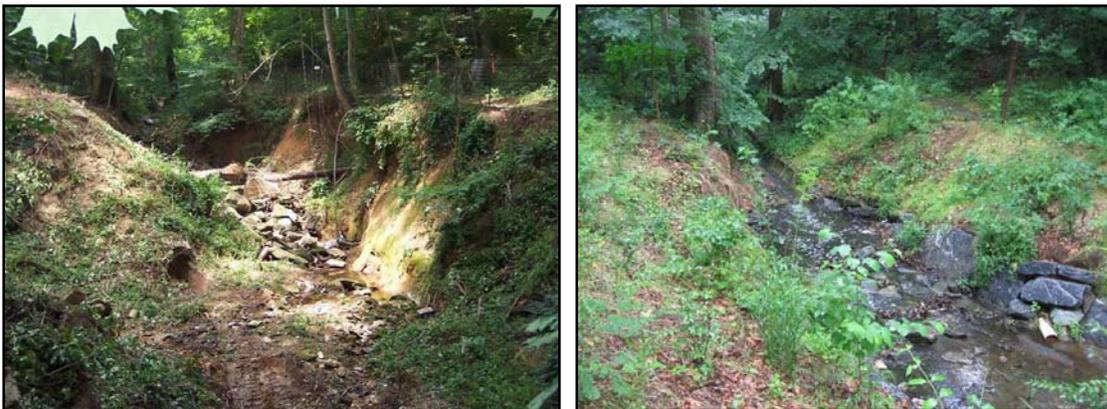
Figure 3.18.4 – Little Falls III Mall Tributary Stream Restoration Before (2005) and After Restoration (2007)

Portions of the undermined and unstable "U" shaped concrete channel were removed and replaced with a step pool system to gradually bring the flows from the mall down to the existing grade of the stream. During the step pool construction, WSSC replaced the exposed, leaking sewer line and advised DEP on the placement of the stone step pool structures to ensure their sewer line was protected. Rock pools were constructed at each of the storm drain outfalls to help dissipate the energy associated with the stormwater entering the stream. The vertical eroding stream banks were graded back and planted with native grass seed, ferns, shrubs, and trees. The project attempted to save trees on undercut stream banks with supportive rock packing. Seriously damaged trees were flush cut, allowing root systems to remain in the bank for stabilization.

Once the stream restoration project was completed, the access road was replanted with various native trees and shrubs. At the access road closer to Sangamore Road, DEP planted twelve white pine trees to provide a natural screen between the townhouses on Sangamore Court and Sangamore Road. *Figure 3.18.4* shows ground-level images before and after restoration.

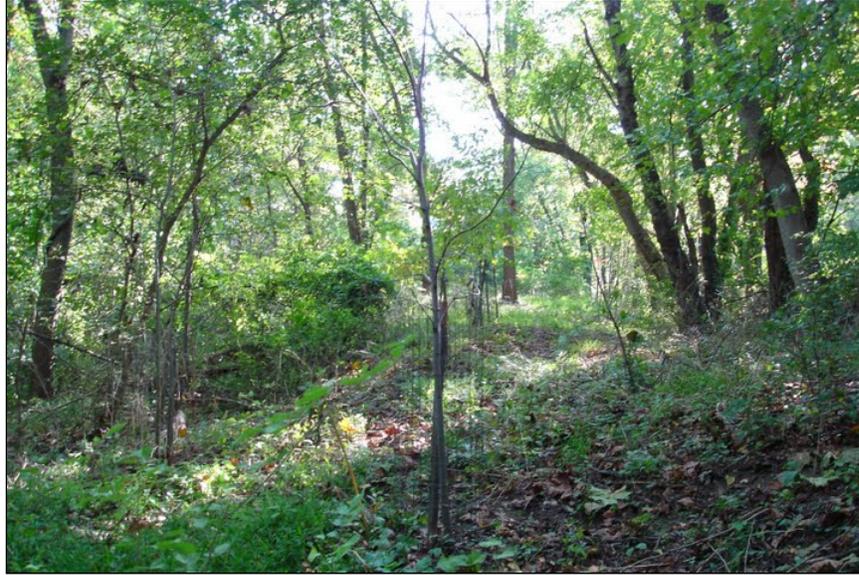
average height of the planted elderberry was smaller than what was planted; these individuals were resprouting after being browsed by deer. Several species of invasive plants were observed, some of which were rather abundant across the site. Those observed included *Rubus phoenicolasius* (wineberry), *Celastrus orbiculatus* (Oriental bittersweet), *Alliaria petiolata* (garlic mustard), *Lonicera japonica* (Japanese honeysuckle), *Wisteria sinensis* (Chinese wisteria), *Microstegium vimineum* (Nepalese browntop), and *Rosa multiflora* (multiflora rose). **Figure 3.18.12** shows the area of reforestation following restoration in 2009.

Figure 3.18.12 – Botanical Zone at LFMT101 along the Little Falls III Mall Tributary (2009)

The current year's monitoring indicated reforestation efforts within LFMT101 have been successful. Overall, the success rate of the planted vegetation, including volunteers was 71 for trees and 41 for shrubs. The health of persisting planted vegetation was good, with approximately 59 percent of trees and 86 percent of shrubs appearing healthy at the time of the monitoring visit. An abundance of planted Christmas ferns were also found along the upstream portion of the project. However, several species of invasive plants were observed, some of which were rather abundant across the site. Invasive control measures are recommended for species that could potentially suppress the health of the riparian plantings such as porcelainberry, Oriental bittersweet, and multiflora rose. Additionally deer appeared to affect many of the planted shrubs and some of the planted trees.
