3.6 Lockridge Drive Stream Restoration

3.6.1 Introduction

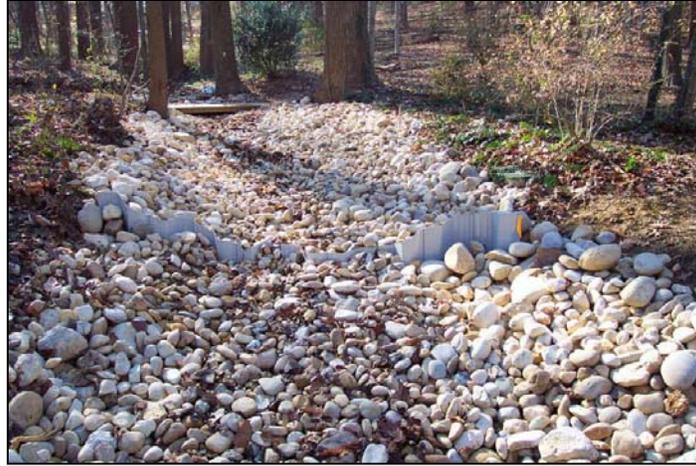
Figure 3.6.3 – Lockridge Drive Storm Drain Outfall Stabilization (2001, View Upstream to Pedestrian Crossing)

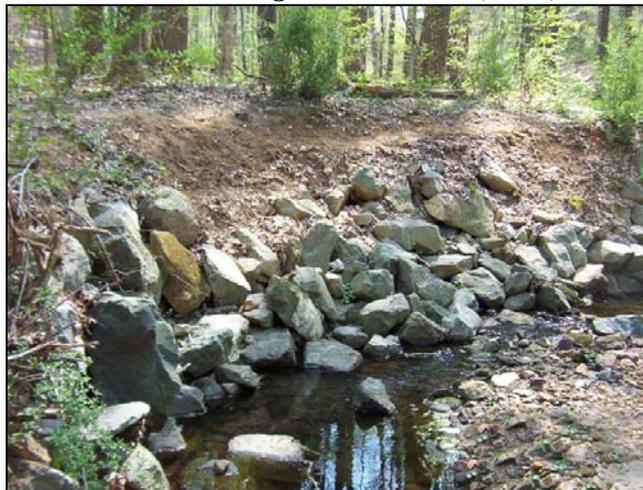
Figure 3.6.5 – Lockridge Drive Bank Stabilization Post-restoration (2005)

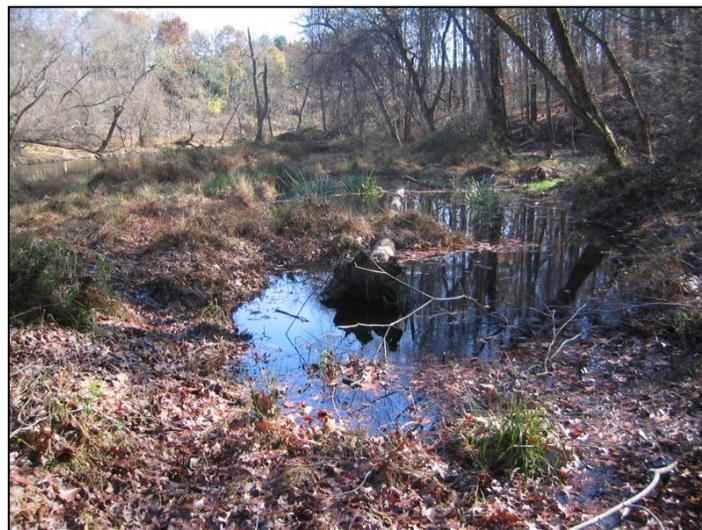
Vegetation at the created wetland was assessed post-restoration to determine the success of plantings and the overall success of the wetland. Between 2003 and 2009, wetland vegetation has flourished (**Figures 3.6.18 and 3.6.19**).

Figure 3.6.18 – Lockridge Drive Wetland Vegetation (Spring 2003)

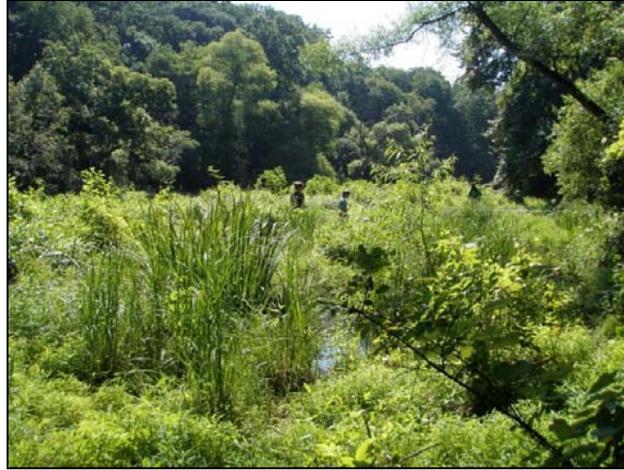
Figure 3.6.19 – Lockridge Drive Wetland Vegetation (Summer 2009)

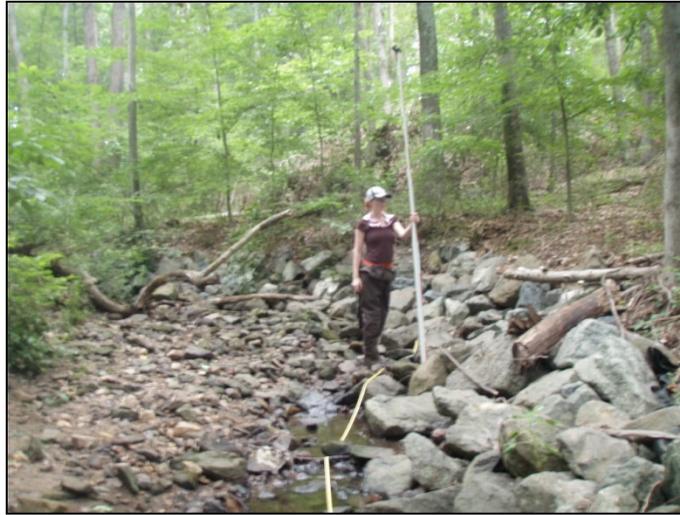
Post-restoration site photographs show stabilized storm drain outfalls and streambanks (**Figure 3.6.20**), and qualitative habitat scores are either Good or Excellent/Good. However, benthic macroinvertebrate scores and community structure analysis show little improvement, with scores remaining in the Poor range. It is not clear why the benthic scores are not improving. Possible explanations include water quality impacts and/or limitations to re-colonization.

Figure 3.6.20 – Lockridge Rip-Rap Bank Stabilization, Upstream View, 2011

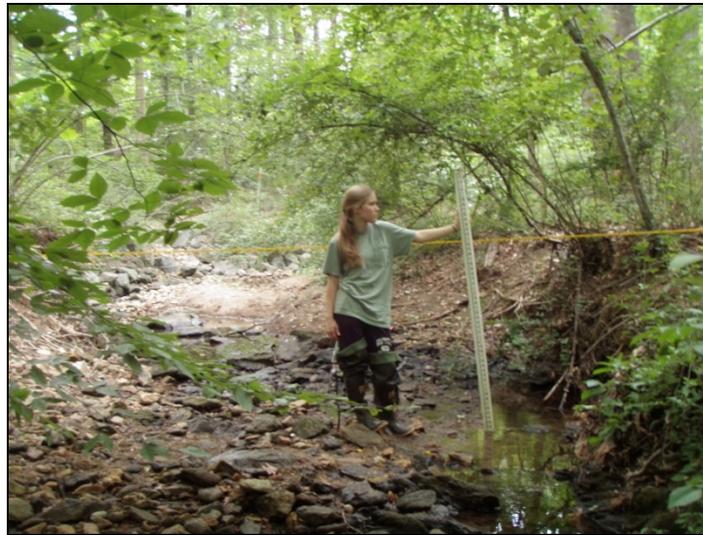
Stable and vegetated banks, wide, sinuous stream channels with coarse substrates, and ample and diverse cover and substrate are associated with high biological condition and diverse community structure. Conversely, unvegetated and eroding banks, and deep channels with predominantly fine substrates are associated with lower biological condition (Pedersen and Perkins 1986; Jones and Clark 1987; Heitke et al. 2006; Moerke and Lamberti 2006). Photo-documentation shows vegetated banks with diverse cover (***Figure 3.6.21***), and water chemistry readings were within acceptable ranges.

Figure 3.6.21 – Lockridge Cross Section Riffle, Upstream View, 2011

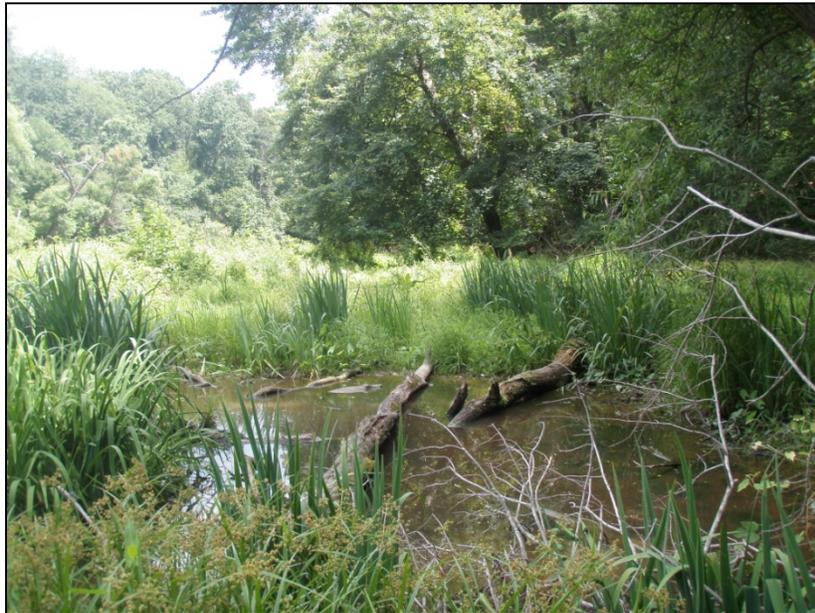
The Lockridge restoration project was successful in creating a functional wetland (***Figure 3.6.22***). Emergent wetland vegetation has successfully colonized this site (hydrophytic vegetation criteria met), and obligate and facultative wetland animals have moved in and are reproducing. Isolated from predatory fish, the wetland is actually a vernal pool that dries

occasionally, providing excellent habitat for amphibians, reptiles, invertebrates, and birds. Micro-habitat such as woody debris in the pool offers places for reproducing amphibians to attach eggs to and seek cover. Amphibian habitat could be improved if more shade trees were planted adjacent to the pool to cool water temperatures.

Figure 3.6.22 – Lockridge Constructed Wetland, June 2011

The created wetland was well-established and colonized by many wetland species. Amphibian habitat could be improved if shade trees were planted adjacent to the pool to cool wetland water temperatures. However, the created wetland had evidence of deer browse and invasive plants in 2009. Treatment of the floodplain for invasives is recommended.
