## 3.15 Piping Rock Drive Stormwater Pond

### 3.15.1 Introduction

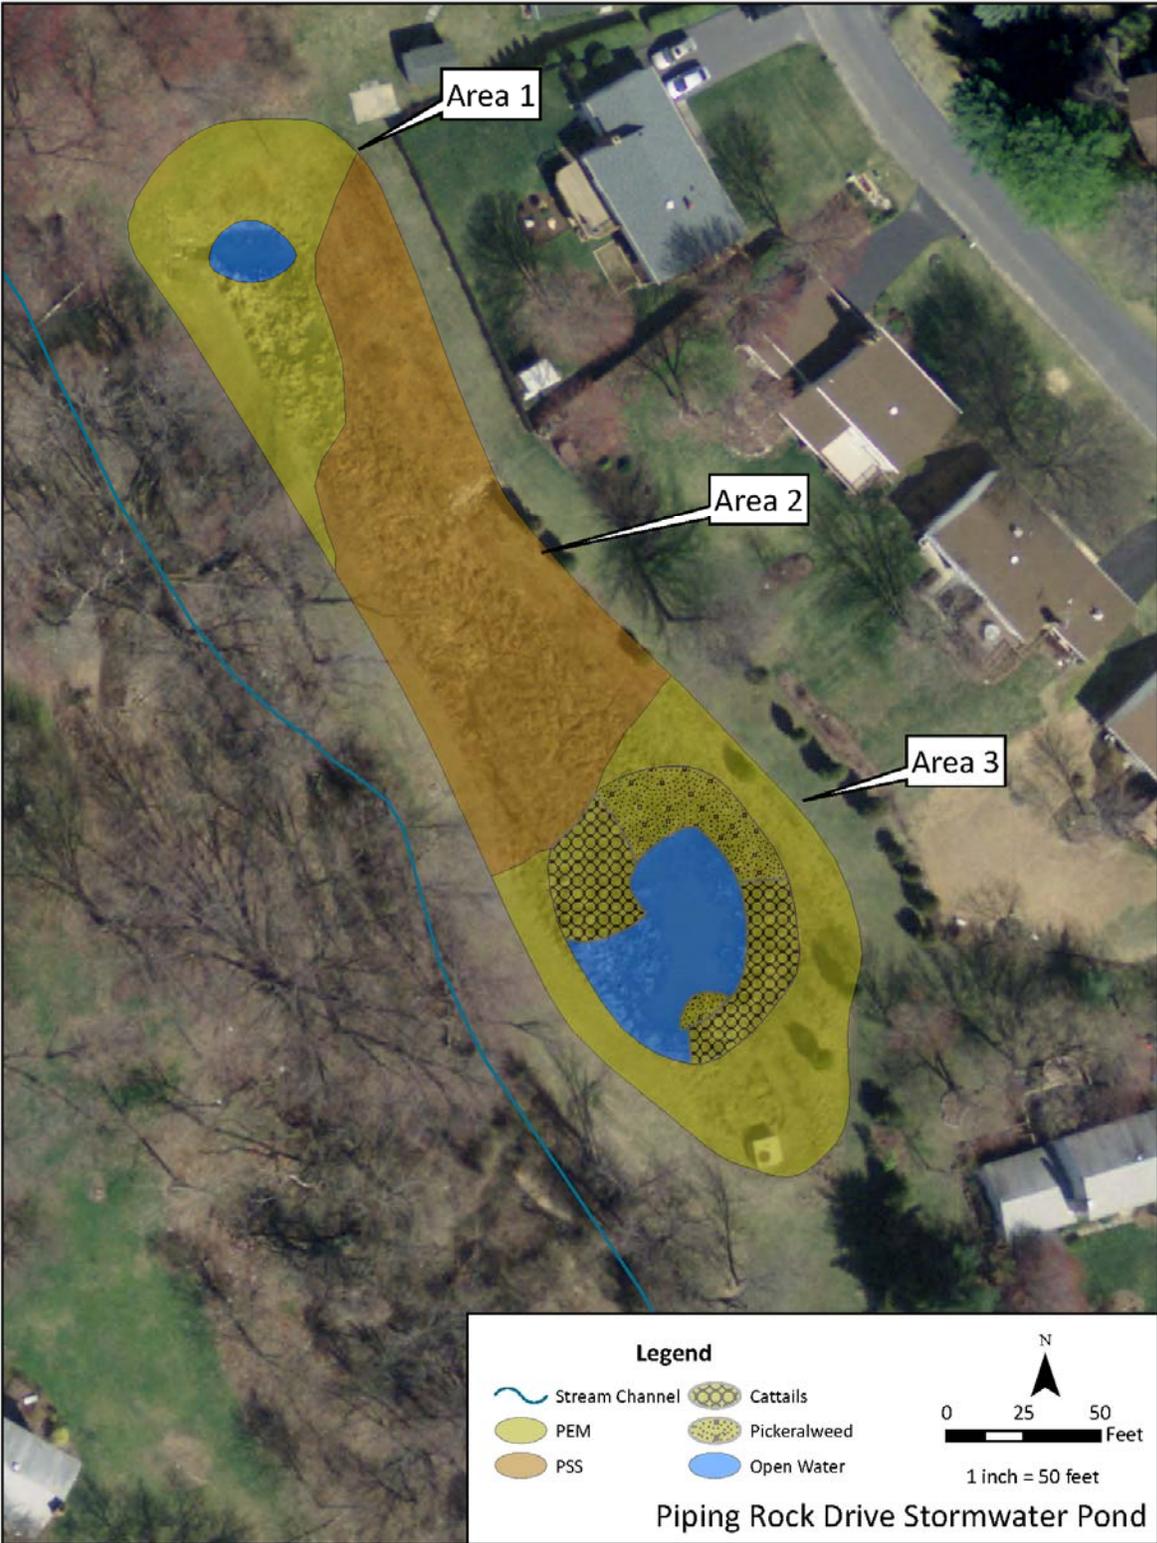
**Figure 3.15.18 – Locations of the 2009 Monitored Wetland Zones at the Piping Rock Drive Stormwater Pond**

The vegetation monitoring in 2009 was based on three distinct wetland zones, one palustrine emergent wetland (PEM) (Area 1) that bordered the northernmost open-water pool, one palustrine scrub shrub (PSS) that extended between the two open-water areas (Area 2), and one PEM (Area 3) that fringed the larger and southernmost open-water. Each of these three wetland zones were monitored and scored separately. *Figure 3.15.18* shows the locations of the three monitored areas.

A total score for the entire site was calculated based on a weighting of the sub-scores determined by the area of each zone. The total score for the entire site was 90.25 out of a possible 100 (*Table 3.15.4*). All three areas within the site were determined to be wetlands based on vegetation, soils, and hydrology.

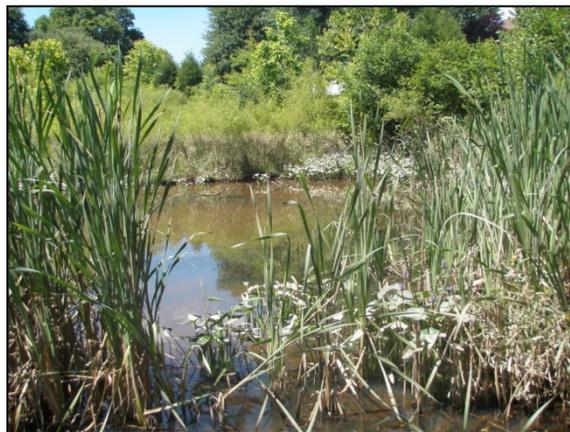
Hydrophytic vegetation was dominant throughout the site. However, it appeared that most of the planted emergent wetland vegetation within the site were not successful, as very few of the plants shown on the restoration project plans were observed during the site visit. The only emergent plants observed that were on the restoration project plans were *Sagittaria latifolia* (arrowhead) and *Pontederia cordata* (pickerelweed). *Acer rubrum* (red maple) and *Cornus amomum* (silky dogwood) saplings were the only woody species from the plant list observed. However, many trees and shrubs that appear to have been planted along the periphery of the wetland cells, particularly on the east side (Area 2), seemed to be surviving and growing. The only species that was found growing in this area (Area 2) that was on the restoration plans was silky dogwood.

Areas 1 and 2 had fairly low plant diversity. Area 1 was dominated by broadleaf cattail and rice cutgrass and Area 2 was dominated by volunteer black willow. Area 3 had a higher diversity of planned wetland plant species and was dominated by broadleaf cattail, pickerelweed, and arrowhead. Invasive plant species were mostly absent from the wetland, although *Arthraxon hispidus* (small carpgrass) was observed in Areas 2 and 3. The site had hydric soils and most of the planned wetland area had suitable wetland hydrology to support wetland vegetation. The wetland complex was determined to provide several biological, hydrologic, and water quality functions, including 1) providing habitat for reptiles, amphibians, and other wetland dependent wildlife, 2) filtering sediments, pollutants, and toxins, 3) furnishing organic material to aquatic food webs, 4) floodwater and headwater storage, and 5) several other important wetland functions. Overall, this restoration site appears to support highly functioning wetlands (**Figure 3.15.19**). 2009 field data sheets for this task are included in **Appendix D**.

**Figure 3.15.19 – PBGH100P in 2009, dominated by broadleaf cattail, pickerelweed, and arrowhead**

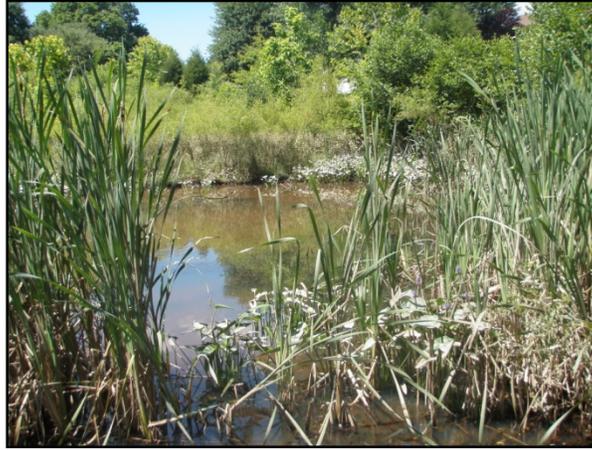
The Piping Rock Drive stormwater pond appears to have met several of the project goals including creating amphibian habitat, creating wetlands, and reforestation (**Figures 3.15.24 and 3.15.25**). The wetlands created in the restoration area were determined to be highly functioning. They provide several biological, hydrologic, and water quality functions such as habitat for amphibians, and other wetland dependent wildlife; filtering sediments, pollutants, and toxins; furnishing organic material to aquatic food webs; floodwater and headwater storage; and several other important wetland functions. Several amphibian species were documented living within and around the pond complex. However, no obligate vernal pool species were observed, and fish were also present in the largest of the pools, indicating the stormwater facility probably functions as a wetland rather than a vernal pool. The stormwater pond does provide habitat for a variety of amphibians, birds, invertebrates, and fish.

***Figure 3.15.24 – Piping Rock Drive Stormwater Pond 2009 (dominated by broadleaf cattail, pickerelweed, and arrowhead)***

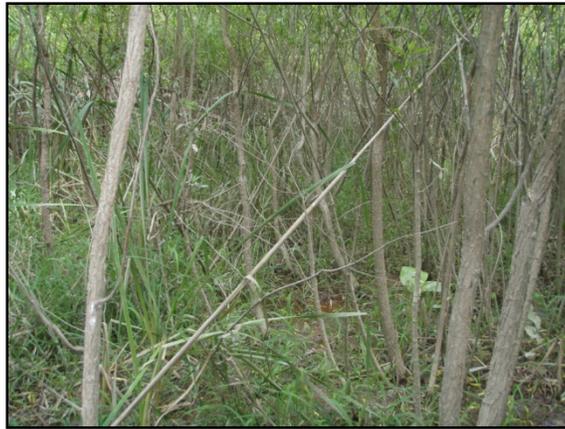
The goal of reforestation also appears to have been met at the Piping Rock Drive stormwater pond. The restoration site has been replanted with native grasses, shrubs, and trees. The trees that were planted within the wetland, dominated by black willow, are surviving. Trees planted along the periphery of the entire restoration site, including alder, silky dogwood, redbud, oak, and green ash are thriving.

***Figure 3.15.25 – Piping Rock Drive Stormwater Pond 2009 (dominated by black willow)***

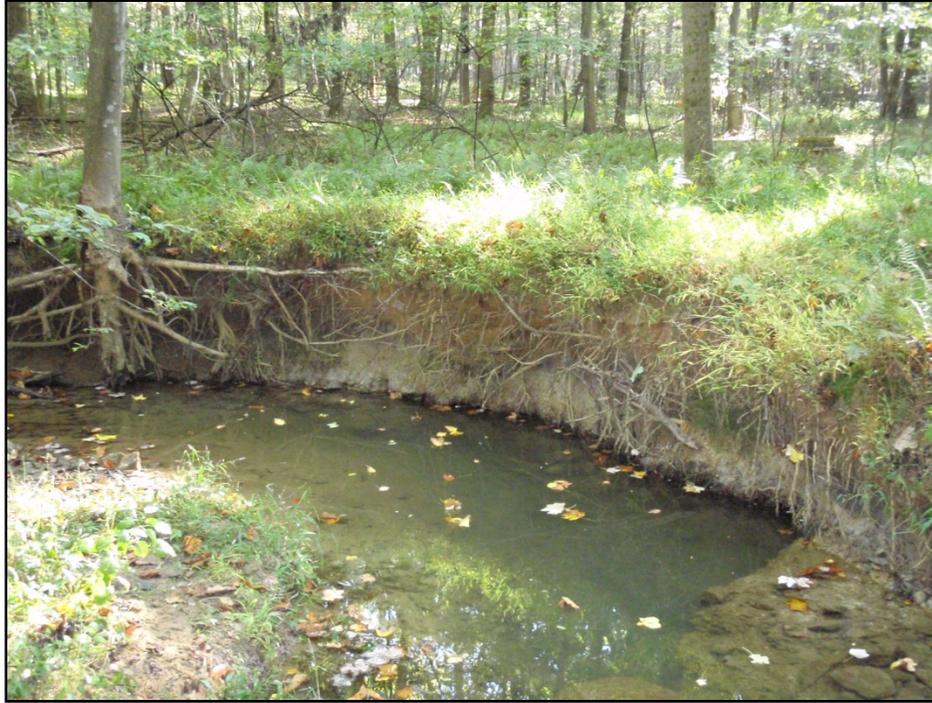
In general, aquatic habitat conditions downstream of the restoration declined from the Excellent/Good range to the lower end of the Good range from 1994 to 2009. The individual habitat parameters that remained consistent over time included channel alteration and riparian buffer width, which would not be expected to change without a major change in land use or development directly adjacent to the site. The most notable degradation in habitat was due to the increase in bar formation and erosion, and the decrease in channel flow status, embeddedness, bank stability, and epifaunal substrate (**Figure 3.15.26**). The overall aquatic habitat conditions continued to decline after the construction of the Piping Rock Drive stormwater pond in 2002. The declines in aquatic habitat over time, despite the restoration activities, may have an influence on the project meeting its other goals of improving stormwater quantity control, reducing stream erosion and sedimentation, and improving water quality. The decline in aquatic habitat conditions and the benthic macroinvertebrate community may be due to other factors in the overall watershed, such as increased imperviousness and urbanization. However, the data collected downstream of the pond seem to indicate this project has been unsuccessful at improving aquatic habitat.

***Figure 3.15.26 – PBGH108, below the Piping Rock Drive Stormwater Pond (example of the degraded habitat including an eroded bank and dewatered roots providing little habitat that look to be previously watered)***
