Upper Rock Creek

3.22 Stream Valley Drive Stream Restoration

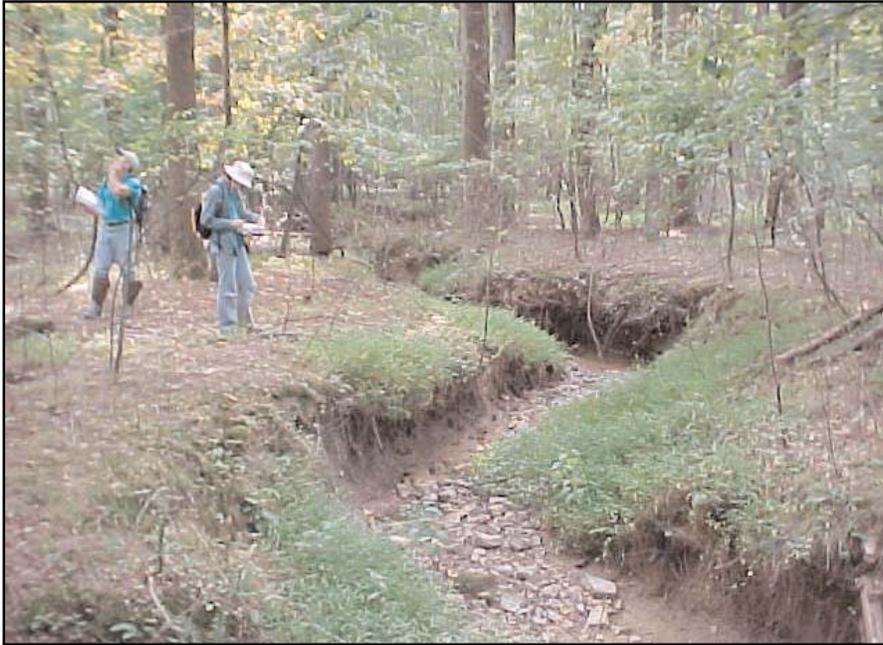
Generally, the Upper Rock Creek Watershed was categorized by the *CSPS* as having excellent to good stream conditions. In the Stream Valley Drive tributary, however, land use impacts such as residential development, historic agricultural practices, a power line crossing, and road crossings increased stormwater flow velocities, which in turn created erosion, high sedimentation, incised channels and degraded instream habitat (**Figure 3.22.2**).

Figure 3.22.2 – Pre-Restoration Conditions at Site URSV201 in 2002, Picturing Eroded Stream Bank and Undercut Trees

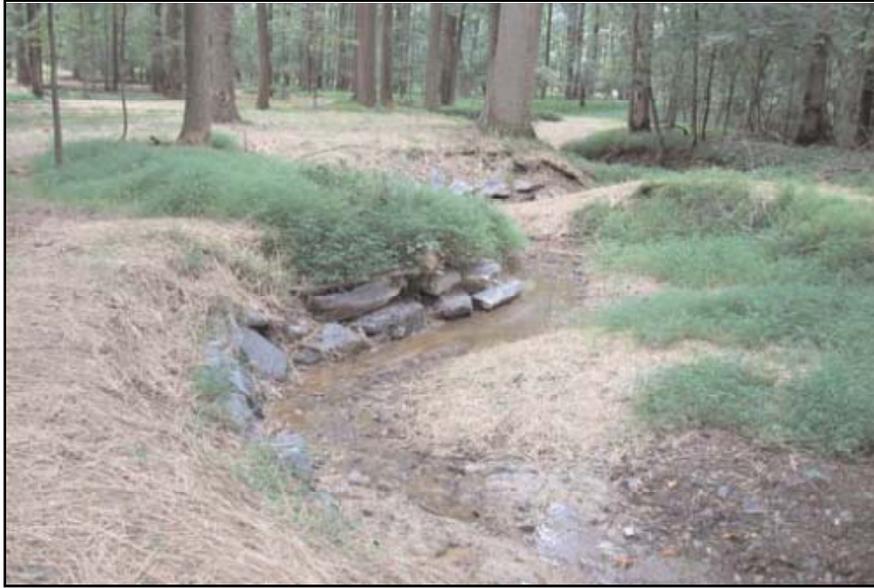
The Stream Valley Drive stream project used in-stream restoration techniques to stabilize stream banks and enhance aquatic and riparian habitat. Newly built instream structures included log cross vanes, which direct water away from unstable stream banks and form downstream scour pools, providing habitat for fish. Log cross vanes also function as grade control structures, which slow the erosive process of stream down-cutting. Rock was also installed at the toe of the streambank slope, stabilizing the area of the stream channel subject to the greatest erosive energy, or “shear” stress. The slopes above the reinforced toes were graded back to create new floodplain terraces, which allow high flows to lose erosive energy by escaping the confined stream bank (**Figure 3.22.3**).

Figure 3.22.3 – Example of the Stream Restoration at Site URSV201 in 2005, Picturing Stabilized Stream Bank and Graded Banks

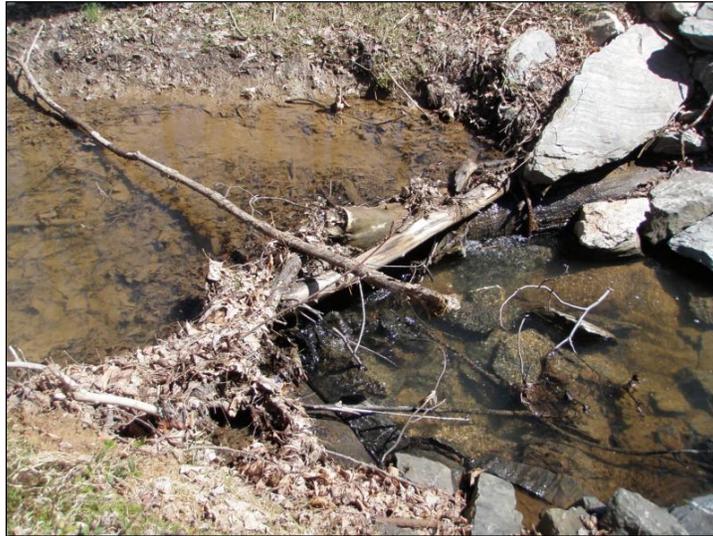
No one habitat parameter decreased the most, but bank vegetative protection had a clear decline from the pre-restoration conditions, as did instream cover for fish, and epifaunal substrates for benthic macroinvertebrates. Additionally, some of the stream structures

did not appear to be stable, were being undermined by the stream flow, and in some cases constricting the natural stream flow and causing siltation upstream of the structures (*Figure 3.22.18*). Native vegetation covered more than 90 percent of both banks in 2002, prior to restoration, and declined to between 50 to 60 percent after restoration. An increase in the percentage of invasive plants on the banks may also have contributed to the lower bank vegetation scores. Embeddedness, sediment deposition, and bank stability conditions were similar to those recorded prior to restoration. 2009 field data sheets for this task are included in *Appendix D*.

Figure 3.22.18 – Cross vein and Rock Stabilization Creating Constriction and Upstream Siltation at URSV201 (2009)

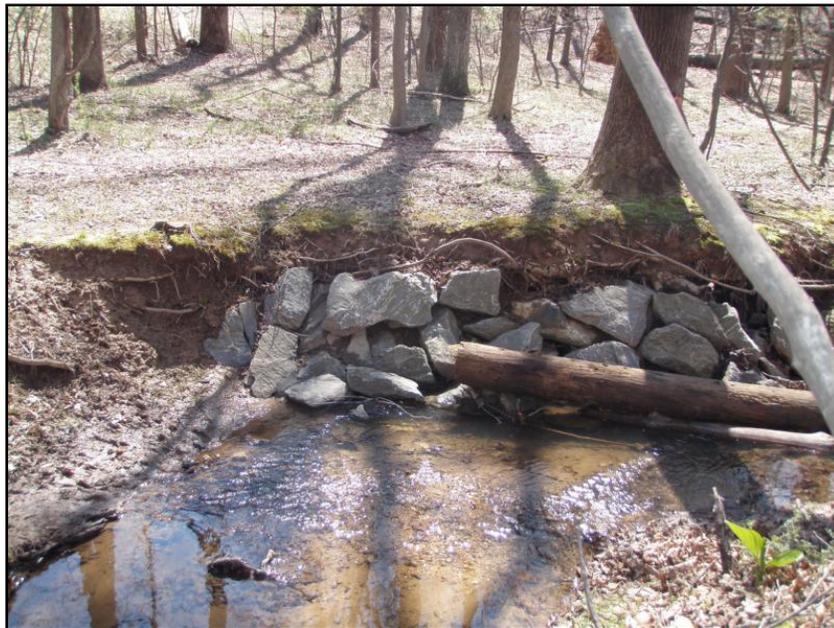
Figure 3.22.19 – Rip Rap at URSV201 Being Slightly Undermined (2009)

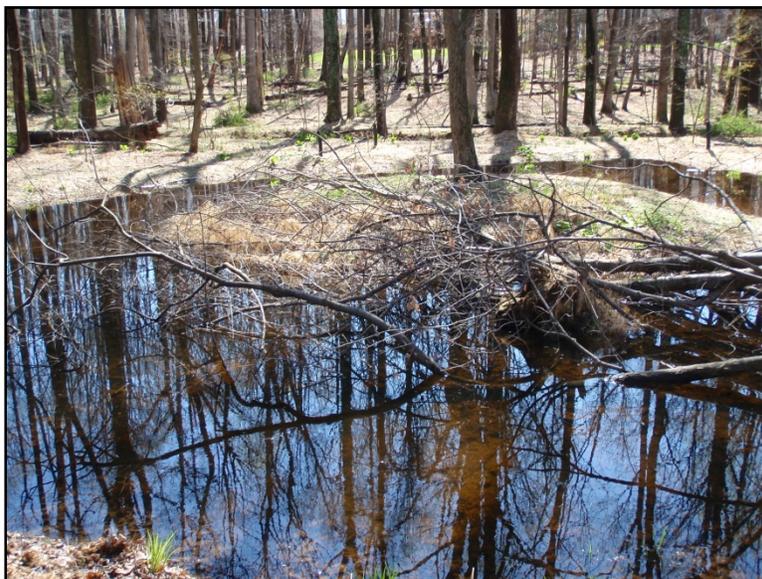
In 2009, the vernal pool dimensions were the same as they were in previous years. During the 2009 site visit, the vernal pool appeared to be full when monitored, the depth of the water in the pool was approximately 1 foot, and the temperature within the vernal pool was 45°F. Emergent and submerged herbaceous vegetation was found growing in the vernal pool. Additionally, a large fallen tree branch and many smaller pieces of downed woody debris were observed in the pool creating a natural vernal pool condition (**Figure 3.22.20**). Spring peepers were heard calling from the pool, more than 1,000 *Bufo* sp. (toad) tadpoles were seen swimming in the pool, and four spotted salamander egg masses were observed (**Figure 2.22.21**). The egg masses were submerged and attached to the woody debris. Several invertebrate taxa were also observed including: Culicidae (mosquito larvae), Dytiscidae (diving beetles), copepods, and Gerridae (water striders). No crayfish burrows or fish were seen in or around the pool. Field data sheets for the 2009 vernal pool monitoring task are included in **Appendix D**.

Figure 3.22.20 – Created Vernal Pool at Site URSV201 in 2009

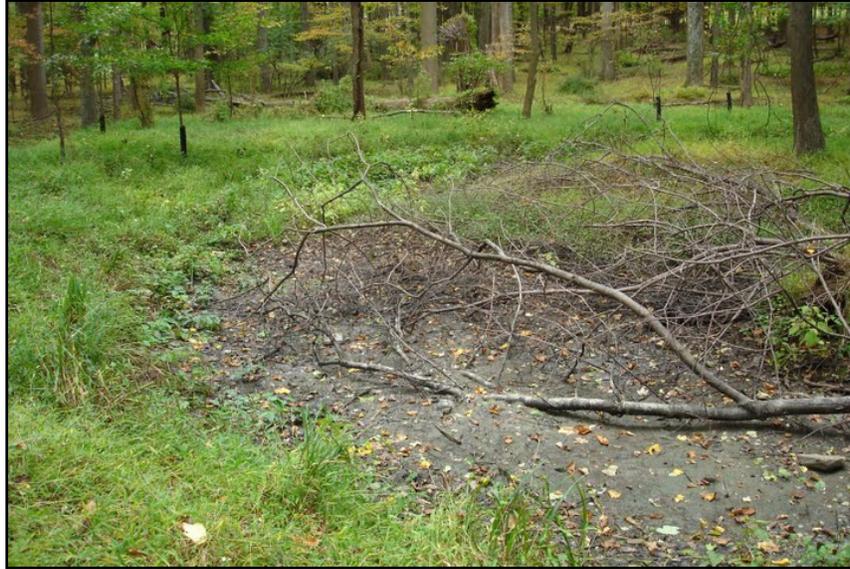
In October 2009, on the day the monitoring occurred, the pool was dry and the areas inundated in the spring completely lacked vegetation. The periphery of the pool was vegetated, as was the center island (**Figure 3.22.22**). Lizard’s tail, *Polygnum sp.* (smartweed), and *Boehmeria cylindrical* (smallspike false nettle) were the dominant plants in the assessed emergent wetland. Sweetflag, fringed sedge, and *Calamagrostis sp.* (reedgrass) were also present in lesser amounts. No woody plants were observed in the wetland. Nepalese browntop and *Polygonum perfoliatum* (Asiatic tearthumb) were prevalent throughout the floodplain. These species may be a concern for future wetland success as they are invasive species that are known to take over other native vegetation. This wetland scored a 92 out of a total possible score of 100. Overall, the emergent wetland that fringes the vernal pool in area 10 appears to be functioning as a wetland. In addition to supporting wetland vegetation, this area has hydric soils, and appears to have groundwater and surface water inputs that will support wetland hydrology. **Table 3.22.5** below shows the individual scores for the wetland vegetation monitoring for each wetland monitored at URSV201.

Figure 3.22.22 – Wetland Area 10 at Site URSV201 (October 2009)

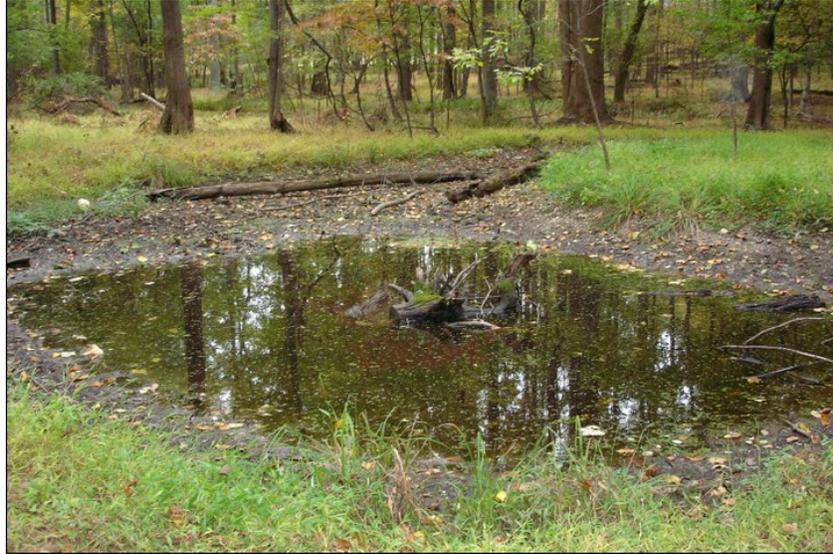
Area 9 is about 60 feet north of area 10 and is another created wetland with rip rap on the edge closest to the stream. This wetland consists of an open water area with a palustrine emergent fringe. In 2005, the dominant species found in the wetland fringe were Nepalese browntop, lizard’s tail, sweetflag, and fringed sedge. In 2009, dominant species in the emergent portion of the wetland included: smartweed, Nepalese browntop, and *Carex* sp (**Figure 3.22.23**). No woody species were present. Similar to Area 10, the invasive species Nepalese browntop and Asiatic tearthumb are a concern for future success of the native wetland vegetation in this wetland. This area had the lowest score of all wetlands at URSV201, with a score of 52. Overall, the vegetation lacked diversity and had a high percentage of invasive coverage. In addition, bare ground was present in some areas where plant potential existed. Hydric soils existed at the site, however, high amounts of gravel and clay were present in the soil profile, which may limit plant growth. Wetland hydrology is supported at this site from groundwater and surface water sources, however, most of the planned vegetated area is often inundated and too wet to support wetland vegetation.

Figure 3.22.23 – Wetland Area 9 at Site URSV201 (October 2009)

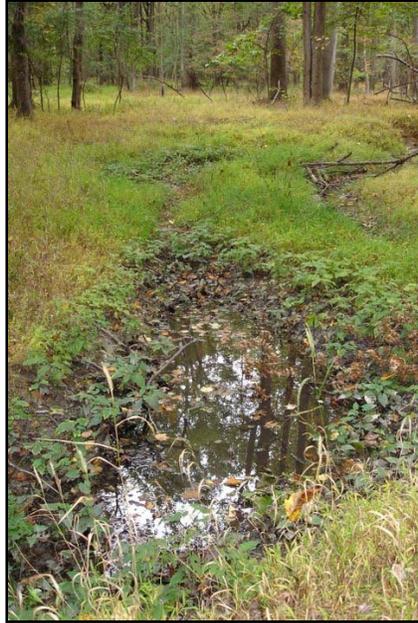
Area 8 is a remnant stream channel, long and narrow in shape, and has been reinforced with rip rap to maintain an emergent wetland adjacent to the existing streambank. The wetland is hydrologically connected to the adjacent stream. In 2005, the wetland was mostly dry with a small pool of water in the center. Dominant vegetation included Nepalese browntop, lizard's tail, sweetflag, and fringed sedge. In 2009, the wetland contained standing water (**Figure 3.22.24**). The dominant emergent plants at the site were lizard's tail, Nepalese browntop, and *Leersia oryzoides* (rice cutgrass). Fringed sedge was also present at the site in lesser amounts. Nepalese browntop accounted for seven percent of the vegetative cover in the wetland. This area scored a 78 out of a total possible 100. Hydric soils were present in the wetland, as was wetland hydrology, however, about 45 percent of the wetland was too wet to support wetland vegetation, which lowered the vegetation portion of the score (21 out of 30). It was also assessed as adequately providing several wetland functions, scoring 16 out of 20 for functional gains. Generally this area is successfully supporting wetland vegetation and providing some wetland functions; however Nepalese browntop may be a concern for the future success of this wetland.

Figure 3.22.24 – Wetland Area 8 at Site URSV201 (October 2009)

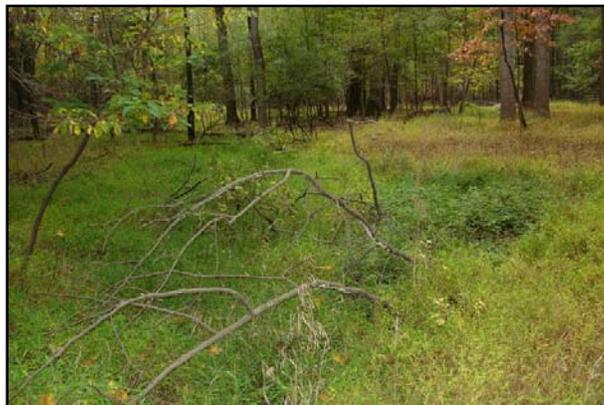
Area 7, similar to Area 8, is a remnant stream channel. It is a long and slender emergent wetland, which is hydrologically connected to the adjacent stream. In 2005, the wetland was dry when it was monitored. Dominant vegetation in 2005 included Nepalese browntop, lizard’s tail, and fringed sedge. In 2009, lizard’s tail, *Ludwigia palustris* (marsh seedbox), rice cutgrass, and Nepalese browntop were the dominant emergent species (**Figure 3.22.25**). Several other less dominant species also occupied the wetland. This wetland area scored 89 out of 100. Hydric soils were present in the area, as was wetland hydrology. Most of the planned vegetated area was occupied by wetland vegetation. The wetland also provided several biological, water quality, and hydrologic functions. Overall, this area appears to support wetland vegetation and provide functional benefits.

Figure 3.22.25 – Wetland Area 7 at Site URSV201 (October 2009)

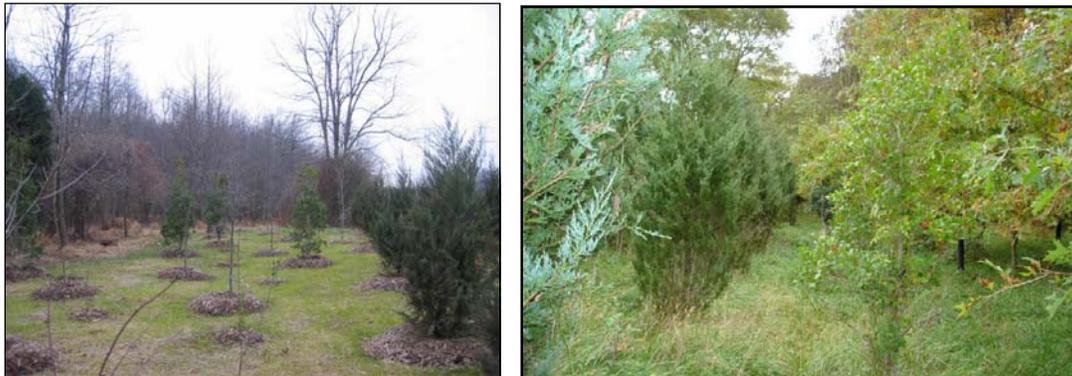
Botanical Zone A includes the planted haul road, upland reforestation areas, and riparian plantings from Fieldcrest Road to the created vernal pool, on the northern portion of the project (**Figure 3.22.4**). This planting zone was fairly successful, with 81 percent of the trees determined to be healthy and six percent dead. Most of the tree species planted in these areas were found growing and most individual trees were healthy (**Figure 3.22.26**). Red maples were the exception; most red maple individuals had been damaged by deer rub and did not appear to be growing as well as the other species. Very few shrubs were observed in these areas; only 25 percent were assessed as healthy and 38 percent were dead. Some shrub species were planted according to the planting plan, but were not found onsite. These species included *Cornus florida* (flowering dogwood), *Lindera benzoin* (spicebush), *Viburnum dentatum* (arrowwood), and *Sambucus canadensis* (elderberry). No woody trees or shrubs were observed in or around the wetland or streambank (terraced) zones even though several were planted in these areas.

Figure 3.22.26 – Botanical Plantings at Zone A (2004 versus 2009) Showing Planted Eastern Redcedar

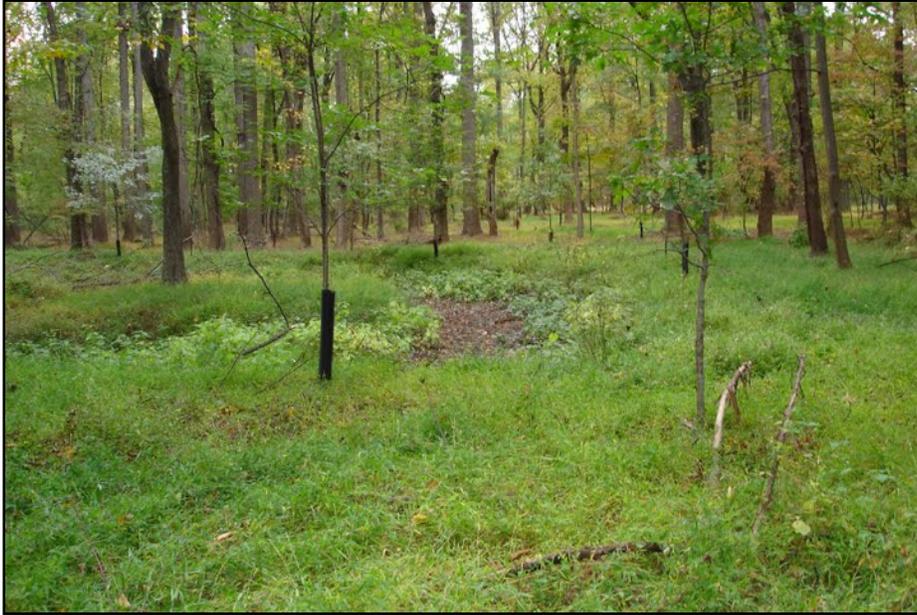
Botanical Zone B is located south of Zone A, along the floodplain of the Stream Valley Tributary, from the constructed vernal pool to the southern end of the project. These floodplain plantings were slightly more successful than the Zone A plantings (**Figure 3.22.27**). Ninety percent of the observed trees were healthy and ten percent were dead. Only two shrubs were noted in this area, one of which was dead. Invasive plants were found throughout most planting zones, with Nepalese browntop and Asiatic tearthumb being the two most dominant. Generally, these species were not impeding tree or shrub growth, but in some areas Asiatic tearthumb was found climbing on native vegetation.

Figure 3.22.27 – Botanical Zone B in the Floodplain at Site URSV201 Showing Red Maple and Other Plantings (2009)

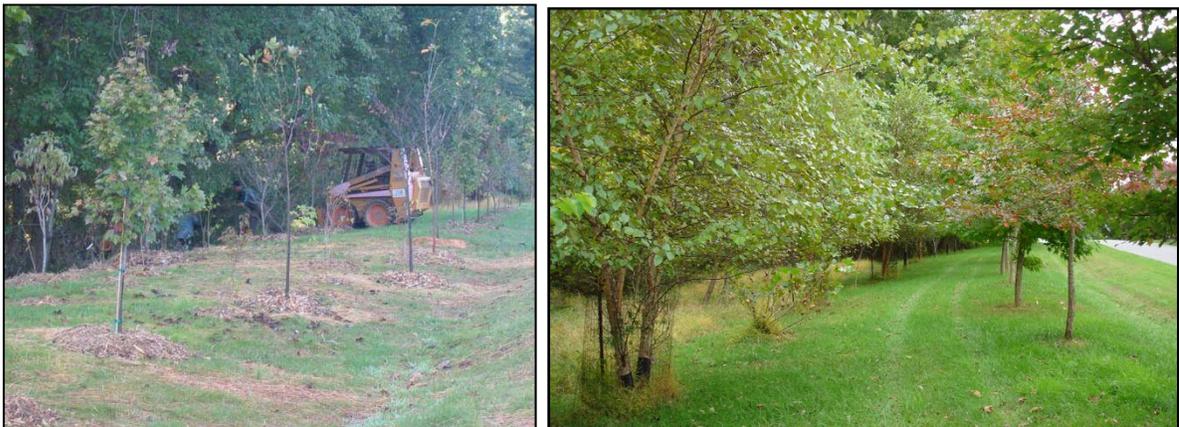
The plantings at Zone C, on the Falling Spring access area, parallel to Falling Spring Court, were determined to be growing successfully (**Figure 3.22.28**). Ten tree species were found within the zone. Ninety-seven percent of the trees were assessed as healthy and three percent were dead. However, many of the trees had been rubbed by deer. Two shrubs were observed in this zone, both of which showed signs of tip dieback.

Figure 3.22.28 – Botanical Reforestation Zone C Along Falling Spring Court at Site URSV201 Showing American sycamore Plantings (2004 versus 2009)

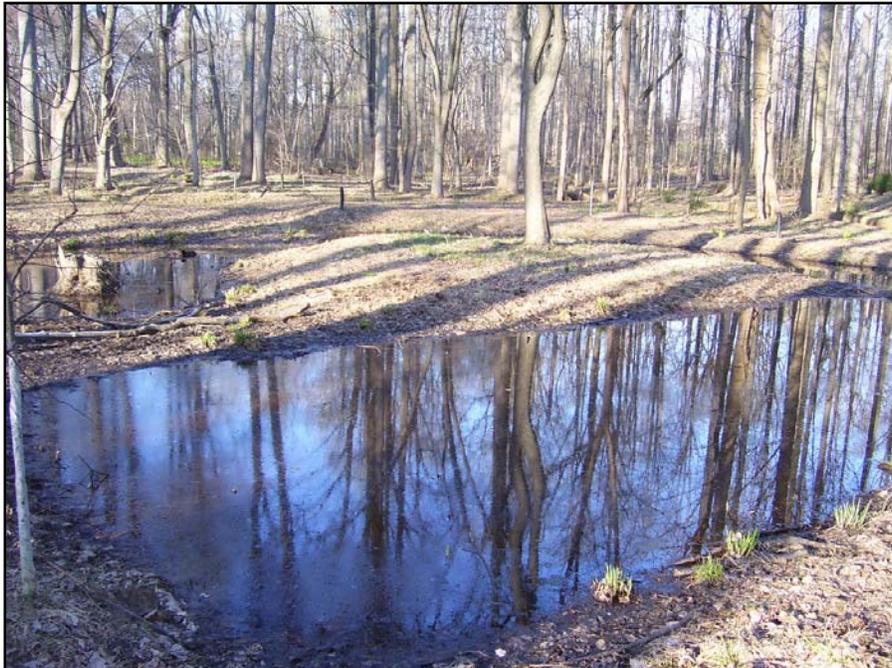
The highest scoring wetland at URSV201 was also constructed as a vernal pool. Over the post-restoration period, this wetland supported two obligate vernal pool species, spotted salamander and wood frog, and several facultative species. Therefore, the wetland appeared to be successfully functioning as a vernal pool. The presence of the woody debris in the pool helped to create a natural vernal pool condition. This woody debris fell naturally into the pool after construction and was not part of the engineered design.

Figure 3.22.29 – Created Vernal Pool at Site URSV201 in 2007

Overall, the Stream Valley Drive stream restoration project has met or partially met most of the project goals. The restoration has created wetlands and amphibian habitat as well as helped reforest the riparian zone. The vernal pool that contained downed woody debris was more successful than the others. It is recommended that future vernal pool designs incorporate the use of woody material to improve pool shading and provide surfaces to which egg masses can be attached.

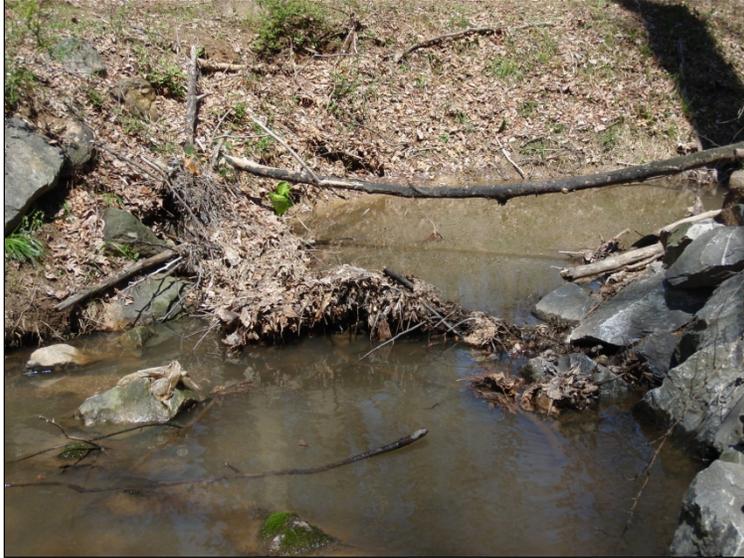
Aquatic habitat conditions declined from the pre- to post-restoration periods from Excellent and Good, to Good and Fair, respectively. Bank vegetative protection showed the clearest decline of all habitat parameters, mostly due to an increase of invasive species on the stream bank after restoration. Additionally, epifaunal substrates for benthic macroinvertebrates and instream cover for fish evidently declined after restoration. Also, some of the instream structures appear to be failing, creating upstream sedimentation and potential fish blockages (*Figure 3.22.30*) Sediment deposition and bank stability, however, remained similar from the pre- to post-restoration periods.

Figure 3.22.30 – Log Vein and Rip Rap at URSV201 Constricting Stream Flow and Creating Upstream Sedimentation (2009)
