Turkey Branch Subwatershed

3.23 Turkey Branch Stream Restoration and Stormwater Ponds

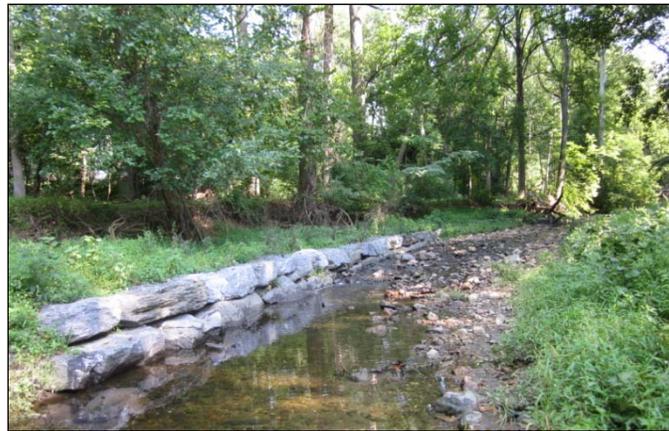
Figure 3.23.1 – Stream Restoration at Lower Turkey Branch (site LRTB203A)

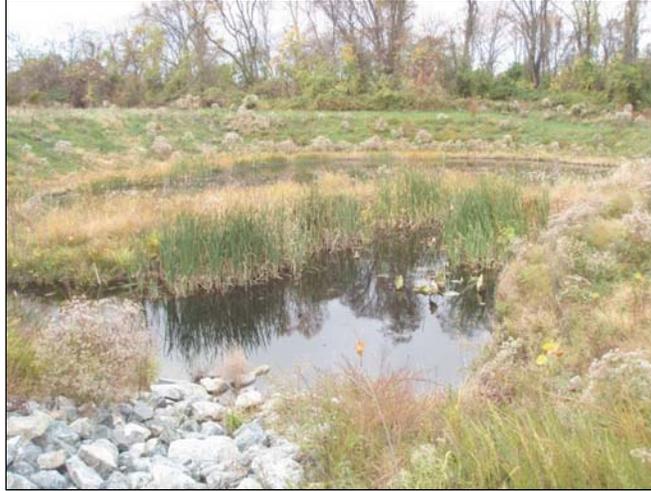
Figure 3.23.2 – Stormwater Management Site Matthew Henson I (dominant emergent species pictured include common three square, broadleaf cattail, and American water lotus)

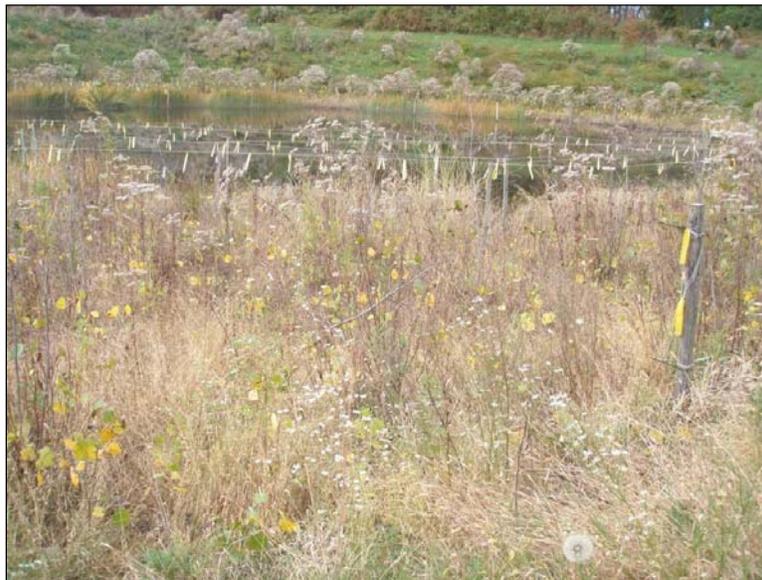
While open water was the dominant cover type site-wide, wetland vegetation was present within the southern half of the site as well as along the edges of the pond. **Figures 3.23.48** and **3.23.49** show images of the different cover types present during the 2009 vegetation monitoring. The cover types observed were characterized by 70 percent herbaceous cover and 30 percent palustrine scrub shrub. The scrub shrub area was dominated by small trees; however, as it grows, this cover type most likely will be classified as palustrine forested. Herbaceous vegetation in the wetland was characterized by *Schoenoplectus pungens* (common three square), *Typha latifolia* (broadleaf cattail), and *Nelumbo lutea* (American water lotus). Cover estimates for these species were 35, 15, and 10 percent, respectively. Woody species found growing around the edge of the pond consisted of relatively abundant *Populus deltoides* (eastern cottonwood) and *Salix nigra* (black willow). Woody plants were generally one to one-and-a-half feet tall, and did not appear stressed. Some deer browse was noticeable, but did not appear to be limiting the success of woody plants. The presence of eastern cottonwood is notable as this species was not included in the planting plan. A high density of desirable, native wetland vegetation at the site led to a vegetation score of 28.8 out of a possible 30, or 96 percent.

Figure 3.23.48 – Matthew Henson I Stormwater Pond 2009
(volunteer eastern cottonwood seedlings growing in herbaceous zone)

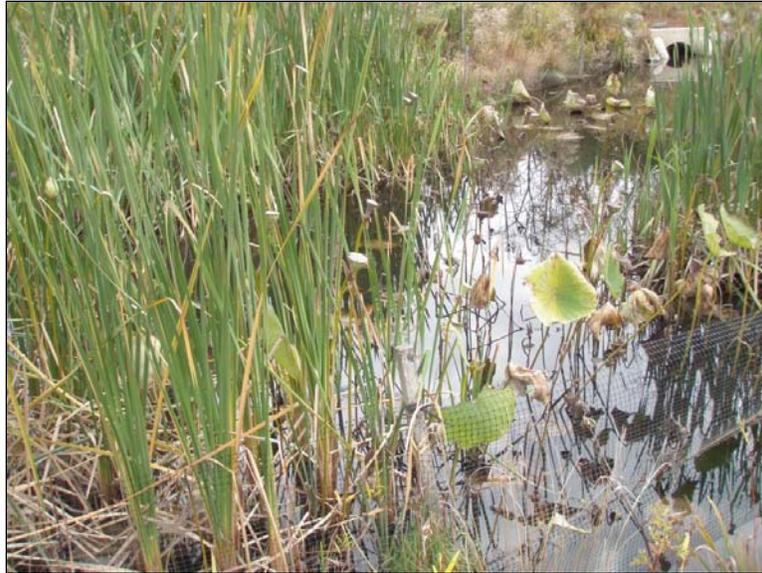
**Figure 3.23.49 – Matthew Henson I Stormwater Pond 2009
(American water lotus plants near southern outlet)**

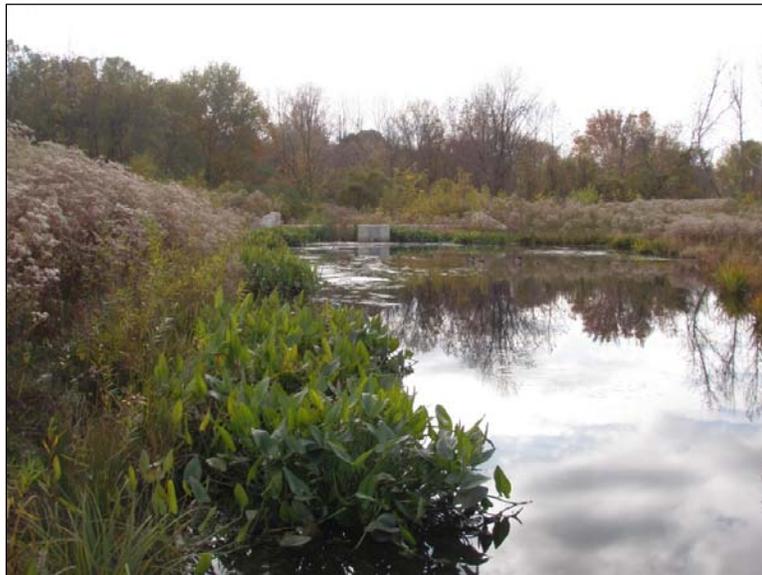
While open water was the dominant cover type site-wide, wetland vegetation was generally present around the periphery of the pond. This open area was planned to be vegetated with water smartweed, however no vegetation was observed in the open water area. **Figure 3.23.50** is an image of the pond at the time of wetland vegetation monitoring in 2009. Based on the dominant species observed, future vegetative cover was estimated to be 20 percent herbaceous and 10 percent forested, although at the time of the 2009 site visit this ten percent cover was assessed as a scrub shrub vegetation type since the tree species present were very small. The herbaceous community was characterized by *Pontedaria cordata* (pickerelweed), *Iris versicolor* (harlequin blueflag), and broadleaf cattail. Cover estimates for these species were five, two, and two percent, respectively. One to two foot tall black willow trees occurred across much of the western pond edge. These trees did not appear stressed despite their small size. Evidence of browsing by deer was not present at the time of the site visit. A relatively high density of desirable, native wetland vegetation around the edges of the pond led to a vegetation score of 17 out of a possible 30, or 57 percent. This score reflects the open water unvegetated portion of the wetland that was planned to be vegetated.

Figure 3.23.50 – Matthew Henson II Stormwater Pond 2009
(*vegetated strip along western edge of pond, with pickerelweed and other herbaceous plants pictured*)

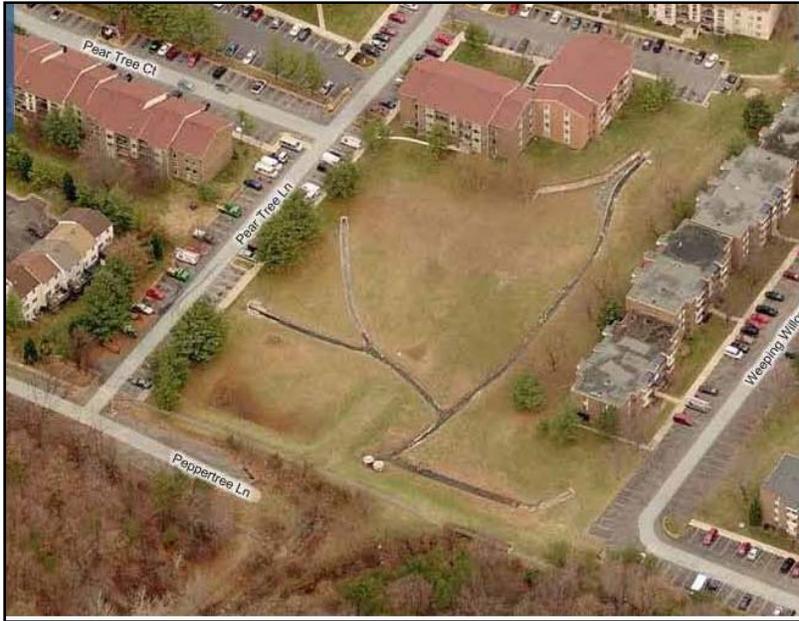
Figure 3.23.52 – Aerial View of the Peppertree Farm Dry Pond Prior to the Retrofit in 2007

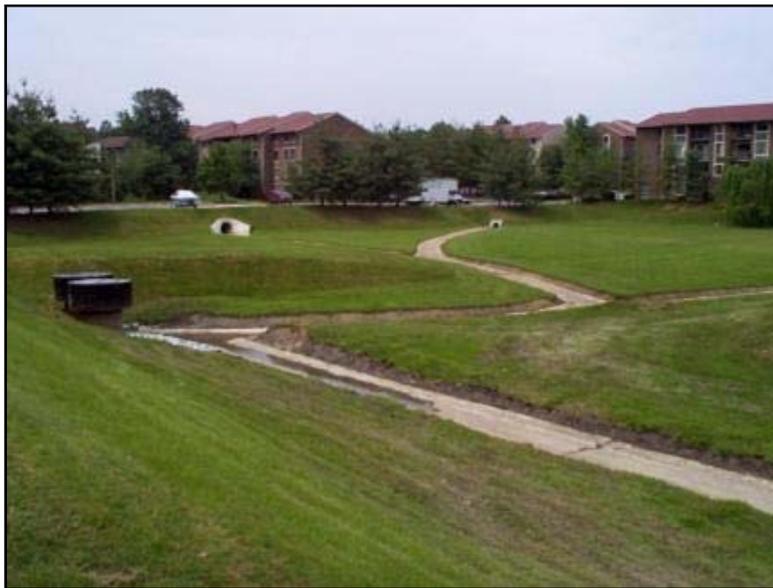
Figure 3.23.53 – Ground View of the Peppertree Farm Dry Pond Prior to the Retrofit in 2007

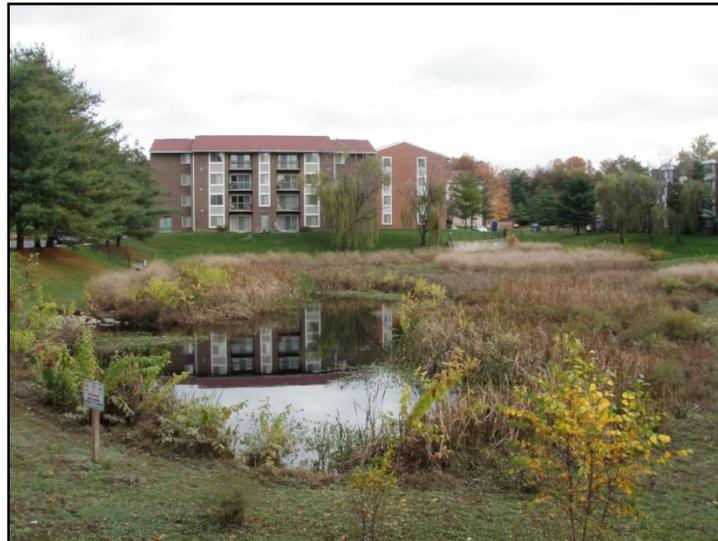
Open water was the dominant cover type site-wide, however wetland vegetation was extensive both around the edges of the ponded areas as well as on slightly raised areas between the open water cells (**Figure 3.23.54**). Based on the dominant species observed, future vegetative cover was estimated to be 80 percent herbaceous and 20 percent scrub-shrub over the entire site. The herbaceous zone was characterized by *Ludwigia peploides* (floating primrose-willow), *Panicum virgatum* (switchgrass), broadleaf cattail, and pickerelweed. These species accounted for approximately 25, 25, 20, and 10 percent cover, respectively. *Betula nigra* (river birch) was the only dominant woody species, although a few *Cercis canadensis* (eastern redbud) and black willow individuals were also observed. These represent the only surviving planted trees in the herbaceous zone. Deer activity such as browsing and scraping may be limiting the success of the plantings in this zone.

Figure 3.23.54 – Peppertree Farm Stormwater Pond 2009 (looking north at emergent portion of site from end of Peppertree Lane)

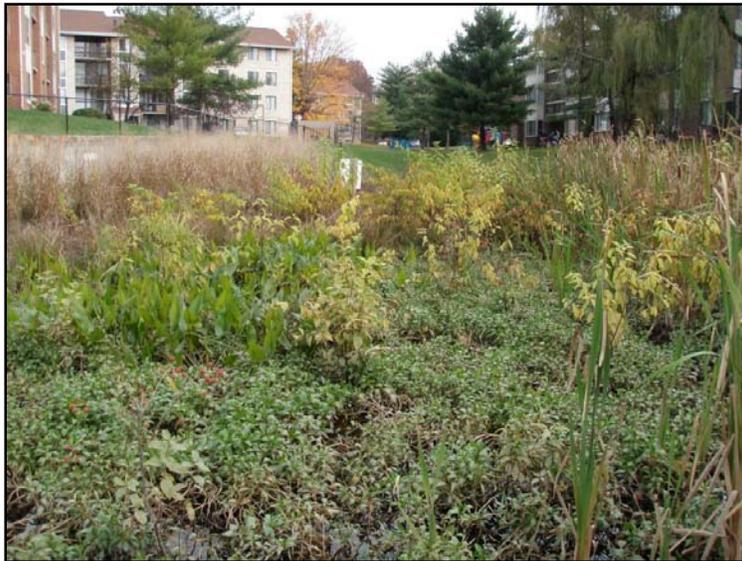
The scrub-shrub zone was characterized by the presence of relatively abundant *Cephalanthus occidentalis* (common buttonbush) and *Alnus serrulata* (smooth alder) (**Figure 3.23.56**). These plants comprised 20 and five percent cover, respectively. Planted shrubs were generally about five feet tall and did not seem stressed. Some deer browse was noticeable, but the plantings did not appear to be significantly impacted. Herbaceous plants observed, including switchgrass, broadleaf cattail, and pickerelweed, constituted 25, 20, and 10 percent cover in the scrub-shrub zone, respectively. Due to a high density of desirable, native wetland vegetation in the palustrine scrub shrub (PSS) portion of the site, a vegetation score of 27.5 out of 30 (92 percent) was given. The palustrine Emergent (PEM) portion of the site, despite dense herbaceous growth, only scored a 24.2 out of 30 (81 percent) due to the presence of the non-native floating primrose-willow.

Figure 3.23.56 – Peppertree Farm Stormwater Pond 2009 (scrub shrub area in northern portion of created wetland Black willow, switchgrass, and broadleaf cattail among plants pictured)

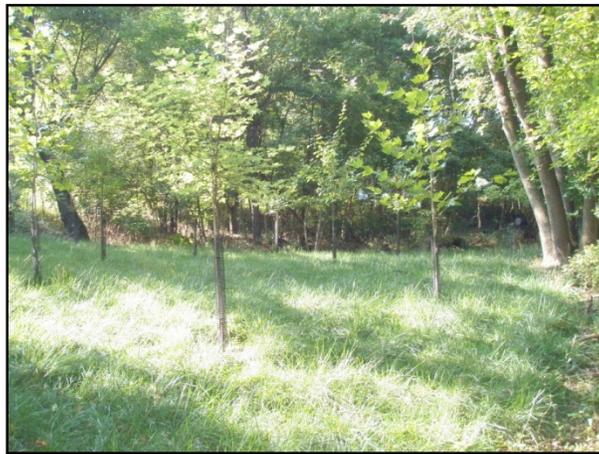
As mentioned above, this planting area was the most successful of all in the Turkey Branch project area (**Figure 3.23.57**). A summary of plantings observed at this site in 2009 per zone can be found in **Table 3.23.11** below. Planting zone 12 is located on the right bank of an unnamed tributary to Turkey Branch between Connecticut Avenue and Turkey Branch Parkway, beginning near Independence Street and extending south for approximately 500 feet. This area was

Figure 3.23.57 – Site LRTB101, Zone 13 (planted American sycamore)

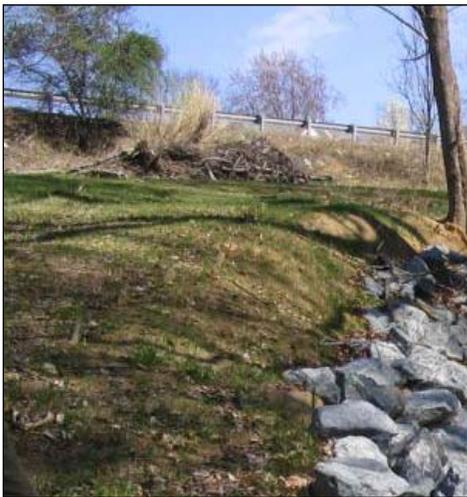
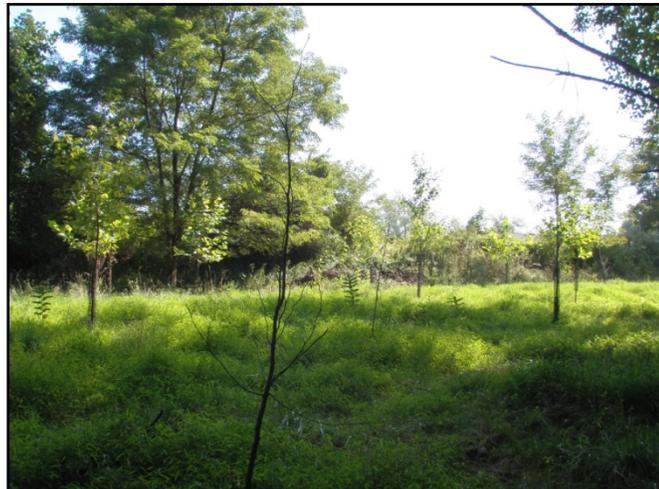
Figure 3.23.58 – Site LRTB203A, LTB-8 2008 versus 2009 (planted American sycamore with stiltgrass covering herbaceous layer)
