Pedestrian Road Safety Audit

Middlebrook Road

From Father Hurley Boulevard to Waring Station Road

December 2017

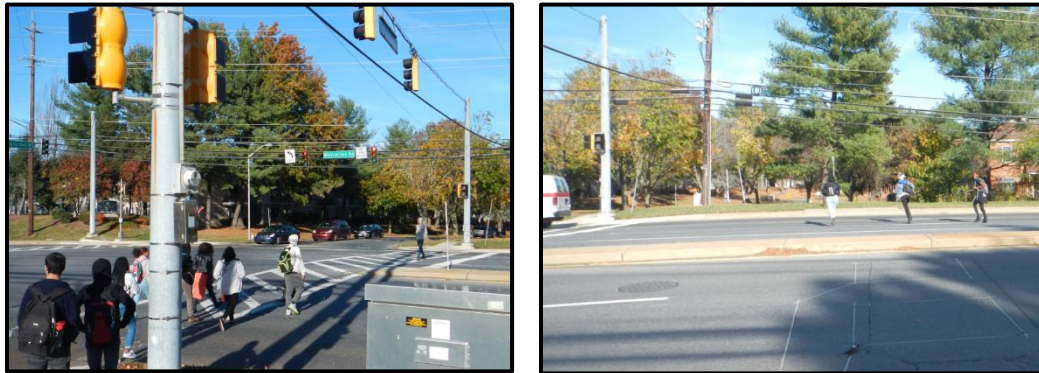
Figure 11: Examples of Pedestrian-Vehicle Conflicts

At multiple locations along the corridor, pedestrians were observed crossing outside of marked crossings or during the Don't Walk phase of the pedestrian signal. Additionally, conflicts between turning vehicles and pedestrians crossing during the Walk phase were observed. The audit team recommends coordination with the MCDOT Pedestrian Safety Coordinator and Seneca Valley High School to increase pedestrian education about where and when to cross and recommends that signal phasing changes, such as protected left-turn phases or Leading Pedestrian Intervals (LPIs), be evaluated where turn conflicts are present.

Left: Pedestrian crosses during Don't Walk phase. Right: Pedestrian crosses outside of marked crosswalk.

Safety Issue	Suggestion(s)
Pedestrian Vehicle Conflicts	<ul style="list-style-type: none"> Consider installing lane arrow pavement markings along Middlebrook Road and lane usage or shoulder markings, particularly on side streets, where applicable. (ST) Restripe all faded stop bars along the corridor. (ST) Consider installing Turning Traffic Yield to Peds signs (R10-15L) at intersections with permissive left turns. (ST) Work with MCPD to ensure appropriate levels of enforcement of posted speed limits. (I) Consider coordination with the MCDOT Pedestrian Safety Coordinator to increase pedestrian education and enforcement along Middlebrook Road. (I) Determine the feasibility of installing a Leading Pedestrian Interval at signalized intersections with high left and right turn conflicts. (LT) Evaluate the feasibility of adding protected left turn phases for applicable approaches to reduce conflicts. (LT) Evaluate the traffic signal coordination along Middlebrook Road to help create gaps at unsignalized intersections. (LT) Consider installing speed limit sign (S5-1) with flashing lights during school hours to better notify vehicles of the speed reduction. (LT) Evaluate right turn radii, particularly at the Great Seneca Highway and Father Hurley Boulevard intersections, for opportunities to reduce turn radii to reduce crossing distances and vehicular speeds. (LT) Evaluate the feasibility of a road diet on Middlebrook Road between Crystal Rock Drive and Great Seneca Highway to assist with lowering speeds and reducing crossing distance as discussed in the M-NCPPC study. (LT)

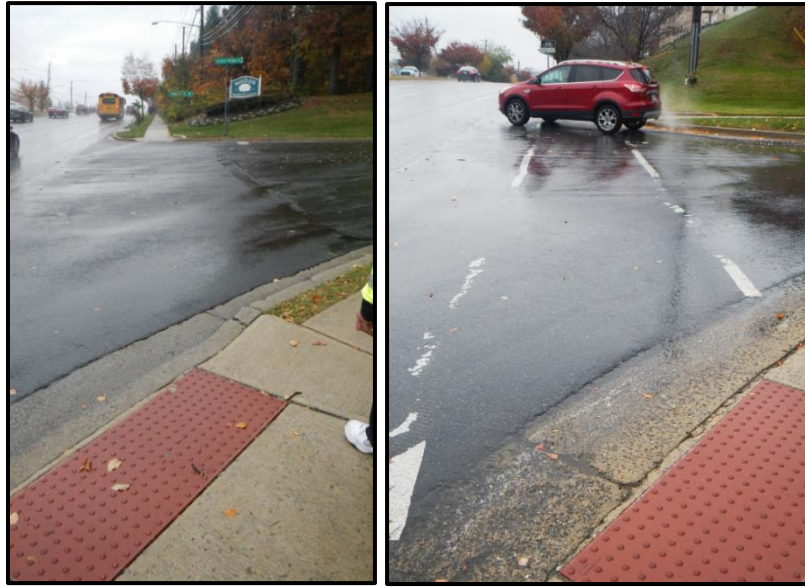
Figure 12: Examples of Pedestrian Facility Issues

A number of issues related to pedestrian facilities were observed during the audit. Examples include lack of crosswalk markings across side-streets, faded crosswalks, and no Accessible Pedestrian Signals (APS) at some intersections.

Left: No marked crosswalks across side streets. Right: Crosswalk markings are faded.

The audit team identified a number of suggestions to improve the condition of the existing pedestrian facilities including, but no limited to, the installation of crosswalks across all side-streets, restriping pavement markings for crosswalks and stop bars along Middlebrook Road, and installing APS where applicable.

Pedestrian Facility Issues	<ul style="list-style-type: none"> Consider installing pedestrian warning signs (W11-2) along the north and south sides of Middlebrook Road, where applicable. (ST) Consider installing Detectable Warning Surfaces (DWS), where necessary, to comply with ADA requirements. (ST) Consider restriping faded crosswalk markings and updating crosswalk markings to ladder markings where applicable. (ST) Consider installing crosswalks at unsignalized intersections, where applicable. (ST) Assess the condition of damaged sidewalk and asphalt path and determine the feasibility of repairs. (I) Consider relocating pedestrian push buttons to conform to ADA standards. (LT) Determine the feasibility of reconstructing sidewalk ramps to align with adjacent crosswalks where feasible. (LT) Consider installing or repairing the Accessible Pedestrian Signals (APS) where applicable. (LT) Evaluate the pedestrian crossing times at the signalized intersections to ensure that the Flashing Don't Walk interval meets standards. (LT) Consider the installation of green pavement for conflict areas within the marked bicycle lanes. (LT) Consider installing Rectangular Rapid Flashing Beacons (RRFB) on the pedestrian warning signs at the unsignalized crosswalk at Celebration Way. (LT)

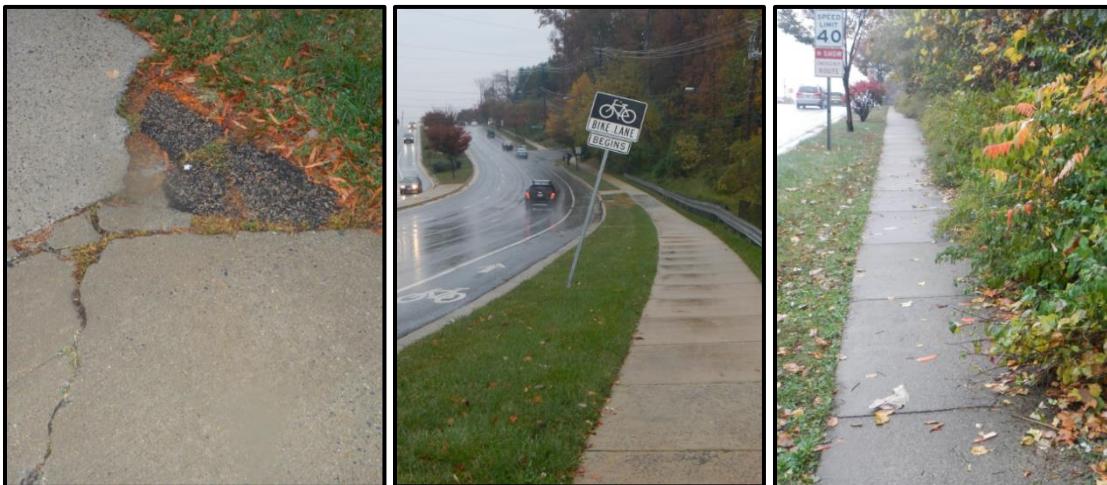
Figure 13: Examples of Maintenance Issues

A number of conditions were observed that may contribute to pedestrian safety issues that could be resolved through maintenance improvements. Such issues include signs that are damaged, sidewalk that is damaged or overgrown with vegetation.

Left: Damaged sidewalk on the south side of Middlebrook Road. Center: Sign is leaning east of Great Seneca Highway. Right: Overgrown vegetation greatly reduces sidewalk width.

The audit team recommends that all damaged or missing signs be replaced and that all foliage along the sidewalk be trimmed to maintain the full available width of walkable space. The condition of the sidewalk should be assessed along Middlebrook Road and the feasibility of repairs should be evaluated.

Maintenance	<ul style="list-style-type: none"> Trim the foliage blocking signage along the corridor. (ST) Trim the foliage along and above the sidewalk. (ST) Replace all damaged or faded signage throughout the study area. Evaluate sign size to prevent vehicular damage to future signs. (ST) Consider adding route information to the bus stop signs throughout the corridor. (ST) Consider installing missing Keep Right (R4-7) signs in intersection medians where applicable. (ST) Consider reinstalling raised pavement markers to the correct height between Great Seneca Highway and Waring Station Road. (LT)
Lighting	<ul style="list-style-type: none"> Inspect street lighting throughout the corridor and repair or replace as necessary. (ST) Determine the feasibility of additional street lighting at unsignalized locations where pedestrians cross Middlebrook Road. (LT) Consider installing higher wattage lights between Germantown Road and Crystal Rock Drive. (LT)
