# Pedestrian Road Safety Audit MD 355 (Wisconsin Avenue)

MD 410 (Montgomery Avenue) to Leland Street  
Montgomery County, Maryland

Prepared For:  
Department of Transportation  
Montgomery County, Maryland

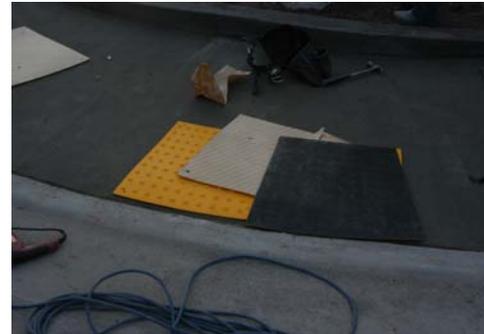
- **ADA Compliance:** ADA-compliance issues in the corridor include non-compliant curb ramp slopes, curb cut locations and crosswalk alignments, and missing truncated domes (i.e., detectable warning surfaces). Steep curb ramps make maneuvering the ramp difficult for pedestrians with mobility limitations, while curb ramps that are not aligned with crosswalks may misdirect pedestrians with visibility impairments into inappropriate areas. Truncated domes provide positive guidance to pedestrians with visibility impairments as they approach a crossing location. These issues may be addressed by updating curb ramps and sidewalks to comply with current ADA regulations.

Truncated domes can be retrofitted easily on existing curb ramps

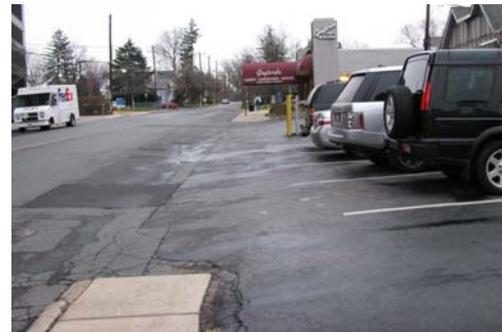
Accessibility issue at a missing sidewalk south of Leland Street.

- *Limited Sidewalk Accessibility:* The PRSA team noted a couple of locations along side streets where sidewalk conditions present accessibility difficulties or limit continuity and walkability within downtown Bethesda. Gaps or narrow widths along some sidewalks could be addressed through future planning efforts, community development, or Policy Area Mobility Review (PAMR) improvements.
