## 6412 Damascus Road, Gaithersburg, MD Hydrology and Hydraulics Calculations

**Property Address:** 6412 Damascus Road, Gaithersburg, MD 20882

**Prepared:** March 28, 2024

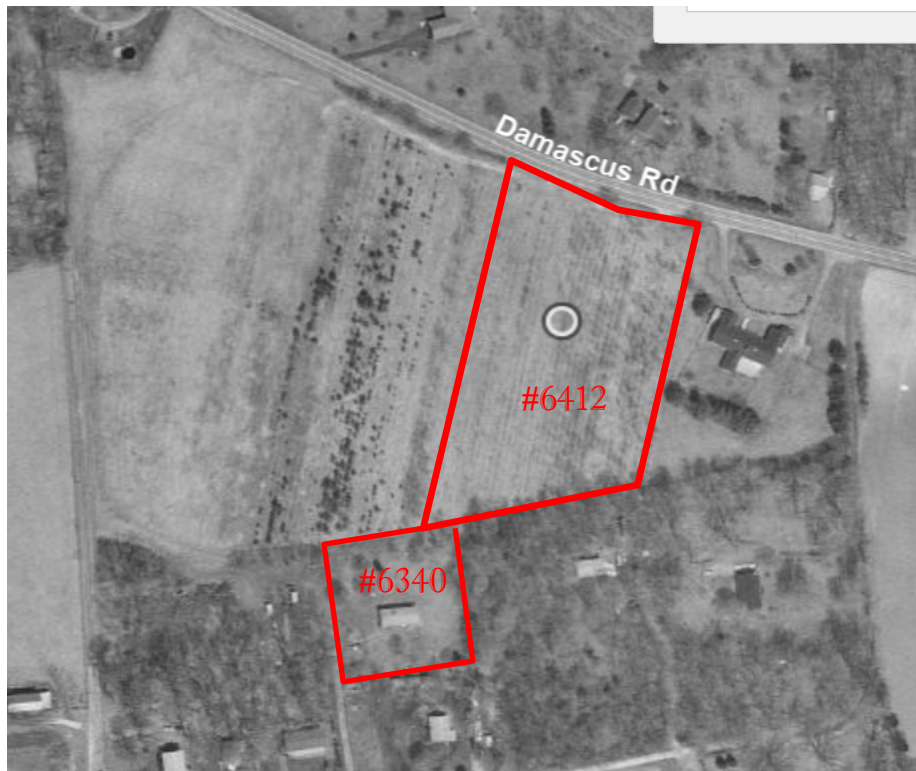
The clients 4.62 acre property is located on the south side of Damascus Road and consists of one lot of a three lot subdivision known as Etchison Acres recorded in 1991 as plat number 19212. Prior to this subdivision, the clients property (as well as the adjoining lots) consisted of farmland as shown in figure 1 below.

Figure 1: 1993 Aerial of client’s property and neighbor’s property.

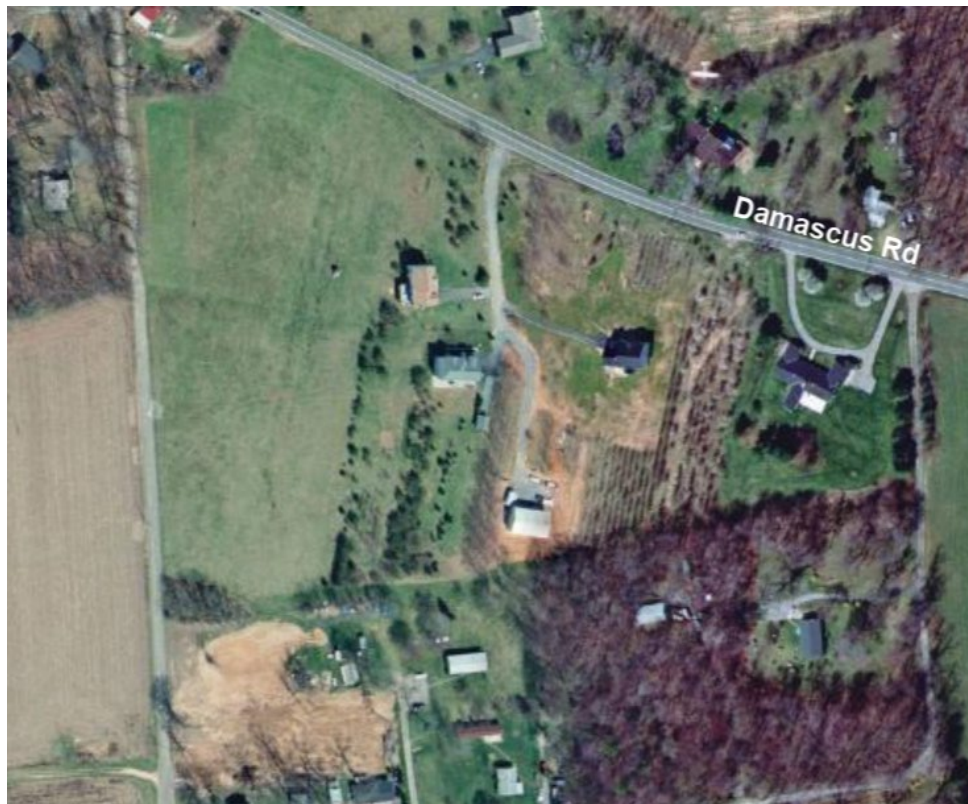
two below is a satellite imagery from 1998 showing the progression and development of the client's property and adjoining properties. Please note the client's property as improved with the house, rear garage, and associated driveway.

Figure 2: 1998 image of client's property and neighbors property.

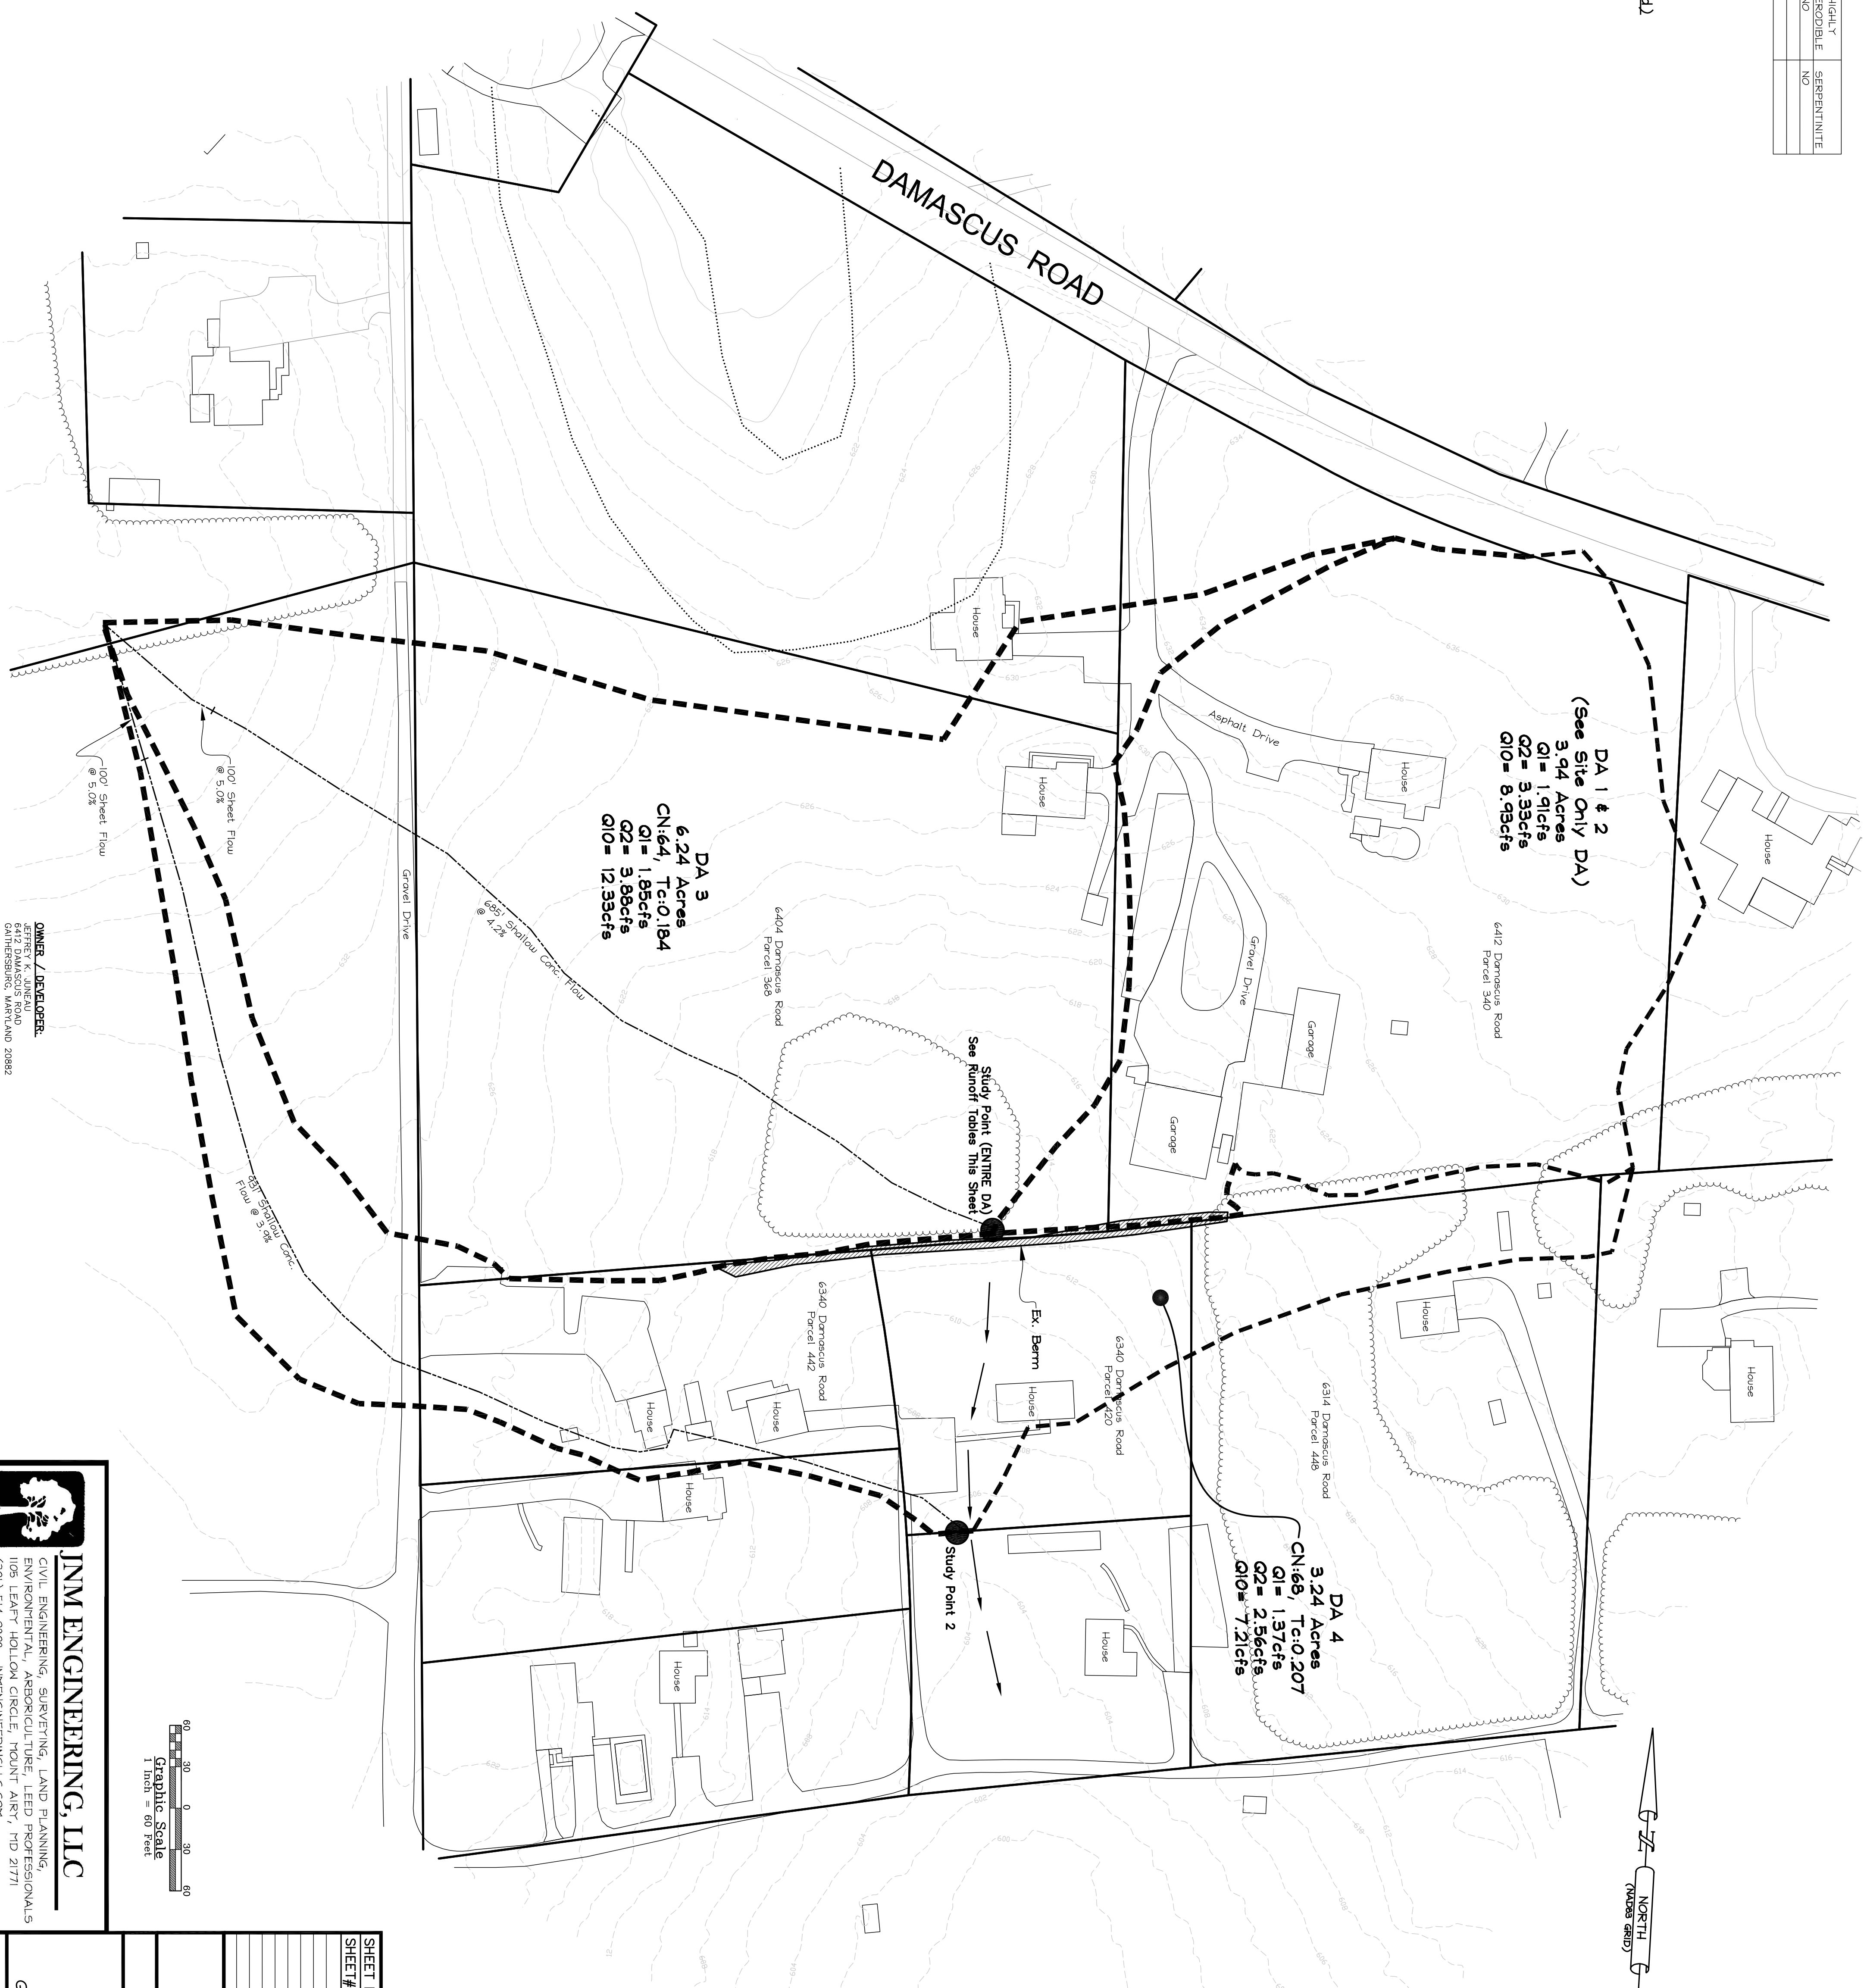
**FULL DRAINAGE AREA MAP**

Our secondary evaluation included the entire drainage area to the study point. This includes drainage areas 1 and 2 noted above as well as 6.24 acres (noted as drainage area 3) to the west of the client’s property. It was noted that there has been limited development on the adjoining parcels (DA3) over the years so we will only be analyzing this under existing conditions. Please refer to the plan titled “Full Drainage Area Map”. The calculated discharges are as follow:

STUDY POINT PEAK FLOW TABLE (Existing)				
Ex. DA1	Ex. DA2	Ex. DA3	Study Point	Storm Event
Discharge	Discharge	Discharge	Discharge	
0.07	3.58	1.85	3.76	2-Year
0.07	3.58	1.85	3.76	10-Year
3.29	5.69	12.53	21.21	100-Year

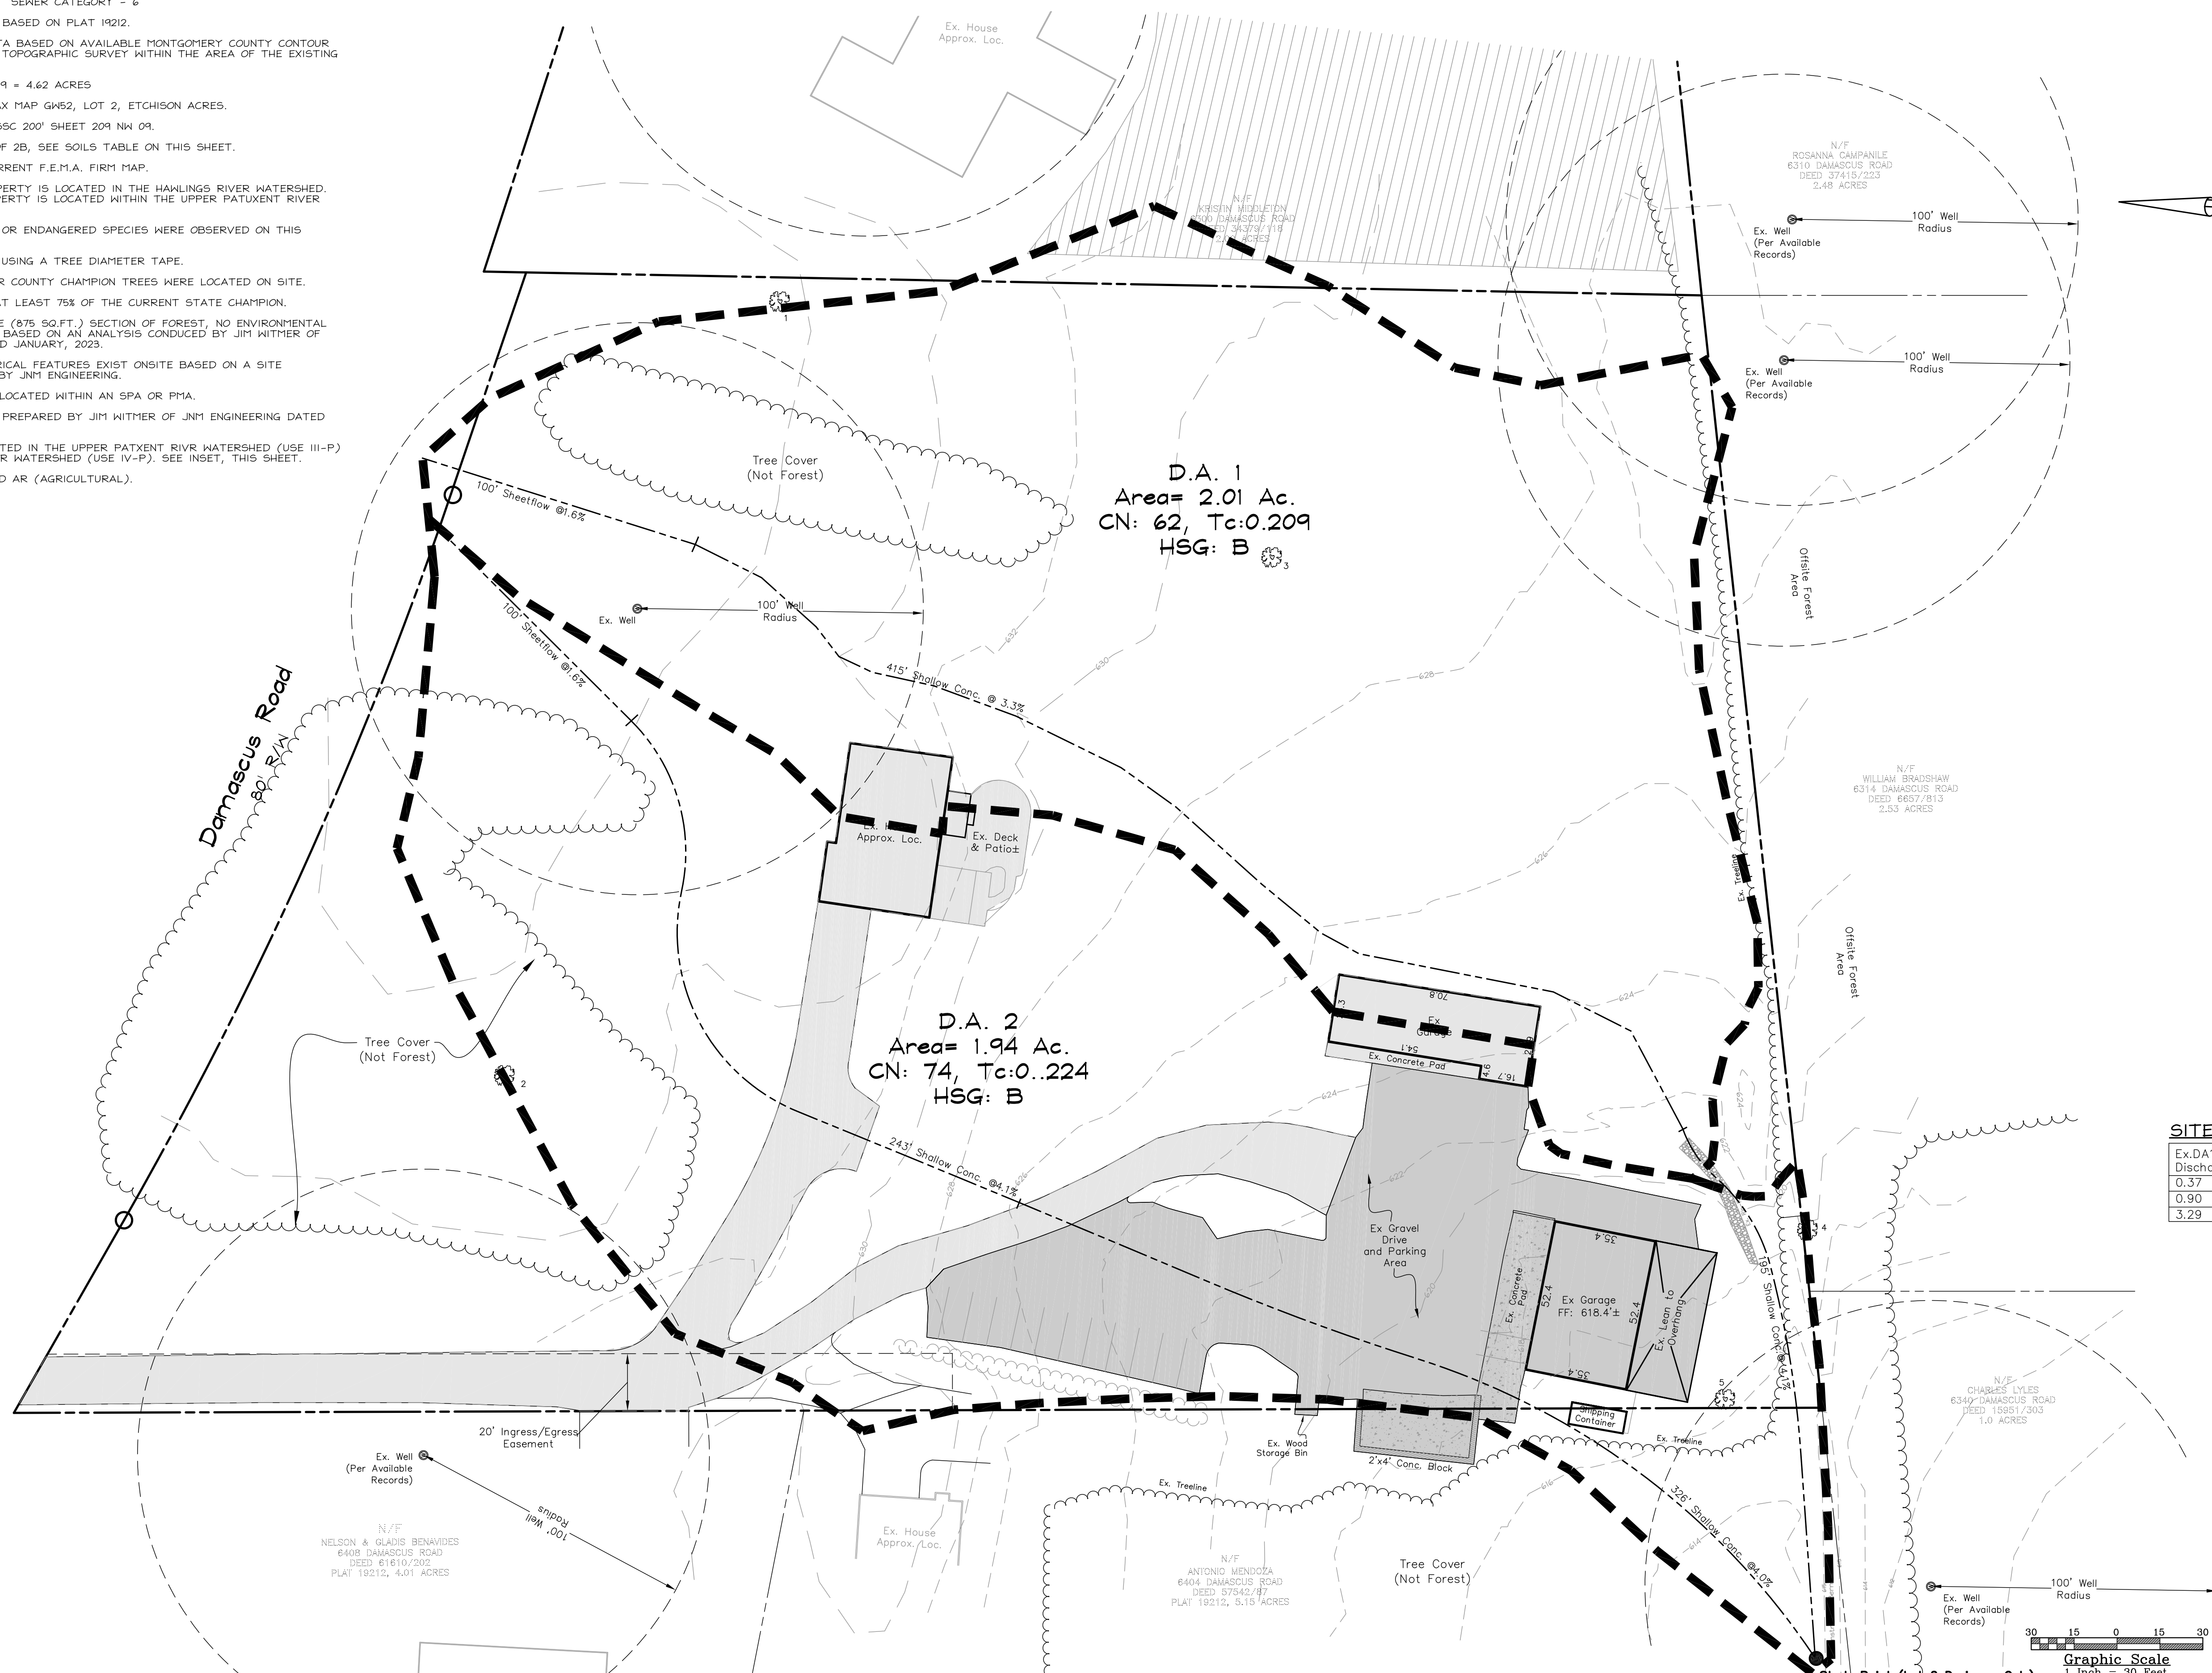
**SITE ONLY EX. CONDITIONS DRAINAGE AREA MAP**

This analysis evaluated the property as it exists today. As shown on the attached drainage area map, there are two primary drainage areas (Da 1 and DA 2). We have analyzed site runoff conditions, from only the client's property, for the 1yr, 2yr, and 10yr storm events. We have chosen the 1-yr storm event as this is the current target event for stormwater management through Montgomery County and Maryland Department of the Environment for all new developments. The 2-yr event was chosen as an intermediate evaluation of drainage. The 10-year was chosen to analyze "safe conveyance" as required by Montgomery County and Maryland Department of the Environment for all new developments. By utilizing WinTR-55 and WinTR-20 modeling we have calculated the following:

Ex.DA1 Discharge	Ex.DA2 Discharge	Study Point Discharge	Storm Event
0.37	1.58	1.91	1-Year
0.90	2.47	3.33	2-Year
3.29	5.68	8.93	10-Year

SWM target is 1-year peak management (CPV) for all existing impervious surfaces associated with the commercial landscaping business.

Volume Requirement = ((2.6"x0.95x0.44)/12) + 43,560sf = 3,945cf  
 - Assume 100% Impervious Area  
 - 2.6" is 1-year storm equivalent rainfall depth  
 - 0.95 is the Rv number for 100% impervious area

Volume Provided within SWM Detention Pond= 5,280cf
