SUBJECT: **Briefing**—January 12 Metrorail incident near L’Enfant Plaza Metro Station

## Initial Report on the L'Enfant Plaza Metro Station Incident on January 12, 2015

# **Preliminary Report Railroad DCA15FR004**

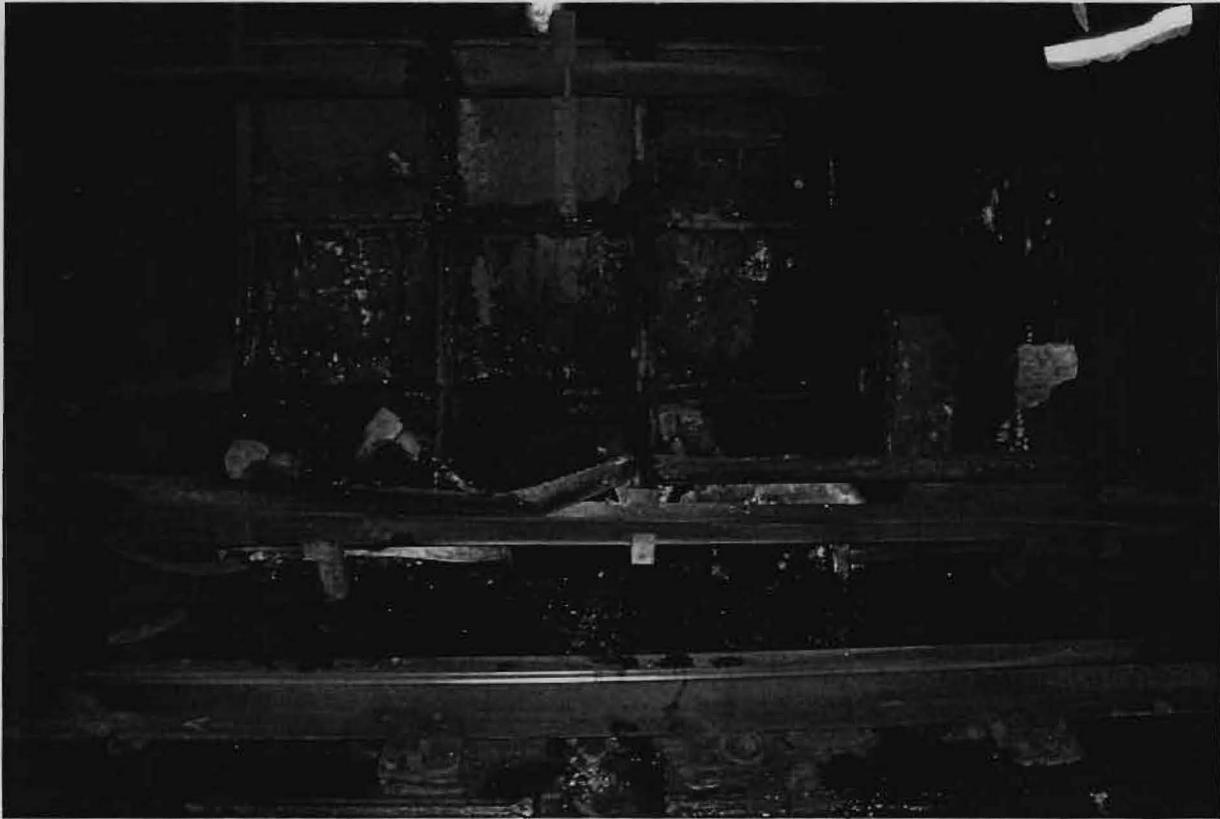
**Figure 2.** Damage from the arcing incident in the tunnel near L'Enfant Plaza Station.
