SUBJECT: **Piney Branch Elementary School Pool**

Future Options Preliminary Report
PINEY BRANCH E.S. INDOOR POOL
7510 Maple Ave. Takoma Park, MD 20912

APRIL 28, 2015

Piney Branch Elementary School Indoor Pool Future Options Preliminary Report

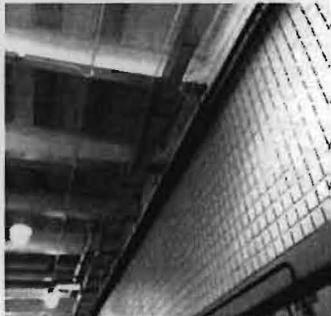
As seen in Photo # 1 below, the main girders supporting the roof are exhibiting minor corrosion at their ends. Although a close-up inspection could not be performed to determine the exact extent of corrosion; observed corrosion appeared to be minor and mostly at the surface of the beams.

Photo #1 - Corrosion at Beam Ends

Clean all steel beam ends by sandblasting and coat them with a zinc rich paint. A minimum of 36" long section should be painted on both ends of the beams. During the painting process, beam bearing plates should be inspected. If bearing plates are found to be deteriorated they should be removed and replaced. Also, the waterproofing membrane on the exterior walls should be checked to ensure that there is no water infiltrating from the perimeter walls.
