SIGNIFICANT INJURY INVESTIGATION REPORT

**219 Frederick Avenue
October 2, 2008**

April 2009

Frederick Avenue - Significant Injury Investigation Report

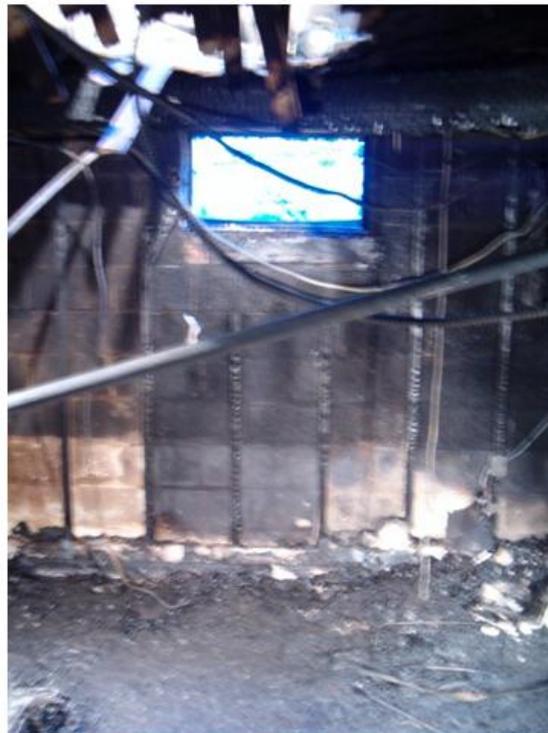
Figure 28: Basement Bedroom toward SIDE DELTA Window

RS703 Driver walked up an incline of debris under the window. The window was at chest level to RS703 Driver. RS703 Driver found a bar across the window and pulled it out by “shaking” it. RS703 Driver felt a “pinch” type injury to the right pinky finger while removing the window frame. While experiencing significant heat and feeling as

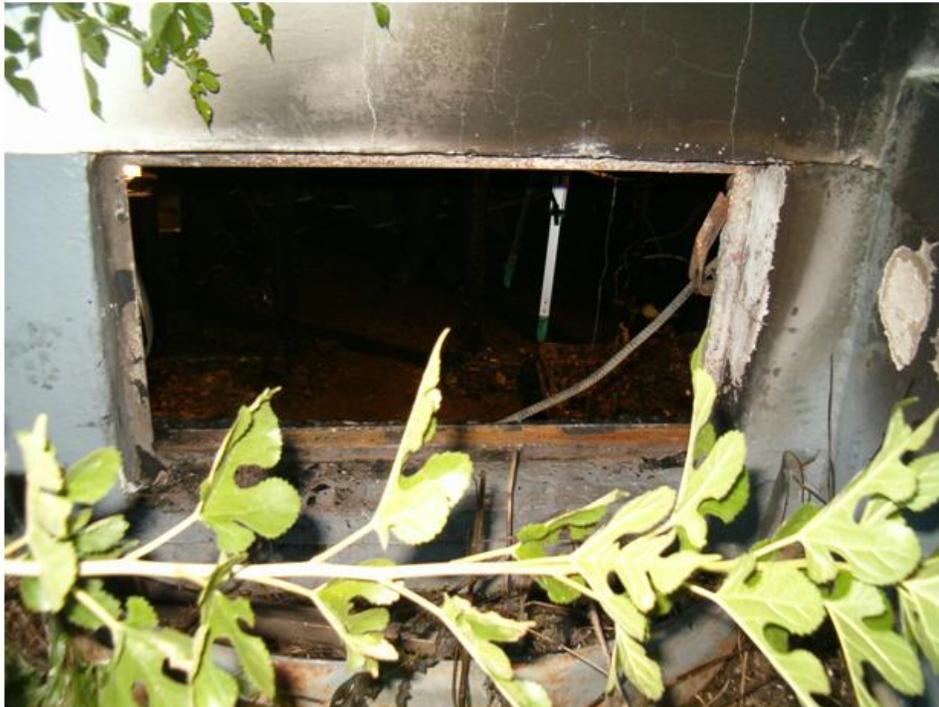
Figure 29: Basement Window

Note: The window is 16” tall and 31” wide and the bottom of window is 65” from clean floor.

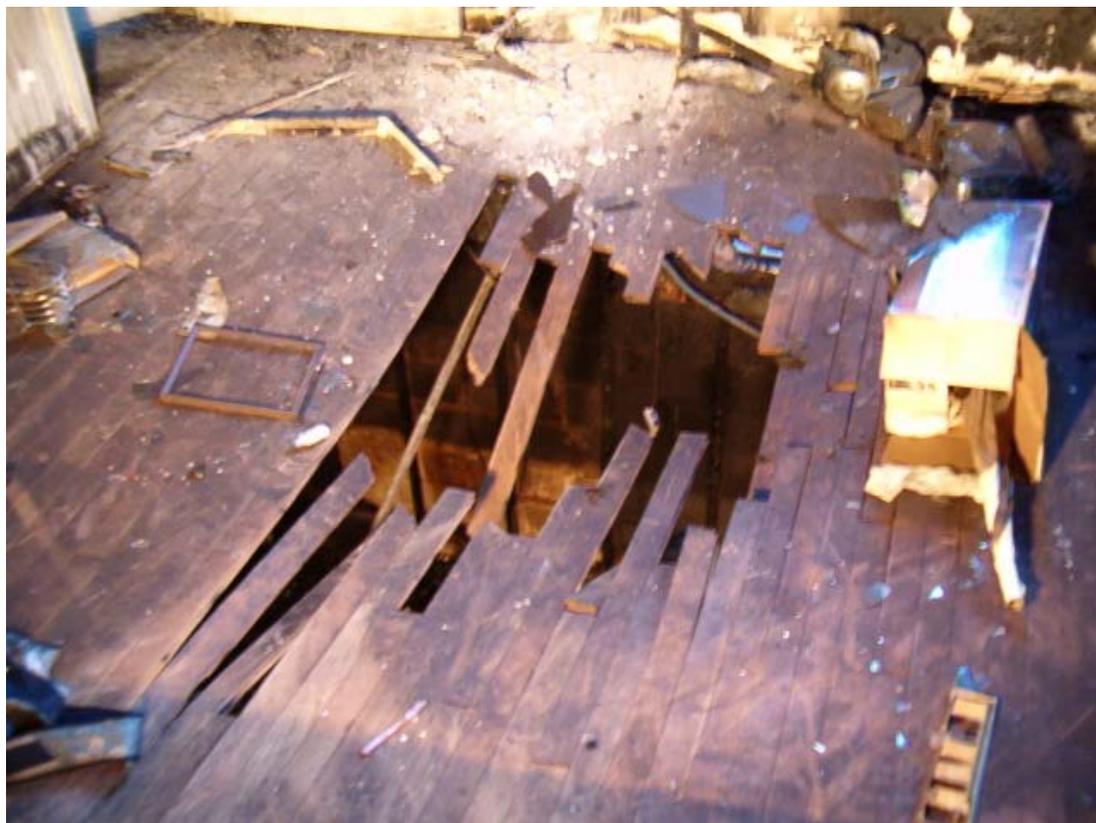
Figure 47: Dining Room Floor - from Front Entrance Way(SIDE ALPHA)

The construction features and building materials, in particular the full dimensional floor joists, 1x6 tongue and groove sub floor, and hardwood finished floor contributed to the timing of the dining room floor failure by maintaining floor integrity longer before collapse.

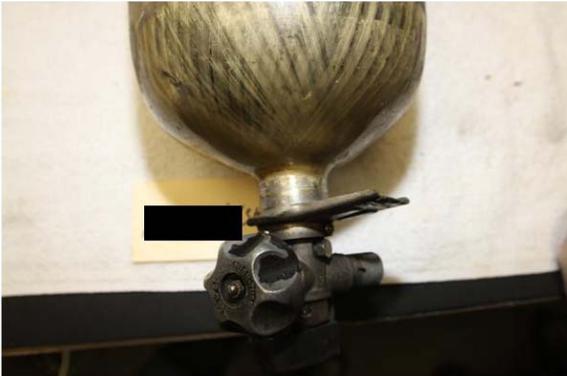
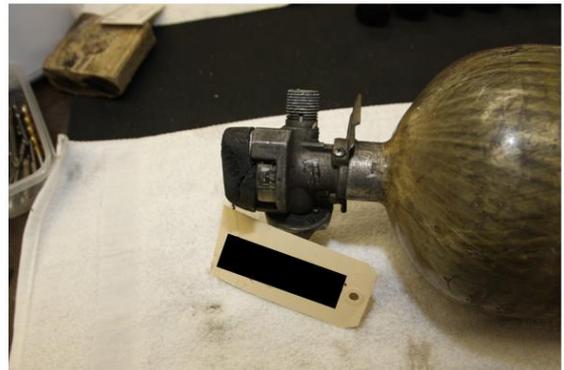
Two gouges in gel-coat through to the first layer of fiber wrap noted on back side of cylinder three inches from cylinder neck

Gauge cover broken and cylinder bumper & guard assembly bent

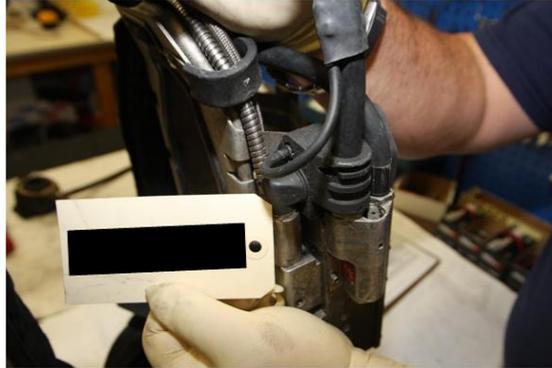
HUD hose found 180 degrees out from where it should be in the anti-rotation hose clamp

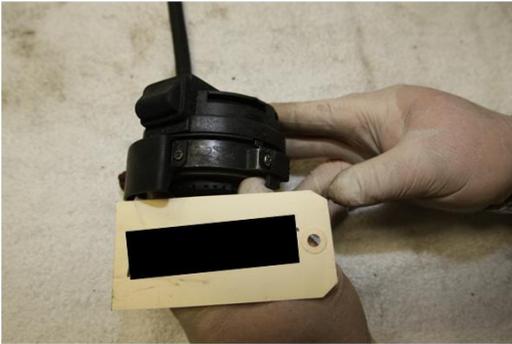
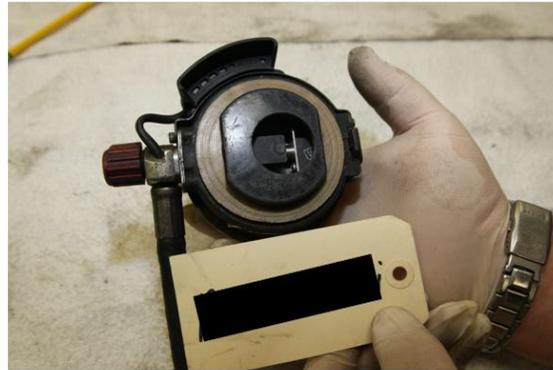
HUD display visor has cut in top of its left side.

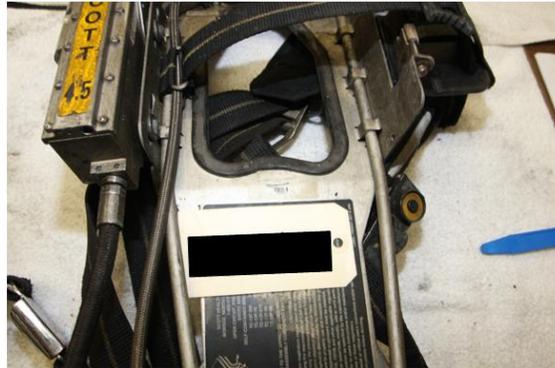
Only damage appears to be to the back frame gasket not seating in frame at bottom of frame opening. All straps are in good shape; waist strap buckle has some rust on it but works ok.

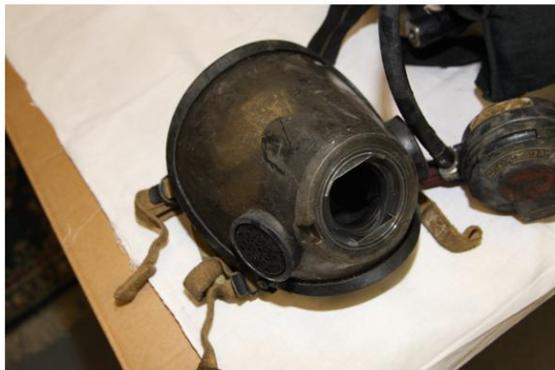
Deep scratch on left side of lens. Other scratches from general use.
