CLOSE CALL/HAZARD REPORT

Swift Water Rescue Training Incident
9200 Old Dominion Drive, Great Falls
April 2, 2014

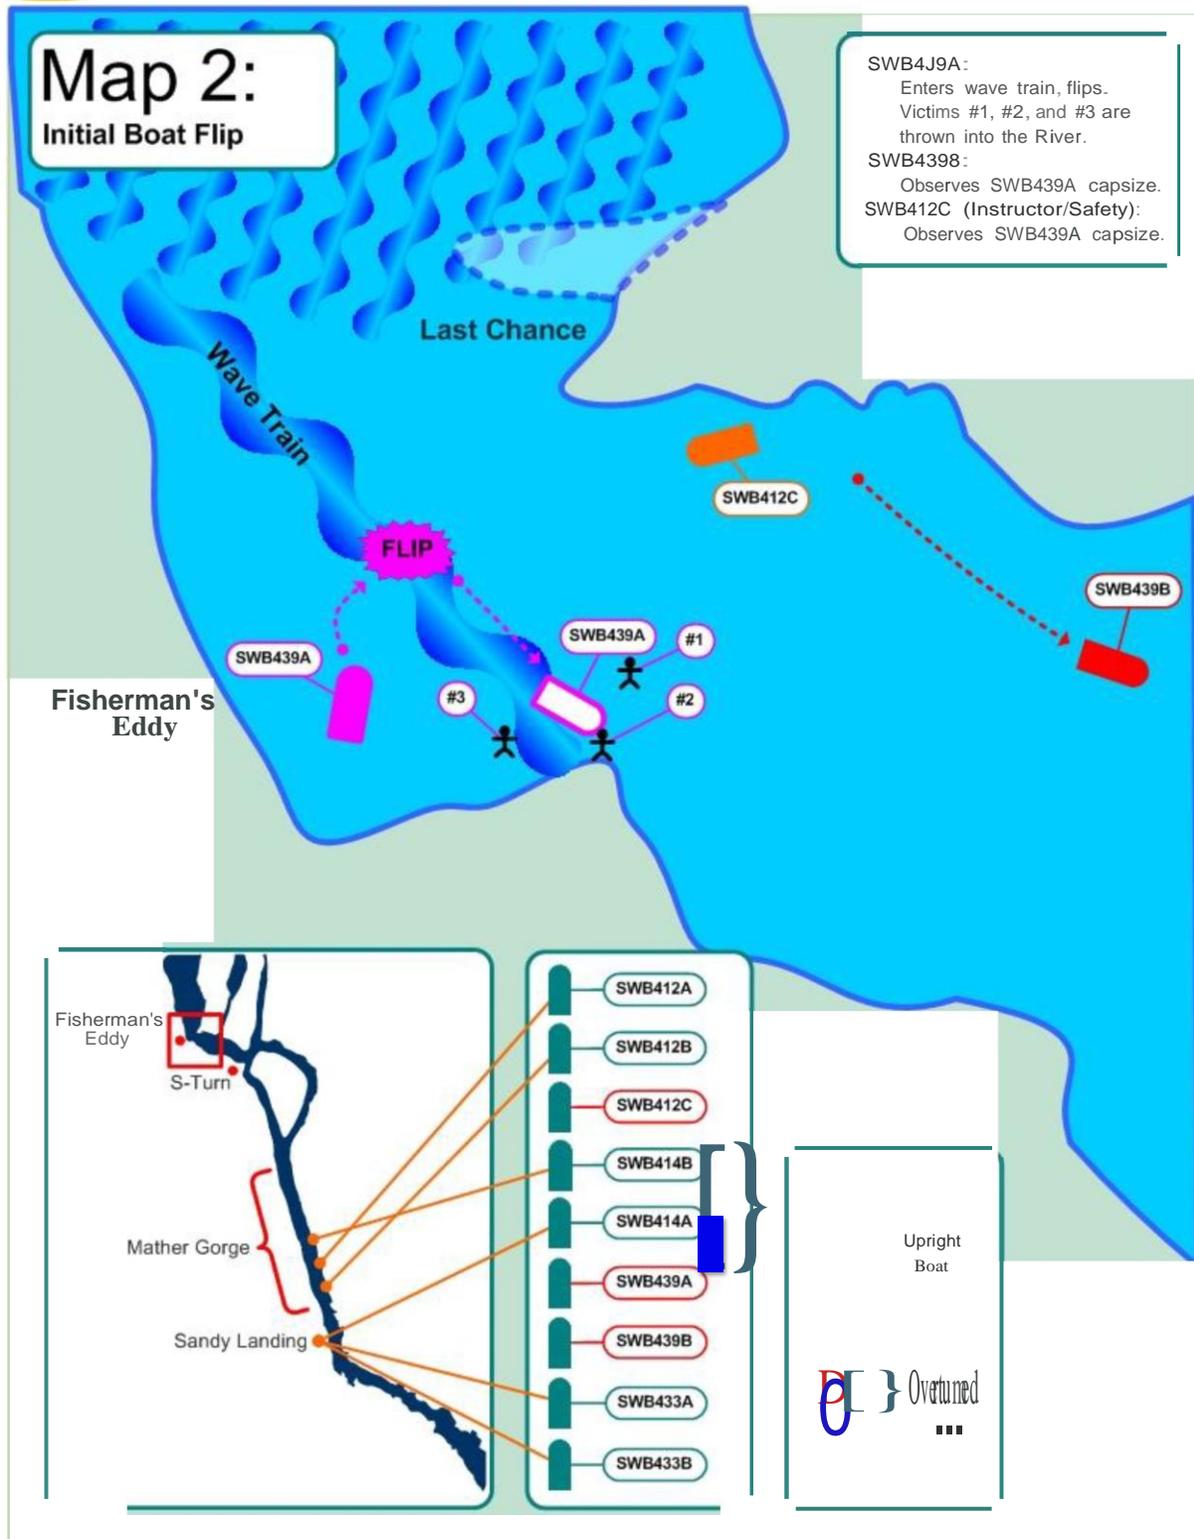
Map 3: 1 Minute After Initial Boat Flip

Victim#1 resurfaced upstream of SWB439A and grabbed the boat's rope handles (Victim #1 later reported that his life jacket was not providing enough buoyancy to keep him at the surface in the aerated water conditions). Victim #2 resurfaced underneath the boat, swam under the pontoon, and ended up on the downstream side of the capsized boat. The boat rapidly moved downstream, pushing victim #2 into the shoreline (rock face), causing a shoulder injury and helmet strike against the rock. Immediately after the collision, victim #1 mounted the boat and pulled victim #2 onto the overturned boat's hull. Both victim #1 & #2 were unable to locate victim #3 (Map #3).

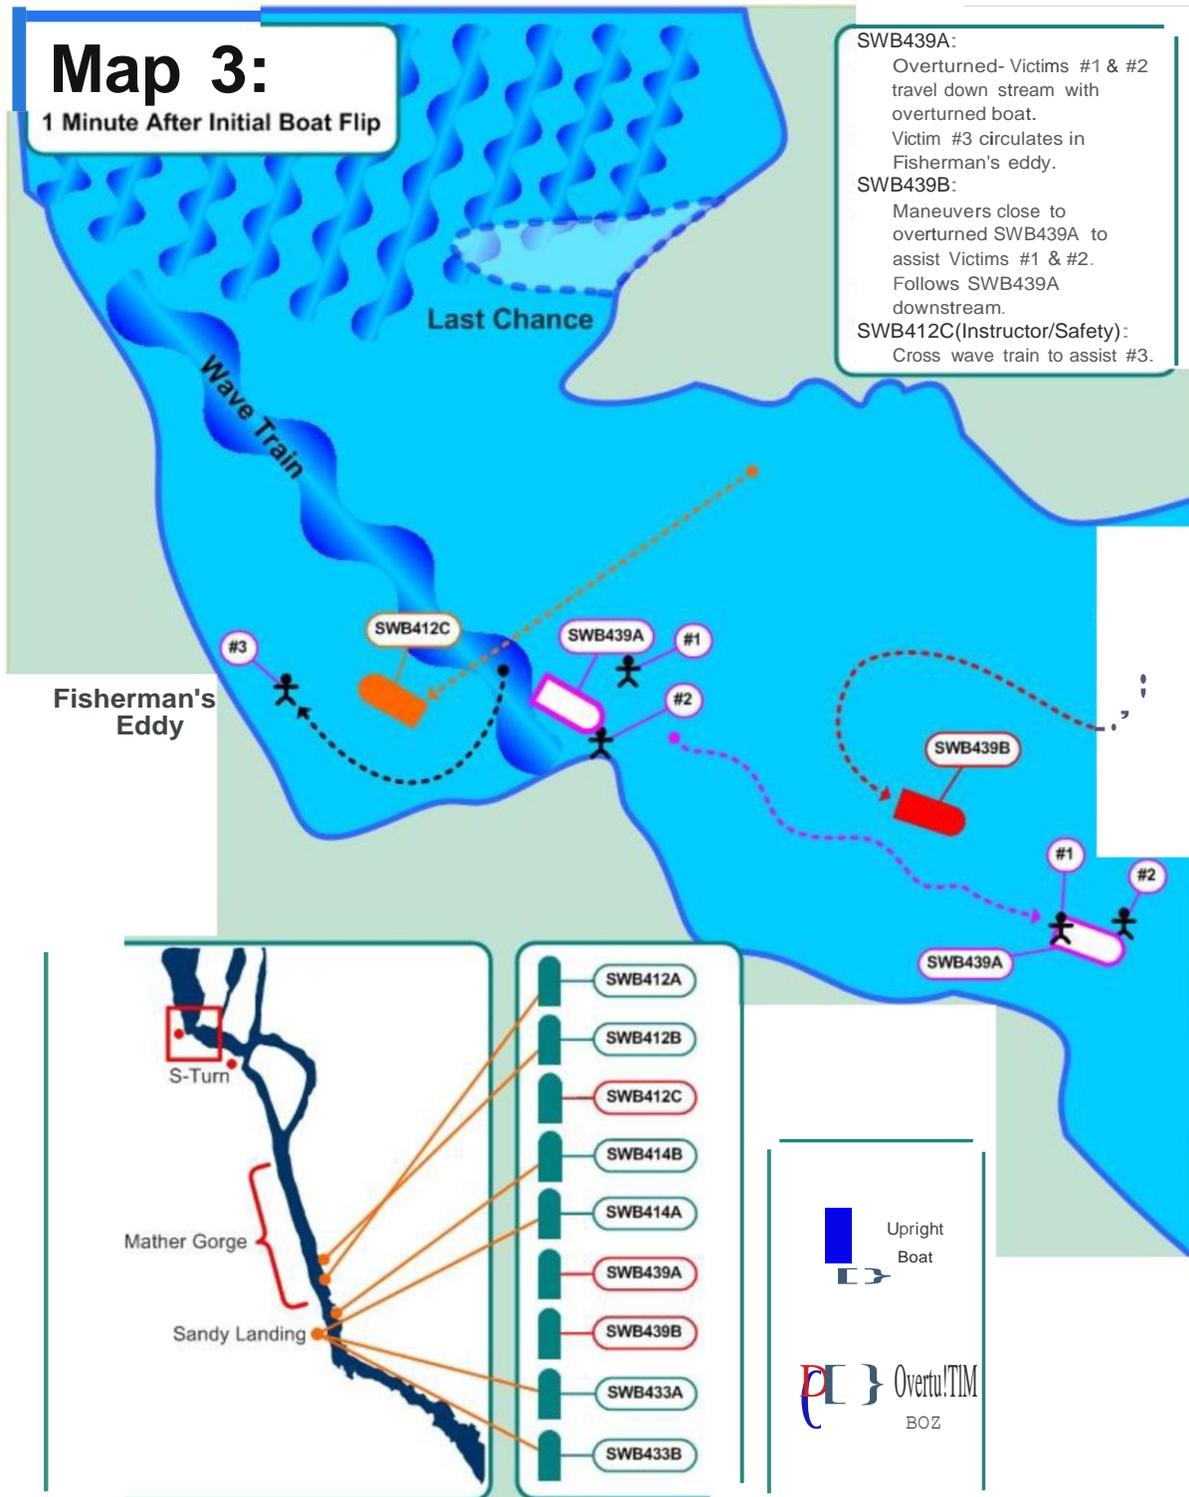
Map 4: Second Boat Flip

Meanwhile, attempting to exit Fisherman's Eddy, SWB412C overturned in the same eddy fence which capsized SWB439A (Map #4). All four personnel (including victim #3, the rescued member of SWB439A) were thrown into the river. The three crewmembers from SWB412C (victims #4 & #5) climbed out of the water, on top of their overturned boat. The third crewmember (victim #6) was significantly delayed as ropes were tangled around his legs (**Finding 10: Boat Performance, Maintenance, and Damage Reporting, Recommendation E**). In the process of disentangling the rope from his legs an attempt was made to transfer the only portable radio in SWB412C crew's possession to the other crewmembers (who were on top of SWB412C). The radio fell overboard and was lost. Consequently, even as they watched victim #3 rush down river toward the S-turn rapid they couldn't report the capsizes or the need for rescue (Map #5).

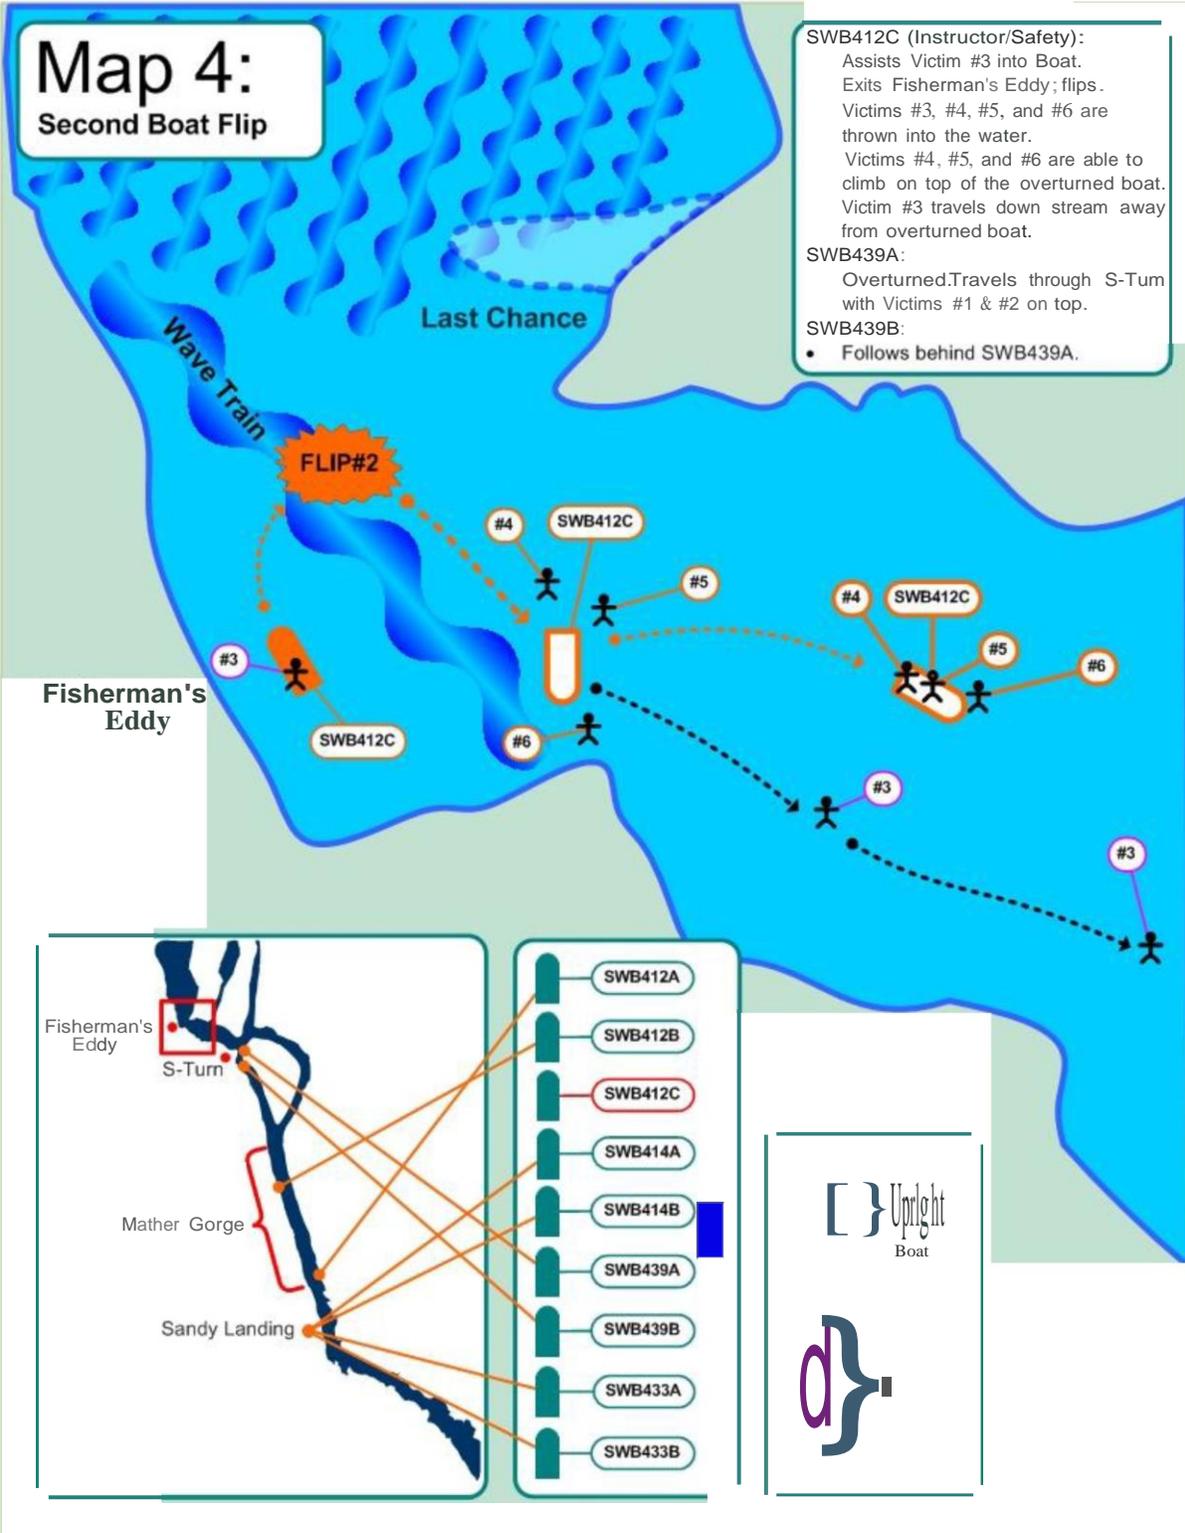
Map 5:

Victim #3 (wearing the radio from SWB439A) entered the S-turn rapid, with the current pushing him towards river-left into the previously identified hazardous whirlpool at the terminal end of the S-turn rapid. Victim #3 submerged in the whirlpool to the point where he couldn't see any daylight for an extended period of time. While moving (underwater) downstream, victim #3 reports that his radio's "out of range alarm" activated. Based on numerous witness reports, cross referenced with map features, victim #3 resurfaced approximately 300-400 feet down from the terminal end of S-Turn. While data does not exist to determine an exact duration of submersion or distance traveled, it is clearly evident that victim #3 was submerged for a considerable amount of time in violently turbulent water (Map #6).

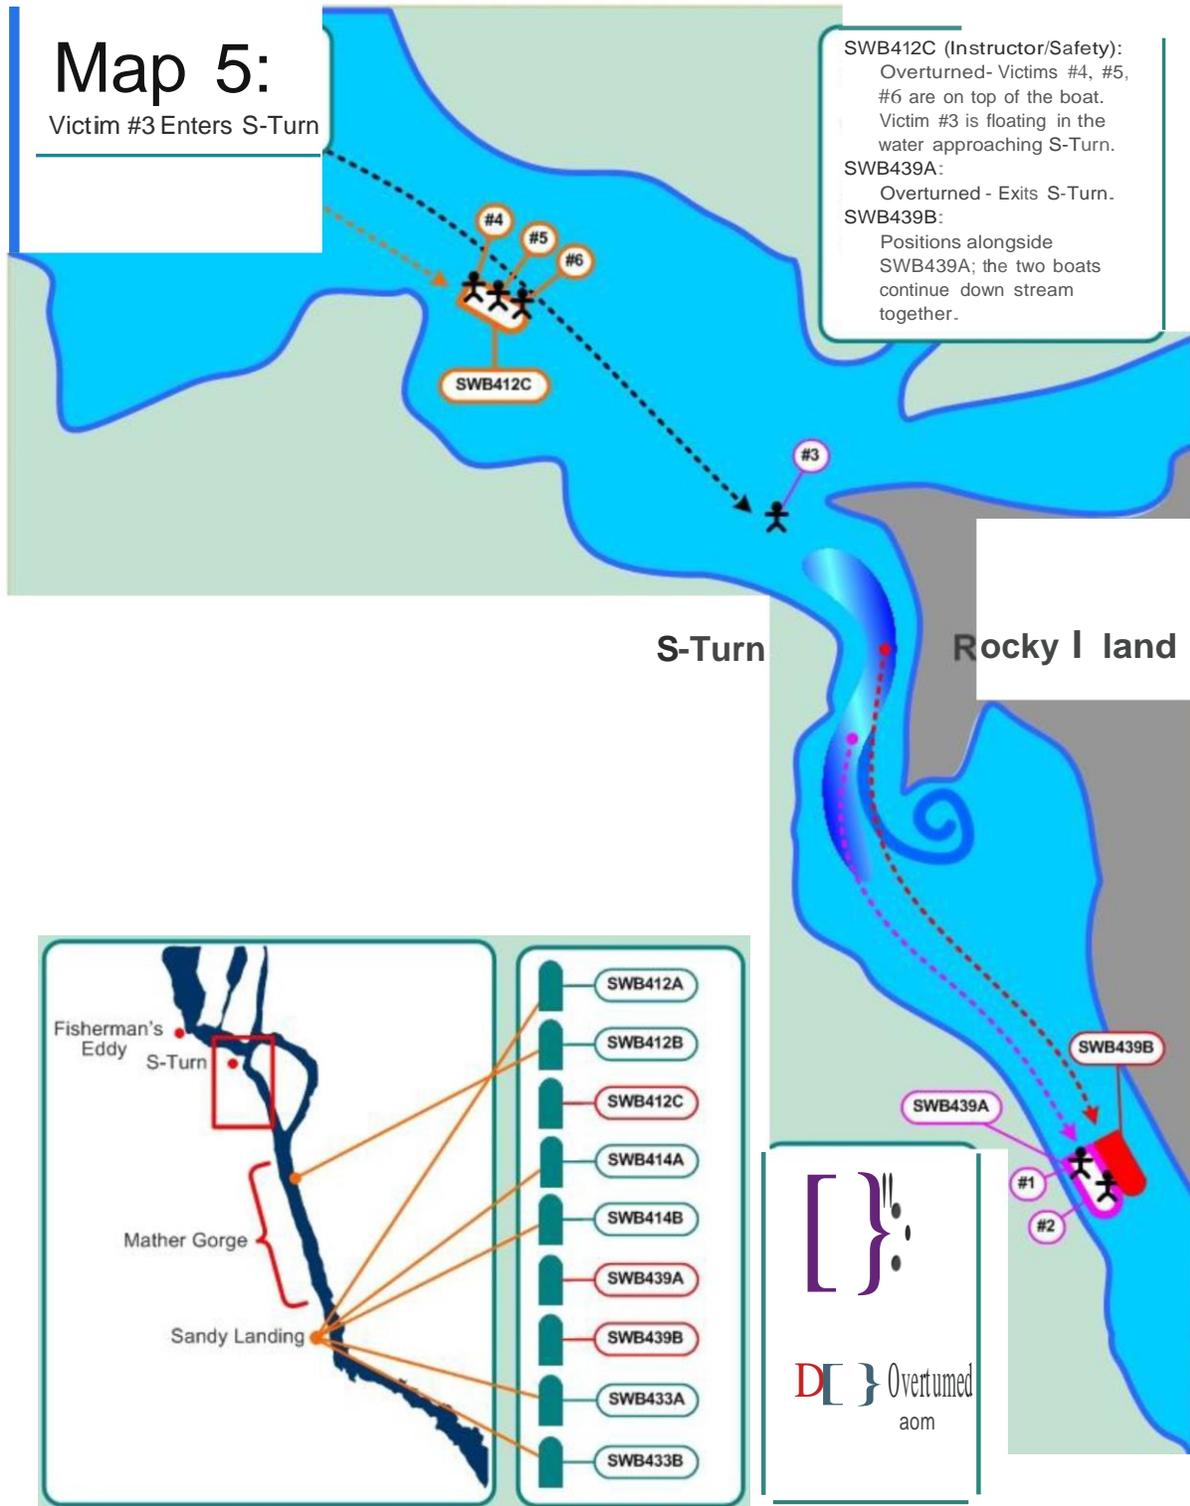
Map 6:

Victim #3 Enters Whirlpool

SWB412C (Instructor/Safety):
Overturne<1 - Victim #3 travels through S-Turn, enters whirlpool, travels underwater, surfaces downstream.
Victims #4, #5, #6, travel through S-Turn on top of boat.
SWB439A (overturned) & SWB439B: Continue down stream together.
