MONTGOMERY COUNTY FIRE/RESCUE SERVICE
POST INCIDENT ANALYSIS

2-Alarm House Fire with Injuries
4610 Iris Street
Box Area 21-04
September 04, 2014
04:33 Hours
Incident # 14-0101041

Written By: Chief Jayme Heflin

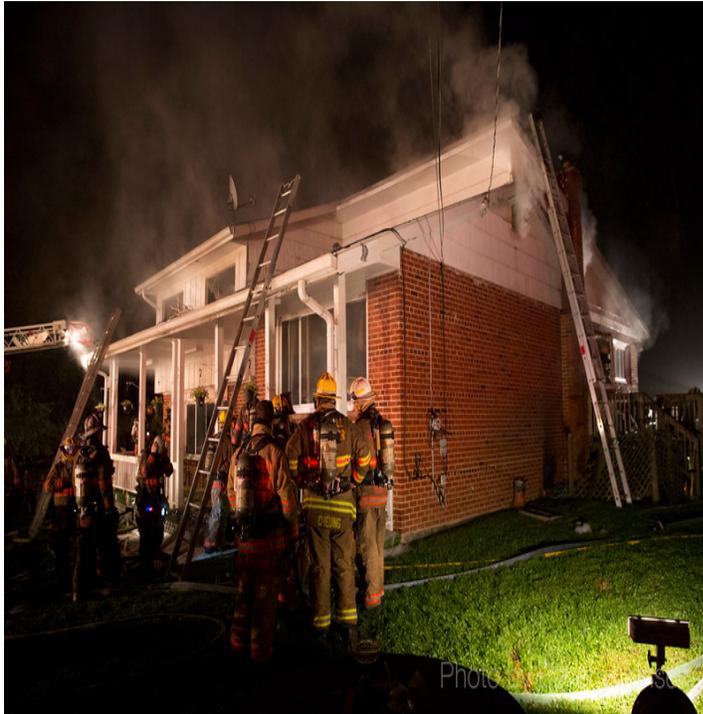
Figure 1 - Alpha/Delta View. Photo Credit: Beverly Jensen

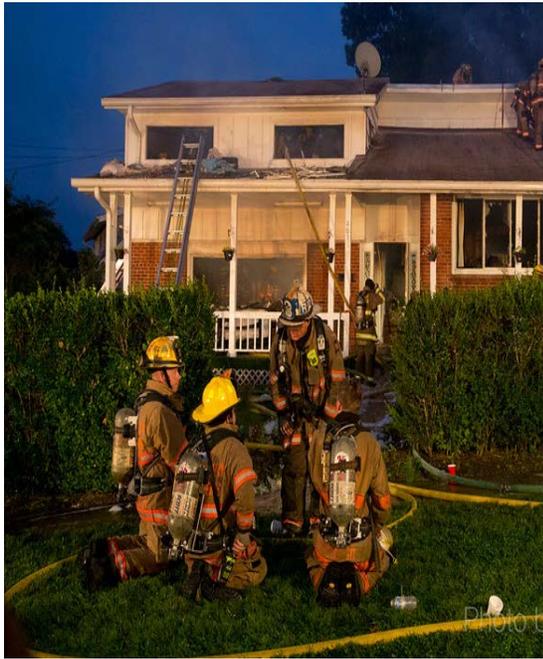
Figure 2 - Street View. Photo Credit: Beverly Jensen

The house is separated from the street by a hedge row (Figure 2). There are no other immediate exposure issues to the house. The driveway is located on the Bravo side and accessed from Magellan Avenue. The hydrants used on this incident are located at 4632 Aspen Hill Road and 4603 Iris St.
