POST INCIDENT ANALYSIS

Two-Alarm Arson Fire

Box 03-07 - 301 South Horners Lane

November 19, 2014

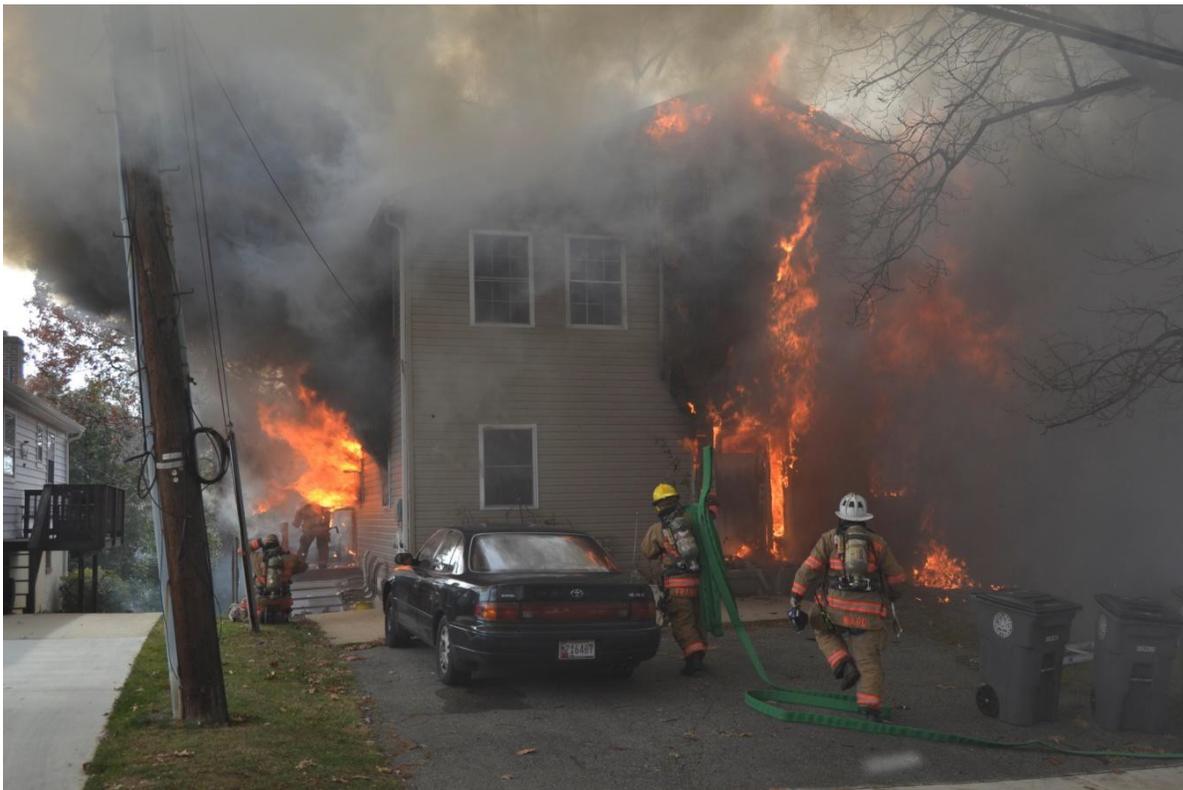
Fire conditions as the first line is being deployed from PE703. Note fire conditions in Quadrant Bravo, and the first and second floors of Quadrant Delta.

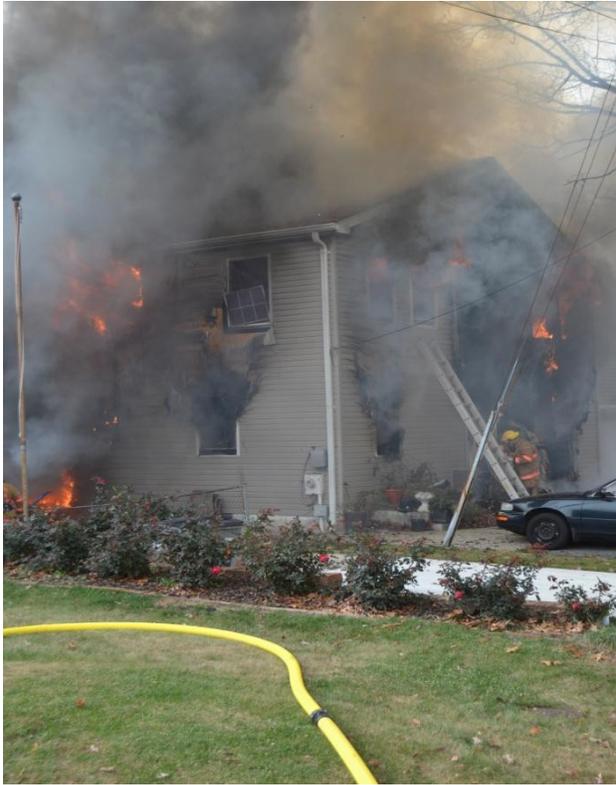
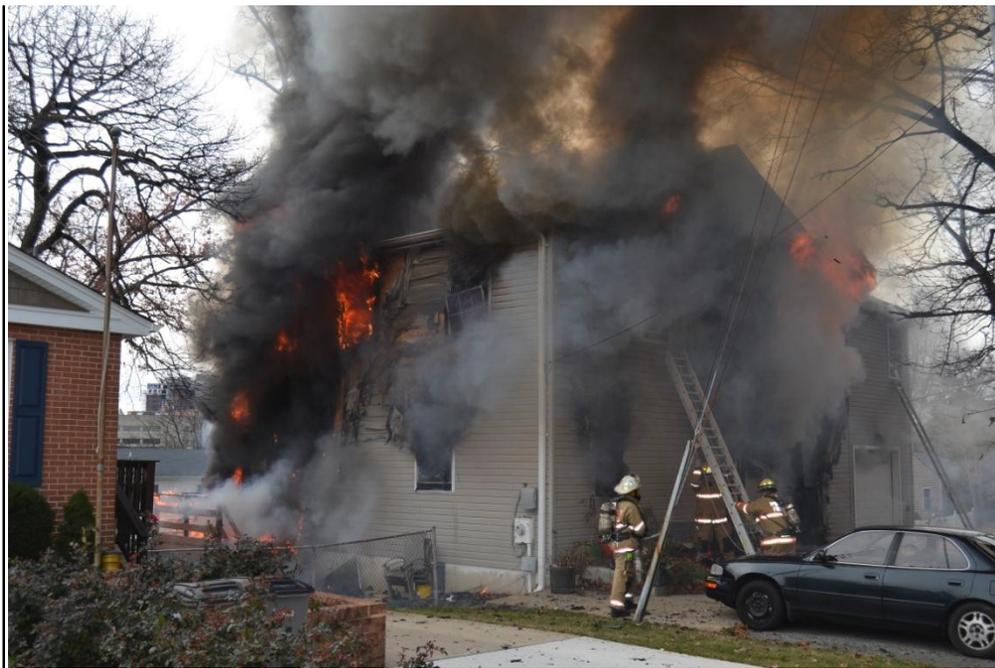
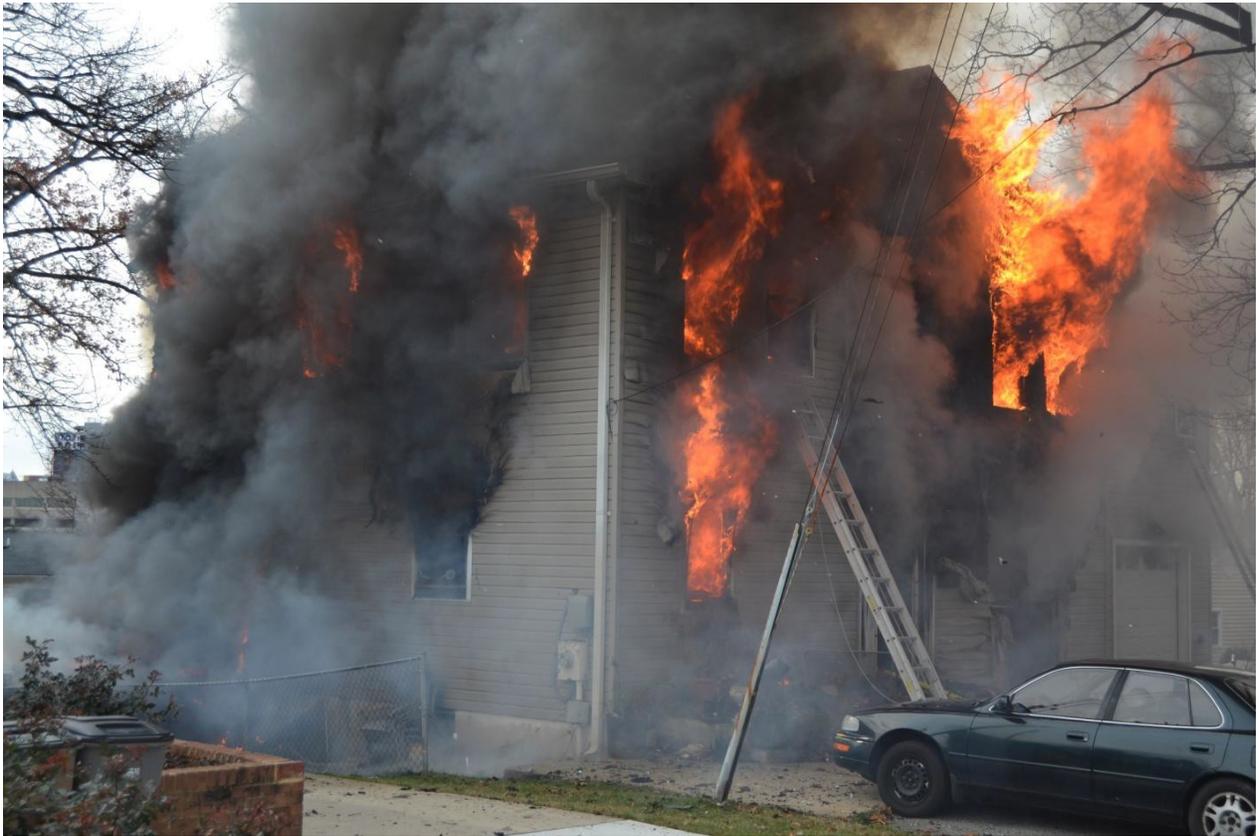
While the Attack and Rescue Groups were operating on the interior of both floors, the conditions on the first and second floors of Alpha Quadrant began to deteriorate as shown in the next sequence of photos.

- Personnel should remain cognizant of the possibility of accelerant use as it relates to normal fire tactics – in this instance the fire flared back quickly, whereas that probably would not have occurred without the presence of accelerants. This necessitated the rapid withdrawal of crews due to changing conditions that would not normally be expected.

At this point units operating on the interior were instructed to withdrawal from the building until the conditions could be stabilized via exterior attack. A Personnel Accountability Report (PAR) was completed for units, and additional large attack lines were brought into play, knocking the fire on all sides. As soon as the conditions were deemed tenable, units re-entered the structure, hitting additional hot spots and continuing the primary and secondary searches. All units were eventually utilized with extensive overhaul on all floors in coordination with FEI personnel.

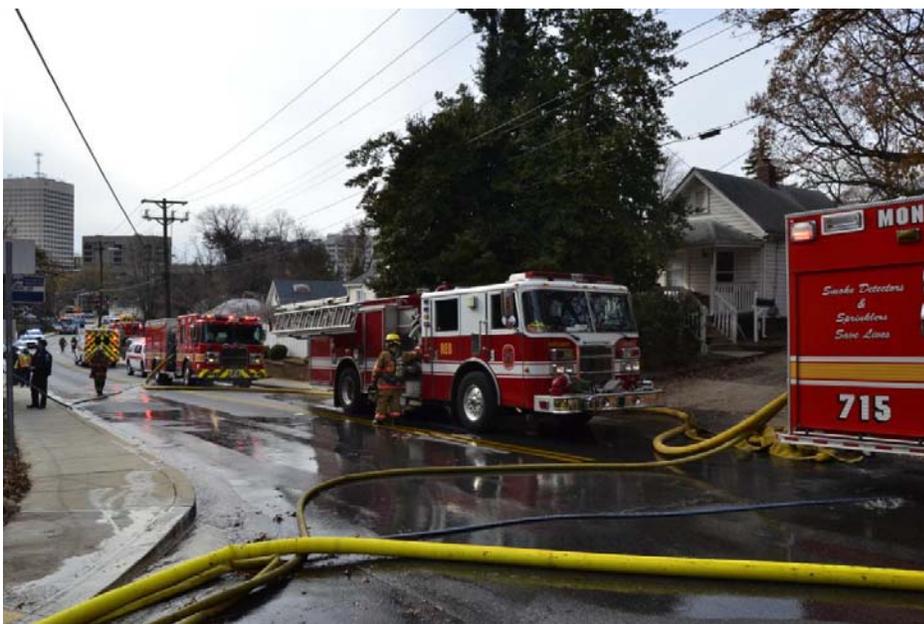
Left to Right on Park Rd – PE721, PE723 and PE715 – South Stonestreet Avenue is in the distance.
