MONTGOMERY COUNTY FIRE/RESCUE SERVICE
POST INCIDENT ANALYSIS

40 Upper Rock Circle
April 1, 2014

Assistant Chief Charles Bailey

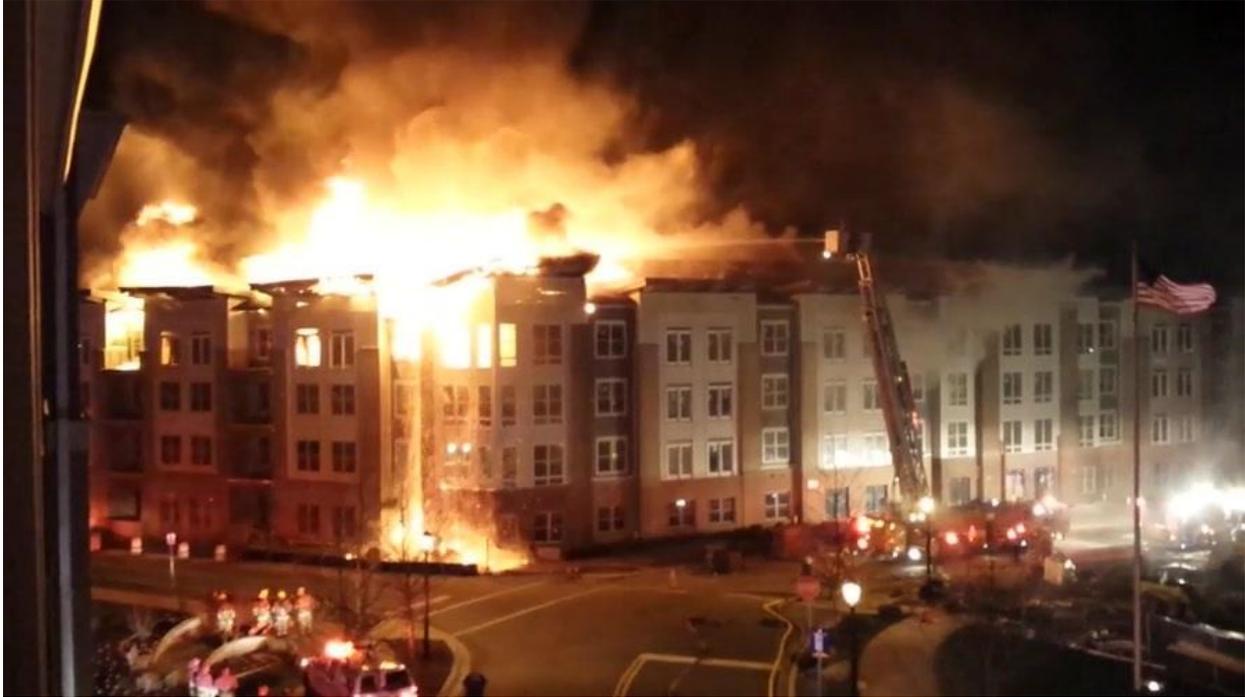
The Scene Shortly After Arrival with Aerial Tower 703 Flowing (Figure 1)

On the fire department's arrival, units were faced with a well developed fire that was moving quickly and unimpeded throughout the roof assembly (Figure 1). However, many parts of the roof remained intact providing cover over the fire and preventing fire department streams from reaching interior burning surfaces. Where the fire had vented through the roof assembly, the fire department was able to direct streams onto those areas to suppress the fire.

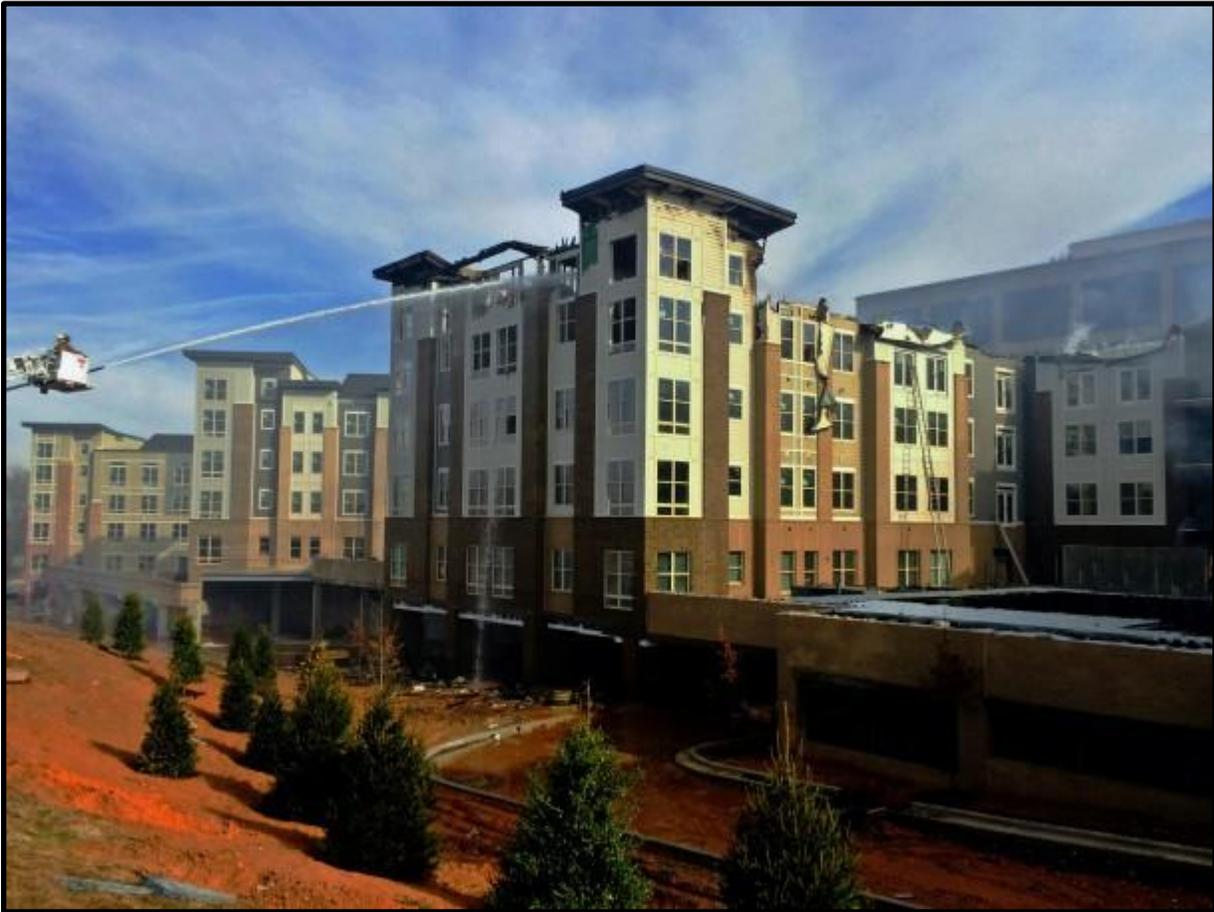
View From the Rear on the Next Morning (Figure 3)

1. The fire department has limited ability to access all sides of the structure because the buildings have integrated parking and are landscaped “into” the environment. These structures are certainly aesthetically pleasing and do make efficient use of scarce urban real estate and are typical of the dense urban land use in the region (Figure 3).

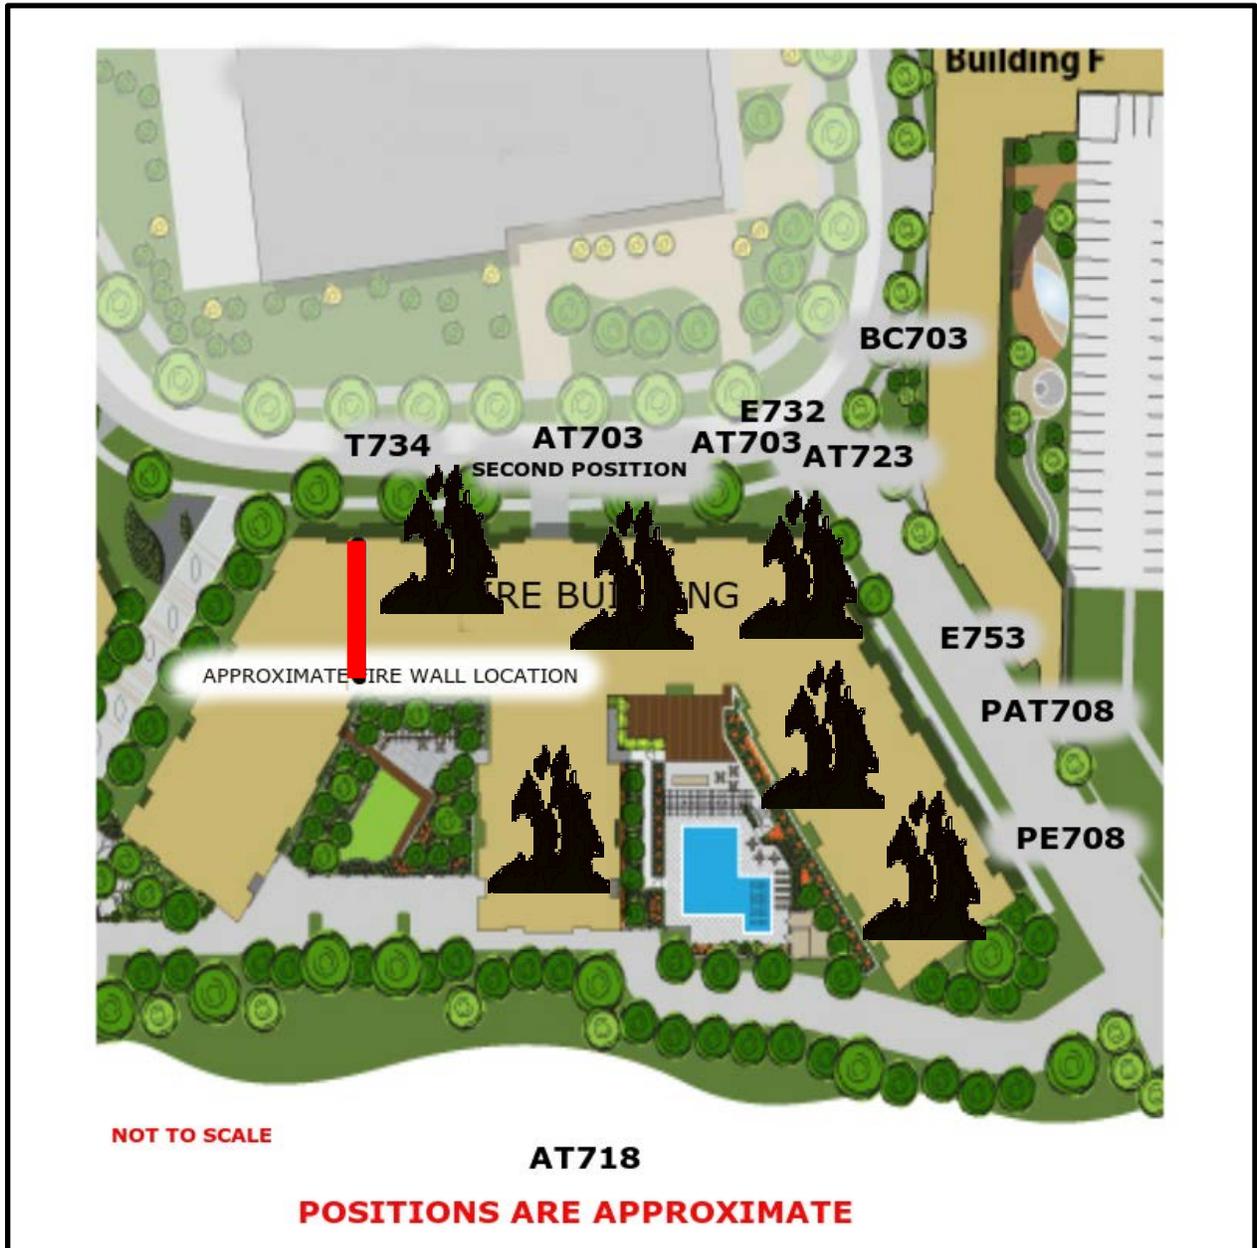
Apparatus Placement (Figure 4)

The layout of the building was the primary obstruction to the implementation of strategies and tactics. First, 360 degree apparatus access to the building was not

possible. A hallmark of the MCFRS Standard Operating Procedure (SOP) is the placement of units all around the building. This part of the SOP is important for two reasons: it provides a “set of eyes” to the rear allowing the Incident Commander a more clear picture of the totality of the incident and; it provides an alternate operational platform - a second vantage point - from which fire suppression can occur. When units cannot access the rear, operations are at a significant disadvantage.

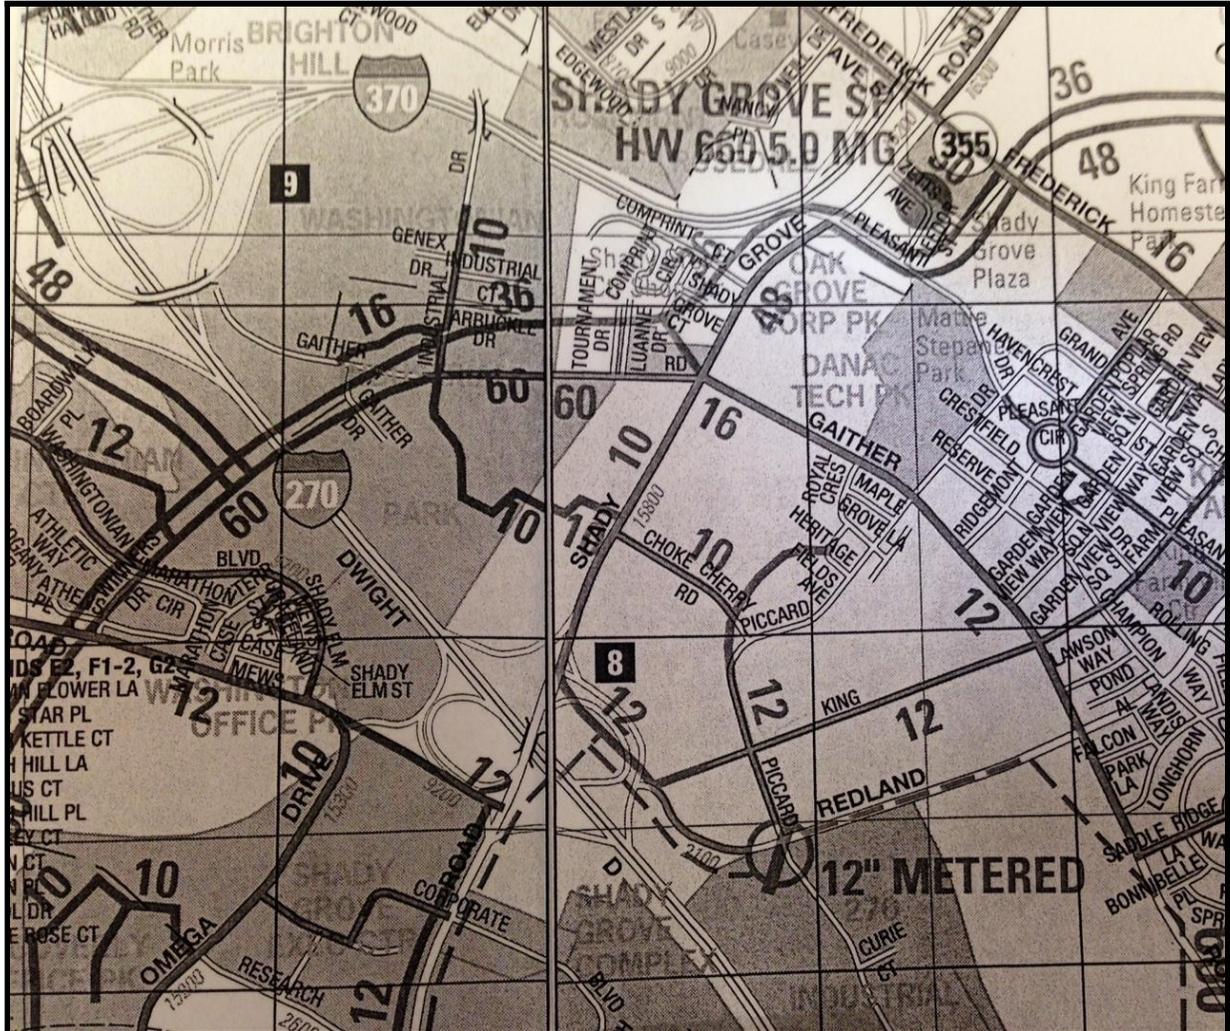
WSSC Water Supply Map

A copy of the map page used by the Water Supply Officer to determine water main size and location. This map is created by the Washington Suburban Sanitary Commission (WSSC), a non-governmental organization that manages the regional water works. These maps are carried in all of the Battalion Chief and Duty Operations Chiefs' vehicles. Please note that the main size in the immediate area of the fire is not indicated on the map and that the map does not show hydrants which forced the Water Supply Officer to drive around and verify the presence and operation of various hydrants.

Anytime that there is new construction in an area it is the responsibility of the first due company to make sure that adequate maps are available for fire service operations. It is understandable that water utility and County GIS maps are behind a few months but Fire Rescue personnel must create and update station maps as early as possible. It did not help that this complex was first in Fire Station 28's area and switched to Fire Station 32's area just two months before when Fire Station 32 opened. However, given the number and complexity of large construction projects like this, station mapping efforts must be improved.
