POST INCIDENT ANALYSIS

2-Alarm Townhouse Fire
19625 Club Lake Road
Gaithersburg MD 20886
Incident # F14-0027716

Submitted by Battalion Chief John J. Gallo

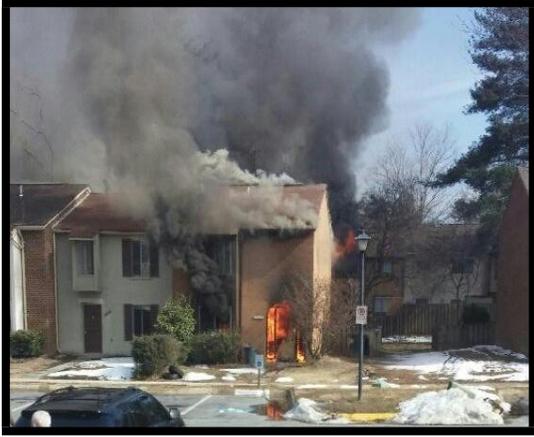
Alpha Side – Prior to MCFRS Arrival

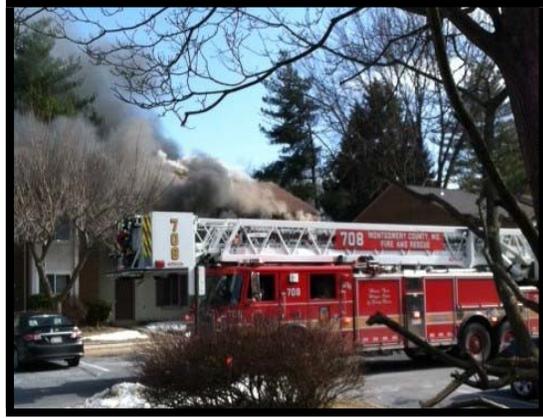
Alpha Side – AT708 First Arriving

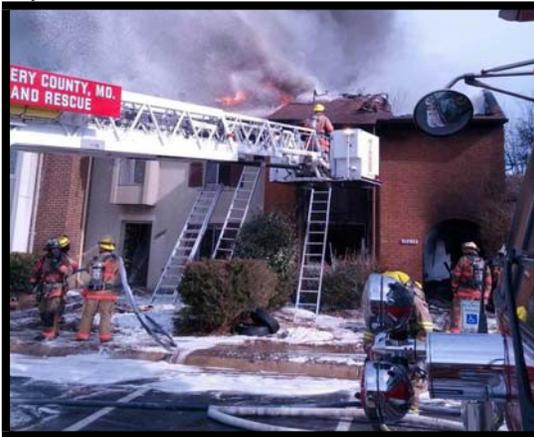
Alpha Side – Fire Re-Set in Main Bldg.

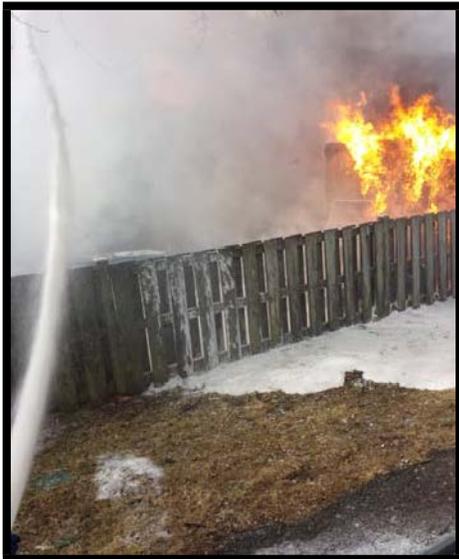
Charlie Side – Solution Application

The use of CAFS or foam solution proved effective during the overhaul phase of the fire. The main fire building suffered heavy fire damage to the roof assembly and structural failure to the second floor joist assembly. This coupled with a large amount of furniture and storage items made safe access to remove all items affected by fire impractical. The hard work of crews to search for extension and the effectiveness of the foam solution allowed a level of confidence that the fire was completely extinguished.

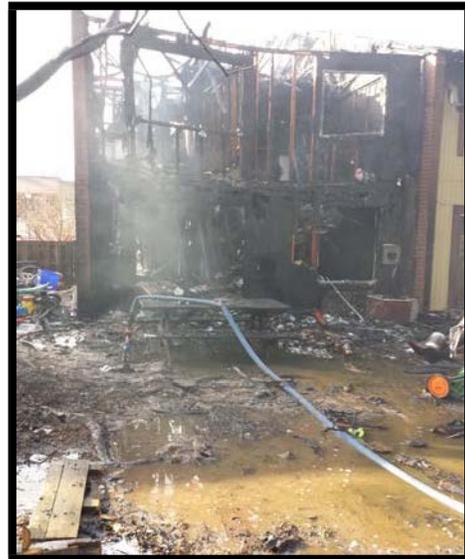
Charlie Side – Structural Failure

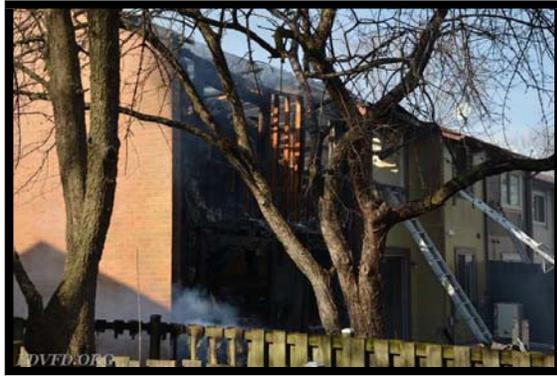
Charlie Side – Post Fire Control

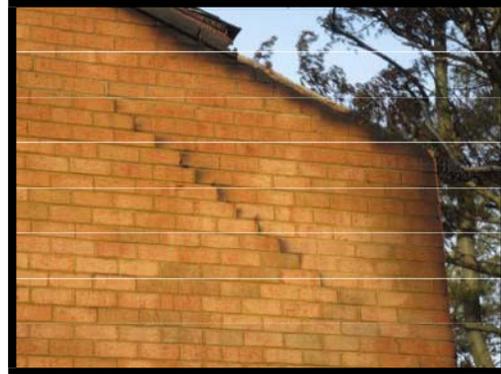
Delta Side – Failure Indicators
