MONTGOMERY COUNTY FIRE AND RESCUE SERVICE
POST-INCIDENT ANALYSIS

11801 Danville Drive

Incident 16-0126017

October 9, 2016

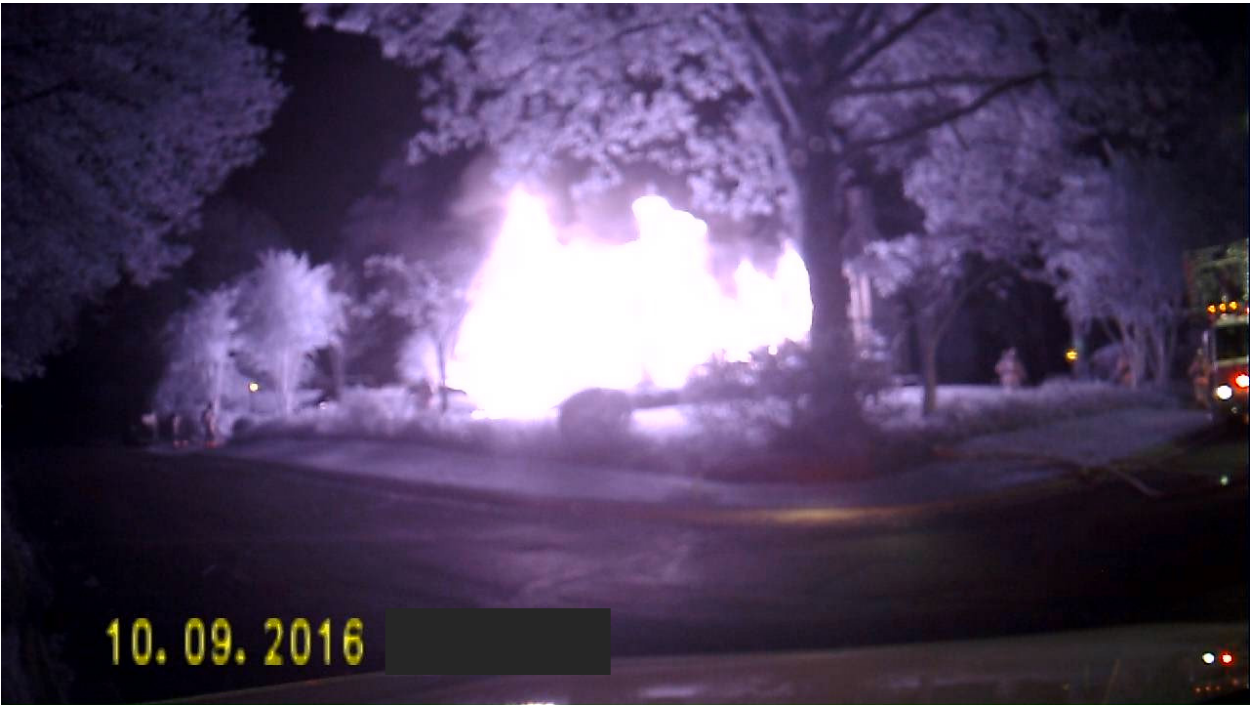
Company 23 units arrived to find heavy fire visible from the first and second floors with Paramedic Engine 723 reporting the house was "fully involved" and establishing Command. Paramedic Engine 723 then clarified the report to say they had heavy fire on Sides Alpha and Bravo. Battalion 702 arrived and assumed Command from Paramedic Engine 723 immediately after the report and established a stationary command post diagonally from the house with Sides Alpha and Bravo visible. Heavy fire was visible from all of Side Bravo on both floors including the garage area with cars inside, and from most of Side Alpha.
