**Montgomery County Fire and Rescue Service  
Montgomery County, Maryland**

**Mayday/Near Miss Report**

Box 17-12  
20720 Goshen Road  
Incident Date: November 12, 2006

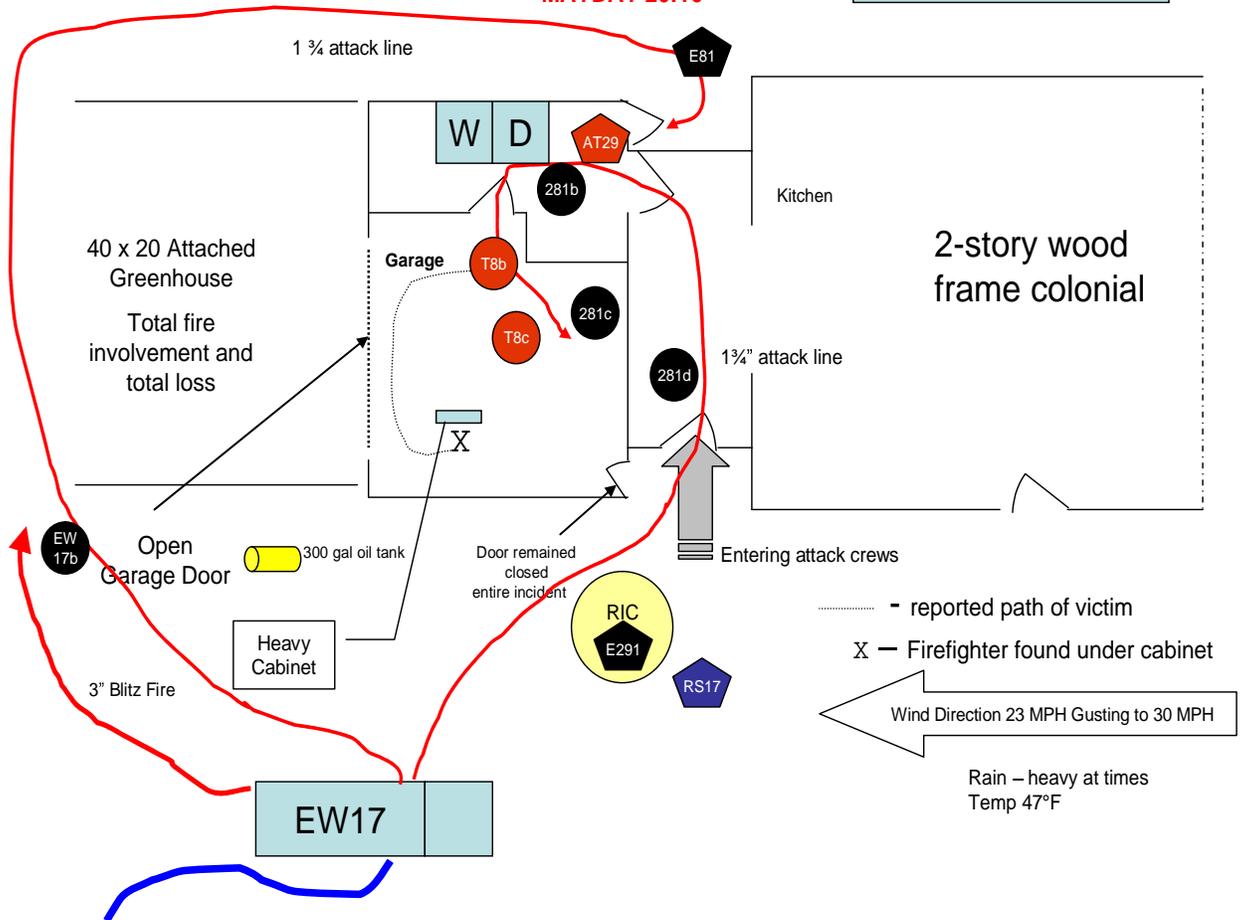
### 20720 Goshen Road

**Position of Units at time of PAS Activation  
MAYDAY 20:16**

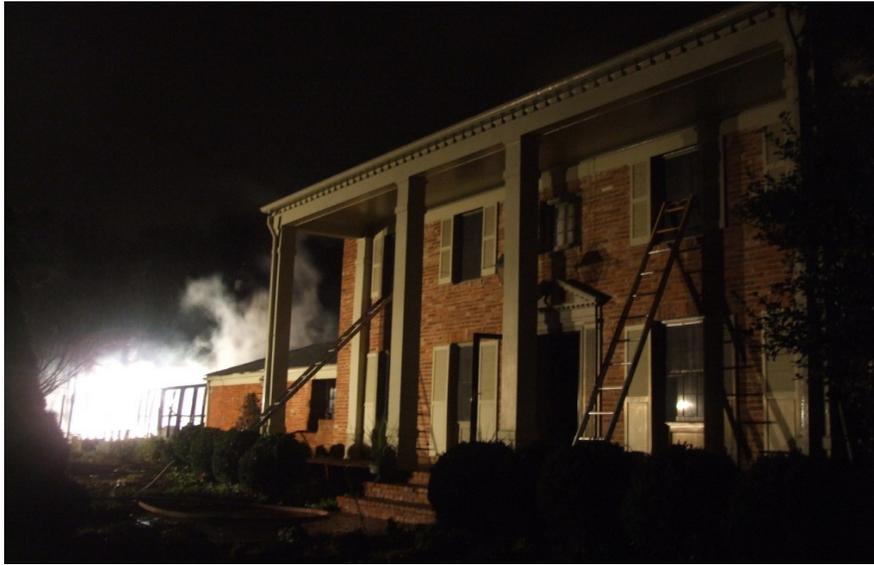
**Immediately after fire knock down**

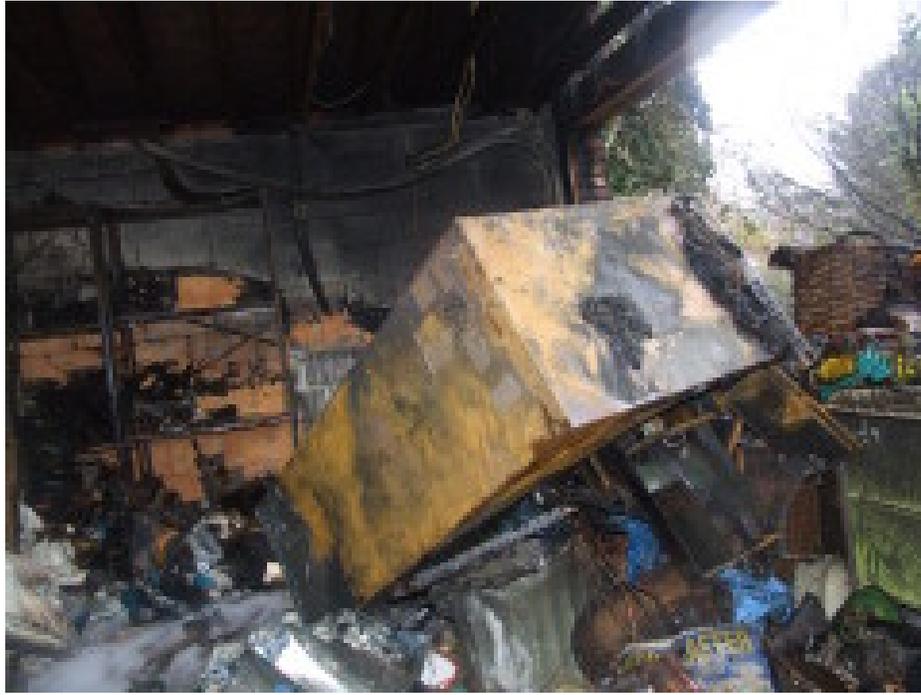
T8 arrived on the scene shortly after EW17. T8's crew paired up with E281's crew and entered the garage by way of the side alpha door to the breezeway and to the rear laundry room and entered the garage from the side charlie door with E281's crew. Working in the garage, T8's crew heard a PASS device activated and was able to quickly locate EW17's firefighter trapped under the cabinet. They removed the cabinet from the firefighter and were able to drag him with

**File cabinet pulled from firefighter**

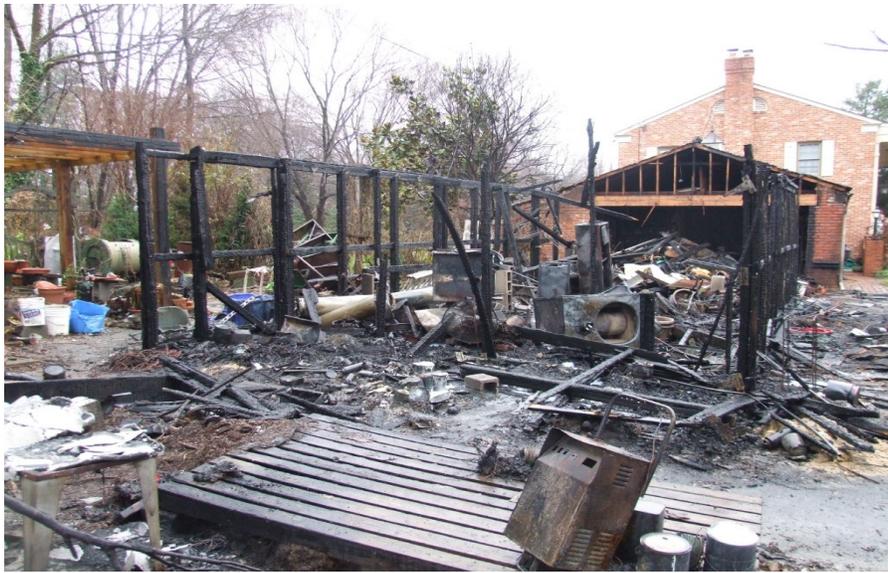
Upon arrival at 20720 Goshen Road, the officer on Engine-Tanker 17 (EW17) found a 35' x 16' greenhouse fully involved, and radioed that the structure was an "exterior building" totally involved. Battalion Chief 5 (BC5) arrived on the scene shortly thereafter and radioed that he had an "out-building" on the ground and established command. Initial on-scene reports were not accurate because the greenhouse was attached to the garage.

**Greenhouse looking into garage**

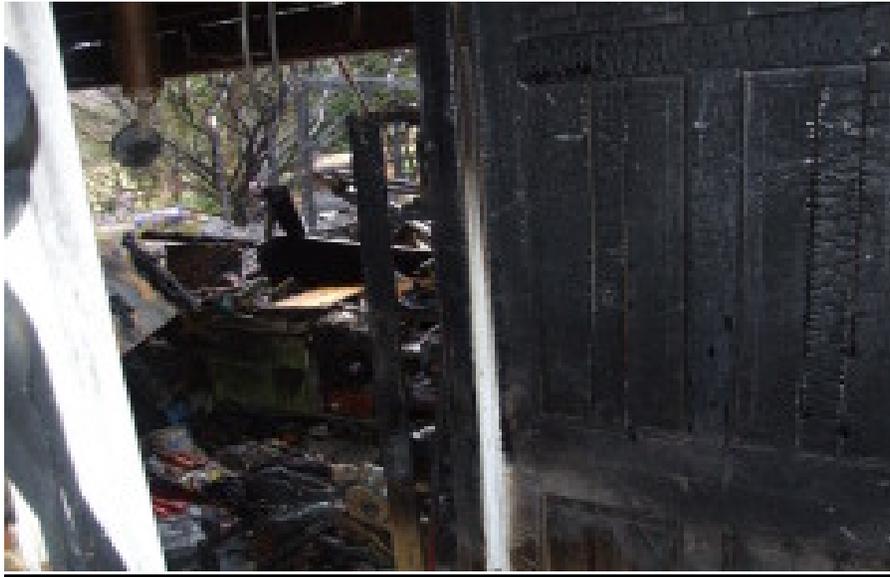
and then into the garage from the side charlie door. The firefighter then entered the garage and engaged in firefighting activities near E281 and T8's crews who were working in the 20' x 24' garage. Inside the garage, units found fire running across the ceiling and smoke banked down to the floor. After working for approximately five minutes, the firefighter from EW17 decided to set out further into the garage to open a window. Approximately ten feet into the garage, the firefighter tripped over some storage and was forced to crawl and then bumped into a large item that did not move. While trying to move the item, he pulled the heavy file cabinet onto himself. Pinned by the cabinet, the firefighter was unable to extricate himself, get to his radio to call for help, or activate his EB button on his portable radio. The firefighter verbally called out for help but was not heard. He remained still to allow his integrated PASS device to activate and go into alarm. His PASS device activated and he was quickly discovered by T8's crew and he was extricated from under the cabinet. While being dragged from the garage with the assistance of E281's crew, a Mayday was declared and the firefighter was successfully removed by the initial two crews and transported to Suburban Hospital with non-life threatening injuries.

**Door entered by firefighters leading into the garage from the laundry room**

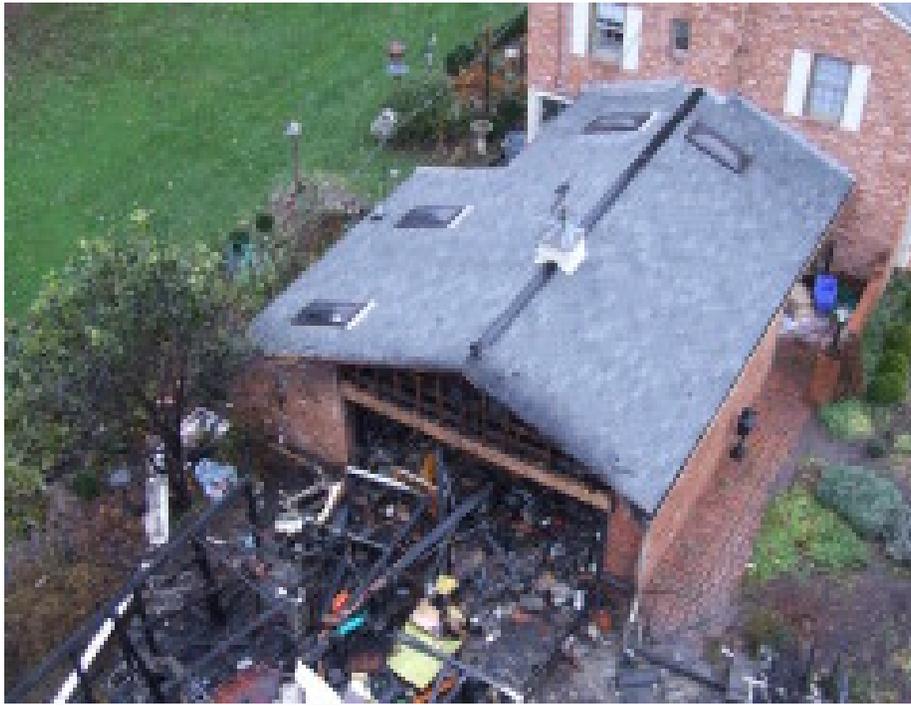
**Aerial view of the aftermath**
