## Montgomery County Fire and Rescue Service

### POST INCIDENT ANALYSIS

17804 Muncaster Road  
Derwood, MD

December 10, 2007

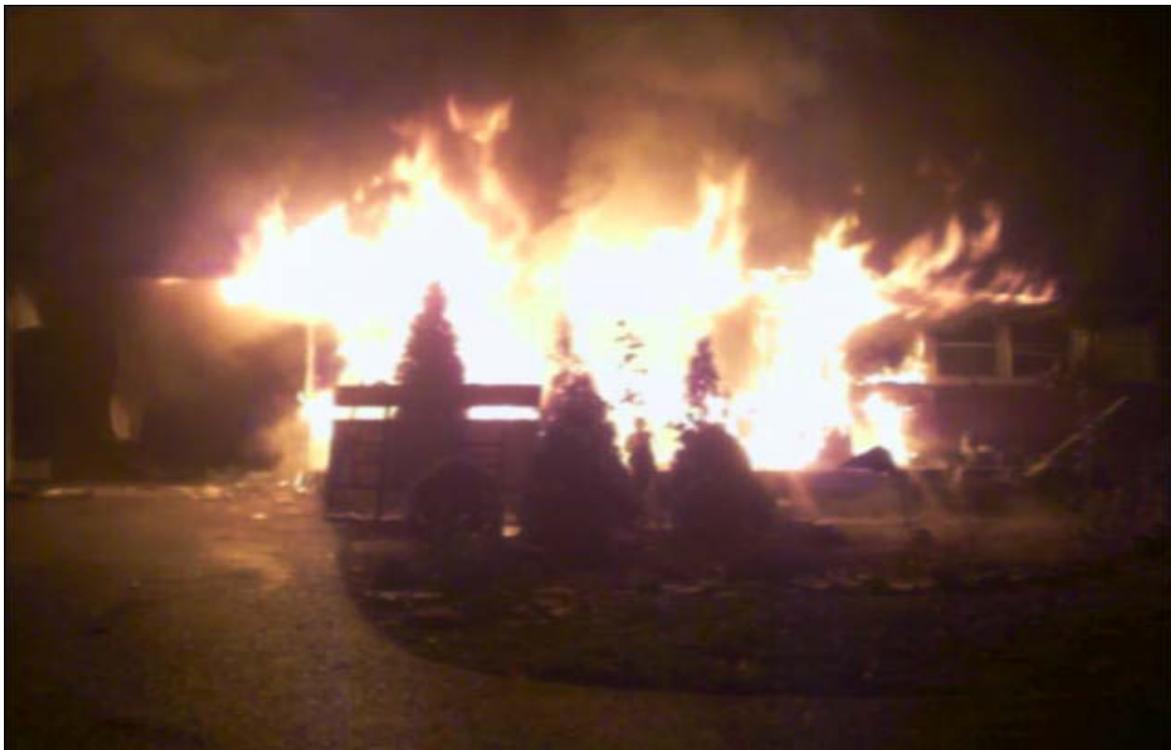
CIMG0532.AVI

December 10, 2007 - At 0348 hours Fire/Rescue units and Montgomery County Police responded to 17804 Muncaster Road, Derwood Md. for a house fire with a report of people trapped. Units arrived on the scene and found a 1,300 square foot “ranch style” dwelling with heavy fire showing from side “A”. An aggressive attack was commenced and crews immediately began to search for the trapped victims. Crews quickly found one elderly victim in the front bedroom and removed her to side “A” of the structure. Once outside it was apparent the victim was deceased. A young male victim was also found in the front bedroom; he too was removed from the house and was transported to Shady Grove Hospital where he was pronounced. The third victim was discovered in the dining room after the suppression effort was completed. She was left in place for investigative purposes.
