Montgomery County Fire and Rescue Service

POST INCIDENT ANALYSIS

10334 Royal Woods Court
Gaithersburg, Md.

July 15, 2007

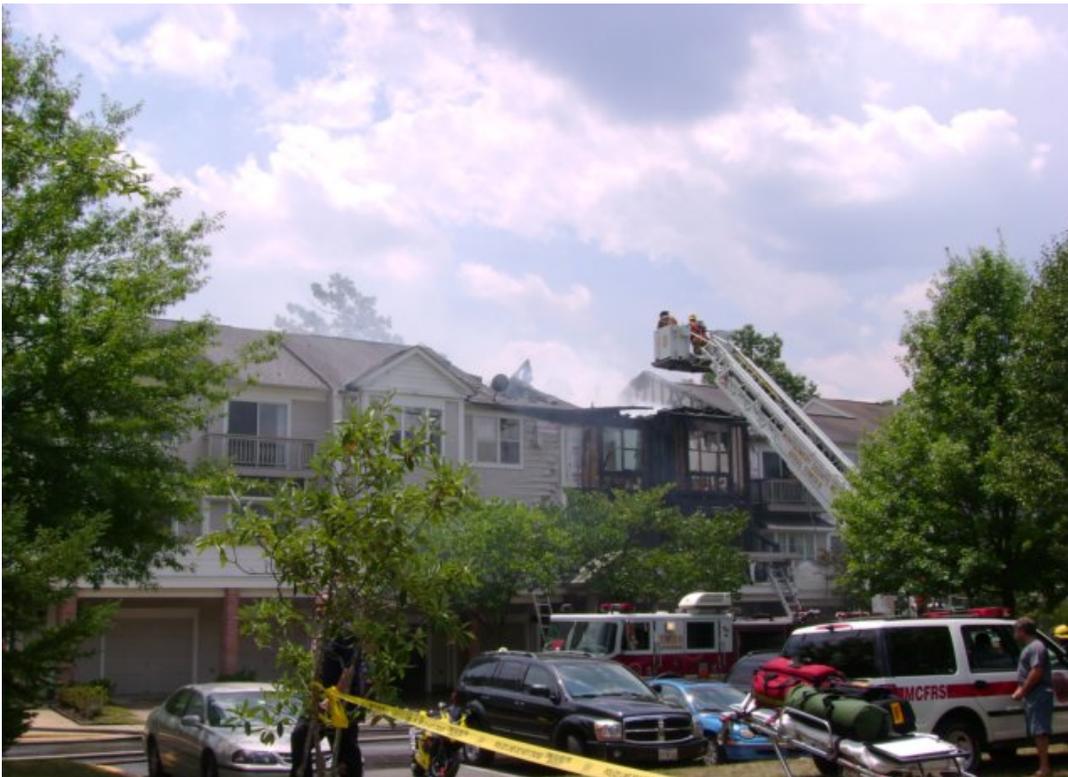
Sunday July 15, 2007 - At 12:35 hours Montgomery County Fire and Rescue Service was dispatched to 10334 Royal Woods Ct. Gaithersburg, Md. for a working fire in a townhouse. Units arrived on the scene to find fire showing from side A of two, three story middle of the row townhouses. Fire was coming from the 2nd floor deck extending into the house involving the 3rd floor and attic of both townhouses. The wind was blowing at 5-10 MPH from the North and the temperature was 93 degrees. A civilian, the occupant of the home suffered minor 1st degree burns of the forehead and forearm attempting to extinguish the fire. The civilian was taken to Shady Grove Hospital by M319, treated and released. A LFRD member from Co.3 suffered minor injury during overhaul. Her front tooth was broken after being struck by moving the bed set off the 2nd floor. This firefighter was also taken to Shady Grove Hospital for follow up care. Eight occupants were displaced from this fire and Red Cross was called to assist them. There was \$750,000 dollars damage to the structure and \$250,000 damage to contents. The cause was determined by the FM's to be caused by overloading a deep fat fryer on the deck to close to the exterior siding.

- Structural integrity of the townhouse based on fire conditions on arrival, was somewhat compromised. The fire was coming from the 2nd floor deck with extension to the 3rd floor and attic of both adjacent townhouses.

- The Origin and Cause of fire was determined by the Investigations Group.
- The main factor contributing ignition and fire spread was determined by the FM's to be caused by overloading a deep fat fryer on the deck too close to the exterior siding. This fire became gas fed by the propane cylinder supplying the fryer.
