2nd Alarm Residential High-Rise Apartment Fire
July 11, 2009
8830 Piney Branch Road
FS16's area

Post Incident Analysis for 8830 Piney Branch Rd

Executive Summary

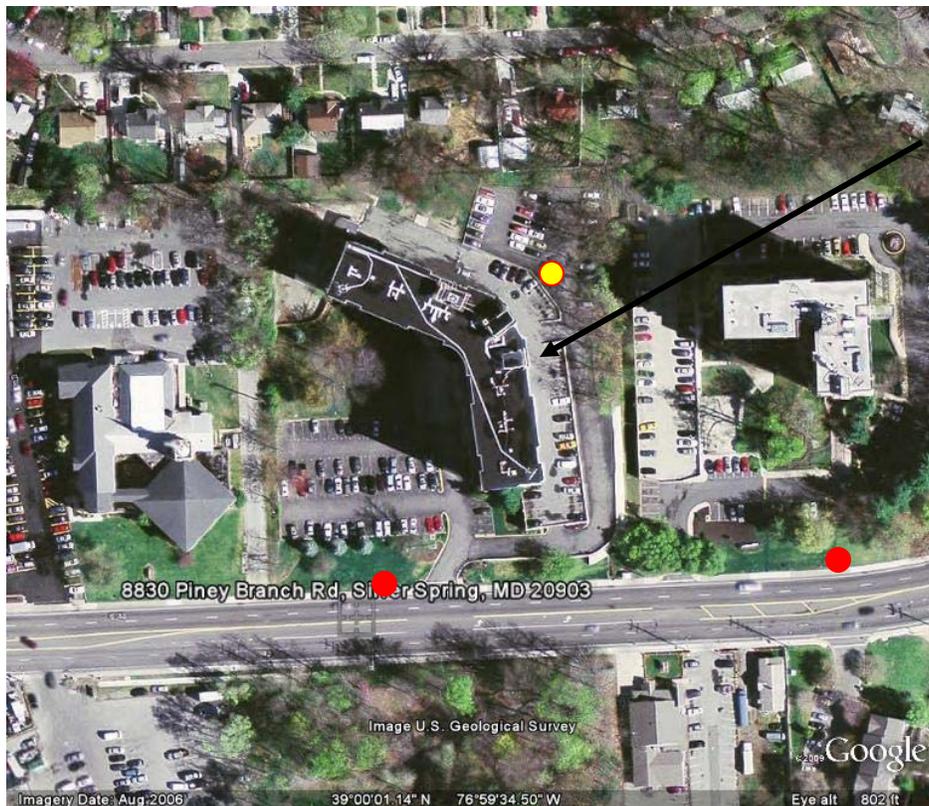
- Fire building identified with black arrow and pointing to the fire apartment
- Two closest fire hydrants are identified with red dots (only two used)
- Pineway Towers were constructed in 1975 as a residential apartment building and sold in 1985 and turned into condominiums.

- The complex has 12 floors with 12 apartments per floor.
- The structure is Type 1B construction with a standpipe system with two fire department connections and three risers (one per stairwell). There is a dry sprinkler system in the parking garage and a domestic wet sprinkler system in the trash chute.
- The building has a common boiler unit and HVAC unit. The building is supplied by natural gas also supplied by a common feed.
- There are three stairwells, one on each end and one in the center. Each stairwell is protected by a two hour fire separation.

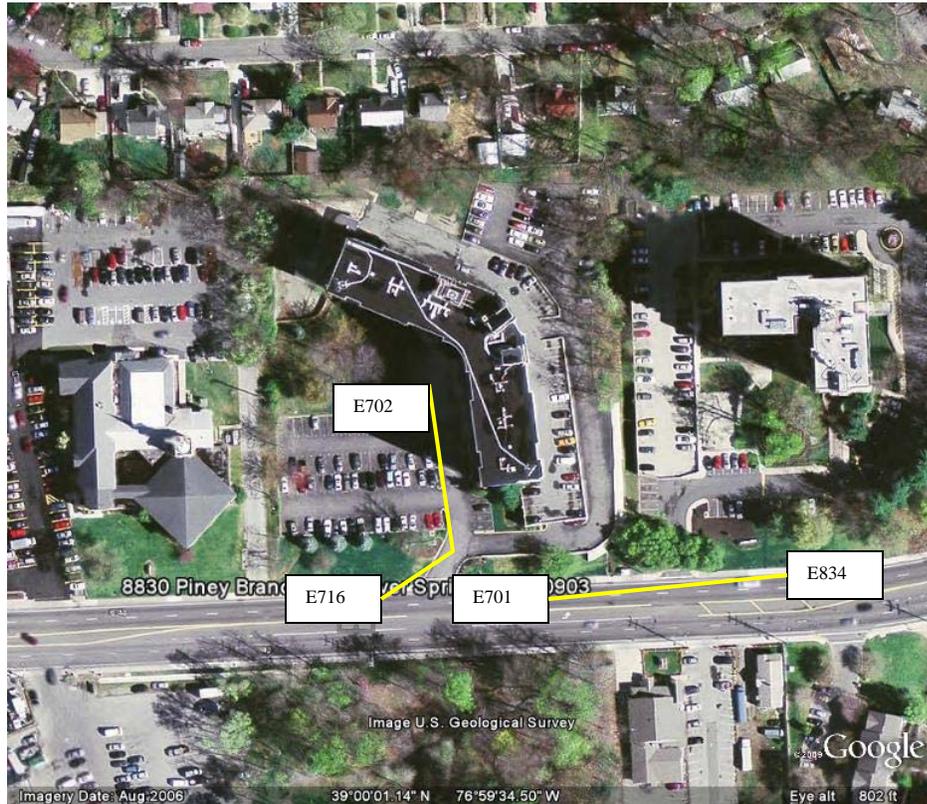
- There were only two hydrants used for this fire. Both of the hydrants were on a 16" water main and tested to above 3500gpm @ 20 psi.

- 1st engine laid a 4" supply line from 8830 Piney Branch Rd and that was picked up by 2nd due engine.
- 3rd engine laid a 4" supply line from 8860 Piney Branch Rd and that was picked up by 4th due engine.
- There were two fire department connections for this building, only one was covered. This could have been more of a severe issue, but luckily the system was interconnected and the pump operator compensated.

- All fire department connections, standpipe & sprinklers, must be charged unless told differently by command.
- Hand-line management was an issue in the center stairwell. Crews tried to place three hand-lines in service in the same area. There should be a maximum of two hand-lines in one area, door, or stairwell.

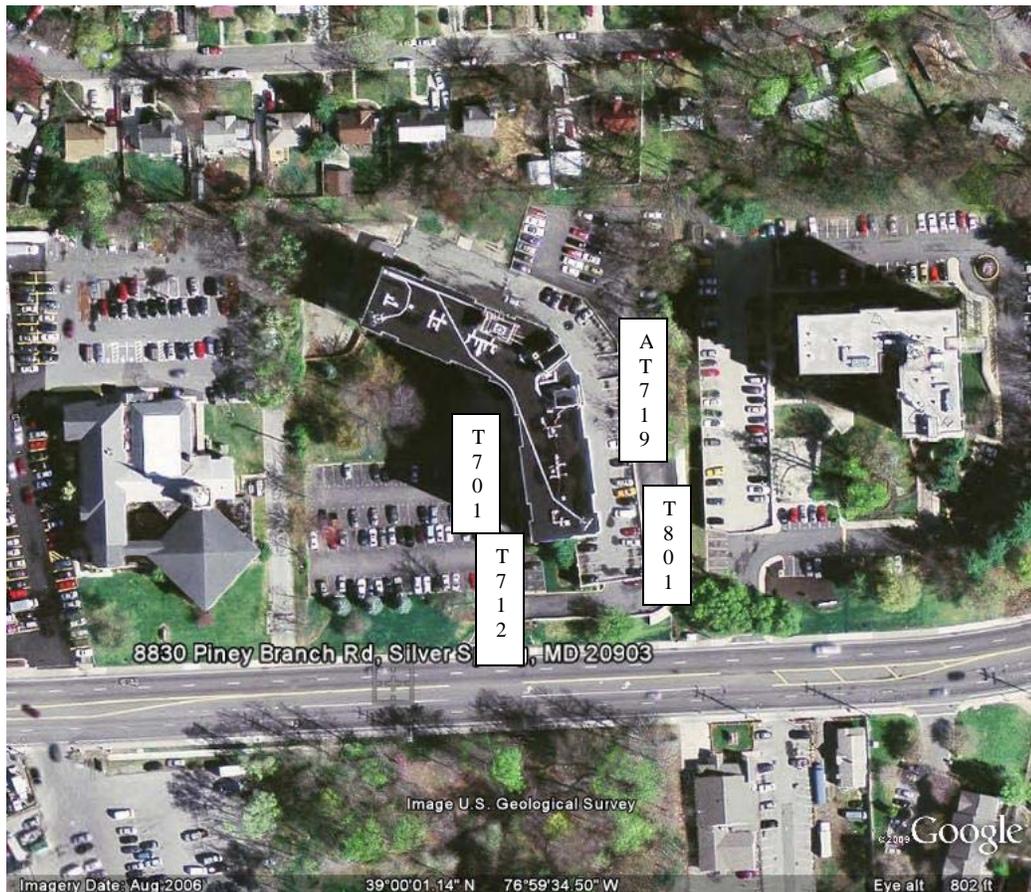
- There was only one engine that made it into the complex, side A for water supply.
- There was limited space due to the small size of the parking lot, amount of cars parked in the lot, and the parking garage restriction on side C & D.
- 3rd due engine could have hand laid a line to side C if needed, but this was not necessary because the connections were on side A & B of the building.

- Very good truck positioning by the first four trucks. Two on each side of the building with aerials to the tenth floor.
- Staging area was the shopping center at Piney Branch Rd & University Blvd. MCP closed off Piney Branch Rd so the staging area was moved onto Piney Branch Rd one block west of the building.
