Building Fire  
324 E. Diamond  
Avenue  
August 17, 2009

Fire on the third floor and through the roof @ 2012 hours  
Occupancy – Abandoned Three Story Garden Apartment

324 E. Diamond Avenue  
DIAMOND COURT APARTMENTS  
August 17, 2009

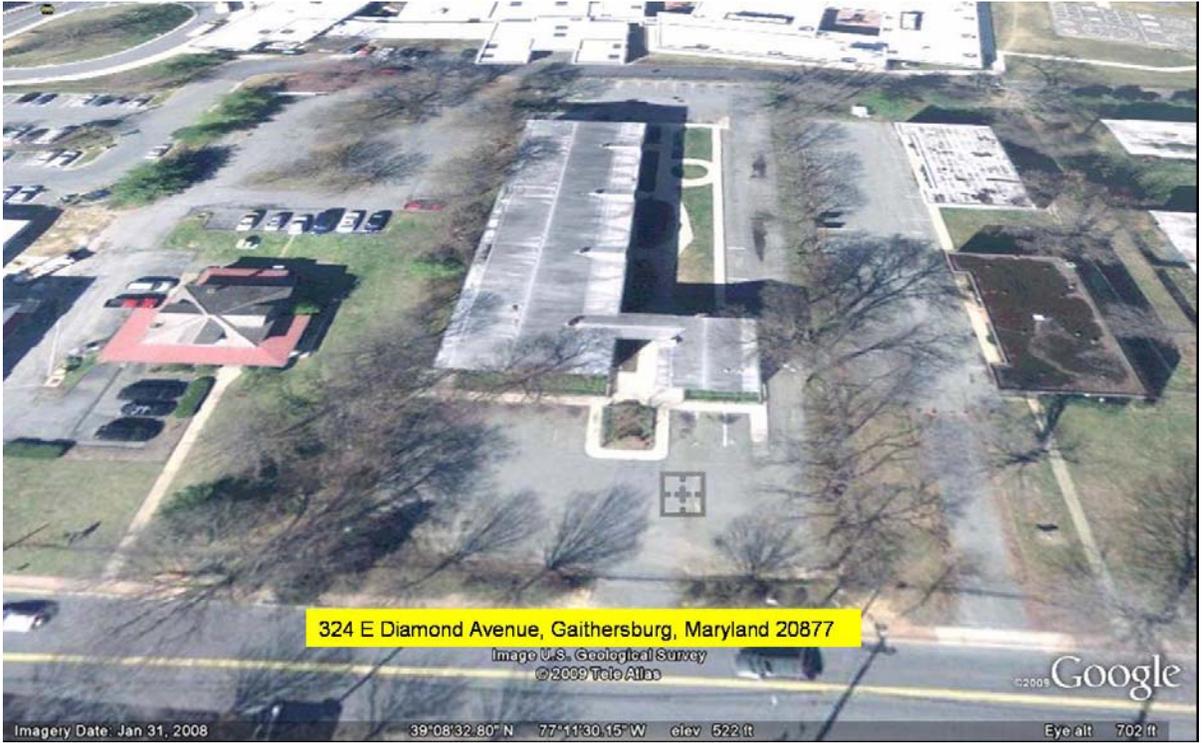
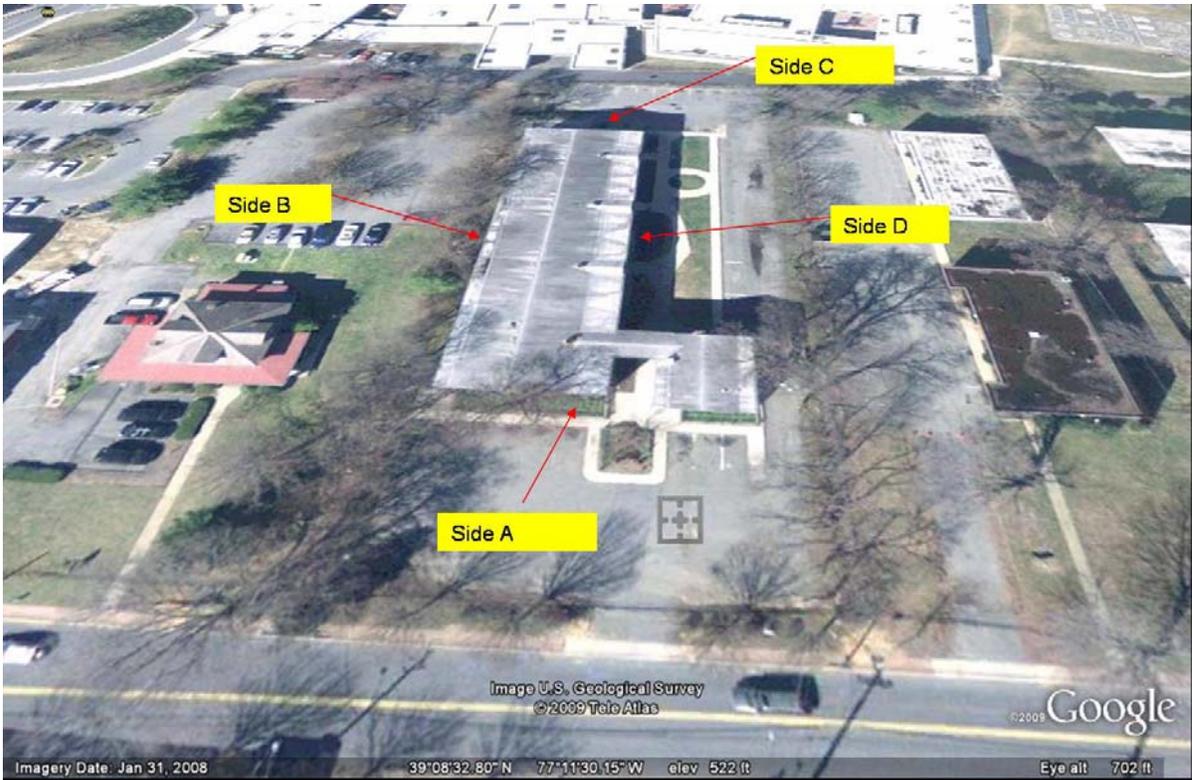
Figure 1

The dispatch information coupled with the shape, layout, and fencing around the structure created a confusing scenario of “what side am I on.” After announcing the IAP to the responding units, communication came from the CP identifying Side Alpha as the E. Diamond Avenue side—See Figures 1 and 2. This allowed for good tactical operations and a coordinated flow of water from: AT-708 Side A; T-731 Side C; and AT-703 Side D. The initial water supply came from E-753 on Side A to AT-708 and E-708 on Side D—See Figure 3

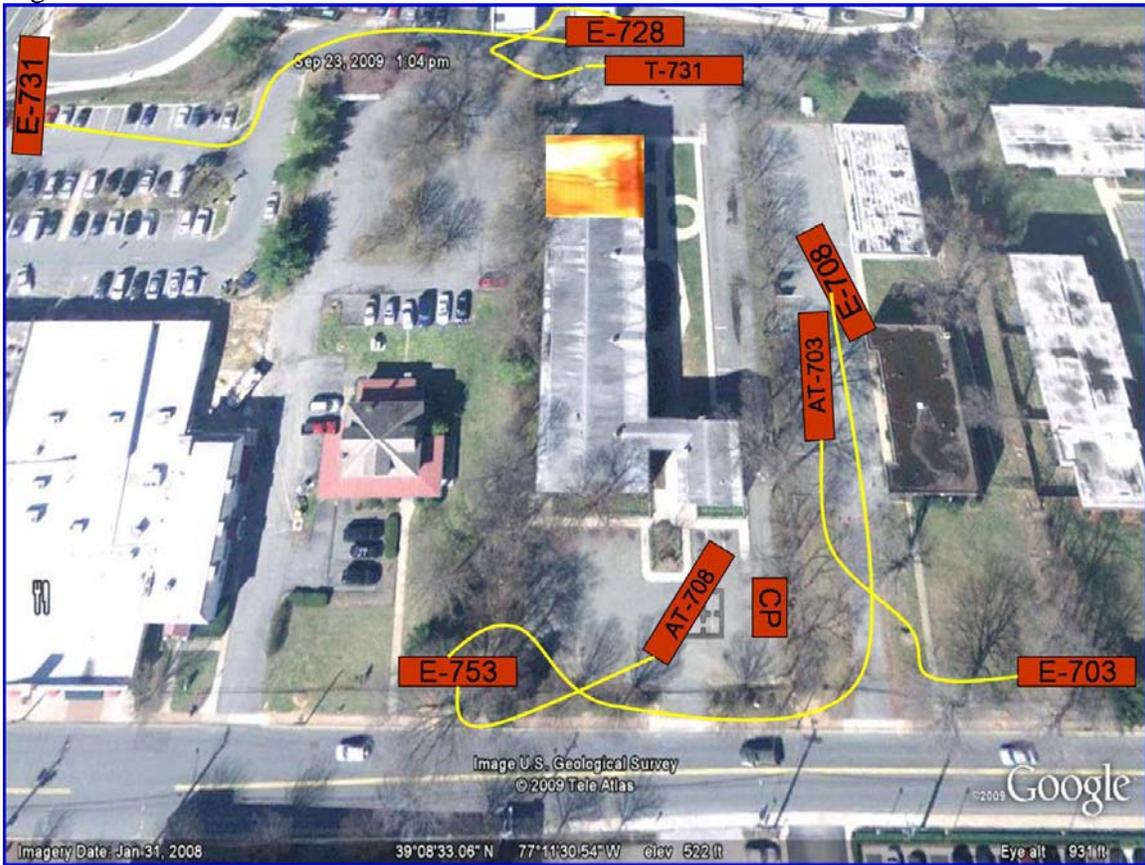
Figure 3

During the April 2008 fire, AT-708 was able to access the Delta side of the building as shown in Figure 6. Since the same crew was working August 17, 2009, they anticipated the same placement; however, the owners had placed a chain link fence around the structure in a way that prevented AT-708's access. Instead, they nosed-in on the Alpha side—See Figure 3. AT-708 was still able to reach the fire area with their ladder pipe.

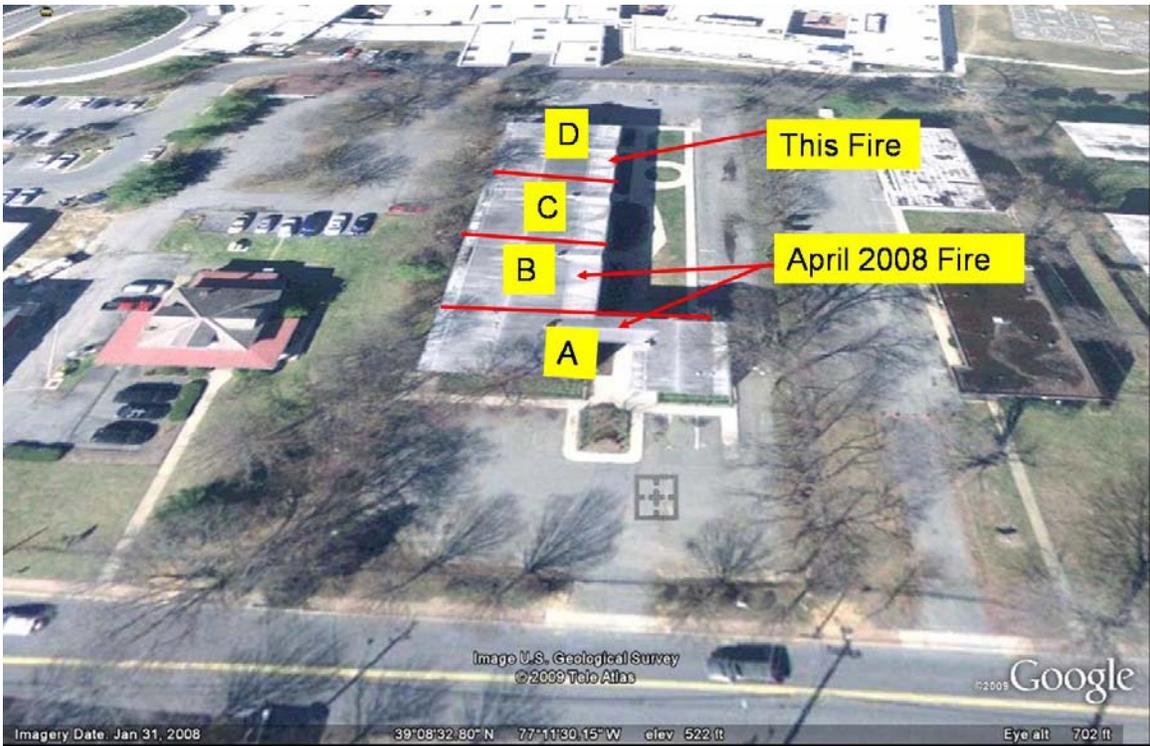
Figure 4

Recon was divided into two Groups based on the areas which needed to be searched. The layout of the building is an “L” shape. Side Alpha was the short leg and is considered Tier A—See Figure 4: The longer portion housed Tier B (the April 2008 fire area) and Tier C and D. Tier C Recon had Special Operations Chief (SOC) 700 as the Supervisor and Tier D had Safety 700 as the Supervisor. During this phase, E-731, AT-708, RS-729, and M-708B were assigned to the Rapid Intervention Group with E-731 as the Supervisor. A complete primary and secondary search of Tier C were negative. Tier D was

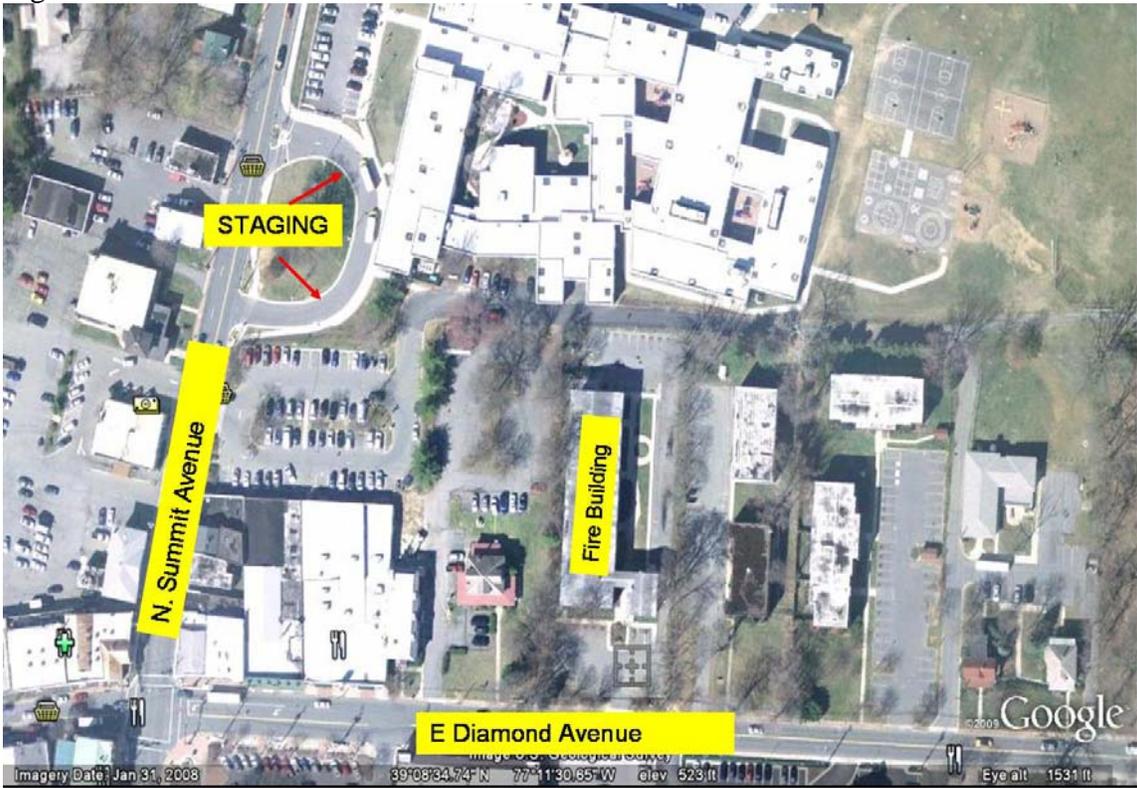
Additional resources requested: Rapid Intervention Dispatch and a Second Alarm (Units told to respond on 7 Delta and stage in town on E Diamond). E-722 identified the circle in front of the school as Staging—See Figure 5

The second alarm units were not dispatched to a specific staging location other than 324 E. Diamond Avenue. Being familiar with the area after having been to a fire in that unit block a year earlier, E-722 chose Gaithersburg Elementary on Summit Avenue as the staging area. The staging area was on side Bravo of the fire building, included a bus turnaround that was utilized and a side parking lot on side Bravo of the school. Upon arrival at the school, command called for 2 engines from staging to report to the Delta division to assist with fire attack in the Delta exposure. E729 and E717 were sent to that division, confirmed by Command. That left E722, E723, AT729, and T723 in staging. M708B which was initially dispatched on the 2<sup>nd</sup> alarm was used immediately on the fire ground, thus they never reported to staging.

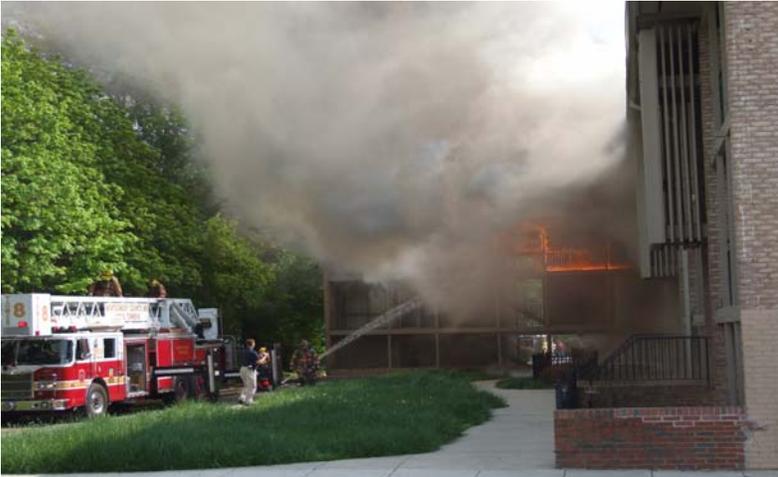
Figure 6. April 2008 Tier A—Access to this point in August 2009 was blocked by chain link fence.

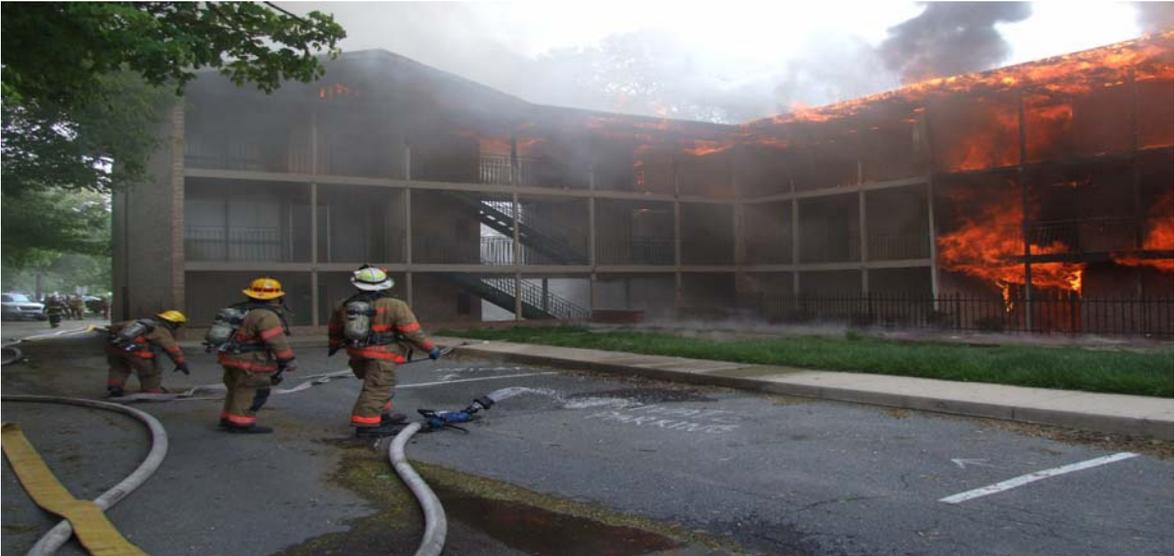
Figure 7. April 2008 Tier B and Tier A heavily damaged.

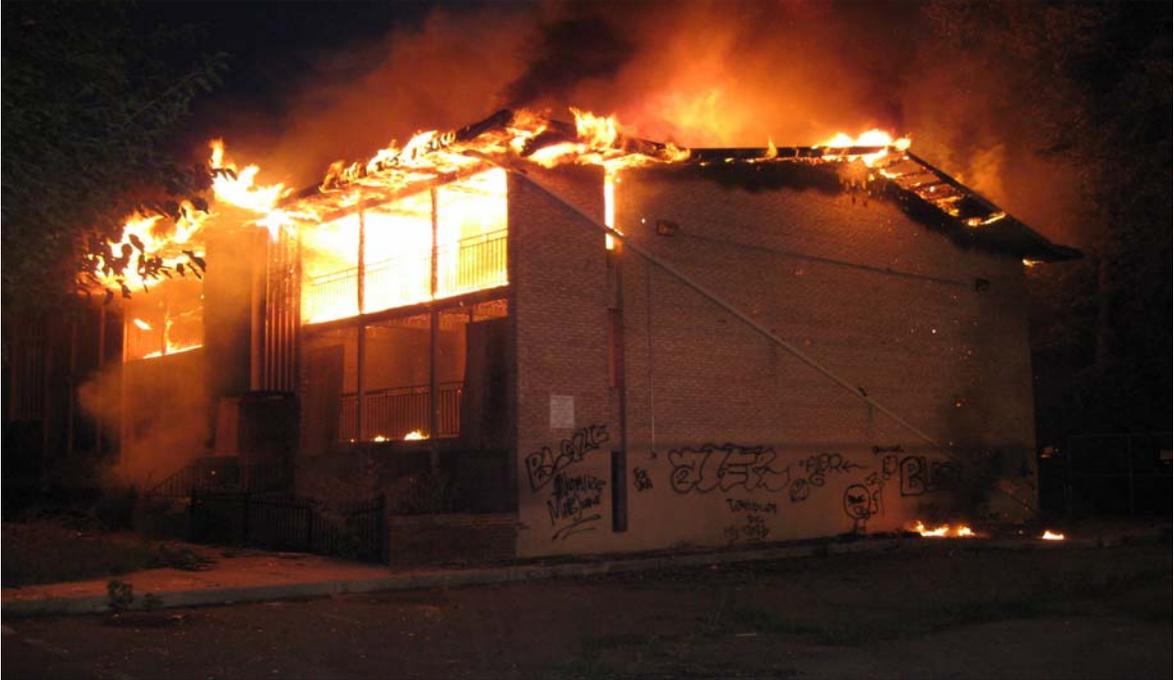
determined to be off limits to personnel and a visual search was conducted with nothing noted. At 2203 hours, A Personal Accountability Report (PAR) was conducted all personnel involved in the Tier C and D groups with all PAR.

Figure 8. August 2009 Tier D

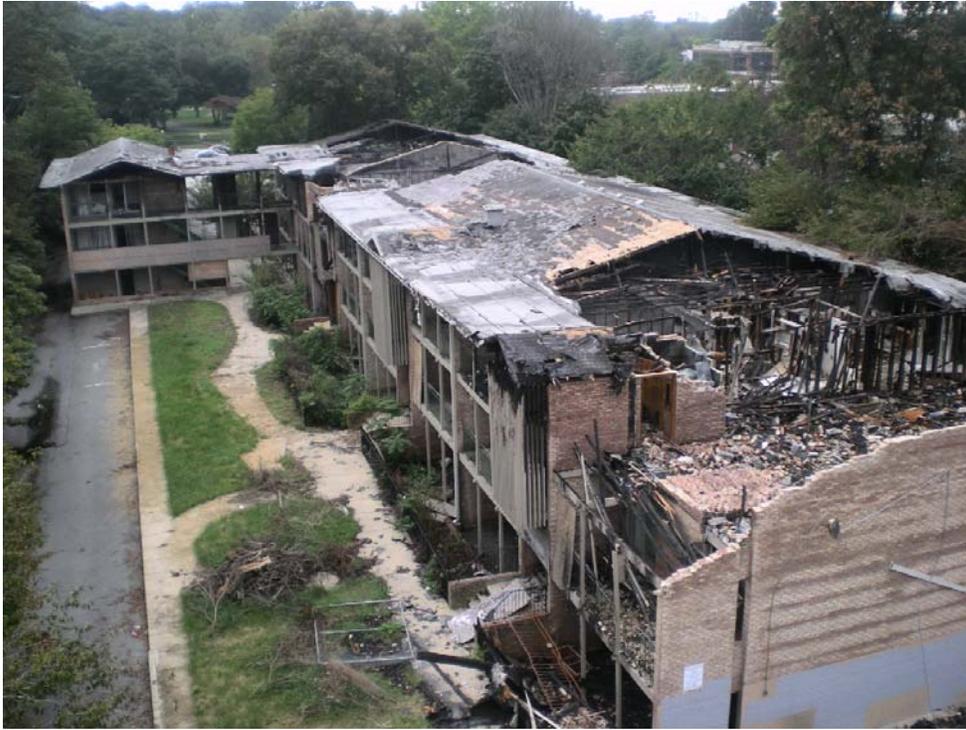
Figure 9. Photo taken September 2009

The final action prior to clearing the incident, T-731 hydraulically knocked over the upper portion of the end wall on Side D—See Figure 9 This was to prevent the potential for injuries should Fire Rescue have to return or trespassers or graffitist engaged in illegal activities.

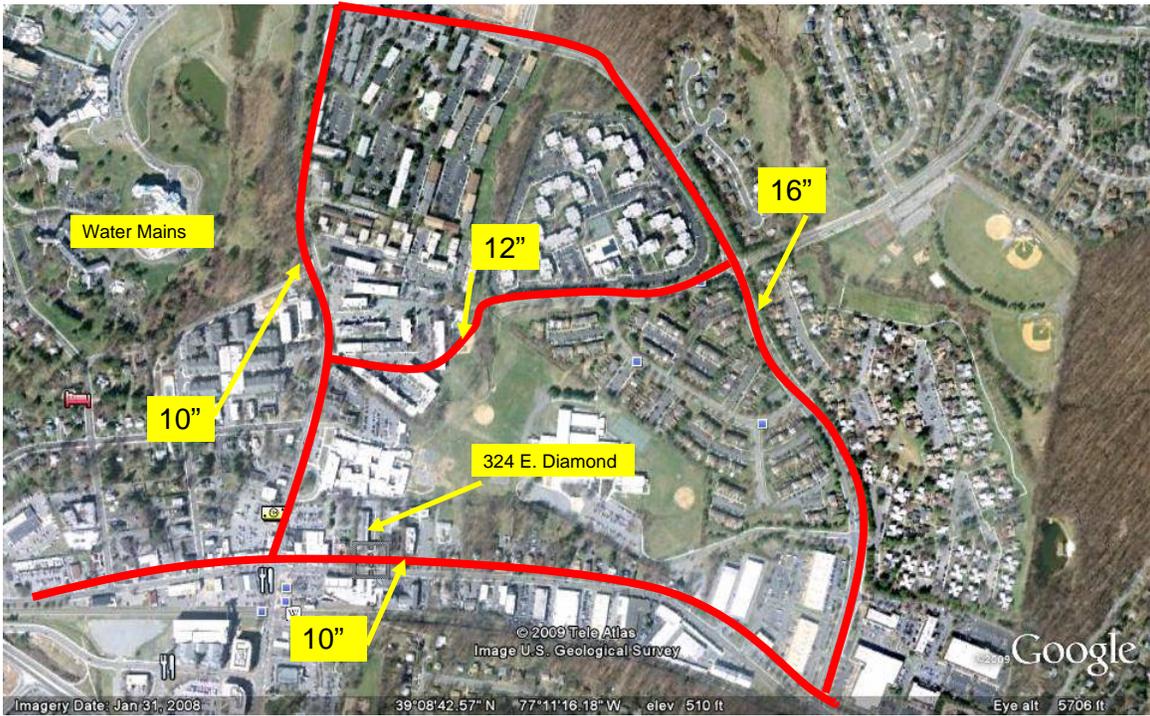
Figure 10

On September 30, 2009 a post-incident an assessment of the water supply was conducted. E. Diamond Avenue has a 10" water main; N. Summit Avenue has a 12" water main; and there is a 12" water main which loops past Gaithersburg Elementary School and connects to Girard Street and then to E. Diamond. The hydrant at 320 E. Diamond has a static pressure of 60 PSI and a residual of 26 PSI. The NFPA discharge table for 4.5" circular outlets indicates a flow of 2776 GPM. On a loop system, each of the three hydrants use on this fire should have the same capability without effect from the other, or a total flow capability of 8328 GPM. Initially, E-753 supplied AT-708 and E-708 (who tried to supply a Blitz Fire and AT-703). This was corrected by having E-703 supply E-708 and AT-703 from another hydrant on the E. Diamond main. See Figure 10.
