Incident 09-086661 – 2025 Featherwood Street, Silver Spring  
*2 alarm fire with 3 firefighters burnt*

**I. Introduction:**

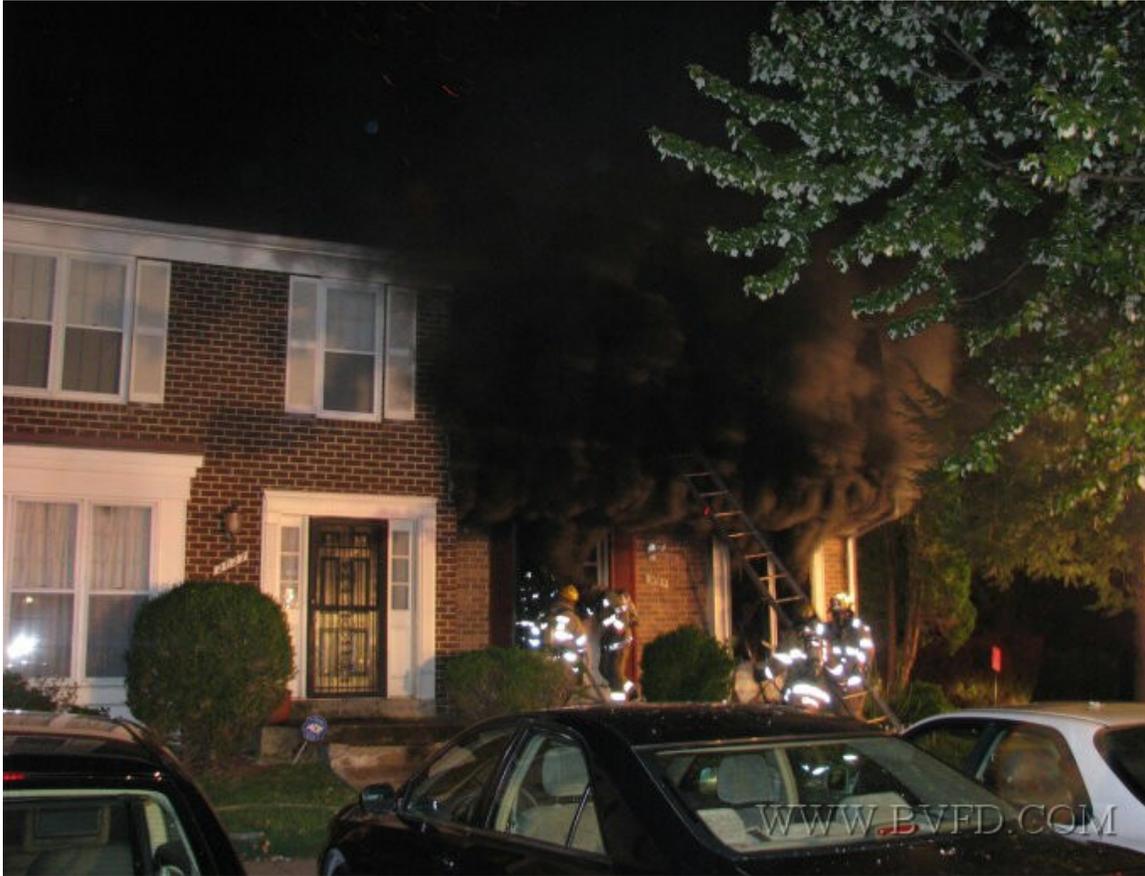
*Ongoing Operations:* Battalion 701 and E716, responding north on Rt. 29, also observed the fire conditions on Side C. When Battalion 701 arrived on scene to the A/B corner of the row, to his great concern he also observed heavy black smoke pushing from the front of the house (above). He immediately gave a size up to the interior crews and asked for a status report. E715 reported high heat conditions and attempted to ask for another unit to sweep the rear, but the radio transmission was garbled. BC701 assumed command and attempted to implement E715's request, but could not get ahold of E716. At this time a 2<sup>nd</sup> alarm was requested. E724 officer reported to the CP face to face and was given the Side C assignment instead. E724 swept the exterior with a 1.75" line from E719 and then observed that the basement was heavily involved (due to large quantities of plastic chairs and cans of sterno). This was communicated to the IC. The decision was made to have units withdraw from the first and second floors so that E724 could hit the fire in the basement from the rear. Units withdrew from the first and second floors and E724 used a 2.5" line from E719 to knockdown the basement fire from the exterior of Side C.

Size up and Strategy: An initial size up was done by E&T715 officers who decided upon an aggressive interior attack. As mentioned before these units were unaware of the fire in the basement. BC701 performed a “drive by” size up of Side C and could see most of Side A upon arrival. He had categorized in his mind the situation as marginal due to the heavy black smoke pushing out the front (as seen in picture above).

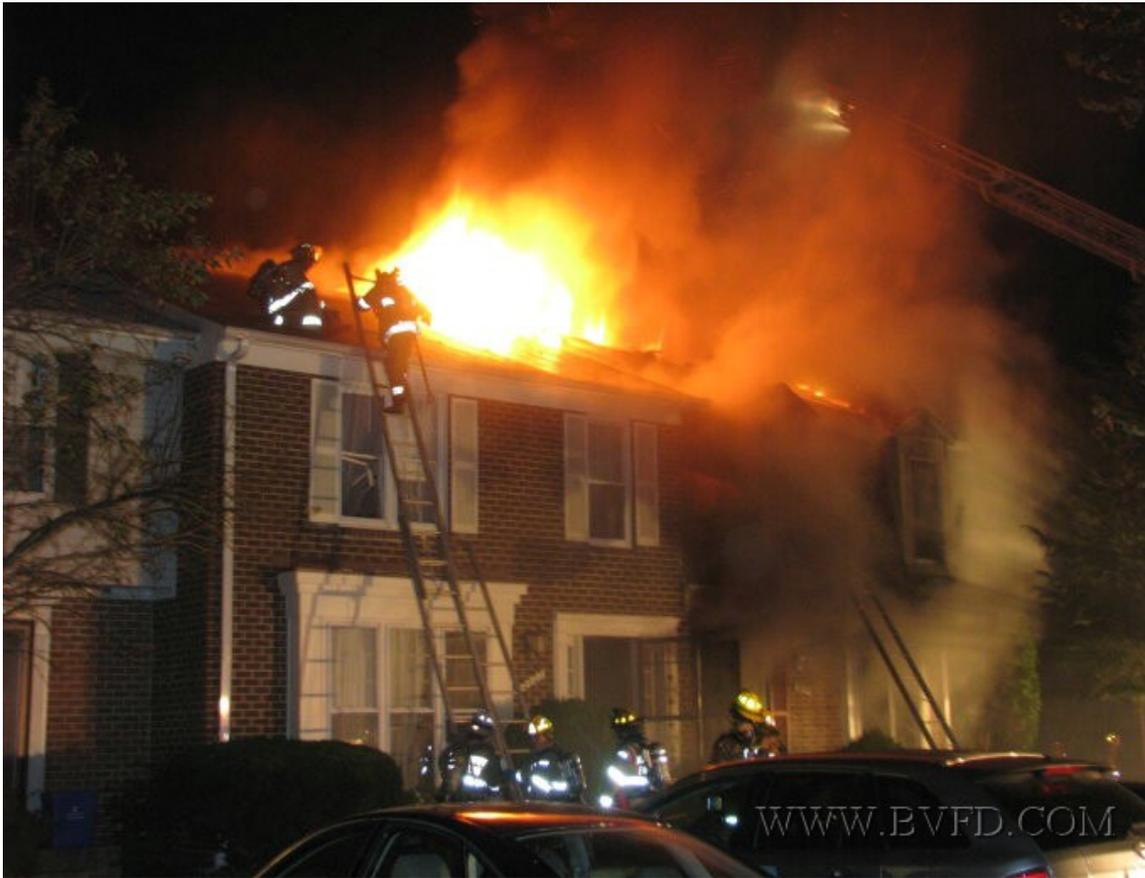
Concurrent with these efforts, a Bravo Division was organized with E718, T701, E716, and C705D. Units found significant fire in the attic and worked diligently to

control it by performing vertical ventilation, using hose streams and aggressively overhauling.

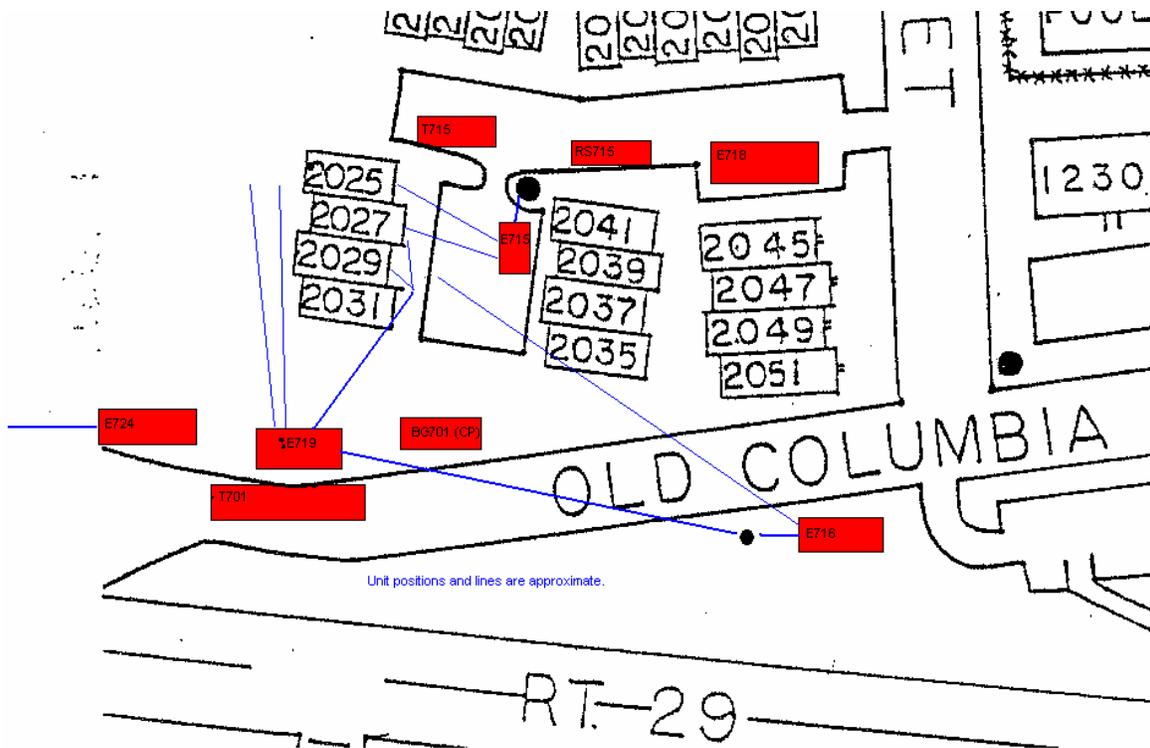
Water supply was obtained by E715 from a hydrant in the court. E719 laid out as shown in the figure below and was supplied from E716. E724 laid back into the scene from a hydrant south of the incident. No issues were noted with water supply or pressure.

E715 supported three attack lines of varying sizes and supplied a ladder pipe on T715. E719 supplied three 1.75" attack lines (2 via a leader line) and a 2.5" line. Unit positions and line locations drawn below are only approximate.
