Montgomery County Fire & Rescue Service

POST INCIDENT ANALYSIS

9863 Brookridge Court
Gaithersburg, MD
F10-0037499

April 5th 2010

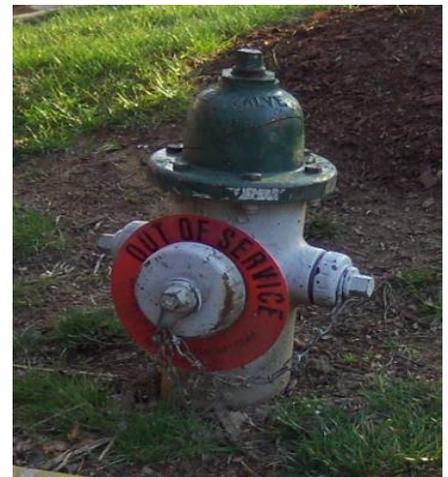
During the response E708 advised that they would be taking their own hydrant at 9870, which was across the street from 9863. Upon arrival E708 positioned to hook up to this hydrant and when the driver exited the vehicle then observed the hydrant marked with an "OUT OF SERVICE" ring.

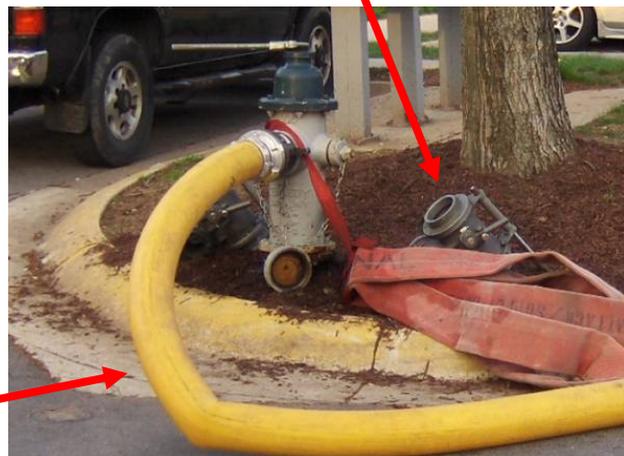
E753 Supply Line

To accomplish this, E753 supplied their 1,000 gallons of tank water to E708 by connecting E708's supply to E753. This provided E708 with another tank full of water to continue the attack. After E708's supply line was charged by E753, E753's supply line was charged, but the section connected to E753 developed a severe leak and this had to be replaced, causing the water supply to temporarily be discontinued.

Because E753 had effectively become a relay engine supporting E708, E728 now assumed the side Charlie responsibilities of the third due engine. E728 laid out from the same hydrant as E753 (at 9814). E728's supply line was never charged from the hydrant because E753's 5" supply line was connected directly to the hydrant steamer connection and no unit could expand the water supply once the hydrant was charged.

All engines operating in Montgomery County should be equipped with a Humat/4-way valve.

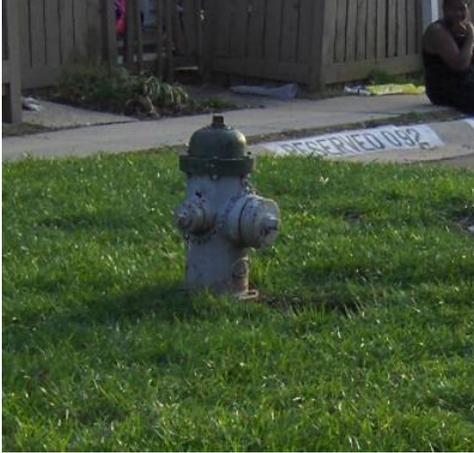
During the process of hand jacking the 4” supply from E708, the observer/ride-along bypassed the hydrant at 9851. This hydrant was the next closest water sources to the fire unit. This was done because the status of this hydrant was unknown and members of the first arriving units did not realize it was there. This hydrant was not utilized during the event until the overhaul stage.

One of the critical functions of the four-way hydrant valve, also referred to as the Humat Valve, is the ability to establish an uninterrupted water supply without requiring an engine at the hydrant initially. When placed at a hydrant, a supply line with a Humat Valve can be connected by any on-scene personnel and water supply can be initiated. Additionally, the water supply engine can connect to the Humat’s 4½” steamer connection and after opening the butterfly valve can utilize additional water from the hydrant.

E753 does not operate with a Humat/4-way valve on their supply line. This required the 5” stortz adapter be connected directly to the hydrant steamer connection. As such, the water supply from the hydrant at 9814 was limited to only the E753/E708 configuration.
