Montgomery County Fire & Rescue Service

POST INCIDENT ANALYSIS

511 S. Frederick Avenue
Gaithersburg, MD
F10-0089987

August 12th 2010

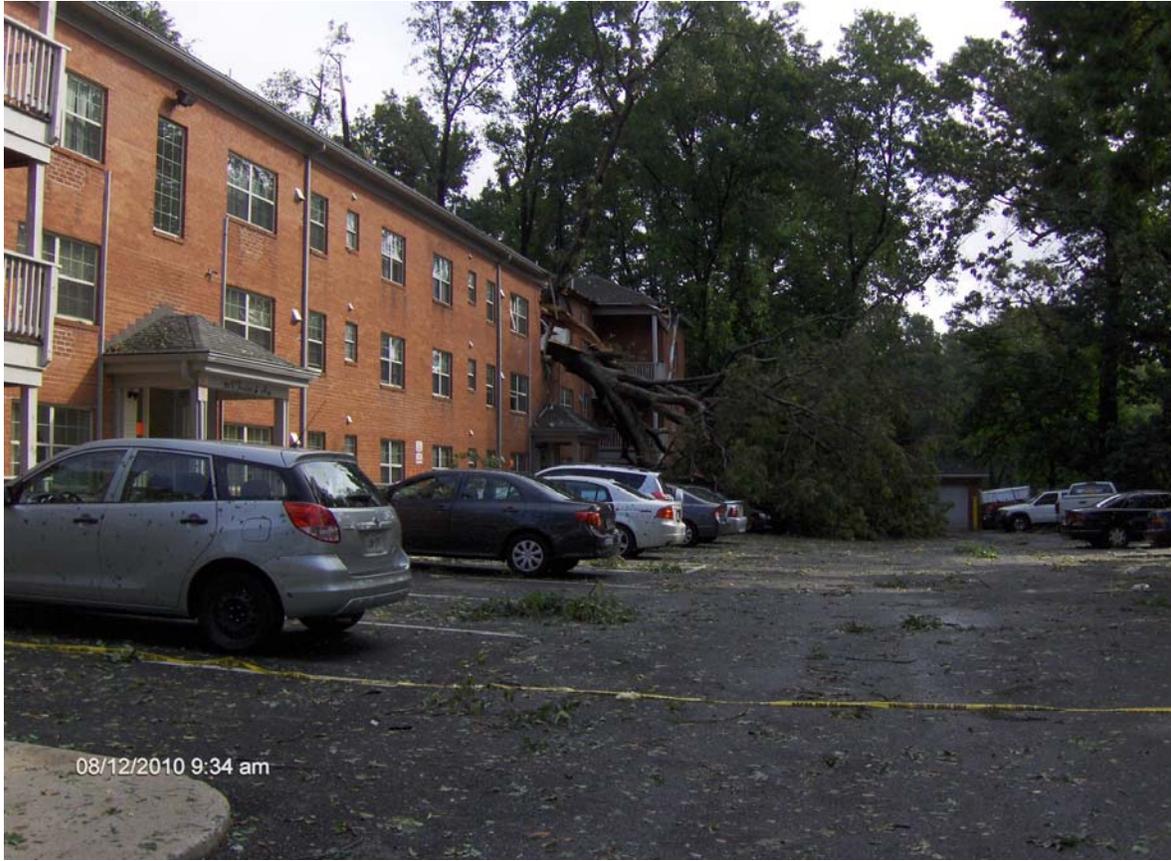
Side Alpha, looking from the Alpha/Bravo corner. 511A is in the foreground.

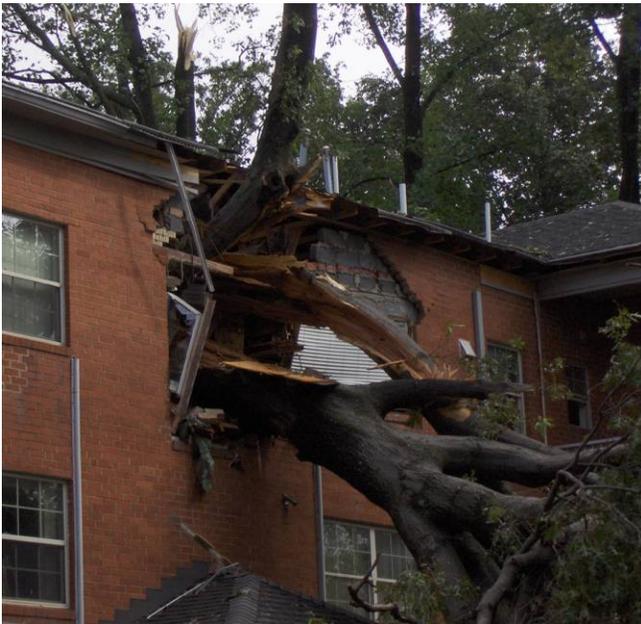
There was significant damage to the second and third floors, and several cars were visibly crushed under the crown of the tree as it lay into the parking lot. A group of at least 20 civilians had congregated in front of the building, and a civilian was visible on a third story balcony of 511B. At this point, SpecOps Chief made the initial request for two engines, two trucks, and four EMS units; two ALS and two BLS; and established command. After exiting the vehicle, the SpecOps Chief approached the building and was intercepted by a resident who reported that she

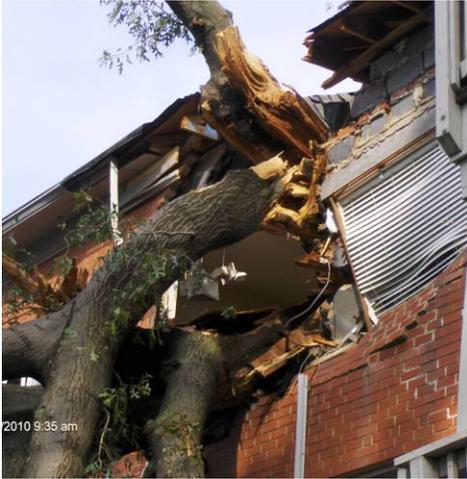
These two windows were broken out and the frames were bent out of shape. The brick and block wall between these two windows was crushed and bowed, and the brick below the double window was folding in towards the apartment. The decorative balconies, which were located in the bumped-out section of the Alpha/Delta corner of the building, had obvious damage and the decks appeared unstable and were partially collapsed.

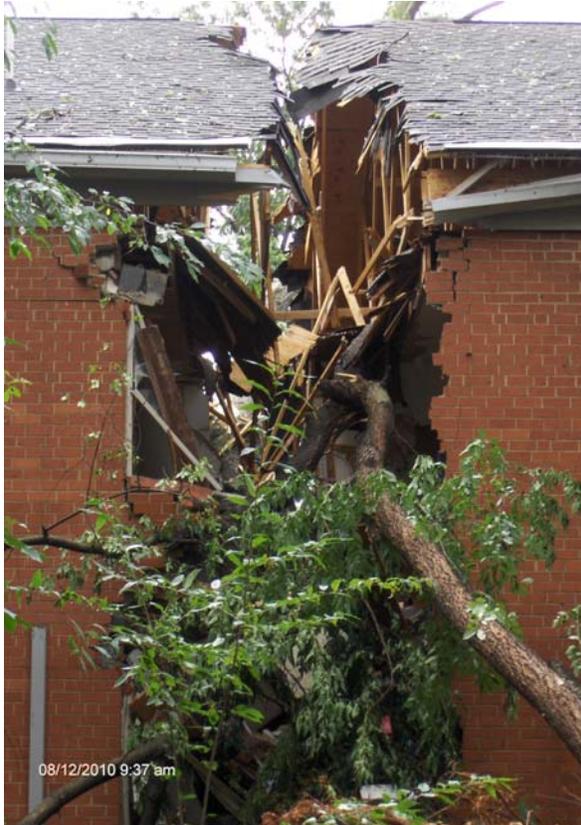
On side Charlie, the windows closest to the midline of the building in the apartments on the second and third floor, as well as the brick surrounding them, were completely missing. From side Charlie, it was clearly evident how far down into the building the damage extended.

Prior to tree removal

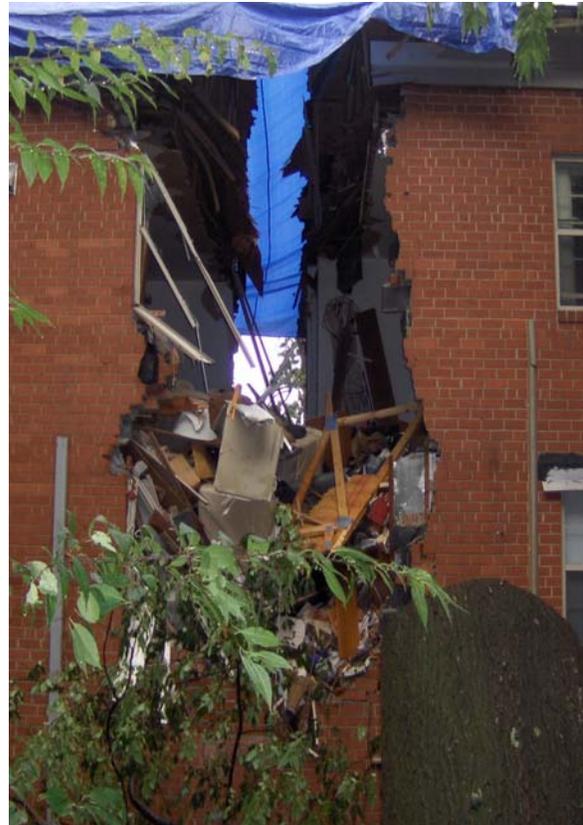
After tree removal

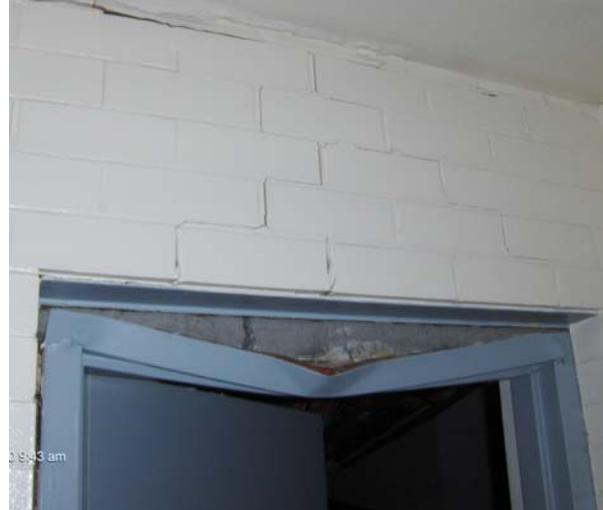
Tree parts blocked access to the third floor via the interior stairwell, so access was made by way of ground ladders to the windows. The partition wall in the third floor stairwell that separated the stairs and apartments 22 and 23 on the Delta side of the stairwell was completely destroyed. The tree prevented movement from the Charlie and Delta quadrants back over to the Alpha and Bravo quadrants, so access was made by exiting the building and re-entering via ground ladders. Damage to apartments 20 and 21 was less extensive; however, on the Alpha side of the stairwell there was a steel lintel on the top chord of the wall that was broken and had fallen into the stairwell below.
