**Montgomery County Fire and Rescue Service  
Post Incident Analysis  
3<sup>rd</sup> Alarm Garden Apartment Fire  
2815 Terrace Drive  
Chevy Chase, MD  
Incident Date: May 1, 2012**

**Prepared by: Battalion Chief Jim Resnick, DFRS  
Submitted by: Chief Roger A. McGary, Silver Spring Fire Department  
June 25, 2012**

## POST INCIDENT ANALYSIS STRUCTURAL FIRE

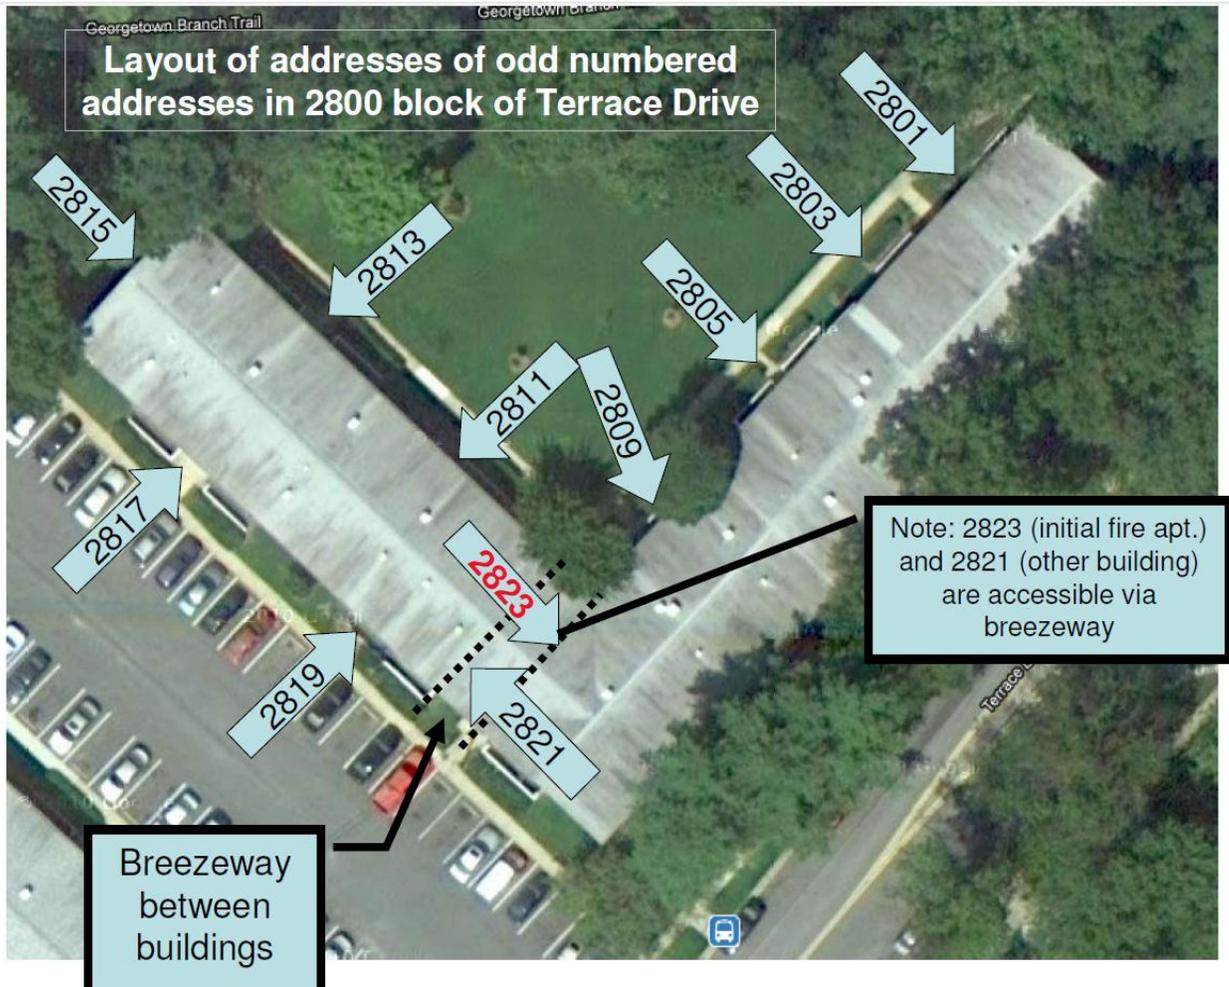
- a. **Review type of structure** – The complex is a lightweight constructed building, built in 1963. The building layouts are rather unusual, with a mixture of ground-level (terrace) apartments (e.g. 2815 or 2817 Terrace Drive) , single floor apartments on the second and third floor of some addresses of each building (e.g. 2813 Terrace Drive), and two-story apartments in other parts of the building (2811 Terrace Drive). From the exterior, there are only very subtle clues as to which addresses have which of the three layouts.

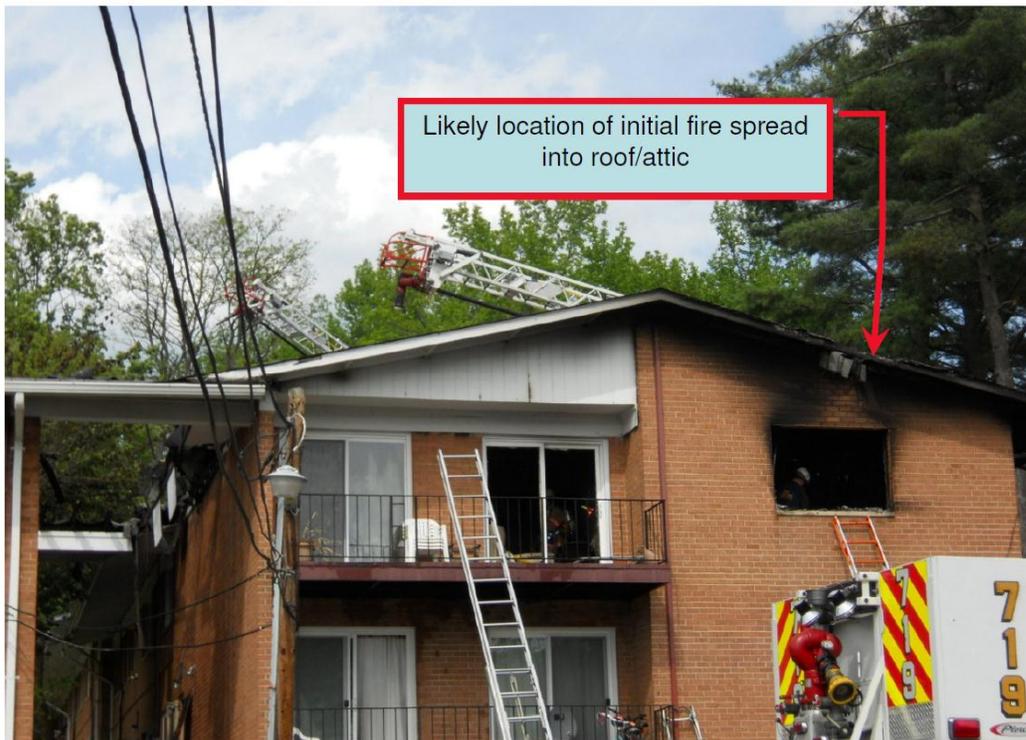
**b. What construction or design features contributed to the fire spread, or prevented fire spread, i.e. sprinklers, fire doors, etc.?** The building was a Type III constructed building with masonry firewalls, a wooden floor assembly, a wooden truss roof assembly, and was built with a wood frame with a brick veneer. The fire most likely entered the roof by vertical extension through either a soffit or a gable end vent above the fire apartment. Given the age of the structure it is possible that there were multiple layers of roofing material that might have concealed fire from crews operating both inside the fire apartment and on the roof.

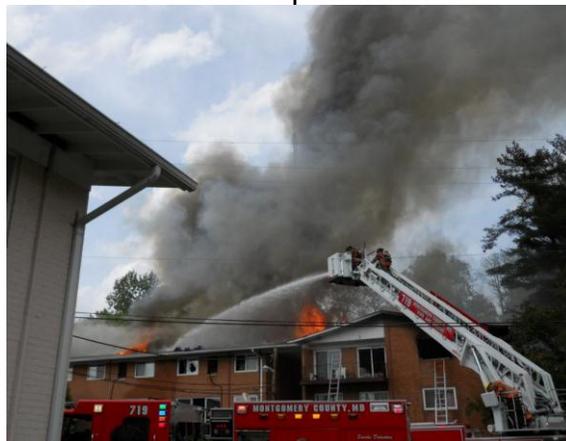
**a. What was the structural integrity of the building based on fire conditions on arrival, at 10 minutes, 20 minutes, 30 minutes, etc.?** Structural integrity was a significant concern of all units operating on this fire, and the source of concern evolved as the incident progressed. Upon the arrival of PE719, the OIC reported heavy fire “blowing out of the Side A window”. While this report provided an accurate description of the volume of fire that was evident, the reference to “Side A” became problematic for other units to identify the other sides of the structure and the complex. Fire in that apartment was fully developed and was actively venting, but there was no apparent concern with the structural integrity of the building at that time. At 10 minutes into the incident there were three engines and one truck putting an effective knock on the fire with multiple handlines. From the exterior, the ICP could observe conversion of smoke from heavy, dark, thick smoke to lighter smoke and the absence of visible fire. At 20 minutes into the incident there is no apparent fire and only a small amount of residual smoke in the apartment that had been completely ventilated (horizontal ventilation). Crews on the interior of the original fire apartment are reported that they had opened walls and ceilings (up to the roof line) with no smoke or fire evident. Just after the 20 minute mark, a small amount of smoke was noted by command as coming from the ridge vent of the exposure building. At approximately the 25 minute mark there was rapid fire growth along the roof line of the exposure building. Crews operating on the roof of that building were rushed in their egress to leave the roof and due to insufficient ladders the crews contemplated dropping off the roof onto third floor balconies for emergency egress. Finally, ground ladders are placed by RS741B and PE707. The roof structure became fully involved in fire and an elevated master stream was put in service by AT719 and T710 only after a PAR was conducted and all personnel were accounted for and a defensive attack was declared. It took over 20 minutes for the roof fire to be extinguished by elevated mater streams. Then, before crews could enter the building for salvage and overhaul there was concern about structural integrity due to the weight of the water that had been used for extinguishing the fire. Crews that were assigned salvage and overhaul were not allowed to enter the structure until SA700 had evaluated the structure and declared it safe for those operations.
