## **Montgomery County Fire and Rescue Service**

### **POST INCIDENT ANALYSIS**

**Townhouse Fire w/Rescue  
11939 Old Columbia Pike  
Silver Spring, MD**

**Incident Date: March 17, 2013**

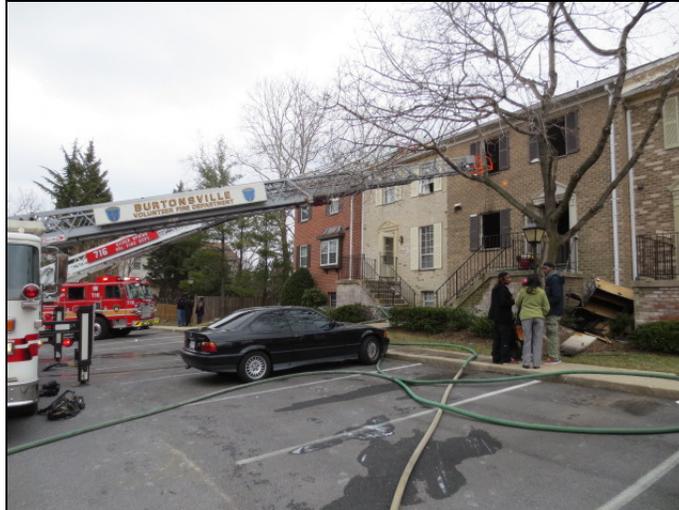
*The townhouse was “raised,” thus making the second floor level 2-1/2-stories high from street level.*

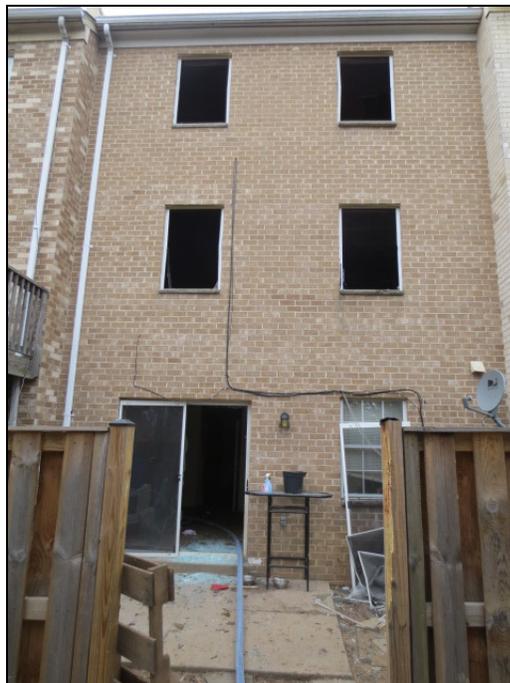
*The rear of the townhouse was a full 3-stories with a walkout basement entrance.*

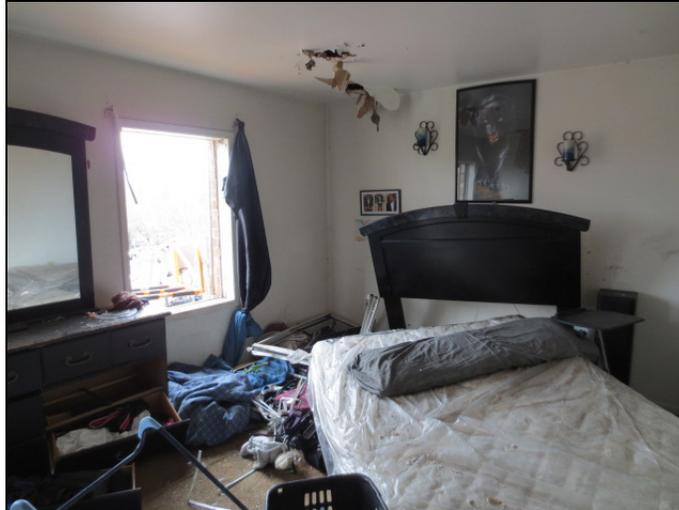
*The window from which the male occupant jumped and the female occupant was rescued is shown above. Note the absence of smoke stains. The bedroom door had been closed until the male occupant opened it after having smelled smoke.*

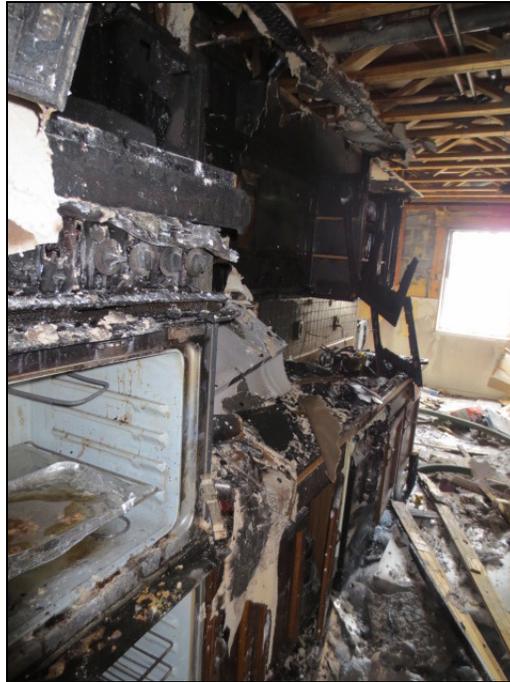
An origin and cause examination was conducted by MCFRS Fire and Explosive Investigations. The findings of that examination indicated that the fire started in the kitchen area of structure. The cause was listed as unattended cooking.

*Fire damage was significant in the kitchen area.*

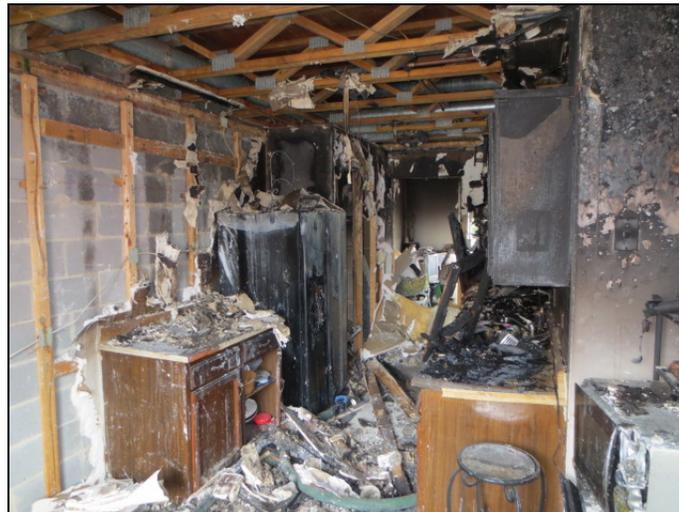
- The walls that separated Exposure Bravo and Exposure Delta from the fire building were masonry block construction with no “poke-throughs” or penetrations. The presence of a masonry fire wall on the Bravo side

of the fire building made a significant contribution in preventing fire extension into the Bravo exposure – especially because the origin of the fire was in very close proximity to that masonry wall.

*The concrete block wall prevented fire spread into the adjoining townhouse.*

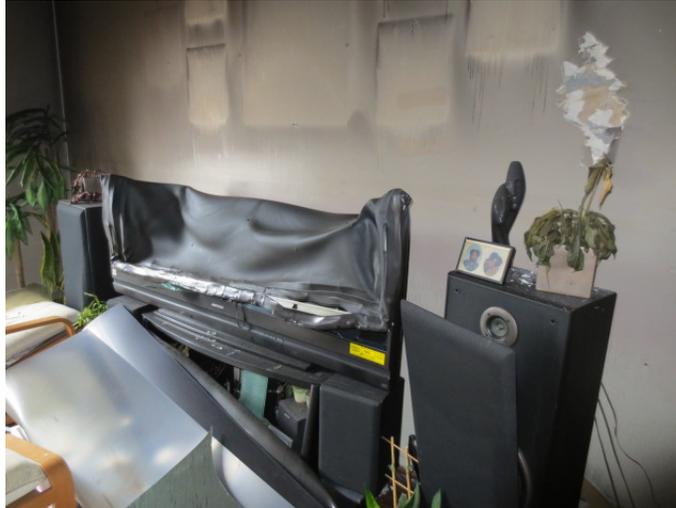
*Heat levels on the second floor were high enough to melt this large screen television.*
