Montgomery County Fire and Rescue Service

POST INCIDENT ANALYSIS

**House Fire with Firefighter Injuries
809 Orchard Way
Silver Spring, MD**

Incident Date: June 27, 2013

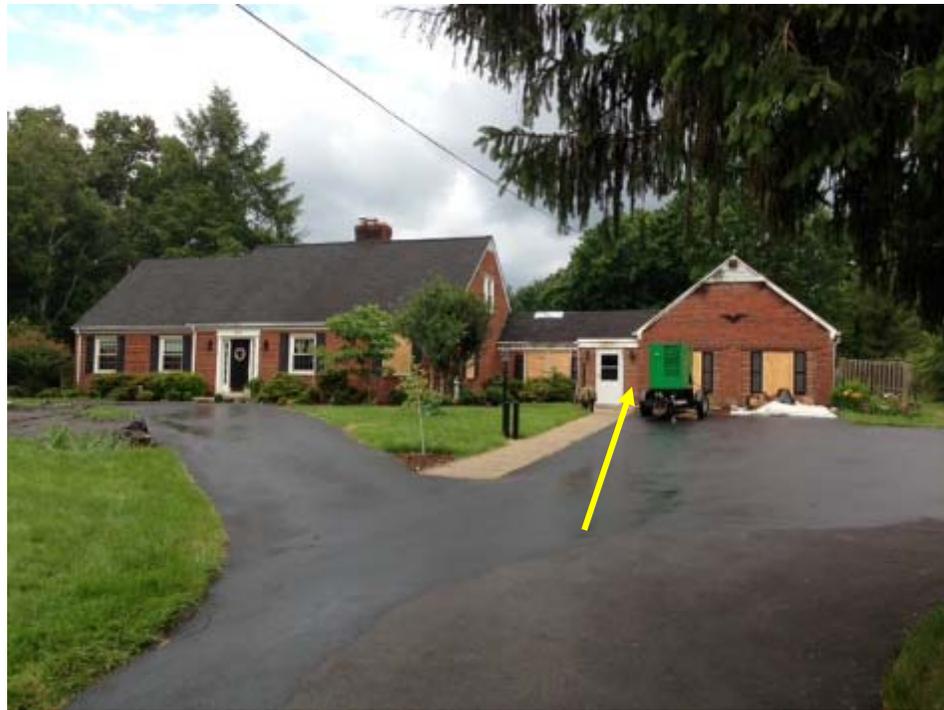
- The house is approximately 3,500 square feet and was constructed in 1950. It was built of Type III construction with no fixed fire detection or suppression systems.
- The main structure consists of two levels; the second floor resembles a finished attic space or a half-story. An attached structure was originally built as a two-car garage but was later converted to a living and storage space. On the 9-1-1 call an occupant referred to the addition as the “Mother-in-Law Suite.” The main house and addition were connected by a breezeway that had no interior thruway. This configuration is unusual and hampered the initial interior efforts.

Figure 2: 809 Orchard Way – 2-story SFD with a finished addition (area of origin) connected to the main house by a breezeway with no interconnection.

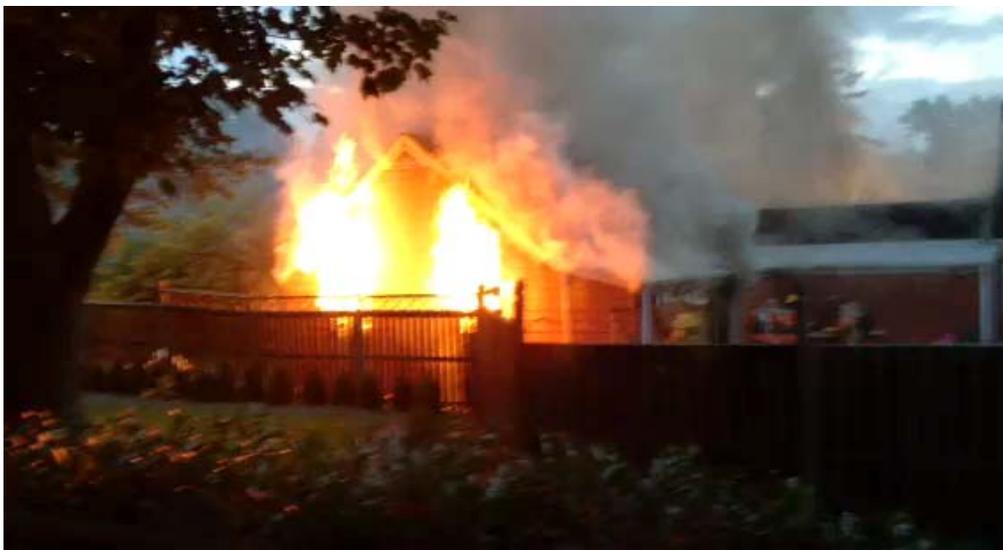
Units arrived on the scene to find a 2-story single family dwelling with smoke showing from an addition on the Delta side of the house. Within one minute the fire advanced to the free burning stage, with fire venting from windows on the Charlie and Delta sides (See figure 3).

Figure 3: From side Charlie moments after the arrival of FD units but prior to the initial knock down.

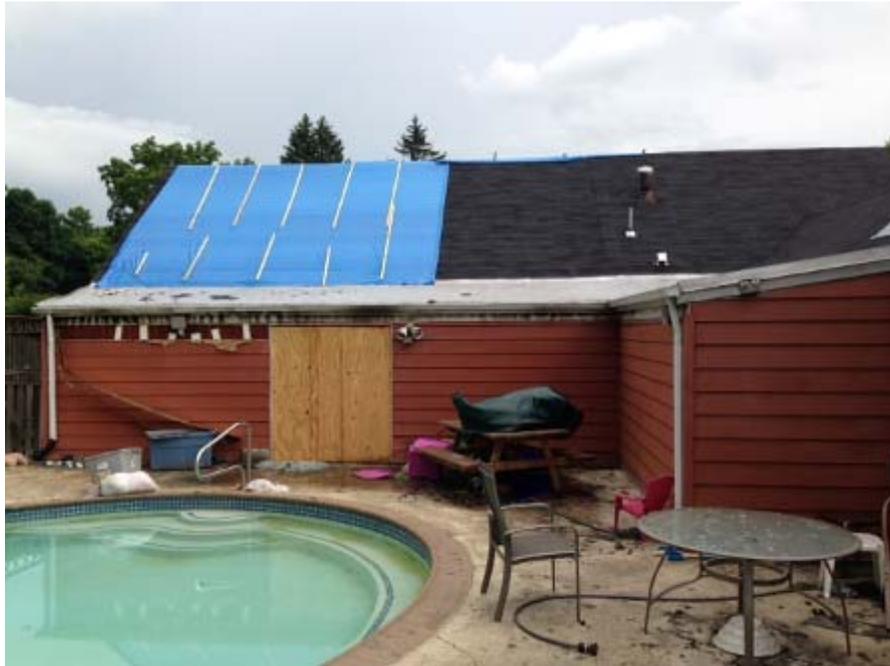
Figure 4: Side Charlie view shows the close proximity of the swimming pool to the addition and main house (just to the right of the glass table).

- A swimming pool located on side Charlie within feet of the main house and addition. Heavy smoke conditions around the house reduced visibility, which created a concern for fire fighters not seeing it and falling in.
- A 5-foot fence on the Delta side of the house further hampered hose line advancement and getting equipment around to the rear of the house (See figure 5).
- A faux breezeway provided exterior access to the addition but added to confusion by not providing access between the addition and the main house (See figure 2).

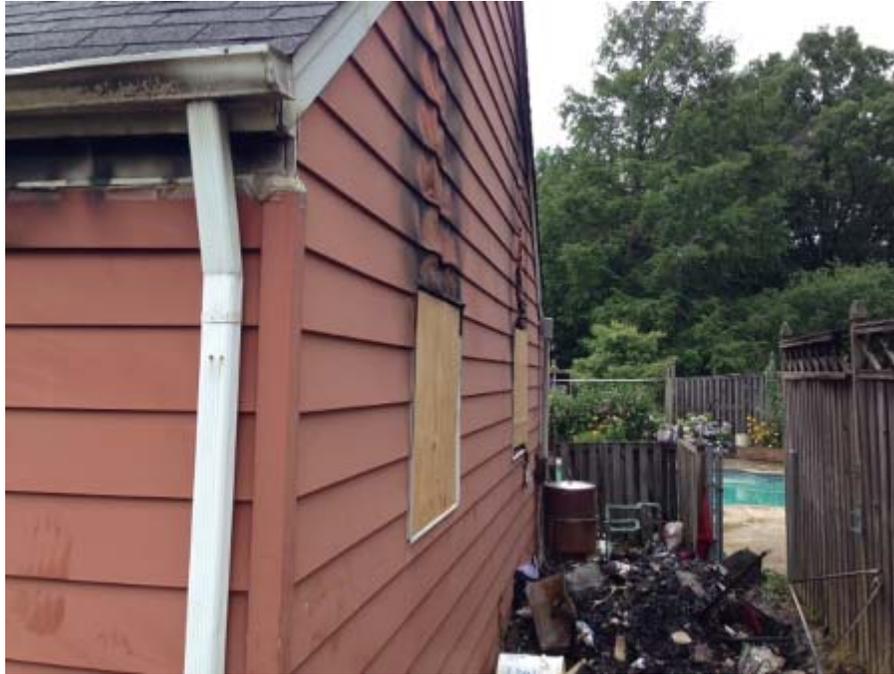
Figure 5: From the Charlie Side of the addition indicates heavy fire involvement and limited access to the rear of the addition due to a fence in close proximity to the house, further hampered by overhaul debris.

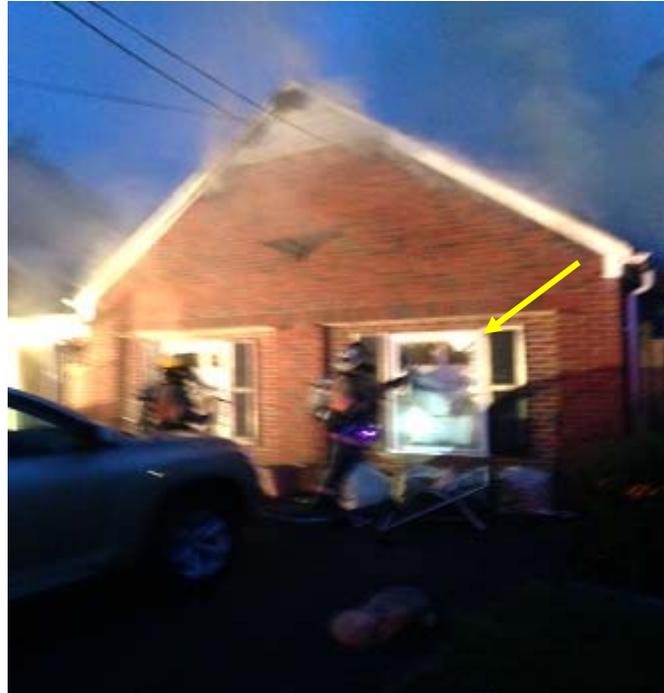
Figure 6: Ventilation efforts in the addition were hampered by because firefighters believed they were ventilating real windows, but were surprised to find an original garage door behind the window openings.

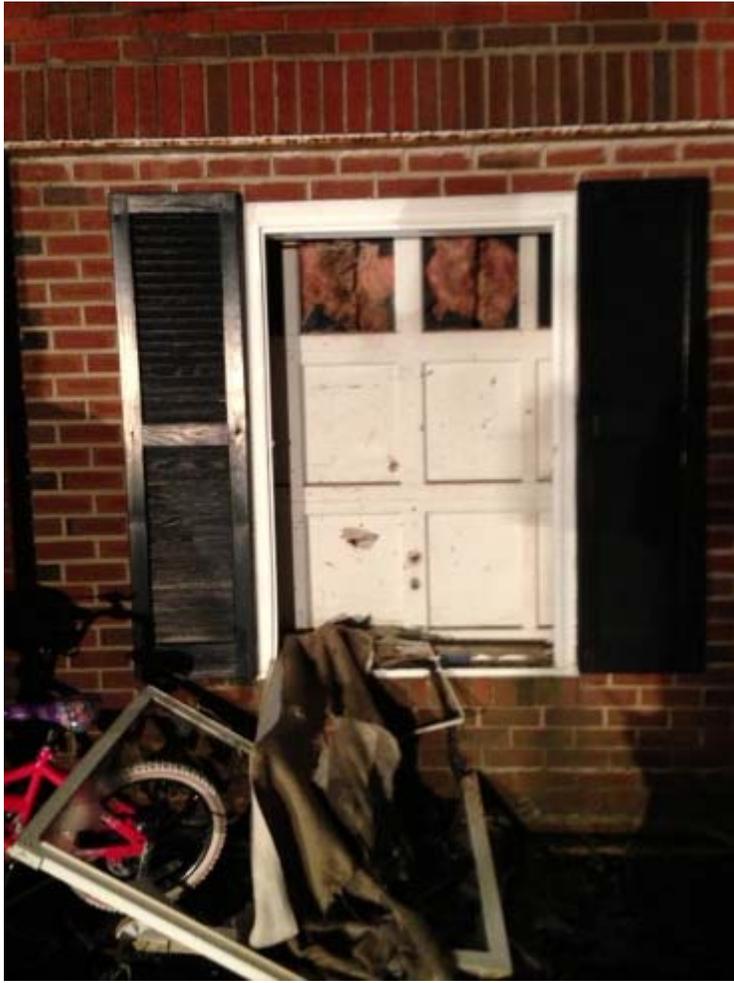
Figure 7: Side Alpha of the addition shows an existing garage door still present after a fully functional window was removed for ventilation.

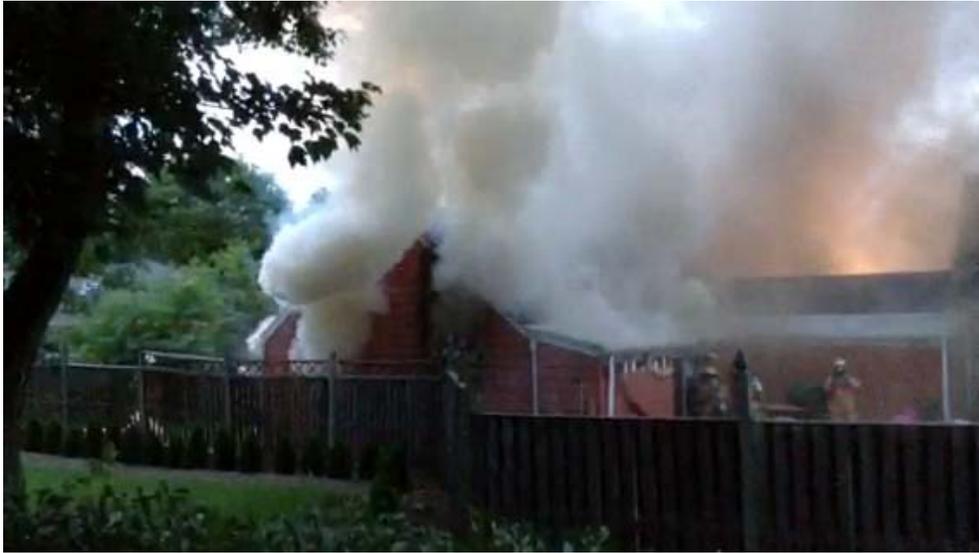
Figure 8: Side Charlie – the bulk of the fire is extinguished but heavy smoke is venting from the entire structure (pictures are taken by a neighbor).
