Incident Summary
21200 Martinsburg Road – Box 14-08
Dickerson Generating Station– November 11, 2013

Incident Number 13-0126517

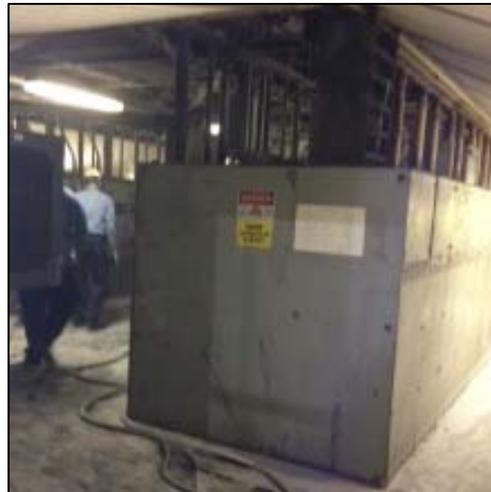
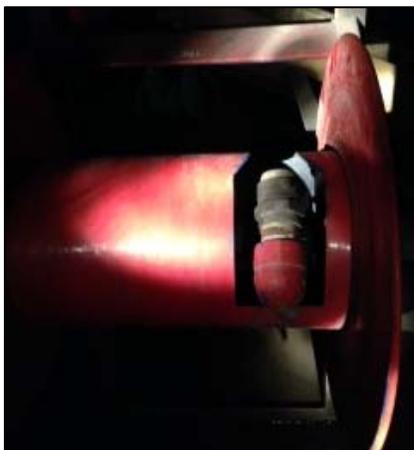
Plant personnel escorted Paramedic Engine 714 and Medic 714 deep within the structure to the volt room. The volt room is the size of a small classroom with two long rows of 4160-volt circuit breakers. Each row contained 28 circuit breakers. Each circuit breaker was the size of a small refrigerator. The 4160-volt circuit breakers worked in conjunction with a generator. The breakers controlled various functions of the generator (electric pumps, motors etc.). The plant floor supervisor and the control room supervisor confirmed the row involved in the fire had been de-energized. The row adjacent to the involved circuit breakers was energized and would take hours to de-energize by standard plant protocol.

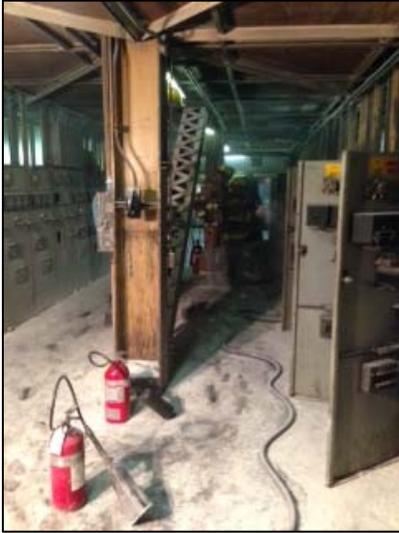
The plant fire brigade used twenty portable ABC extinguishers and a 200-pound Ansul two-wheel industrial ABC extinguisher prior to Paramedic Engine714's arrival. Upon entry into the volt room Paramedic Engine714 discovered a high temperature fire fully involving four 4160-volt circuit breakers. The fire was described as a high intense jet blue flame. Working under the guidance of the plant floor supervisor, and approval from the control room supervisor, and after again confirming the row was de-energized, the use of a controlled and measured water application was authorized. Once the fire was controlled and confirmation that no extension outside the units involved, the hose line was backed out of the room and drained into a floor drain to prevent accidental water application in the high hazard area.

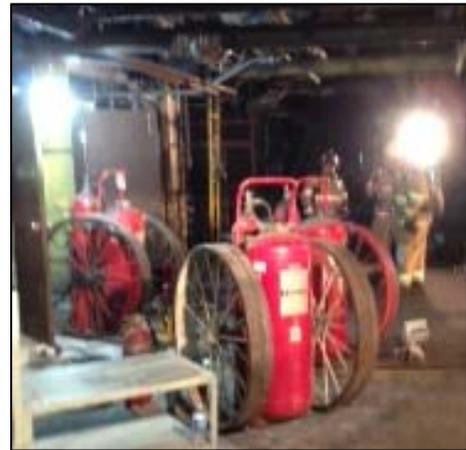
Once the fire in the volt room was stabilized, the process of cooling the superheated circuit breaker units started. After these units were cooled, they would repeatedly build up heat to a glowing orange. In total, 51 CO2 extinguishers, 15 portable ABC extinguishers, and two 200-pound Ansul 2 wheel ABC extinguishers were utilized to bring the incident under control. The extinguishing agents were sourced from the plant, on the response apparatus, and through a special deliver from CMF's Small Tools.
