POST INCIDENT ANALYSIS

**Three Alarm Garden Apartment Fire
19315 Club House Road
Montgomery Village, Maryland**

Incident Date: June 25, 2013

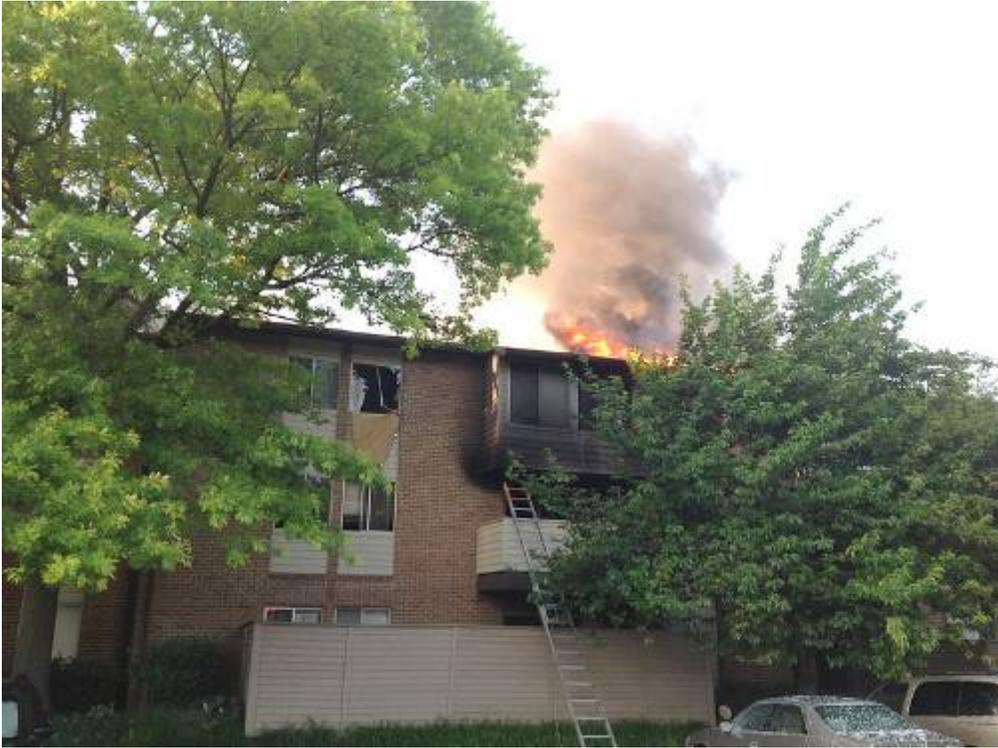
A view from Side Alpha.

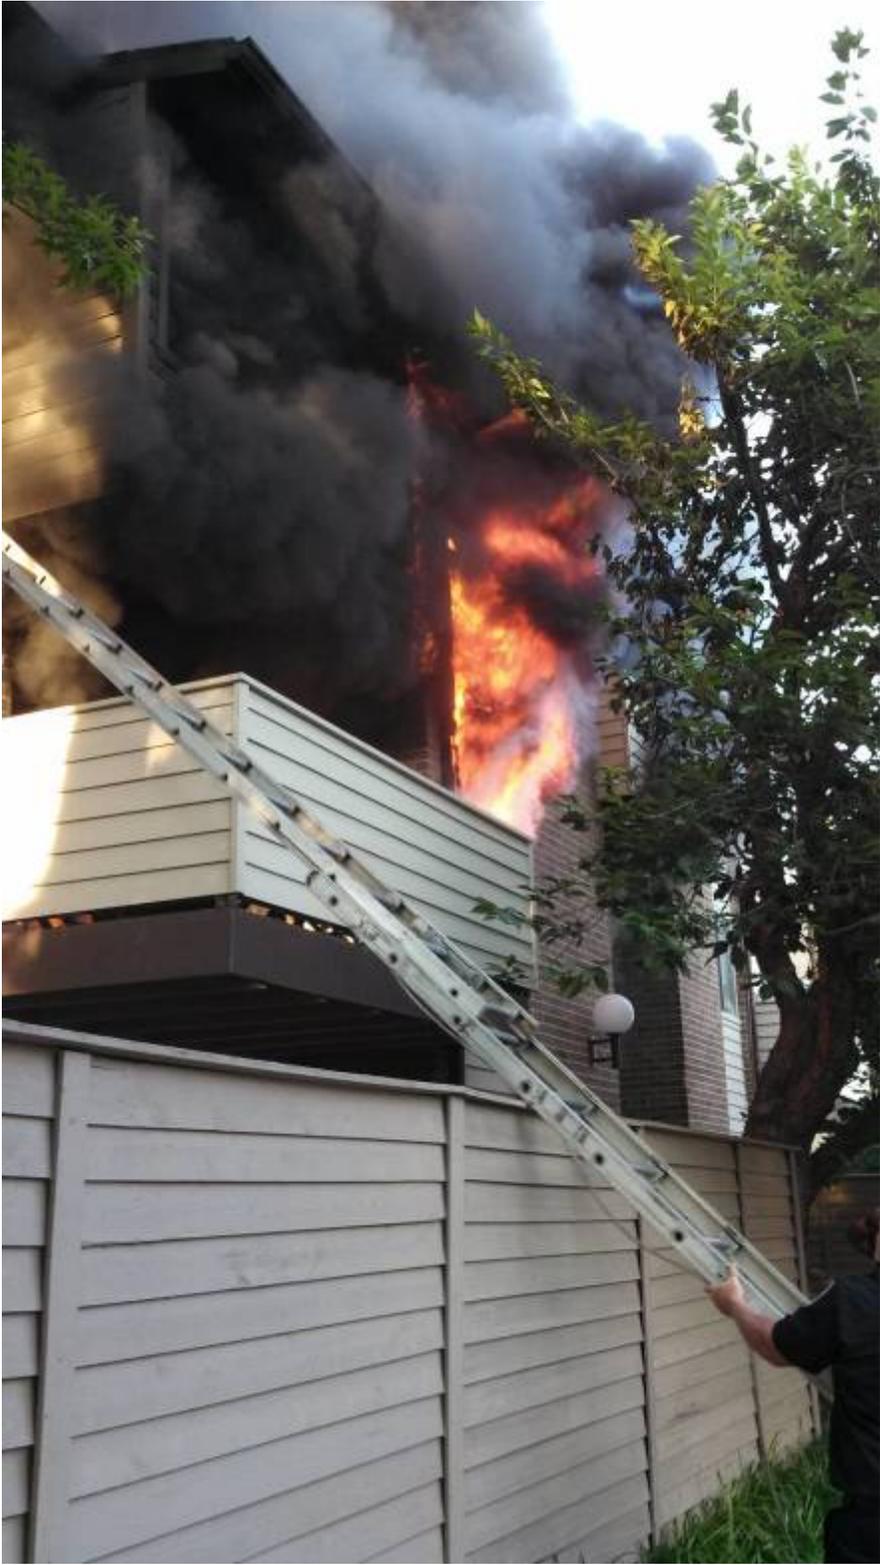
Ladder placement on Side Alpha.
Note: Firefighter not wearing Personal Protective Envelope (PPE)

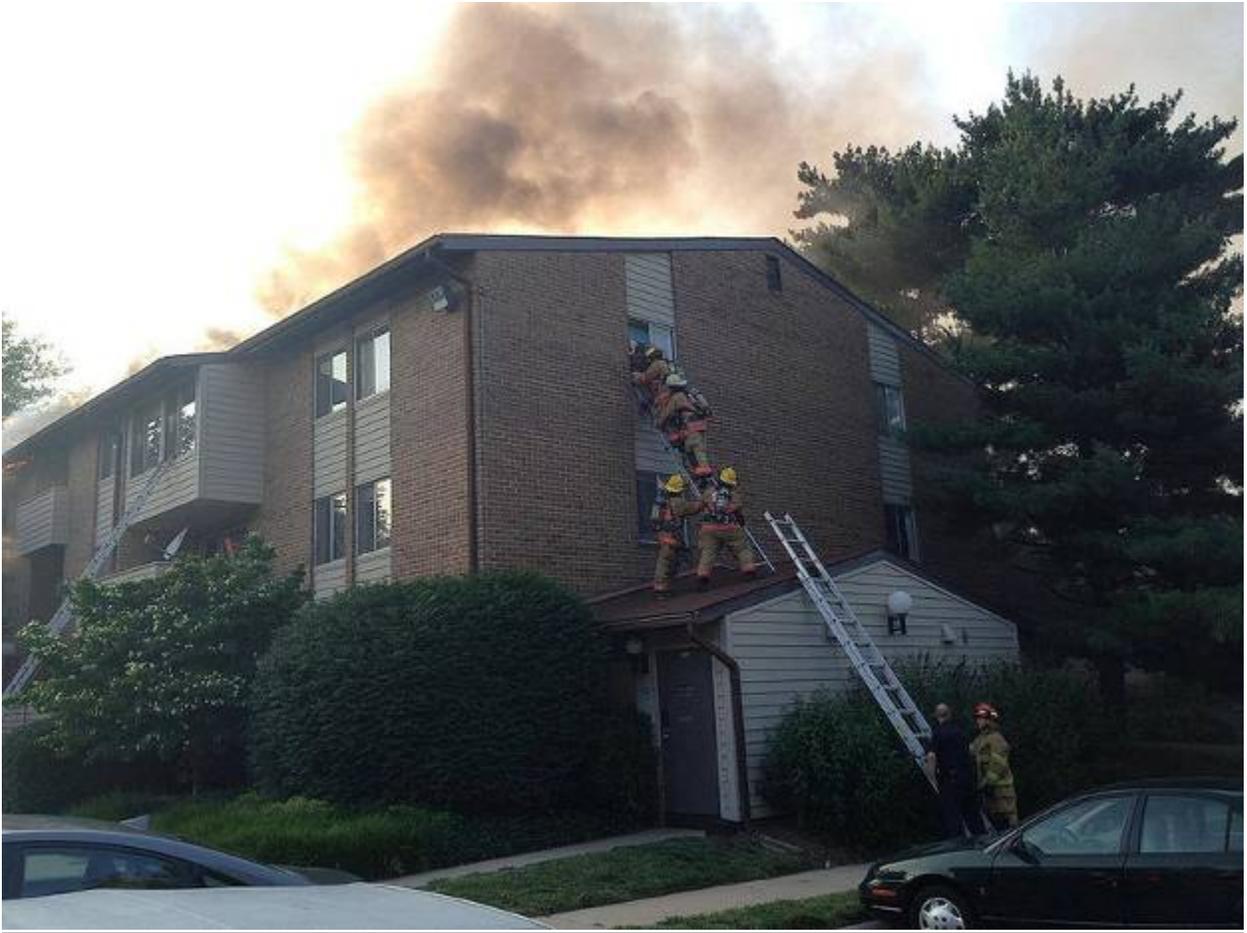
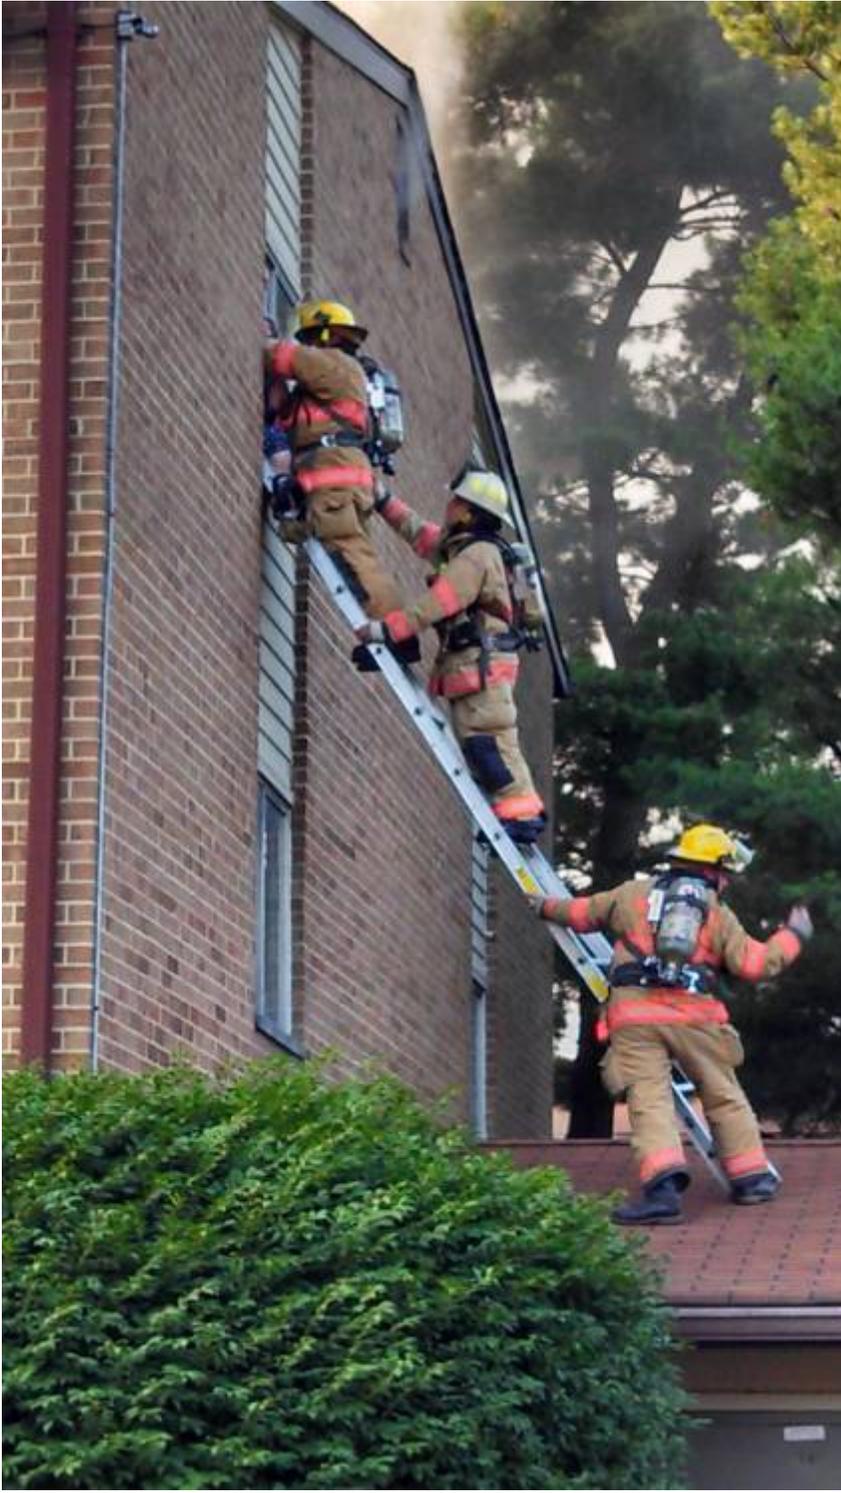
The following two photos show Paramedic Engine 734's crew preparing to remove an adult female occupant from Apartment 304. Engine 753's crew was on the interior assisting her through the window. Engine 753's crew also removed her dog via the interior stairwell. Note crews utilizing two ground ladders to over-come awkward building layout and un-level surface of the lower roof.

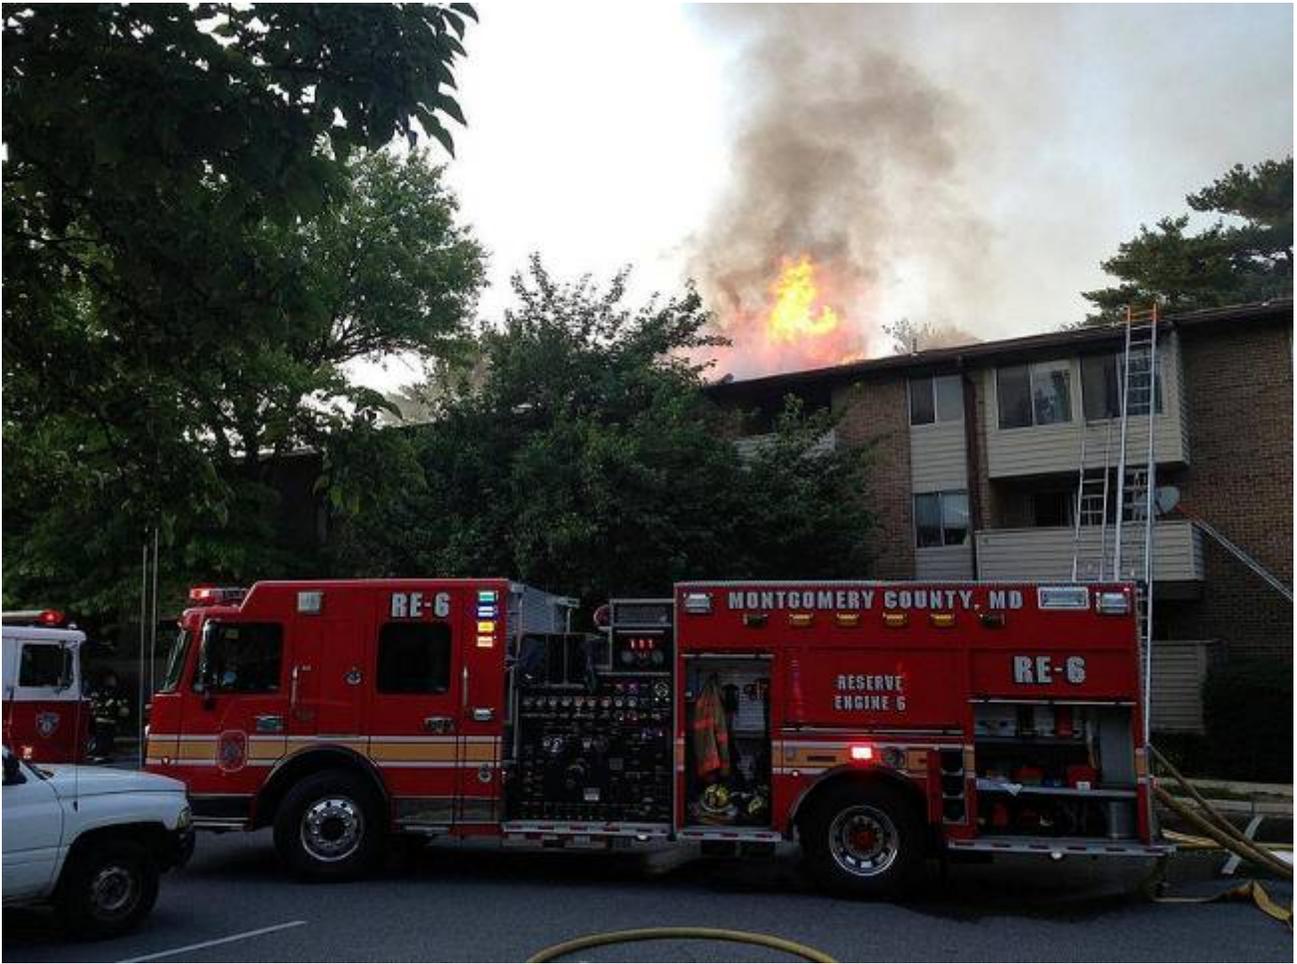
Paramedic Engine 708 (using RE-6) positioned on Side Alpha.

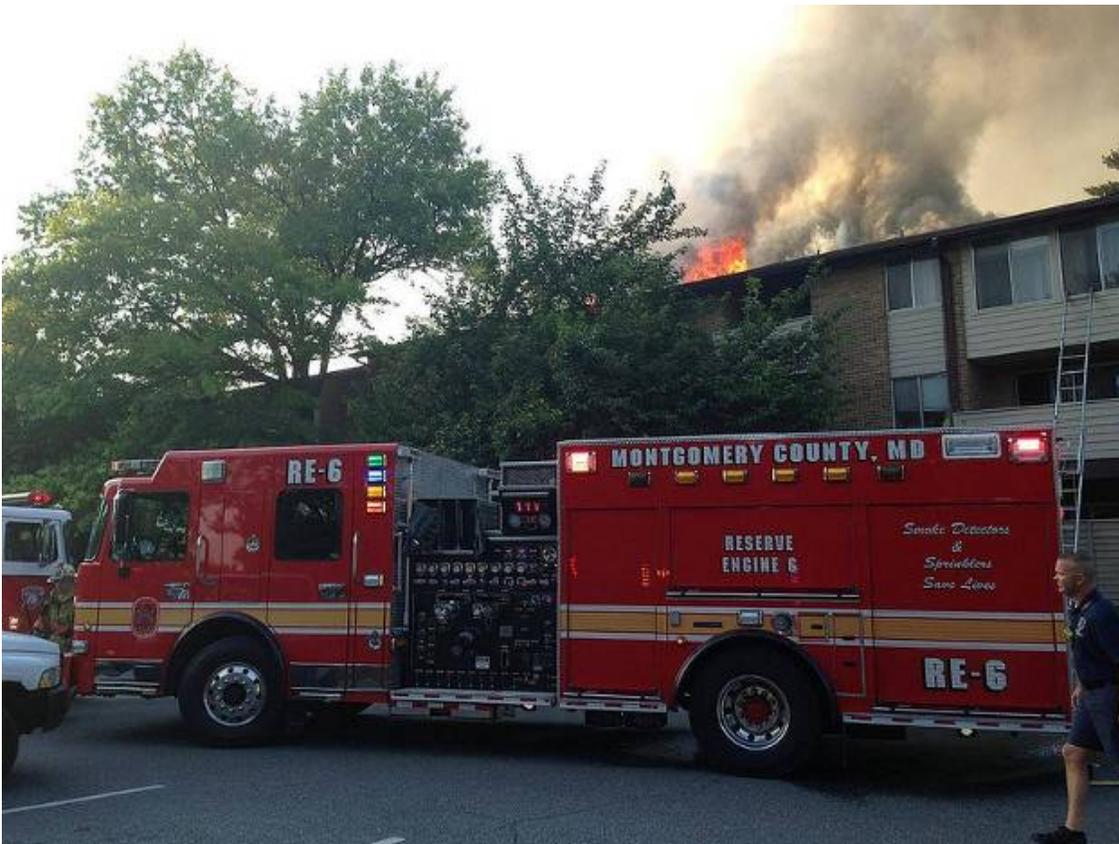
Paramedic Engine 708 (using RE-6) positioned on Side Alpha.

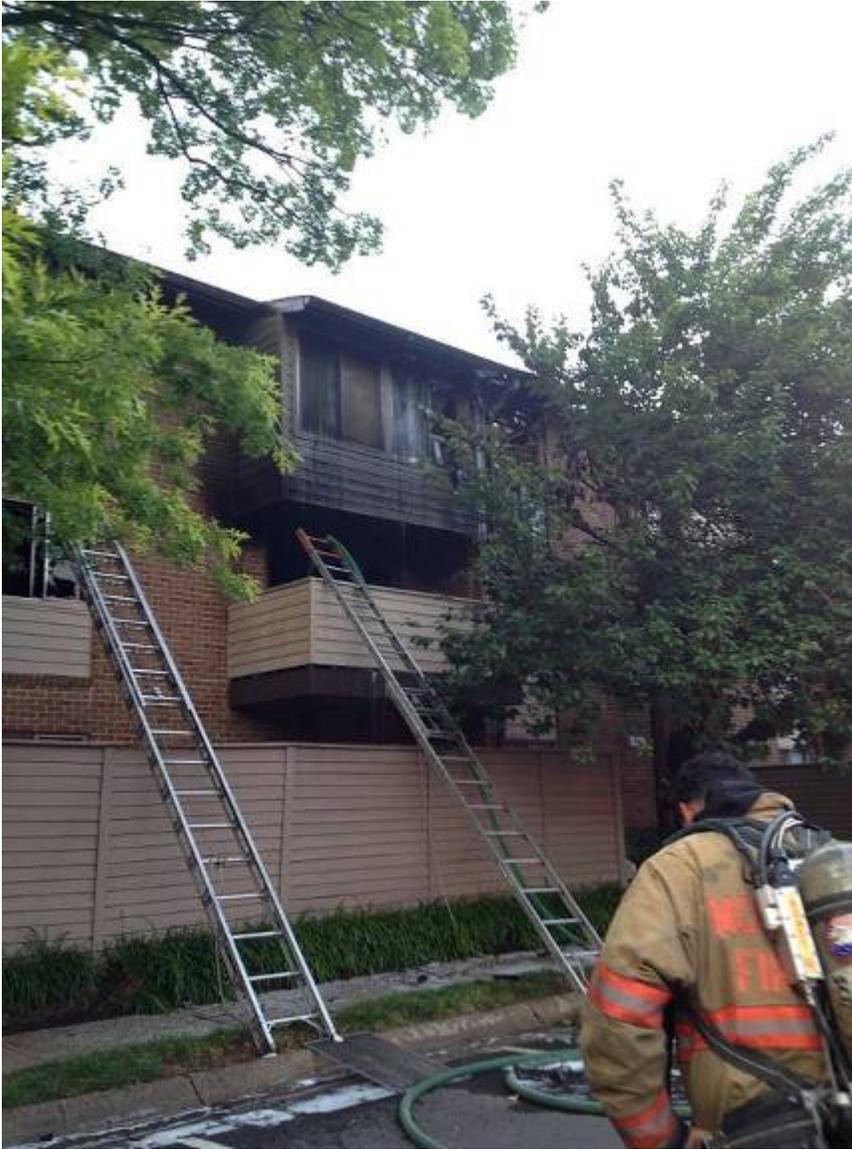
Photo taken after the extinguishment of the fire from Side Alpha.
