Hollywood Branch Stream Restoration

Preliminary Assessment Report *January 2009*

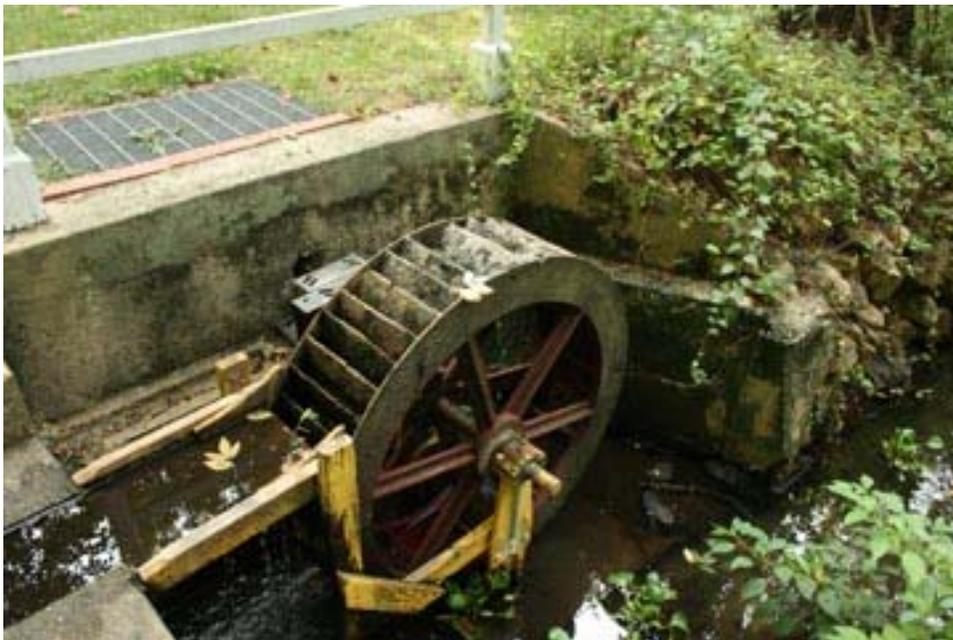
Fig. 7 – One of several small dams with waterwheel constructed along Reach 2

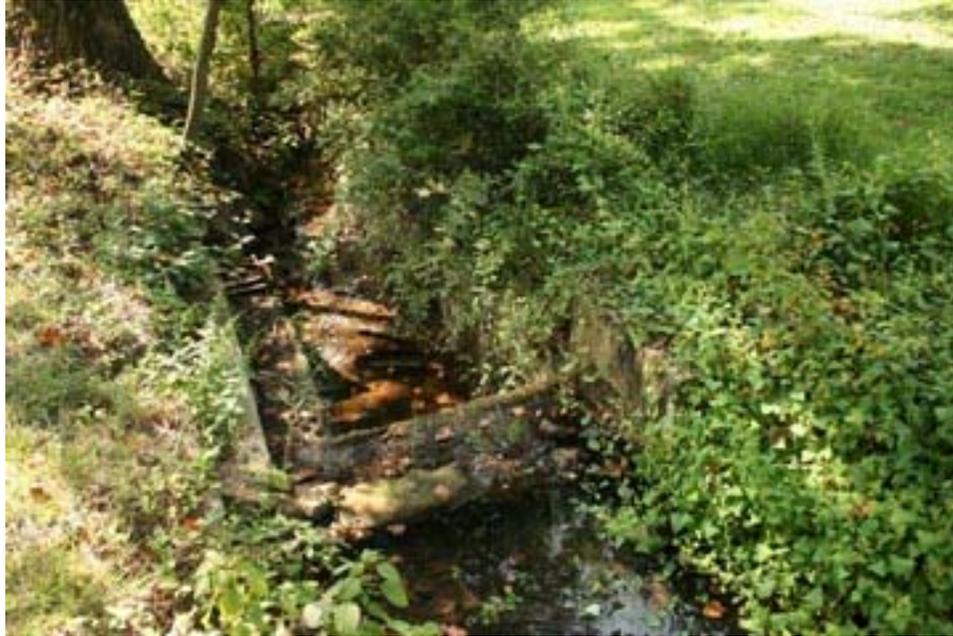
Fig. 8 – Remnants of small dam along Reach 2

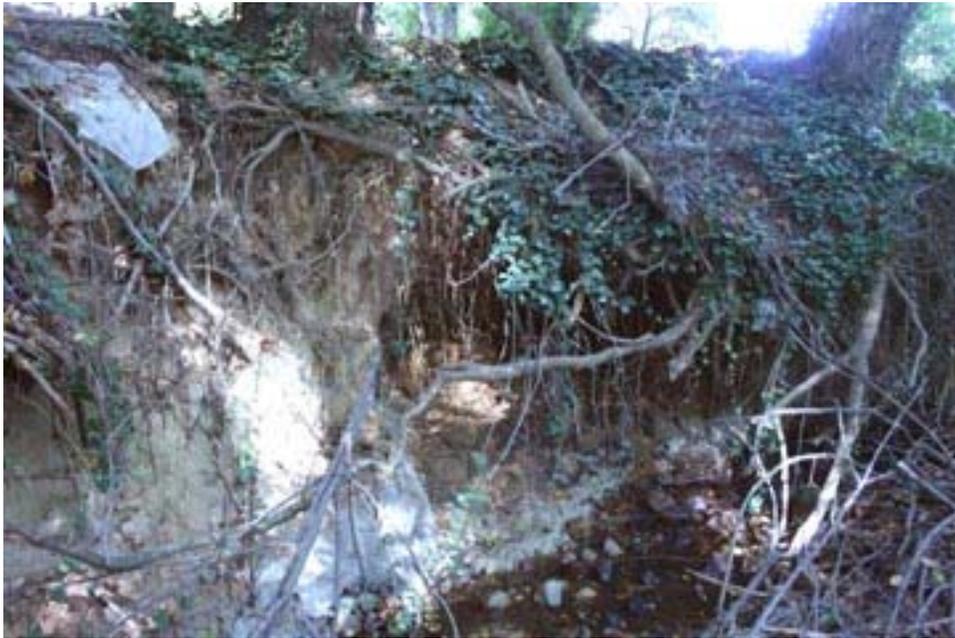
Figs. 16 and 17 – Eroding bank at upstream end of Reach 5.1

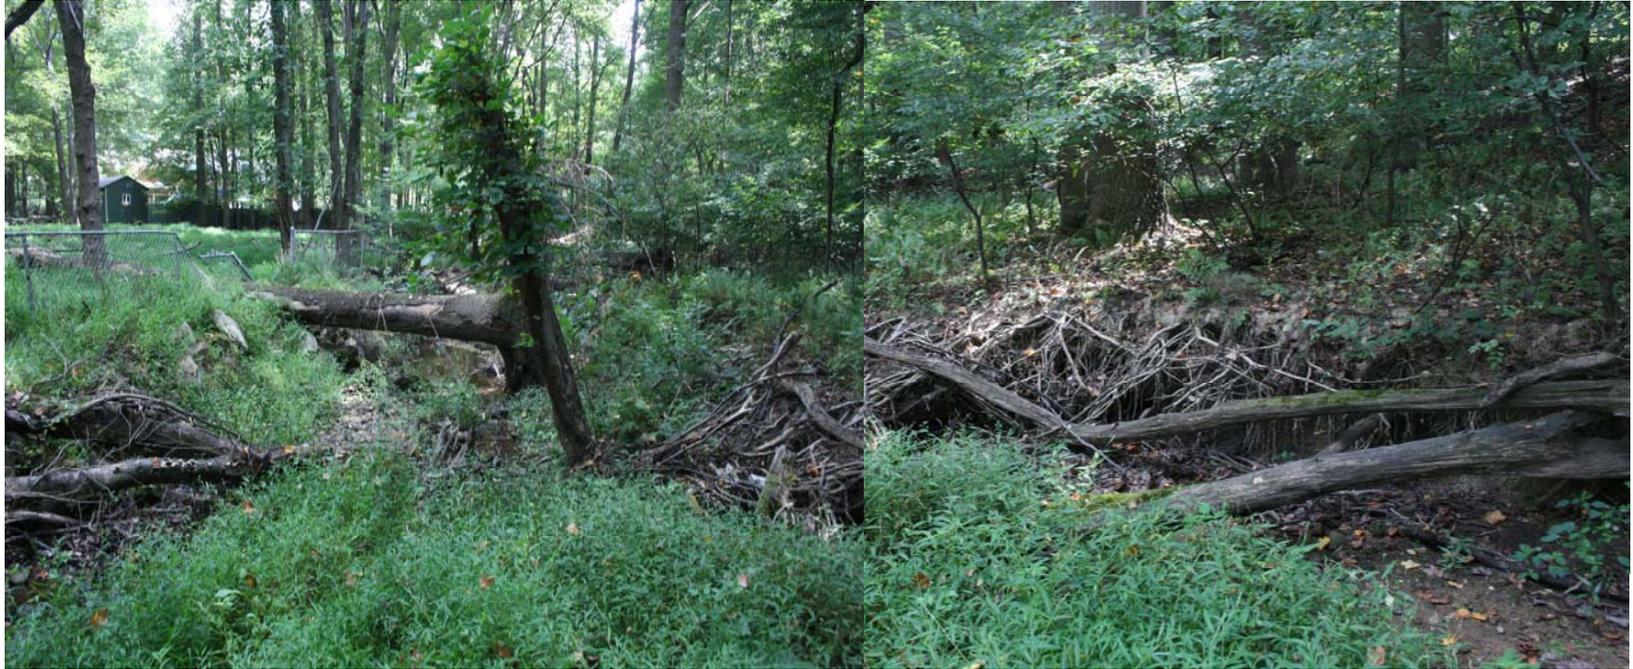
Fig. 25 – Split channel, large debris jam, and aggradation in upper section of Reach 6.1

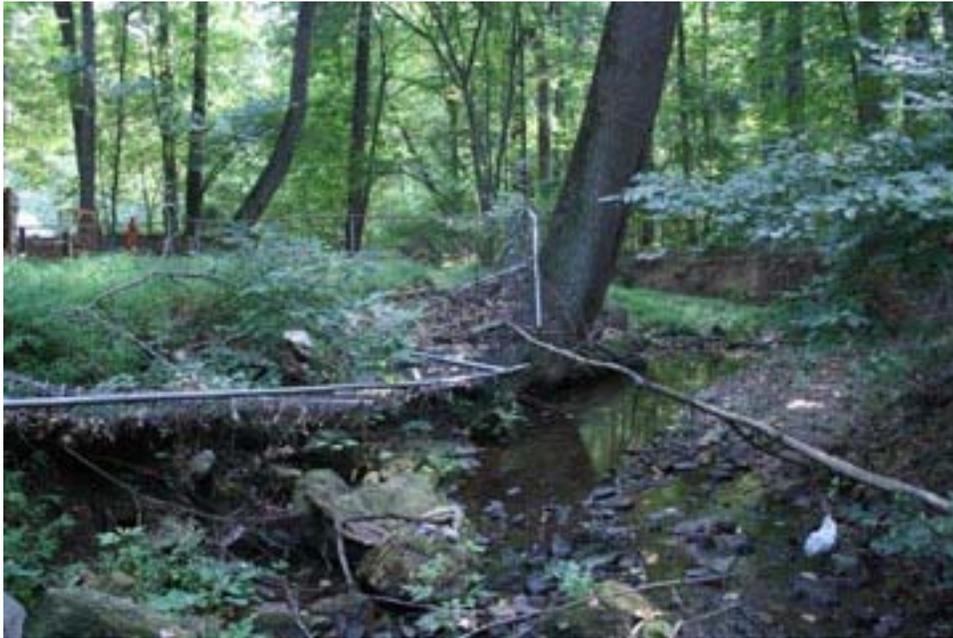
Figs. 26 and 27 – Collapsed trees and damaged fences in upper section of Reach 6.1

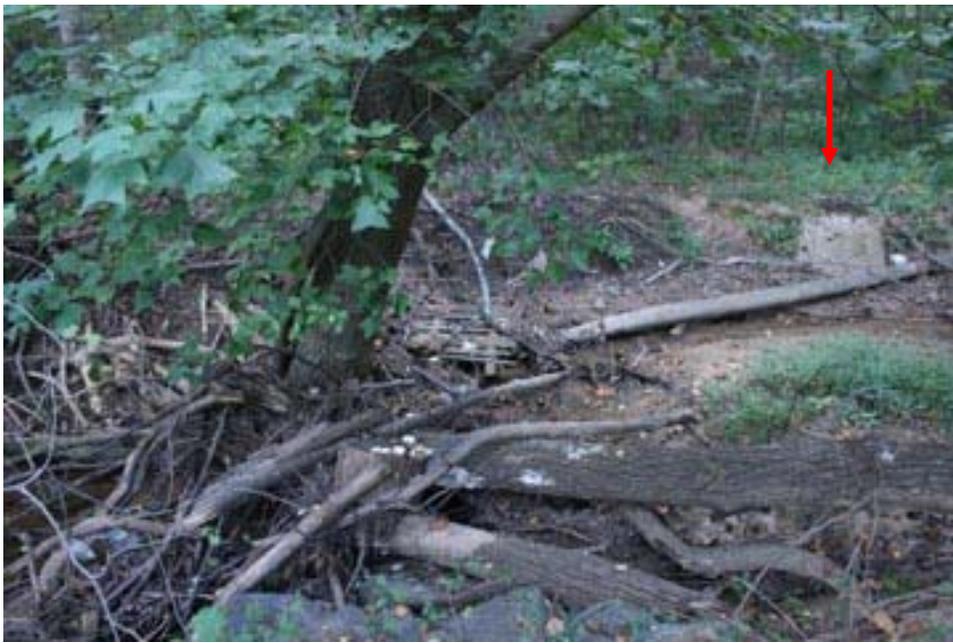
Fig. 29 – Debris jam, aggradation and exposed sanitary sewer manhole

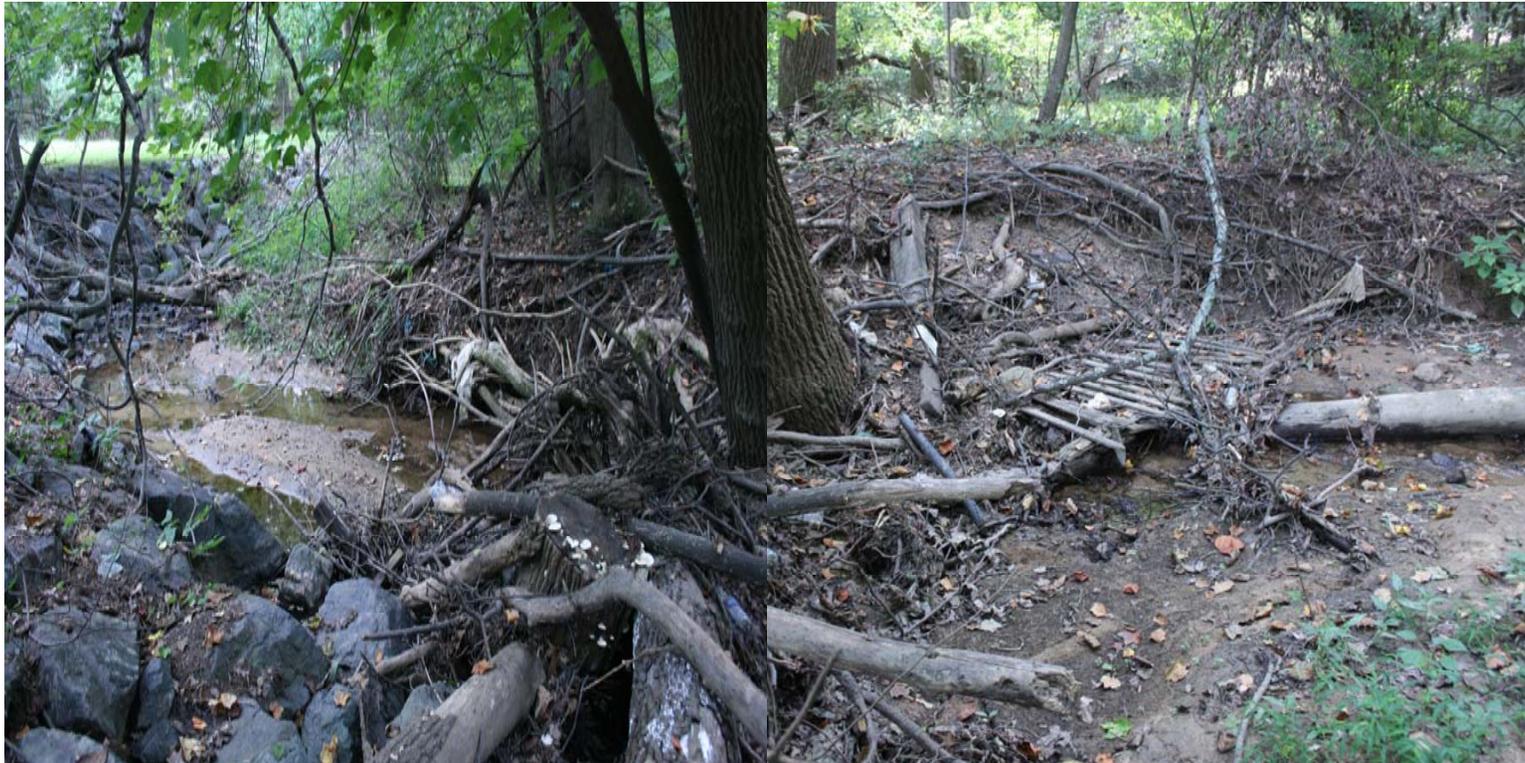
Fig. 30 – Debris jam at knick-point at downstream end of Reach 6.1. Note aggradation upstream and significant drop in bed elevation into Reach 6.2

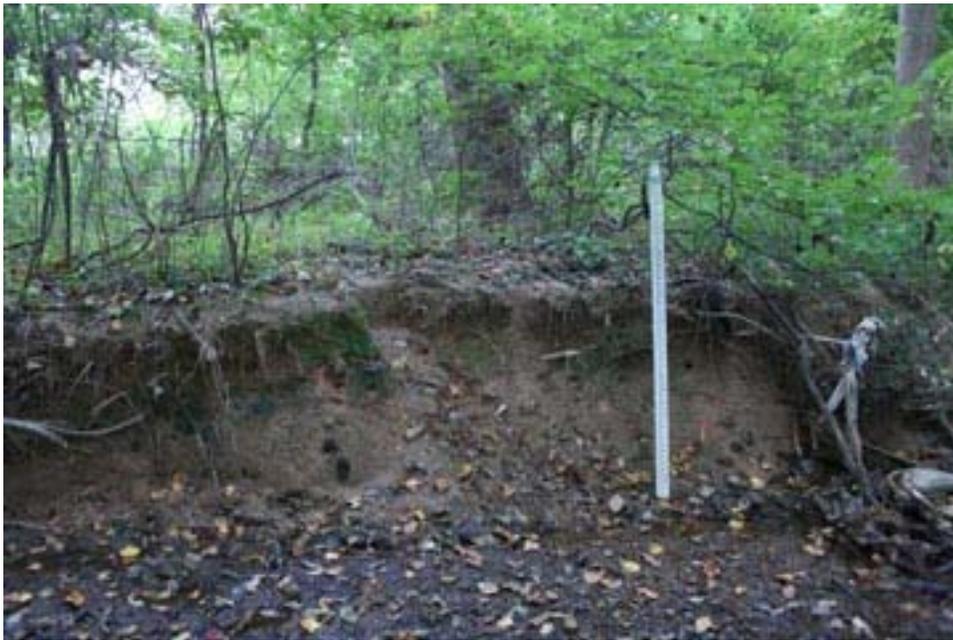
Fig 32 – Bank erosion along middle section of Reach 6.3.

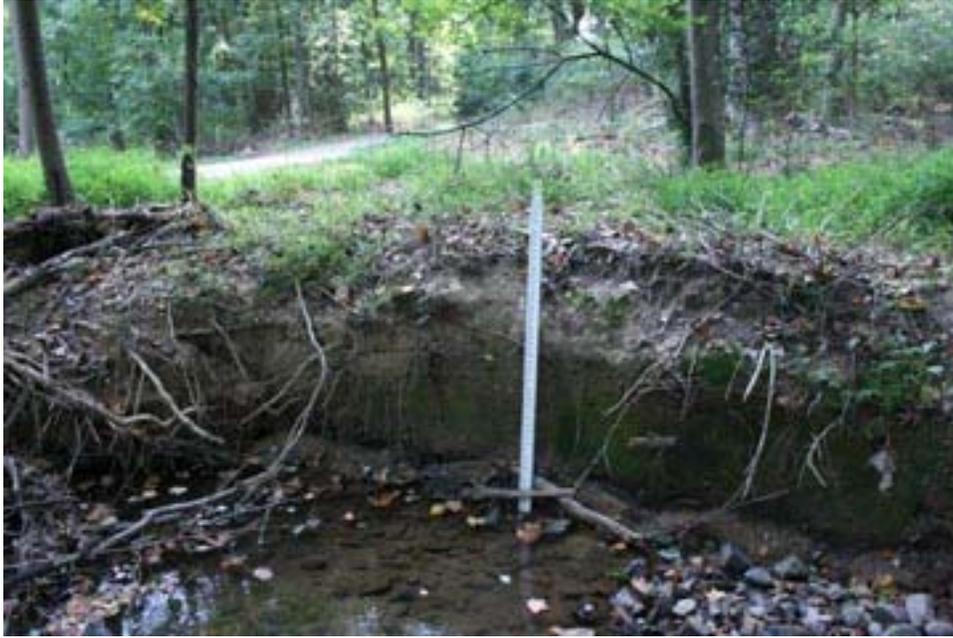
Fig 33 – Bank erosion along lower section of Reach 6.3.

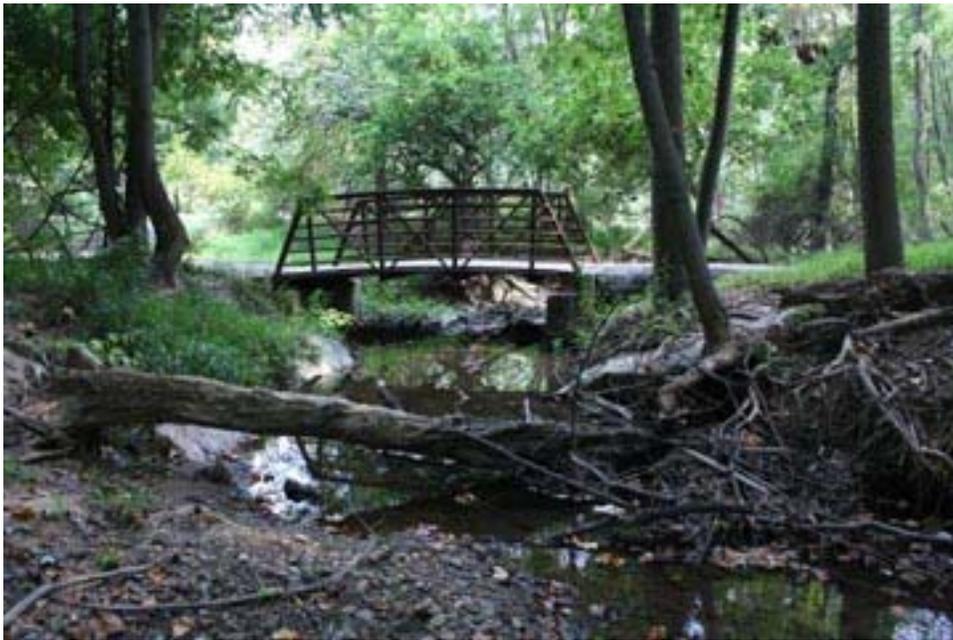
Fig 34 – Debris jam upstream of footbridge at downstream end of Reach 6.3.

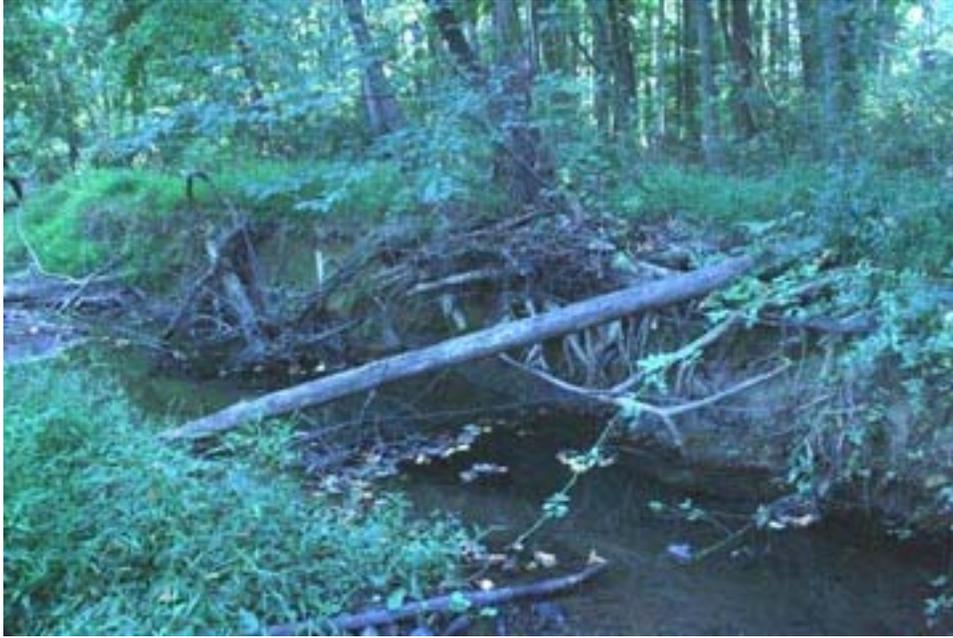
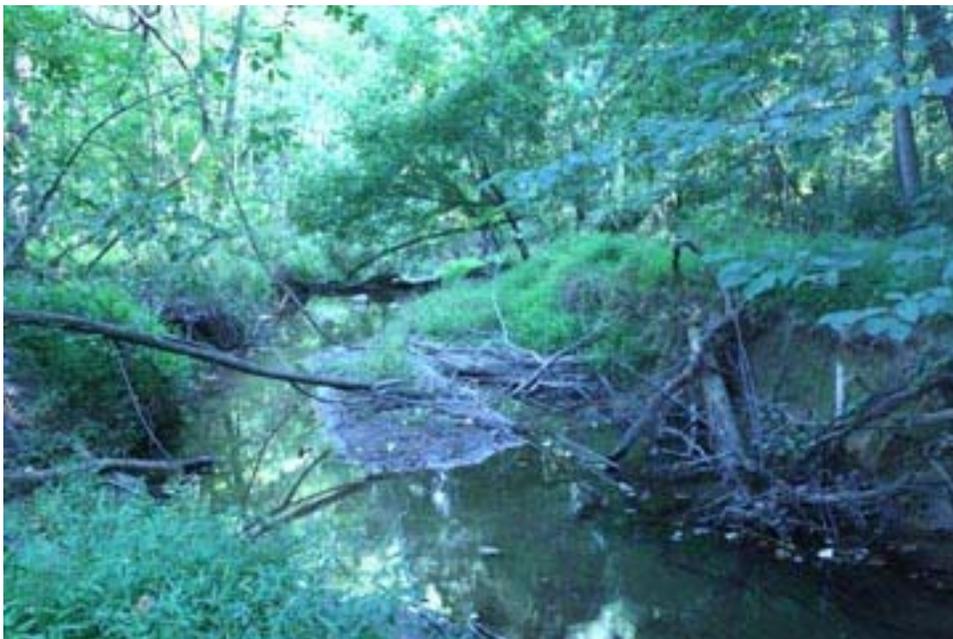
Fig 38 – Bank erosion, debris jam, and aggradation along upper section

of Reach 7

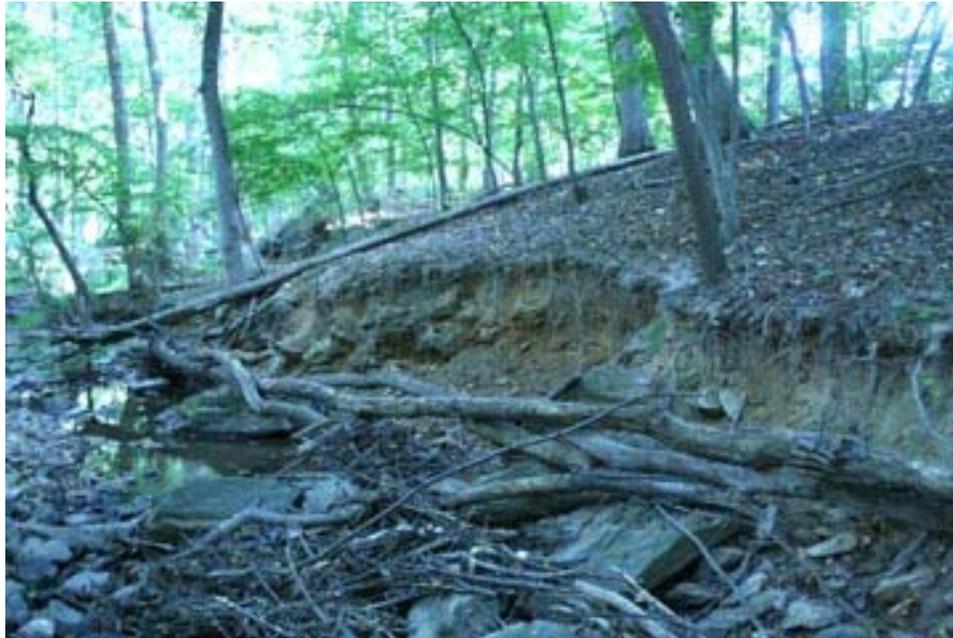
Fig 41 – Bank erosion and debris jams along high terrace in middle section of Reach 7

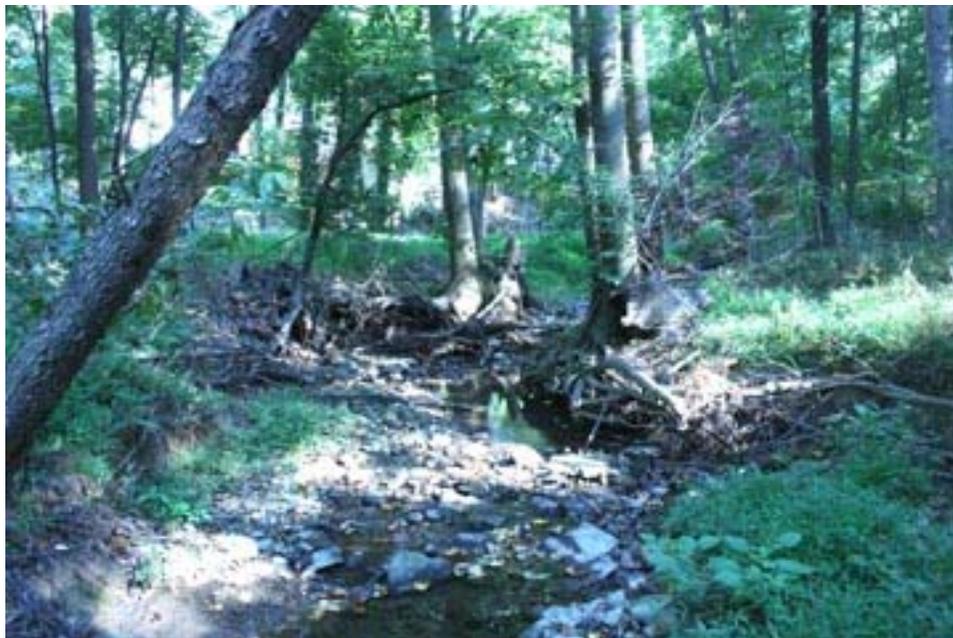
Figs 42 and 43 – Severely undercut trees, debris jams and lateral bars along lower section of Reach 7

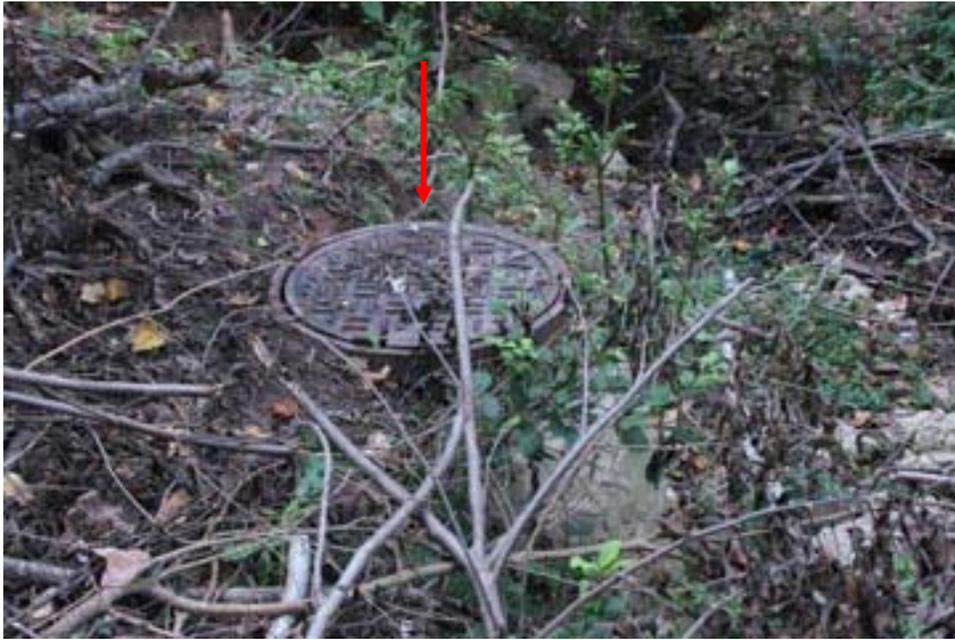
Fig. 47 – Exposed sanitary sewer manhole

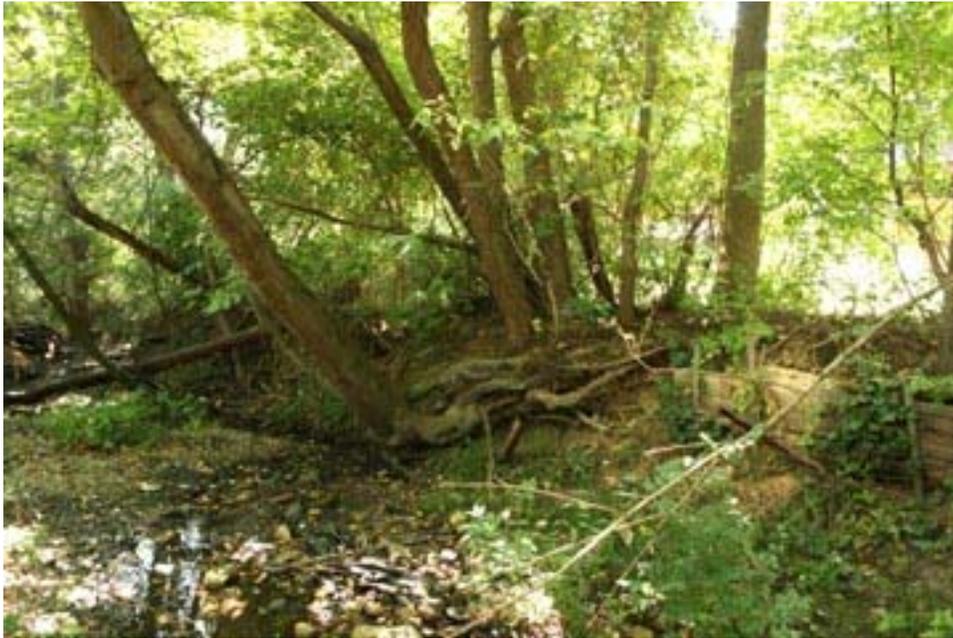
Figs. 51 and 52 – Eroding banks, failing retaining wall, mid-channel bars along upstream end of Tributary 3.1

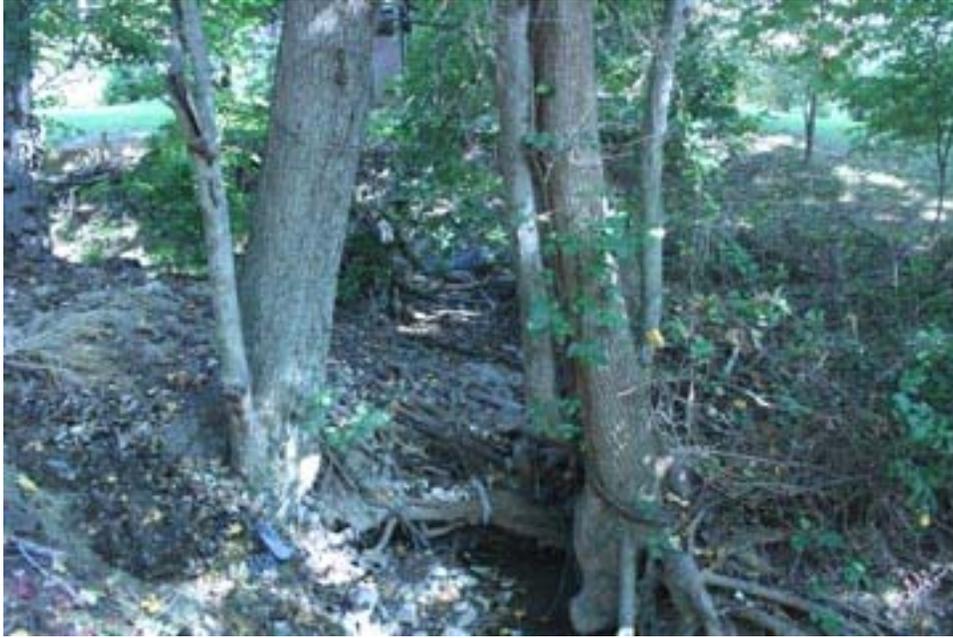
Fig. 57 – Deeply incised channel along Tributary 3.3 with active bank erosion adjacent to structure and fence. Note - debris and rubble dumped into channel by landowner attempting to stabilize bank

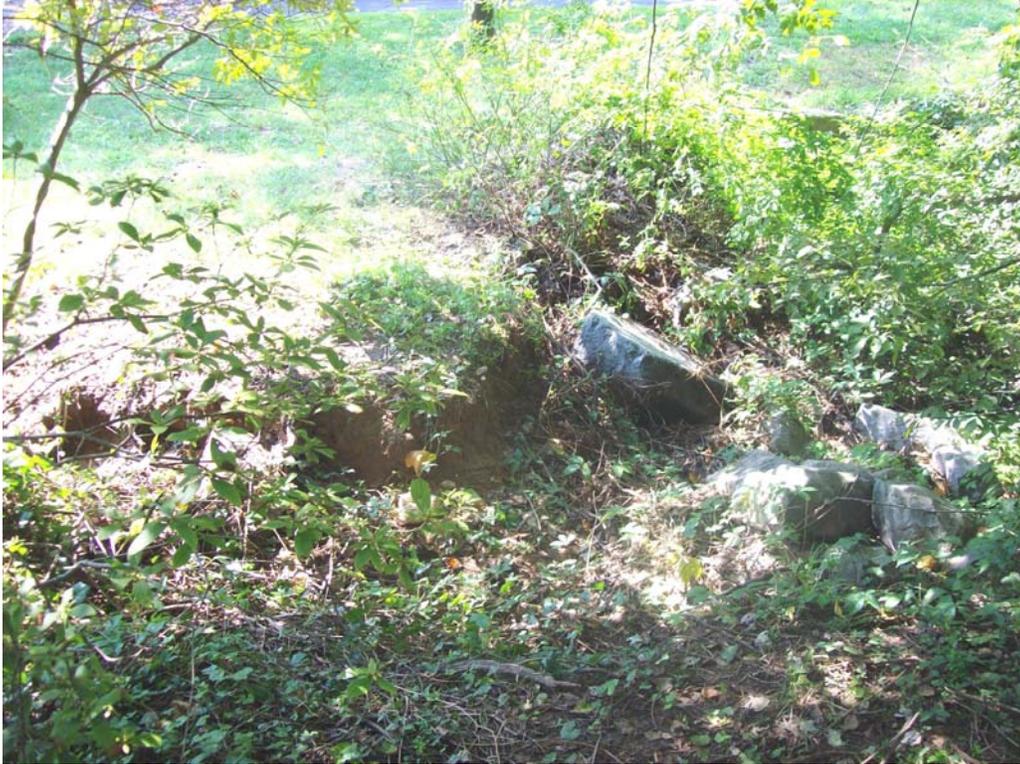
Figure 1.1 Nickpoint upstream of Copely Lane culvert.

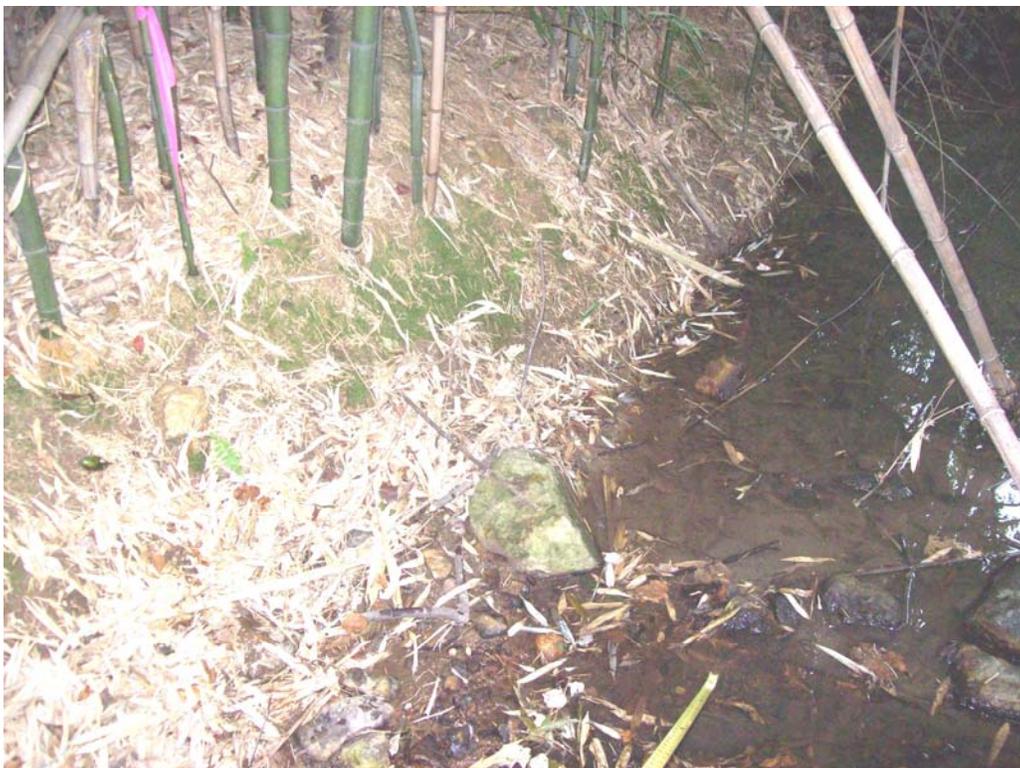
Figure 4.2.1 Small pipe perpendicular to flow at cross section 4.4.

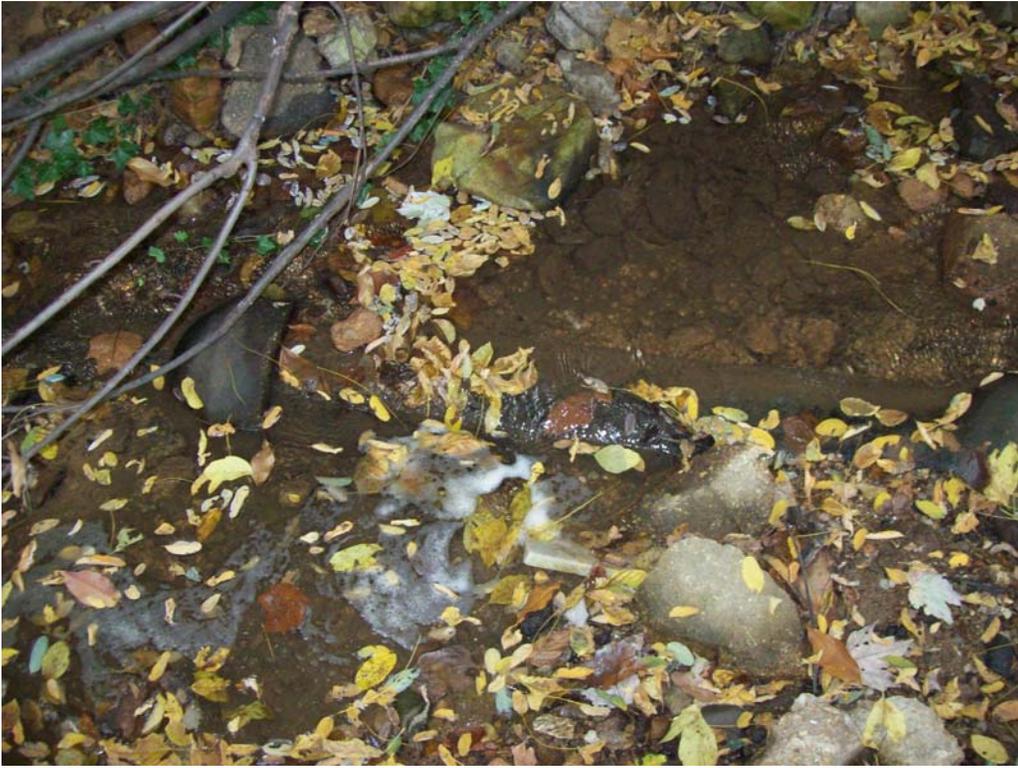
Figure 5.1.1 Exposed 8" sewer line near cross section 5.1

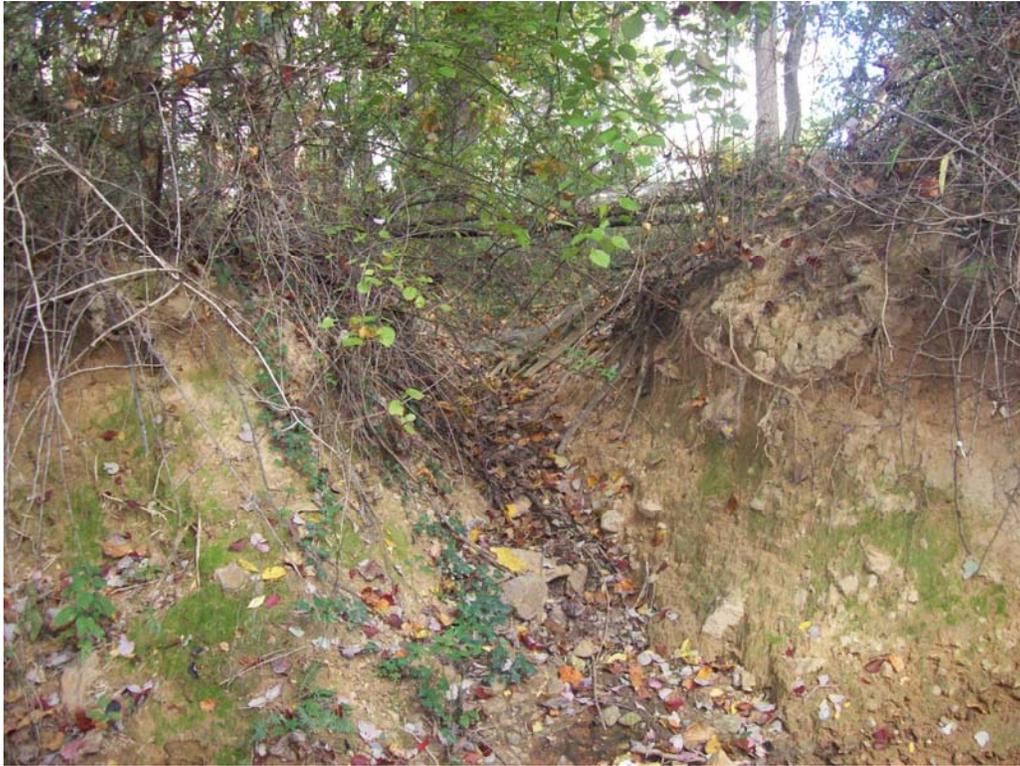
Figure 5.1.3(a) Erosion channel as viewed upstream.

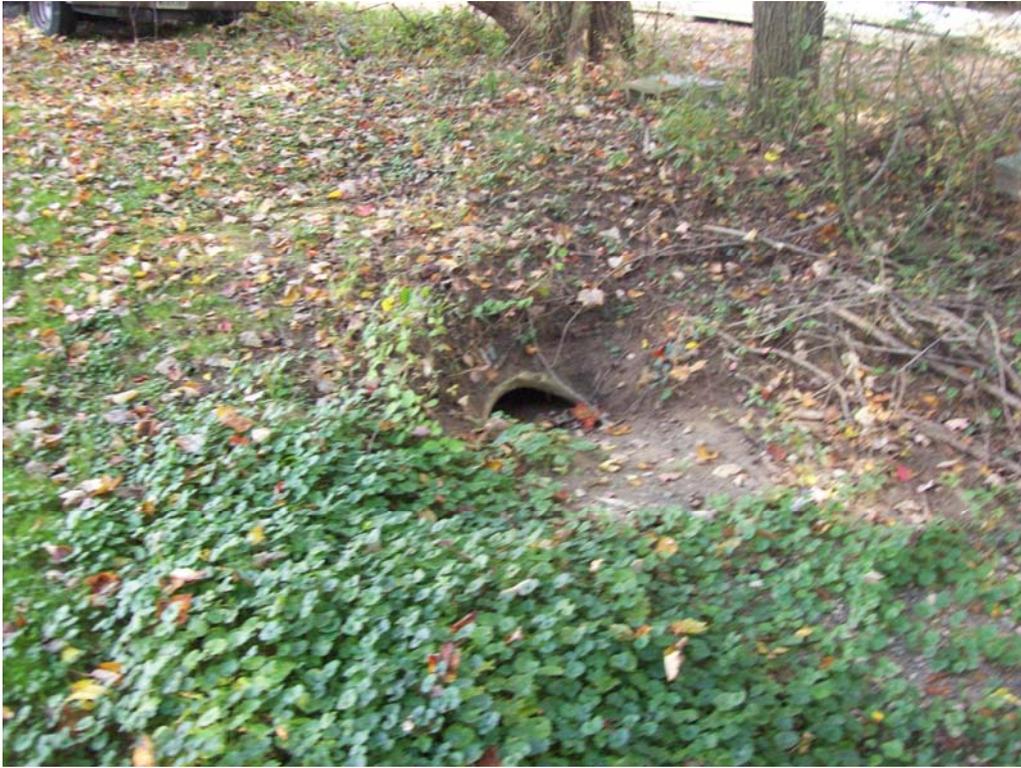
Figure 5.3.1(a) Half-full Anderson St. storm drain outfall.

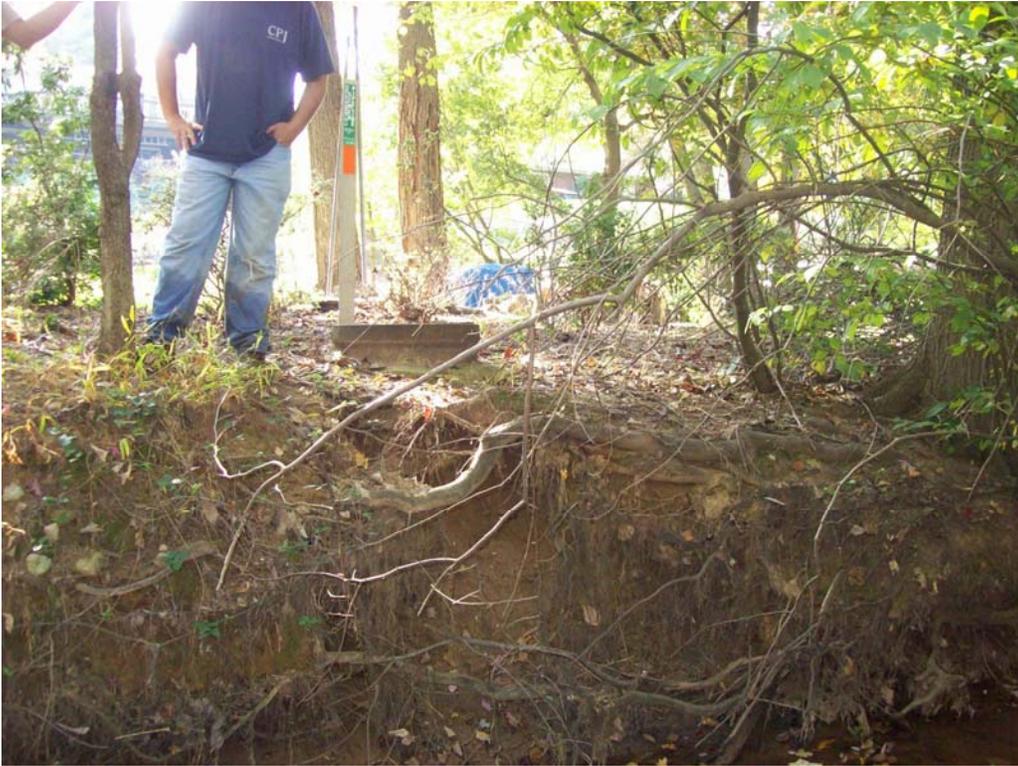
Figure 5.3.2 Sewer manhole almost exposed downstream of cross section 5.7.

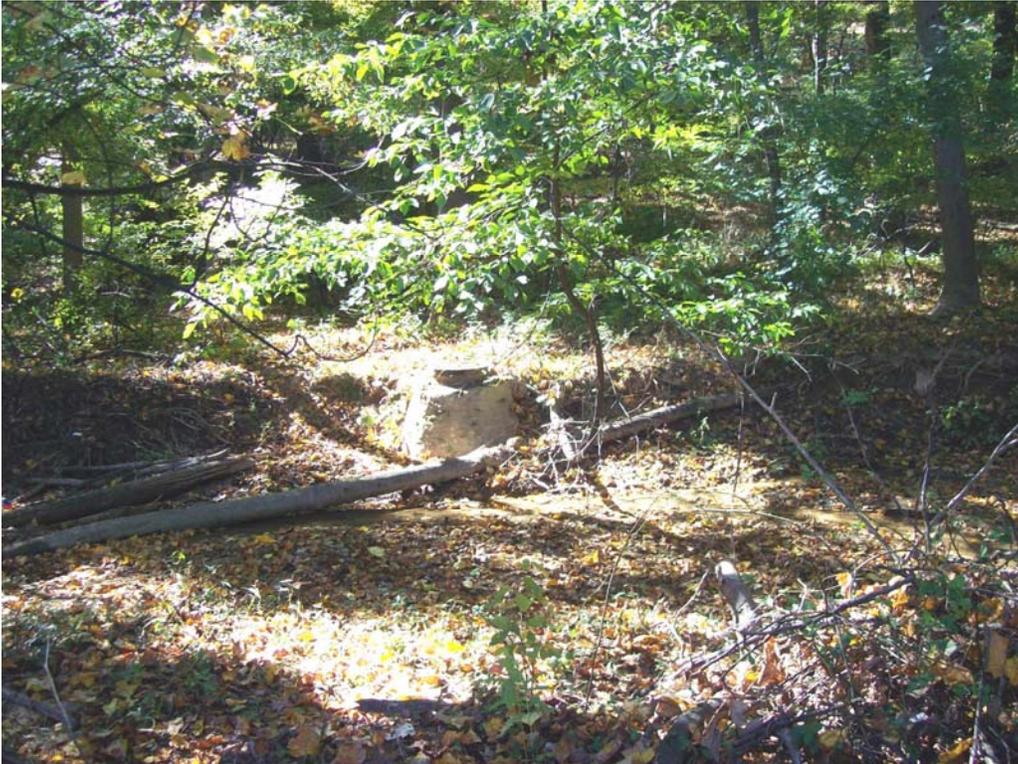
Figure 6.1.1 Exposed sewer manhole across from last residence on Anderson St.

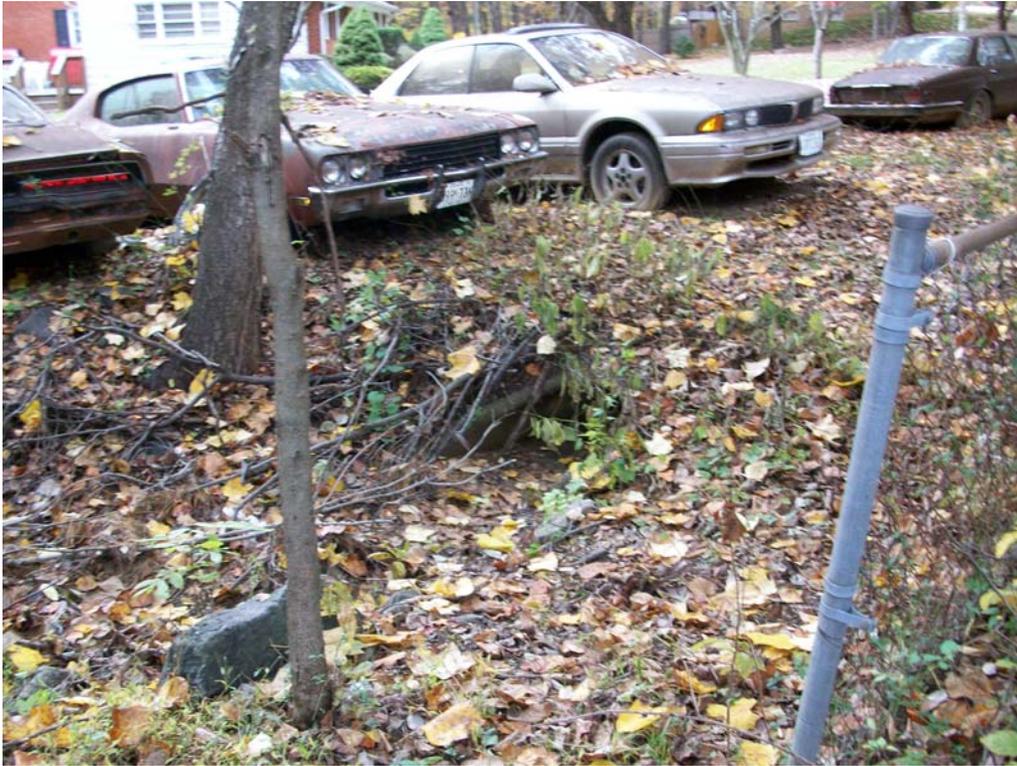
The storm drain from Burkart Bea Kay Drive in section 3 of Tributary 3 has impeding sediment in its apron; see Figure 8.3.1(a). The outfall storm drain flow is causing erosion and a high grade near the junction with Hollywood Branch; see the unstable rip rap in Figure 8.3.1(b).

Figure 8.3.1(a) Storm drain on Burkart Bea Kay Drive.

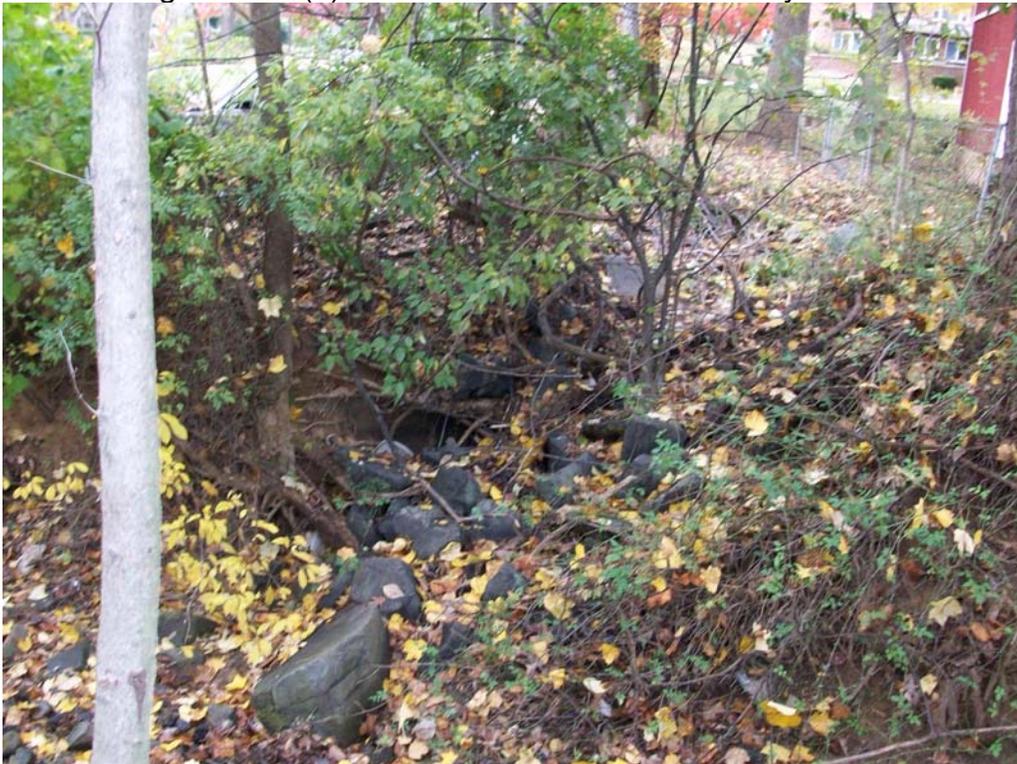
Figure 8.3.1(b) Unstable rip rap near Hollywood Branch junction.
