3.20 Joseph's Branch Mainstem Stream Restoration

3.20.1 Introduction

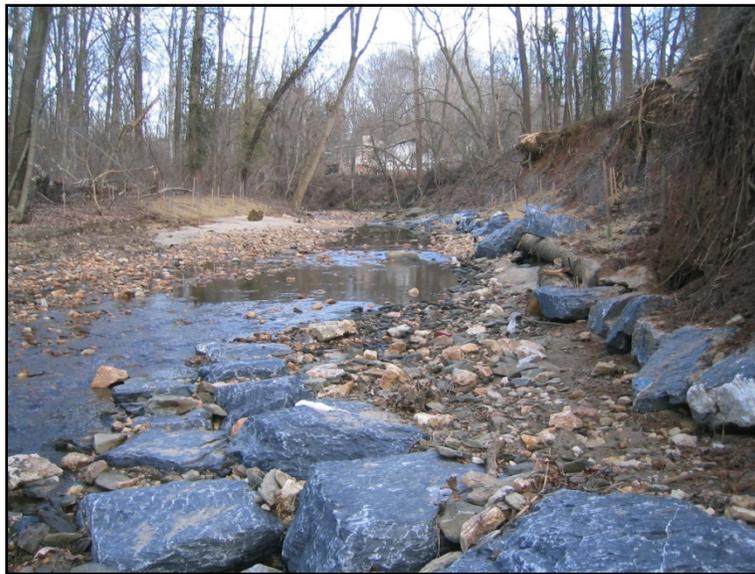
Figure 3.20.1 – Joseph's Branch Stream Restoration in 2005

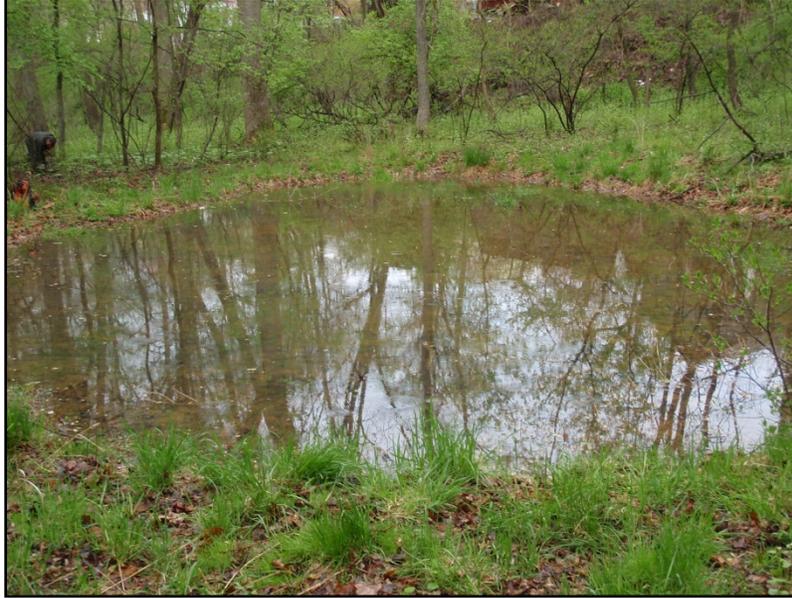
Figure 3.20.2 – Joseph’s Branch Created Vernal Pool in 2009

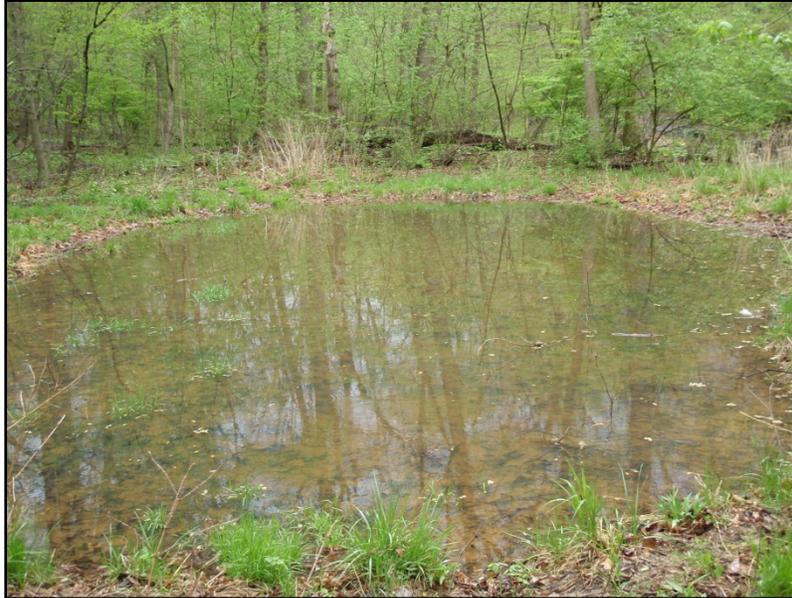
The vernal pool was monitored post-restoration in May of 2005 and 2007, and April of 2009. The pool was approximately 56 feet long and 36 feet wide. In 2005, the pool depth was estimated at two feet and in 2007 and 2009 it was estimated at one foot. The temperature within the pond in 2009 was about 52°F at the time of monitoring. In all years the pool supported emergent, herbaceous vegetation. In 2007, submerged aquatic vegetation *Ludwigia palustris* (marsh seedbox) was also observed in the pool. In 2009, vegetation was noted on the edges of the pool, dominated by *Polygonum sp.* (smartweed), *Elymus virginicus* (Virginia wildrye), and other grasses and sedges (**Figure 3.20.34**). No herpetofauna adults or eggs were noted in either 2005 or 2007. In 2009, an abundance of *Anaxyrus. Sp.* (toad) tadpoles were observed in the pool and three *Plethodon cinereus* (Eastern red-backed salamanders) in the lead-back phase were found under logs around the perimeter of the pond. Several macroinvertebrate taxa were also seen in the pool in 2009 including, Gerridae (water striders), Hirudinea (leeches), and Gastropoda (snails). Field data sheets for vernal pool monitoring in 2009 are included in **Appendix D**.

Figure 3.20.34 – Vernal Pool at LRJB203A in 2009, dominated by smartweed, Virginia wildrye, and unknown grass and sedge species

The vernal pool created in association with this project appears to have improved the riparian buffer habitat within the project area. The pool supported emergent vegetation in all monitored years. Additionally, in 2009, the pool was found to support two amphibian species, an unknown species of toad, of which hundreds of tadpole individuals were found, and three Eastern red-backed salamanders which were found in the pool's periphery. However, amphibians were only found in the last year of monitoring. It is recommended that County monitor this site one more time in the next couple of years to determine if amphibians still inhabit the created vernal pool.

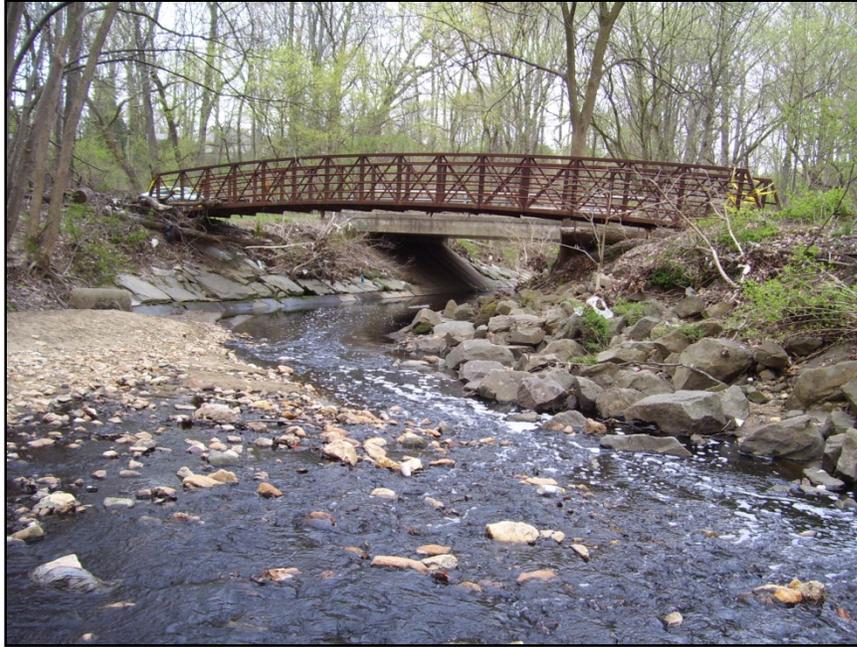
Although minor improvements were noted in association with restoration activities at Joseph's Branch, biological communities have not improved greatly. Water quality may be too impaired due possible point source pollution and the watershed's highly impervious cover to show notable biological improvements within five years after restoration. Site LRJB204, showed the most improvements, including increases in the quality of the benthic macroinvertebrate community and aquatic habitat, and greater improvements in the fish community (*Figure 3.20.35*).

*Figure 3.20.35 – Site LRJB204 Showing a Restored Section of Stream
Successful – Creating Amphibian Habitat*
