3.5 Lamberton Stream Restoration

3.5.1 Introduction

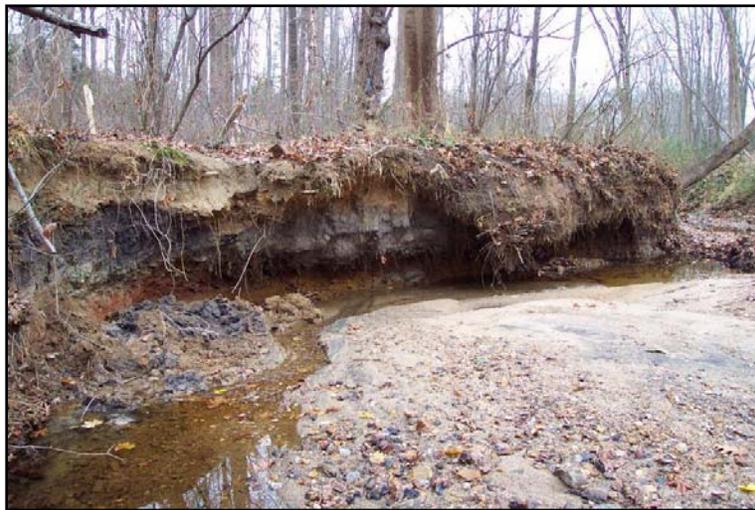
Figure 3.5.1 – Lamberton Stream Before Restoration in 2001

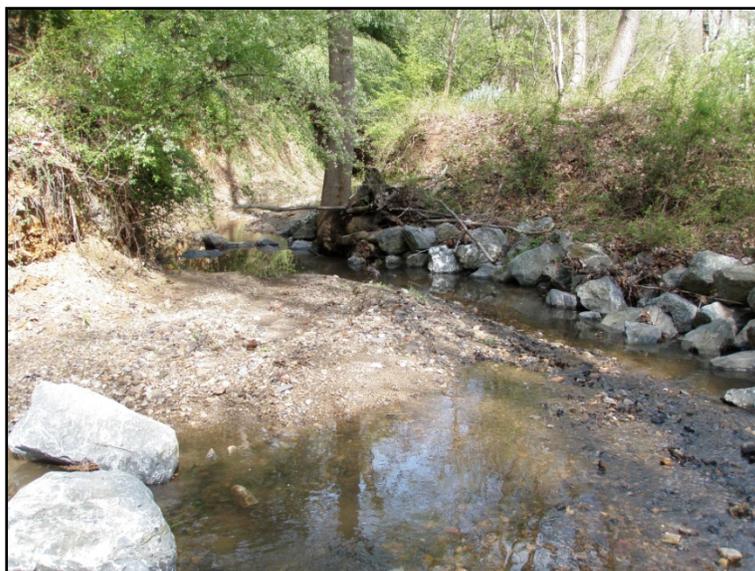
Figure 3.5.2 – Lamberton Stream After Restoration in 2009

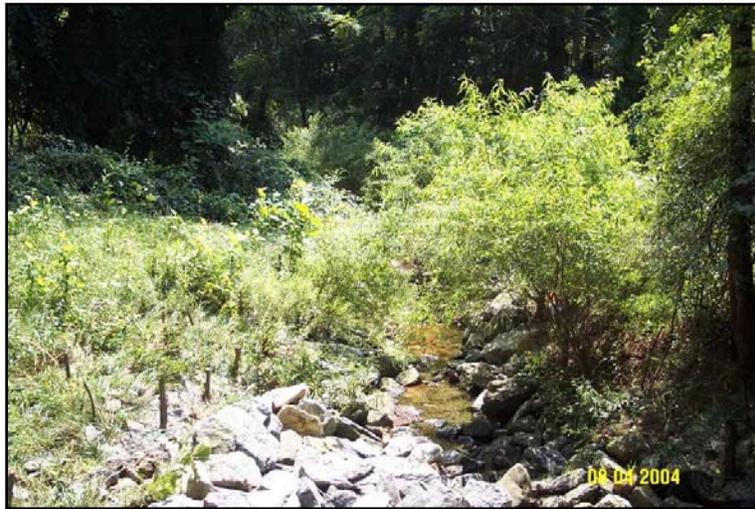
Figure 3.5.3 – Black Willow Tree Live Stake Plantings Stabilizing Streambanks within the Lamberton Stream Restoration Project in 2004

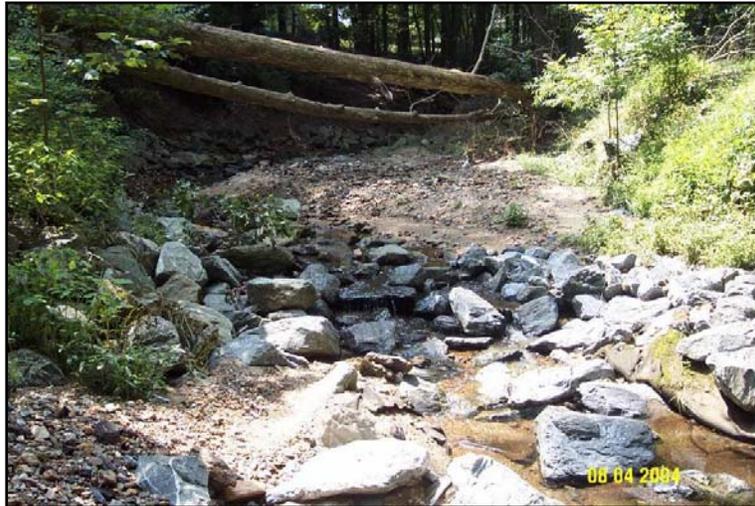
Overall, the fish community remained poor during both the pre- and post-restoration periods and was dominated by tolerant, pioneer fish species such as blacknose dace and creek chub. The highest FIBI percentage was observed prior to restoration in 2002, suggesting a decline in the fish community condition following restoration. Dominant species comprised 96 percent of the community prior to restoration, but increased to nearly 100 percent of the community after restoration, which also indicates a slight decline in the fish community. No changes in the composition of functional feeding groups were observed following restoration, and omnivore and generalist feeders were dominant in all years. With the exception of four individual fish (one bluegill, two white suckers, and one rosyside dace), only pioneer fish species (blacknose dace and creek chub) have been found in this first order tributary. This suggests that this stream may be too small or intermittent to sustain a more diverse fish community, with or without habitat restoration. *Figure 3.5.17* shows the Lambertton tributary in summer of 2004, with low flow conditions and rip rap in the stream channel acting as potential physical barriers to fish migration and improvement. One small improvement in the fish community after restoration was due to an increase in overall fish abundance after restoration. Fish abundance increased tenfold from the pre-restoration period to the later years of the post-restoration period.

Figure 3.5.17 – Lamberton Tributary in 2004 showing low flow conditions and rip rap in stream channel as possible physical limitations to fish migration and community improvement

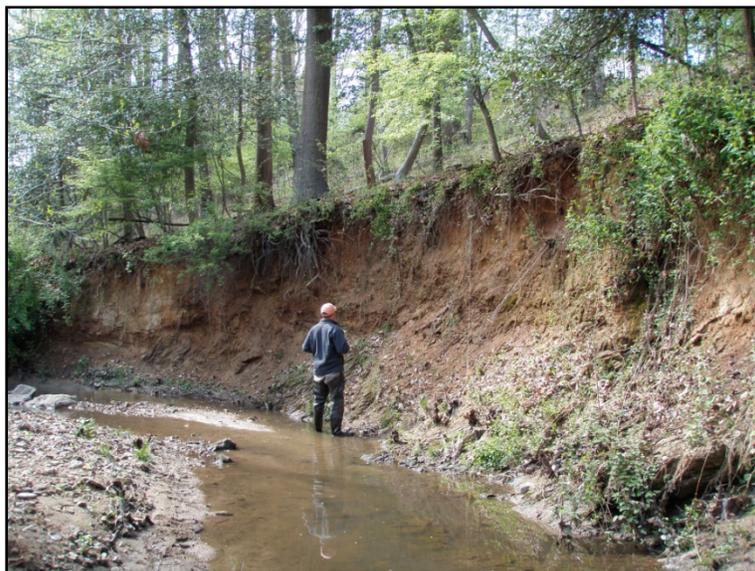
Aquatic habitat conditions slightly increased following restoration due to an increase in instream cover for fish and epifaunal substrate for benthic macroinvertebrates, and a decrease in embeddedness and sediment deposition. However, bank stability and vegetative protection declined after restoration (***Figure 3.5.18***).

Figure 3.5.18 – Lamberton Stream Restoration in 2009 showing severe bank erosion in restored area
