Potomac Direct

Little Falls

3.17 Little Falls I Mainstem Stream Restoration

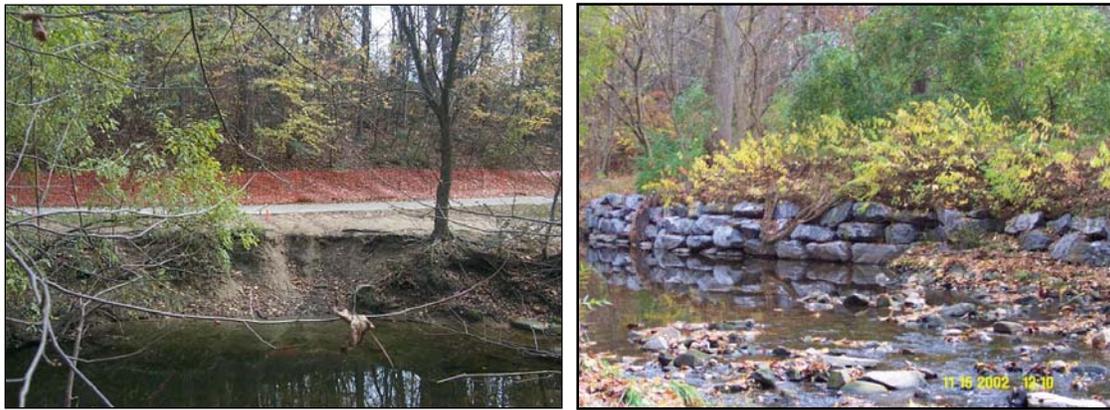
As mentioned above, the mainstem of Little Falls below Massachusetts Avenue was severely degraded and a large amount of streambank erosion was present. Due to this erosion, a large sewer line was uncovered and its vulnerable pipe joints were exposed to the damaging stormwater flows of Little Falls. Approximately 750 feet south of Massachusetts Avenue on the Little Falls, the severe stream bank erosion began to undermine the pedestrian trail that paralleled the stream. The erosion was severe enough that there was a concern the trail may need to close permanently. Approximately 1,100 feet further south along the stream, a pedestrian footbridge that crosses Little Falls was also threatened by the severe erosion. In addition, the aquatic habitat was found to be deficient and there was a lack of riparian buffer along portions of Little Falls.

Figure 3.17.3 – Little Falls I Mainstem Stream Restoration Before (2000) and After Restoration (2002)

The primary focus of the stream restoration project was to stabilize and protect both the exposed sewer and the two areas of the threatened pedestrian trail. At the upper end of the project, large rip rap stone was used to cover the exposed sewer line while a large step pool system was installed just downstream of the sewer line to ensure the infrastructure would not be exposed again.

Large cross vanes and stone toe protection were installed to center and deflect the erosive stormwater flows away from the streambanks to keep erosion from endangering the pedestrian trail again. At the lower end of the project, M-NCPPC replaced the threatened pedestrian footbridge with a longer spanned footbridge to help ensure the abutments of the footbridge would not be exposed again. A cross vane was installed just upstream of this footbridge to help center the flow of water toward the center of the stream and under the highest portion of the new footbridge.

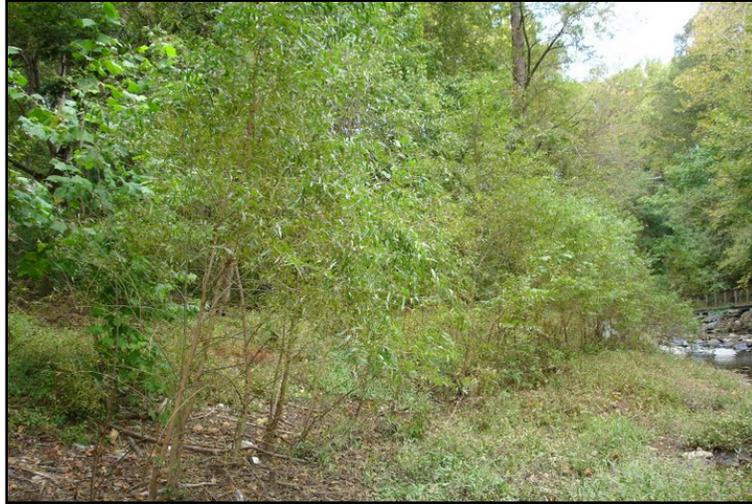
Figure 3.17.16 – Botanical Zone at LFLF301B along the Little Falls Mainstem (2009)

been planted for this restoration project, and as a result the riparian zone is relatively improved. Even though only 33 percent of the planted trees and 27 percent of the planted shrubs survived to 2009, more trees and shrubs were observed in the riparian zone than were planted for this project. Overall, the health of persisting planted vegetation was good, with approximately 64 percent of trees and 70 percent of shrubs appearing healthy at the time of the monitoring visit. Additionally, most species have grown since being planted in 2007, another indication of health, with black willow, red chokeberry, and tulip poplar showing the most growth overall. However, several species of invasive plants were observed, some of which were rather abundant across the site. Invasive control measures are recommended for species that could potentially suppress the health of the riparian plantings such as porcelainberry, Japanese knotweed, and Asiatic tearthumb.
