Potomac River Direct

Little Falls

3.4 Little Falls III Mall Tributary Stream Restoration

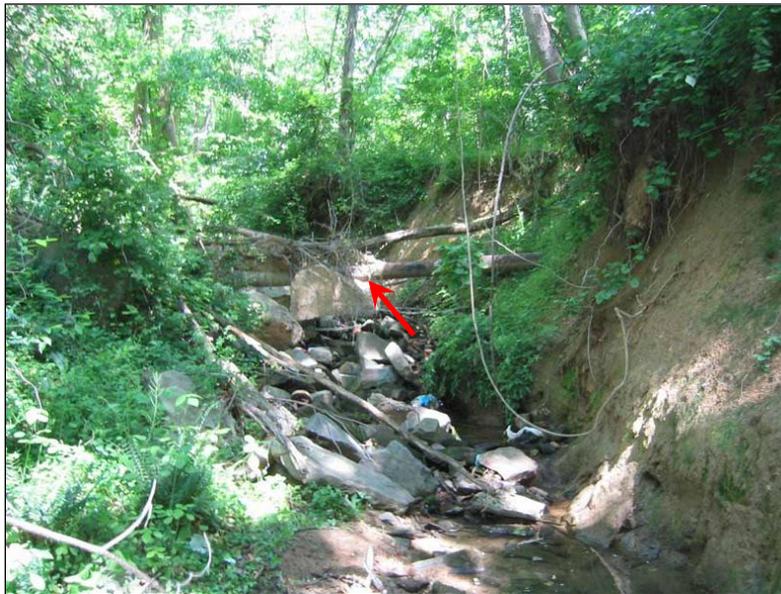
Prior to restoration, this site had severely eroded streambanks and an exposed sewer line, both caused by stormwater received from a concrete channel at the upper portion of the site. The lower section of the concrete channel was undermined and had fallen apart, causing severe stream erosion. Immediately below the failing concrete channel, there was extreme channel down-cutting (*Figure 3.4.1*).

Figure 3.4.1 – Little Falls III Mall Tributary Pre-Restoration in 2005; red arrow indicates exposed sewer line

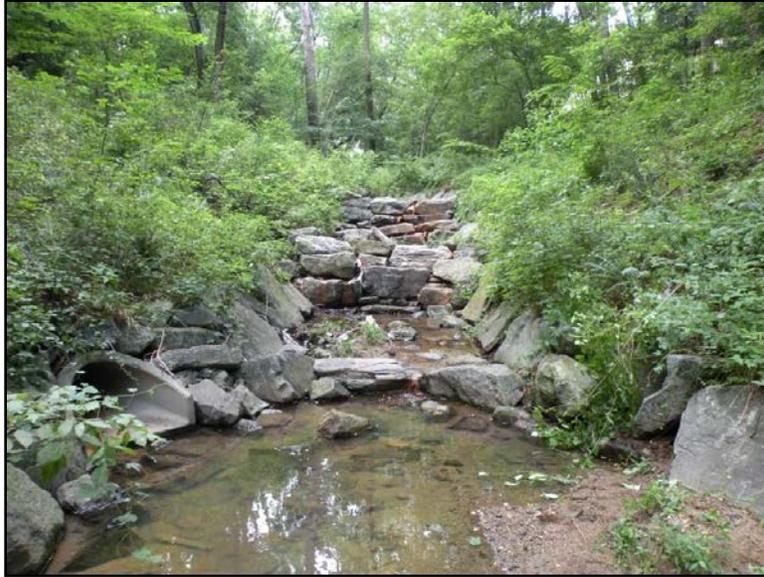
Figure 3.4.2 – Little Falls III Mall Tributary Post- Restoration in 2009; replaced sewer line protected by stone step pool structures

Portions of the undermined and unstable "U" shaped concrete channel were removed and replaced with a step pool system to gradually bring the flows from the mall down to the existing grade of the stream. During the step pool construction, WSSC replaced the exposed, leaking sewer line and advised DEP on the placement of the stone step pool structures to ensure their sewer line was protected (**Figure 3.4.2**). Rock pools were constructed at each of the storm drain outfalls to help dissipate the energy associated with the stormwater entering the stream. The vertical eroding streambanks were graded back and planted with native grass seed, ferns, shrubs, and trees (**Figure 3.4.4**). The project attempted to save trees on undercut streambanks with supportive rock packing. Seriously damaged trees were flush cut, allowing root systems to remain in the bank for stabilization.

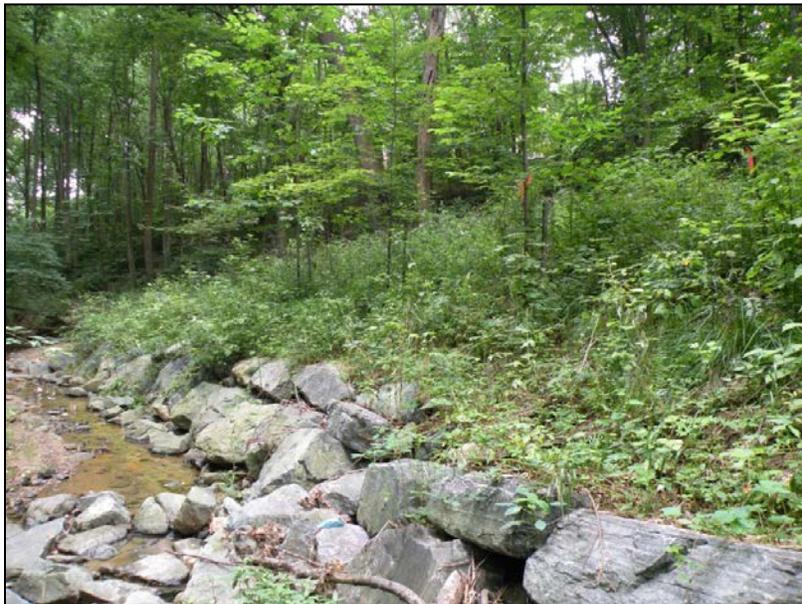
Figure 3.4.4 – Little Falls III Streambanks Stabilized and Planted with Native Grass, Ferns, Shrubs, and Trees (2009)

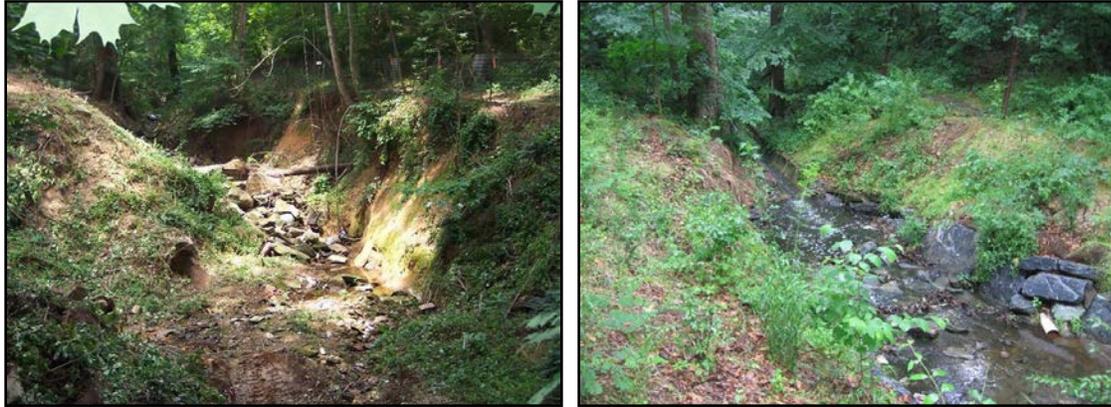
Figure 3.4.5 – Little Falls III Mall Tributary Stream Restoration Before (2005) and After Restoration (2007)

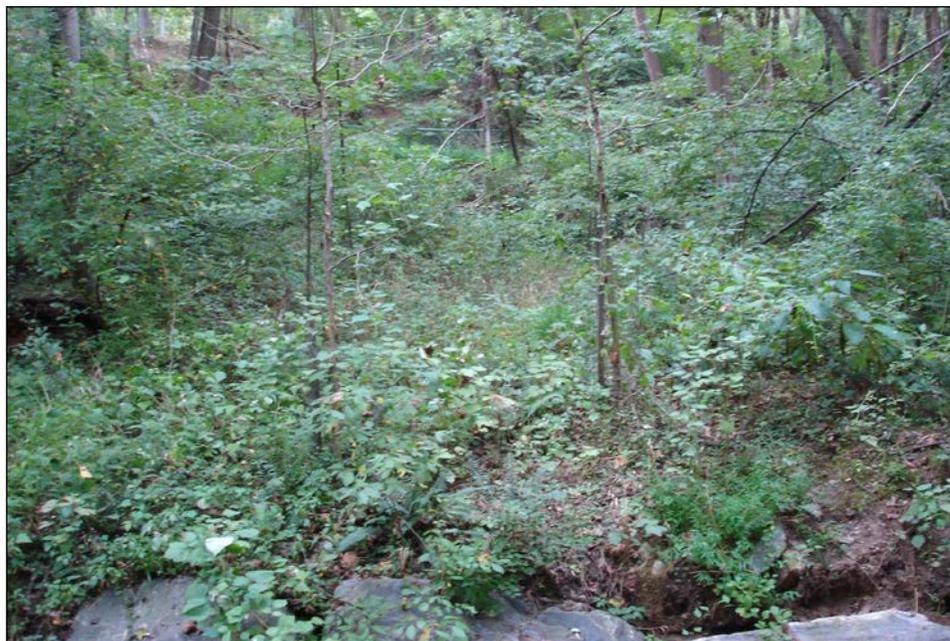
Forty-four stems were counted in the botanical zone, 70 percent of which appeared healthy. Most individuals that were deemed unhealthy appeared to be affected either by deer browse or rub or invasive plants. Only one shrub was dead at the time of the survey. Several species of

invasive plants were observed, some of which were rather abundant across the site. Those observed included *Rubus phoenicolasius* (wineberry), *Celastrus orbiculatus* (Oriental bittersweet), *Alliaria petiolata* (garlic mustard), *Lonicera japonica* (Japanese honeysuckle), *Wisteria sinensis* (Chinese wisteria), *Microstegium vimineum* (Nepalese browntop), and *Rosa multiflora* (multiflora rose). **Figure 3.4.13** shows the reforestation area following restoration in 2010.

Figure 3.4.13 – Botanical Zone at LFMT101 along the Little Falls III Mall Tributary (2010) showing American sycamore plantings and dense invasive herbaceous coverage

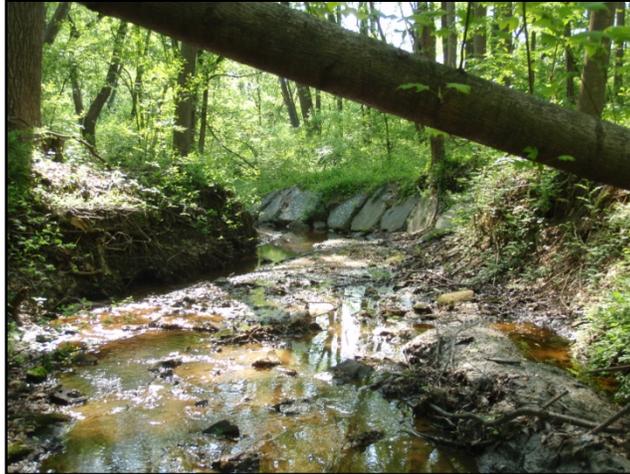
Fish data were not available for the pre-restoration period at this site. The post-restoration fish community was sampled at LFMT101 in 2009 and 2010. No fish were documented during these surveys, thus Fish Index of Biotic Integrity (FIBI) scores could not be calculated. The absence of fish at this site is likely due to the size of the stream, as the stream is small and possibly dry during parts of the year, which suggests that fish are not a good indicator for stream condition at this site (**Figure 3.4.14**).

Based on the results of the fifth year of monitoring, the goal of improving aquatic habitat conditions and aquatic community quality and density in the Little Falls III Mall Tributary was partially met by the restoration actions. Although aquatic habitat conditions did not improve following restoration, the benthic macroinvertebrate community showed greater density and a greater diversity of functional feeding groups. However, scrapers, a specialized feeding group that was present prior to restoration was absent from this site after restoration. Fish were not observed at this site post-restoration. Therefore, the goal of helping to establish a fish community was not met by the restoration actions. The absence of fish at this site is likely due to the small size of Little Falls III Mall Tributary and shallow water conditions. The stream channel may have been dry during the year, suggesting that this site may not be a suitable candidate for establishing a viable fish population (**Figure 3.4.14**).

Figure 3.4.14 – Site LFMT101 in 2010 Showing Low Flow Conditions and Poor Fish Habitat
