MEMORANDUM

SUBJECT: Review of HDR Root Cause Analysis Report and Covanta Response

# Montgomery County Resource Recovery Facility (MCRRF) Root Cause Analysis

**Northeast Maryland Waste Disposal Authority  
And  
Montgomery County**

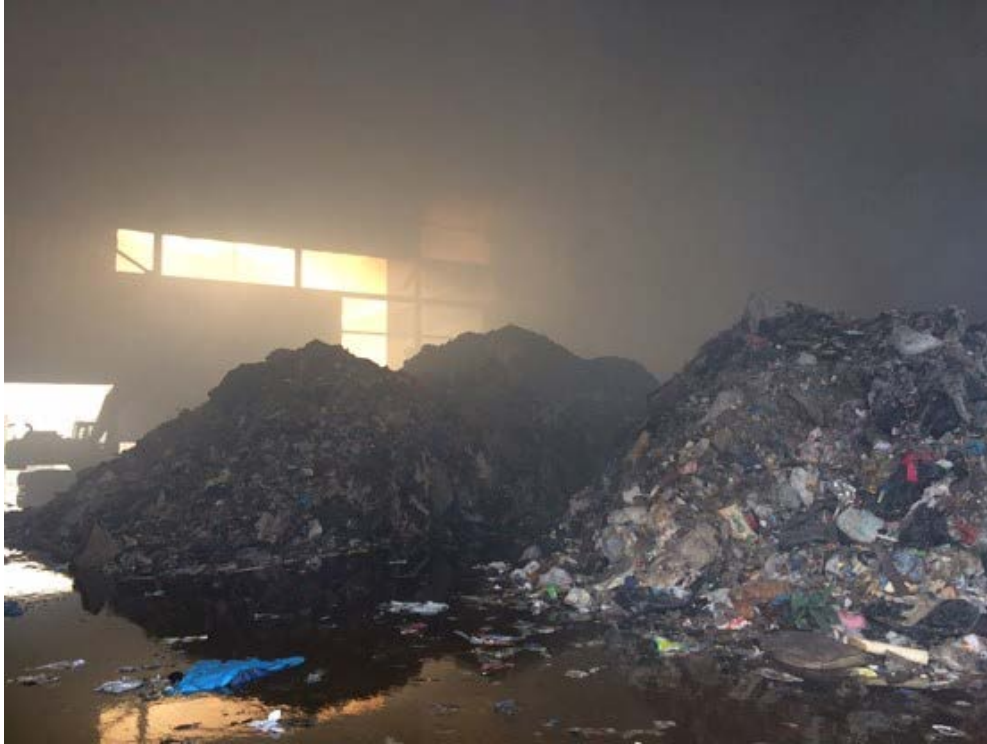
Figure 6 Trash on tipping floor back to entrance bay door (12/10/2016)

Covanta’s shift change occurred around 17:30 the day of December 8<sup>th</sup>. The shift supervisor and chief engineer reported that the rotation of crews was typical and nothing abnormal had occurred. The crane operator claimed that the trash was almost up to his observation pulpit, a level around 85 feet measured from the bottom of the pit. In addition to the large amount of waste in the refuse pit area, there were also two separate piles of waste on the tipping floor. Each pile was approximately 30 feet wide, 50 feet long and 15 to 20 feet high. These piles were in front of tipping bays A and C. A majority of the piles were not visible by the Crane operator due to the line of sight being blocked by the waste, particularly by the waste filling Bays A and C. Figure 4 (taken January 18<sup>th</sup>, after the fire event) shows the refuse pit and tipping floor facing the north wall while standing on the south observation ledge. The designation A is for the closest loading area (South), B for the center loading area, and C for the furthest loading area (North). Figure 5, taken prior to the fire, on December 5<sup>th</sup>, shows the A and C bays filled and blocked with waste, a pile on the tipping floor in front of Bay A and an open Bay B. This is similar to the reported conditions on December 8<sup>th</sup>, with the exception that there was also a pile on the tipping floor in front of Bay C. Reports from Covanta personnel indicated that the amount of trash on the tipping floor and refuse pit was the highest it had been in a while, almost at max capacity. Covanta personnel confirmed that the refuse pit was stacked in a “U” shape around the edge of the pit. The lower portion being bay B and the outer portion was stacked at 85 feet all around completely blocking loading bay A and C.

- The tipping floor should not be used to store waste during anything other than emergency situations, such as crane or loader failures, in which case waste should be moved into the pit within four (4) hours. Waste discharged onto the floor for inspections should be pushed into the pit as soon as practical once the inspections are completed, typically within an hour. Storage of waste on the tipping floor during emergency situations should be monitored by a fire watch.

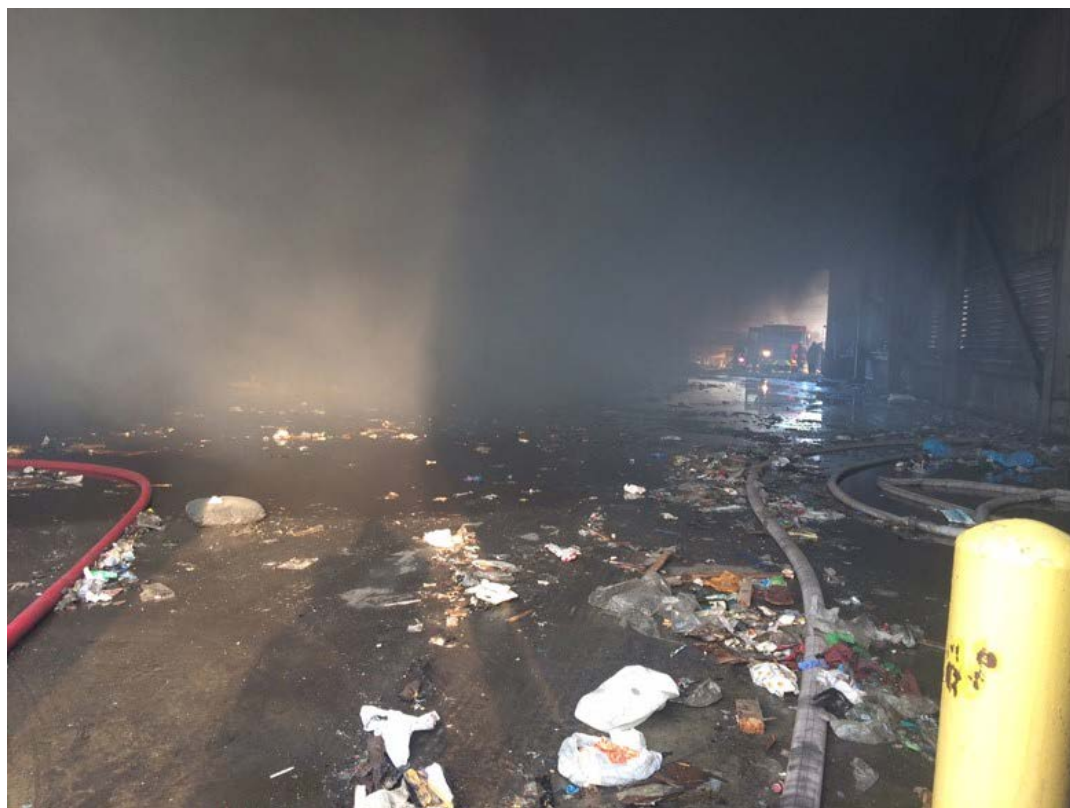
Figure 8 Tipping room floor visibility, PE714 seen north side rollup door (12/09/2016)

The fire department in conjunction with Covanta personnel used large box fans on the roof above the smoke hatches to try to eject the smoke. John Kinsley stated that the ventilation attempts produced minimal results and that the roof and siding needed to be opened further to allow for more air flow (see Figure 9 and Figure 10, below). John Kinsley also stated that the weather was quite windy and cold which was contributing to the minimal ventilation efforts. John Kinsley stated that Centimark Roofing cut large roof openings on December 11, which was confirmed by Mark Freedman, Covanta’s Business Manager. Additional roof openings were cut in on Monday December 12. After the building was opened, the conditions improved dramatically with minimum further fluctuation of visibility and smoke conditions.

As part of the EAP and other procedures, Covanta should address ventilation during fire events, as well as set standards for the use of SCBA and limiting access to various areas around the facility. SCBA should be required when the operators are exposed to smoke from the burning waste, and the Crane Operator should use the SCBA when exiting the crane cab and passing into the boiler building or other exit. Reliance on the positive air system (pressurized crane cab) for the crane operator safety needs review, and consideration should be given to the installation of CO monitors in the crane cab.

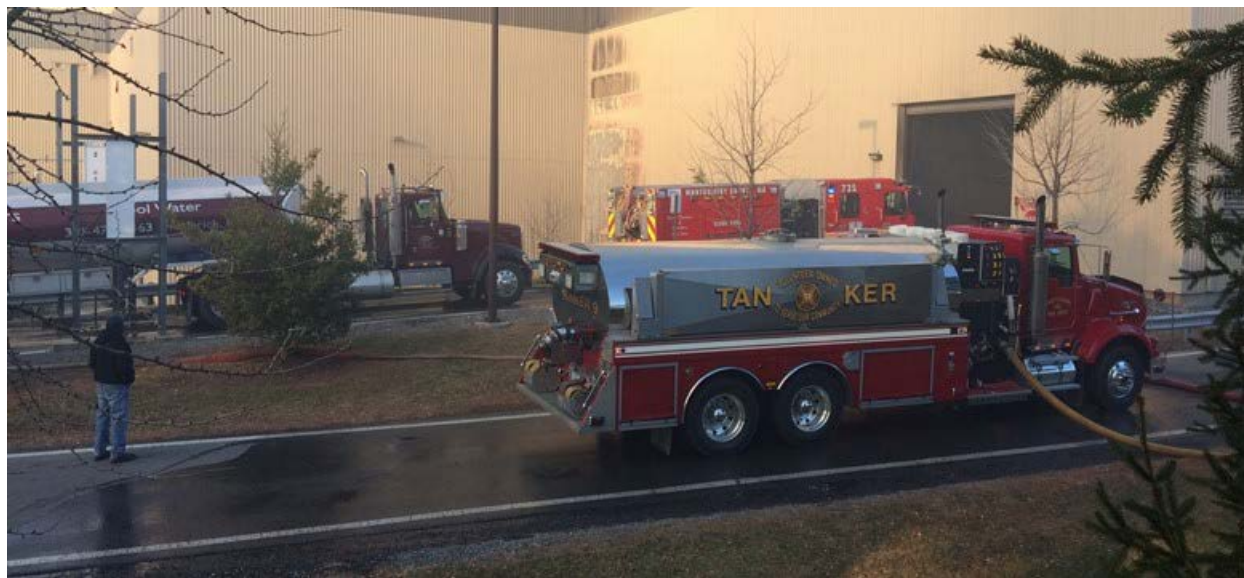
**Figure 11 Tankers on scene to supply additional water (12/09/2016)**

Covanta's Environmental Coordinator, Kim McIntyre, stated that tankers from Darling & Daughters were on scene and that one 6,000-gallon tanker was located at each side of the tipping floor entrance. MCFRS brought their tankers as well and had an off-site fill site per the incident log. Figure 11 shows the tanker size and location during the fire incident.

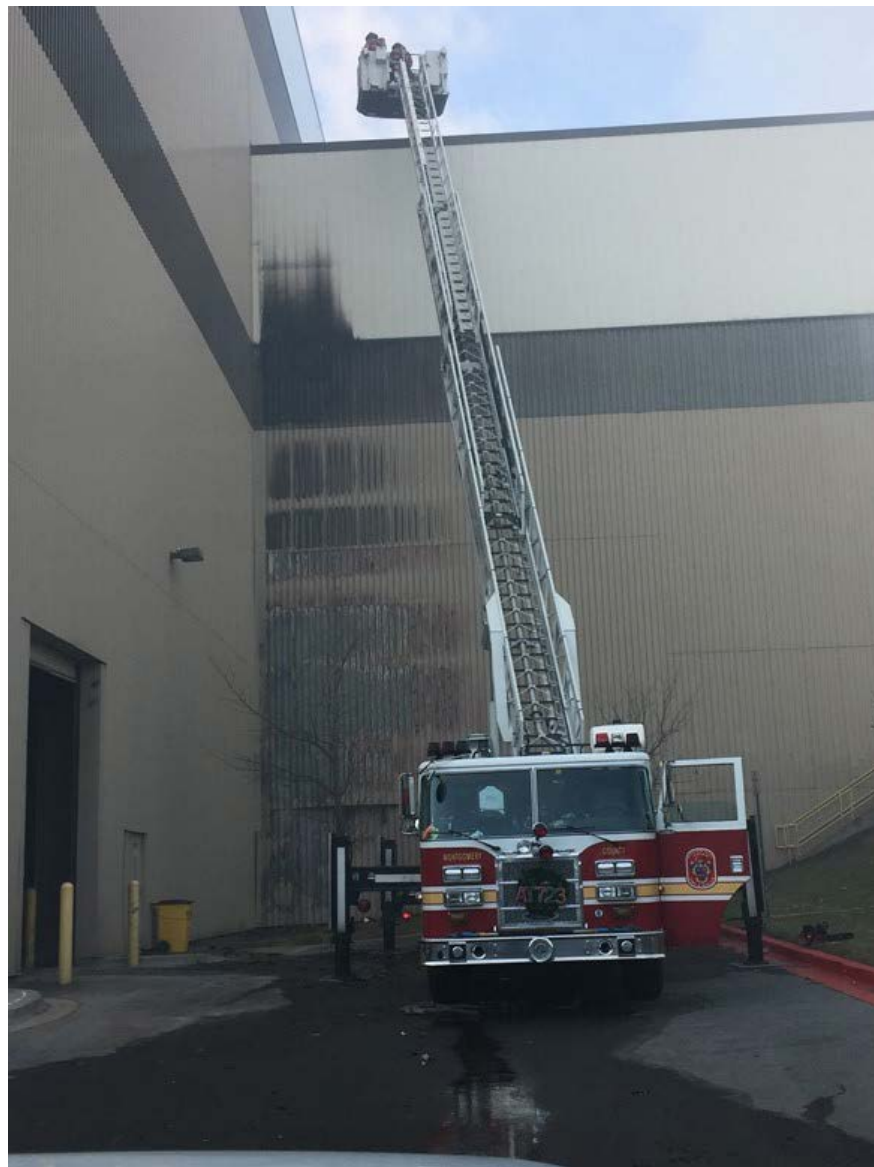
Figure 12 Blistering paint on the tipping floor south wall (12/08/2016)

There were no reports of personnel on the tipping floor at the time of Ron Bricker’s report, however the first individual on scene of the tipping floor was Matt Gerlach. He responded to the reported location from the basement to find blistering paint at the corner of the south wall building at the connection point to the refuse pit. Figure 12 shows the potential conditions of the wall Matt Gerlach observed responding to the tipping floor. Blistering paint confirms that the fire was past the incipient stage. Matt Gerlach stated that as soon as he got to the tipping floor there was a significant amount of fire and smoke along the south wall of the tipping floor area at the corner of the refuse pit. Figure 13 indicates the origin is at the south corner as represented with the star. MCFRS incident report suggests that the origin of the fire was on the south portion of the tipping floor as well.

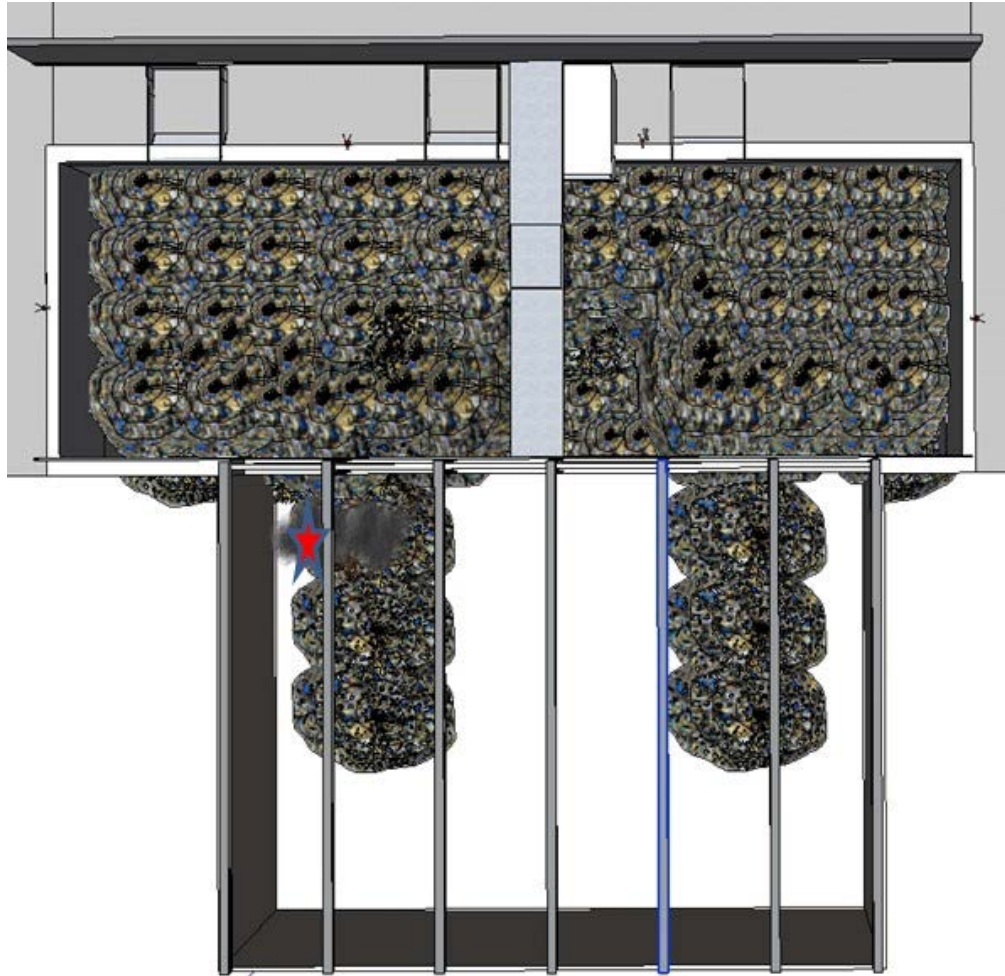
Figure 13 Layout drawing with star indication of fire origin

Each of these possible scenarios are deemed plausible based on the waste stream delivered to MCRRF; however, determining a specific cause is not possible given the lack of evidence. HDR/FRA was not able to obtain video recordings captured during the event, as the recordings of video of the refuse pit cameras had reportedly been copied over through the normal course of the DVR system operation, and there are no cameras on the tipping floor that would have captured the initial fire. The refuse pit cameras may have provided some limited insight and would further confirm the observations made by the crane operator (Ron Bricker).

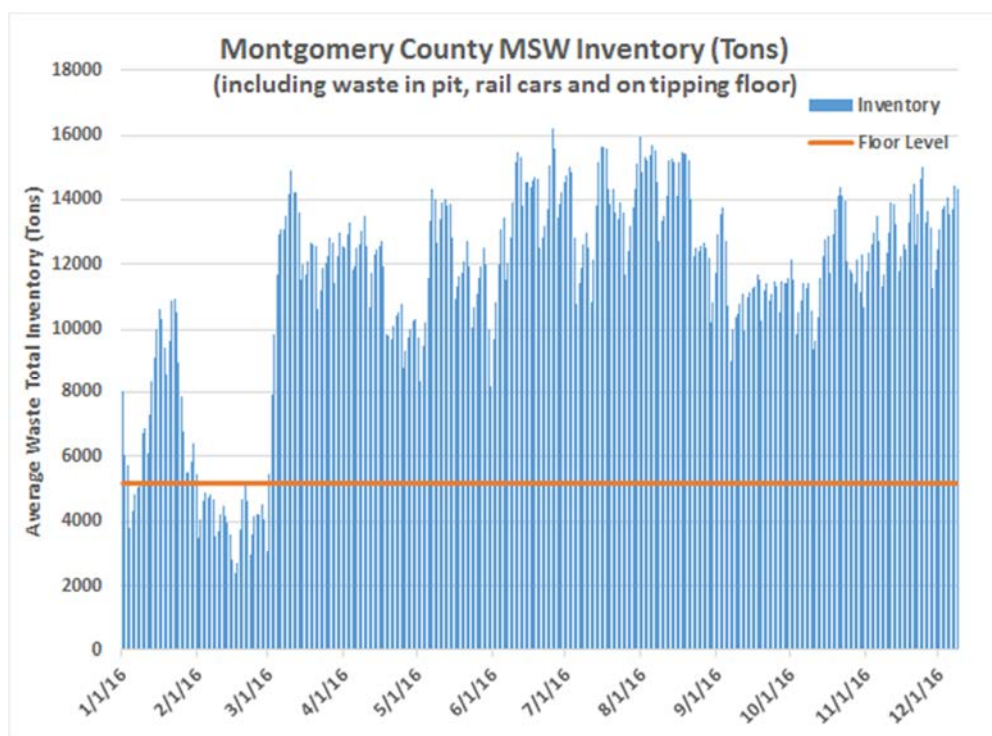
Figure 14 Graph of Estimated Waste Inventory for 2016

height of approximately 15 feet on February 15, 2106, which represents an MSW inventory of approximately 2700 tons. This low level is a good starting level when entering the Scheduled boiler outages in February and March. After the outages, which were extended outages, the pit level was high, at approximately 12,200 tons on March 15. For a majority of the time, waste inventory levels remained above approximately 10,000 tons up until the December fire.

HDR has reviewed the plant data and has made estimates for the boiler steaming rates throughout the year based on the waste deliveries, reported inventories, and assumed densities, and developed the following Figure 14 to provide an estimate of the inventory throughout the year. This inventory is based on the total inventory on site, including any waste on the tipping floor and in containers. Figure 15 provides an estimate of the midnight pit level projected as if all waste had been emptied from containers and the tipping floor and was pushed into the pit. While this overstates the pit inventory for periods when the inventory was stored in containers, this methodology was used based on the limited data HDR could find for the number of full containers on site. Waste inventory, including the midnight tonnage reports should be better documented and maintained by Covanta. A daily and weekly update and running spreadsheet should be maintained as is typical at other facilities. Monthly calculations that rely on tons processed, such as the HHV calculation and the kWh/ton are suspect based on major discrepancies in inventory values.

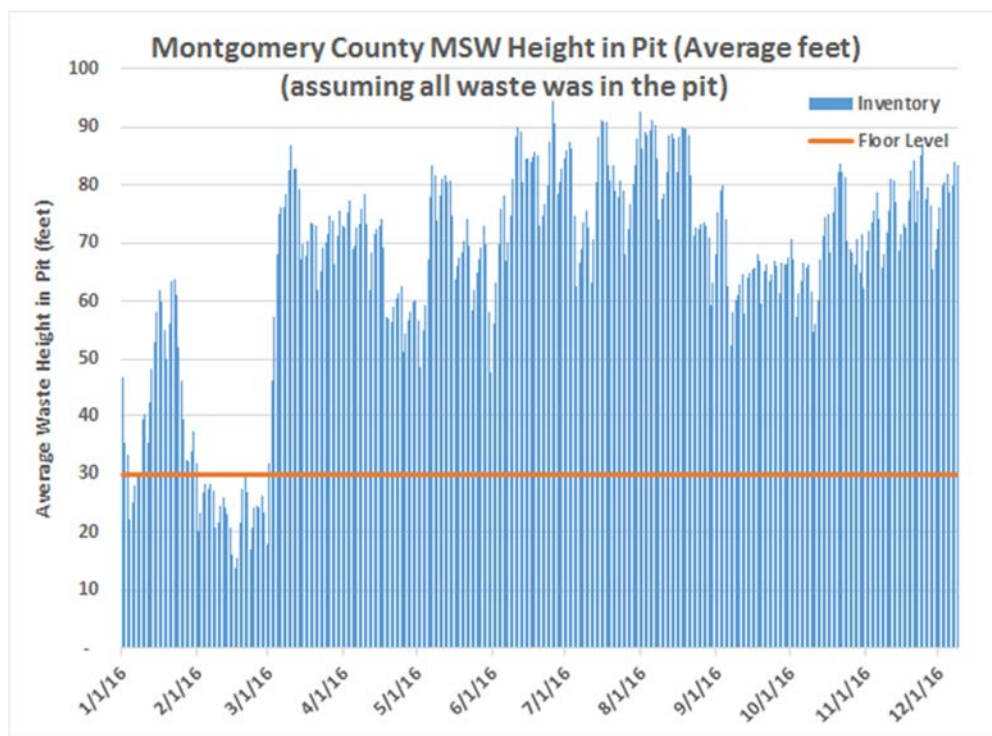
Figure 15 Graph of Estimated Pit Height for 2016

Prior to the December 8<sup>th</sup> fire, there was a high inventory of waste in the pit and the tipping bays at the North and South ends of the pit were completely filled with waste. The fire started in a location on the tipping floor that was blocked from the view of the crane operator, by the filled South bay door, and was located in an area where there was opportunity for the flames to spread upwards along the face of the waste pile. By the time the Crane operator observed the fire, the flames had reached a height of 40 to 50 feet above floor level, leading to a significantly harder fire to combat than the previous fires. Additionally, since the fire was on the tipping floor it was not accessible to the crane and could not be gathered up by the crane and deposited in the boiler feed hoppers, further allowing the opportunity of the fire to spread. Once the December 8<sup>th</sup> fire spread from the floor into the pit, the ability to use the crane to dispose of the smoldering trash was frequently not possible due to heavy smoke in the building which resulted in insufficient visibility for safe crane operations.

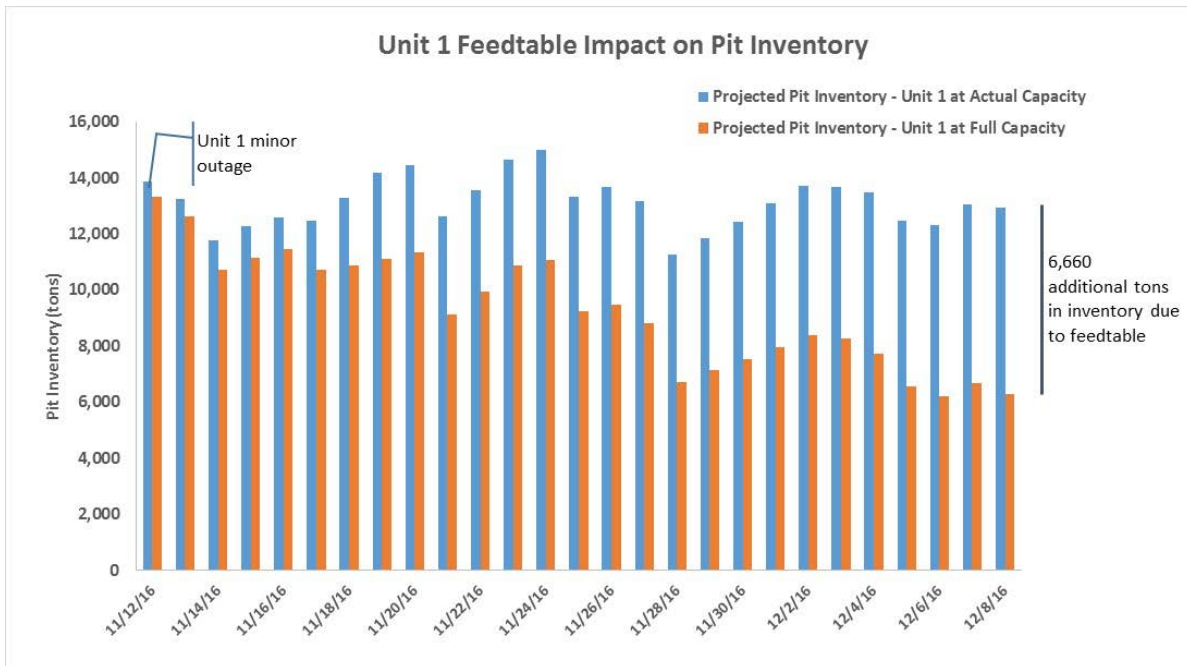
Figure 16 Impact of Boiler #1 Feed Table Damage on Waste Inventory

Boiler availability and boiler capacity at the MCRRF is below industry standard and has resulted in reduced boiler throughput. The lower throughput results in high waste inventories. This reduced availability and capacity is a result of a lack of maintenance and repair on the boiler and air pollution control systems. By way of example, boiler feed table and feed chute repairs that were made to Boiler #1 during the November 2016 scheduled outage were not reasonable and below industry standard. As a result, the boiler was not capable of operating reliably or at full load after the boiler outage. During the December fire, Boiler #1 was secured and not available to process the smoldering waste for a majority of the time. Boiler #1 operated for 28 days prior to the fire and during that period, based on HDR's calculation the lack of maintenance resulted in an additional 6,660 tons of waste inventory in the pit at the start of the fire. The reduction in capacity also resulted in less ventilation air being pulled from the pit area during the fire. The following Figure 16 shows the impact of reduced boiler #1 capacity on the Pit inventory.

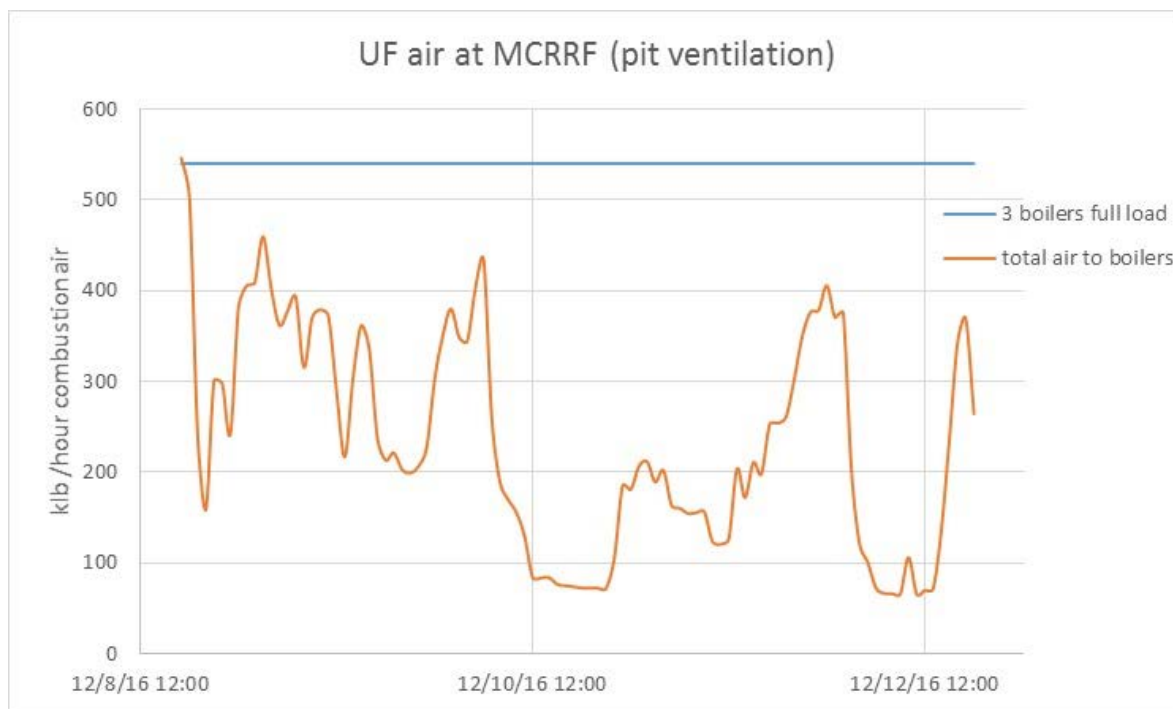
Figure 17 Pit Air

- The ventilation system for the pit and tipping floor relies on the boilers to draw combustion air from the pit area and roof hatches actuated by a fusible link during emergency situations. The large amount of smoke being generated by the fire resulted in reducing boiler loads and shutting down boilers due to safety and visibility issues. With the boilers shut down or reduced in load, the ventilation was reduced, making the situation worse. Covanta did attempt to maximize air flow through the boilers, keeping the fans in service, but burner operation, emissions, and other factors resulted in less ventilation during this period. Figure 17 shows the total air being pulled from the pit compared to the full load design flow. Less than half the typical ventilation rate was available for a majority of this period.
