FACILITY ASSESSMENT FOR Chevy Chase Library

Contract No. 1082489
Sheladia & Associates Project No. 5522.004

Final Report

Date: 03/02/2021

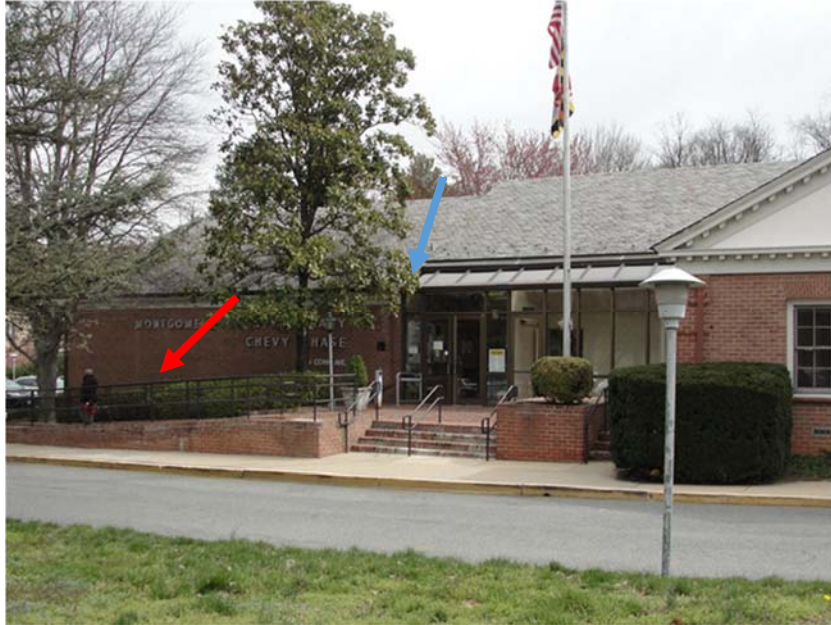
Photo 1: Chevy Chase Library.
See Photo 18 for northwest landscaping (red arrow). See Photo 15 for interior curtain wall leak (blue arrow).

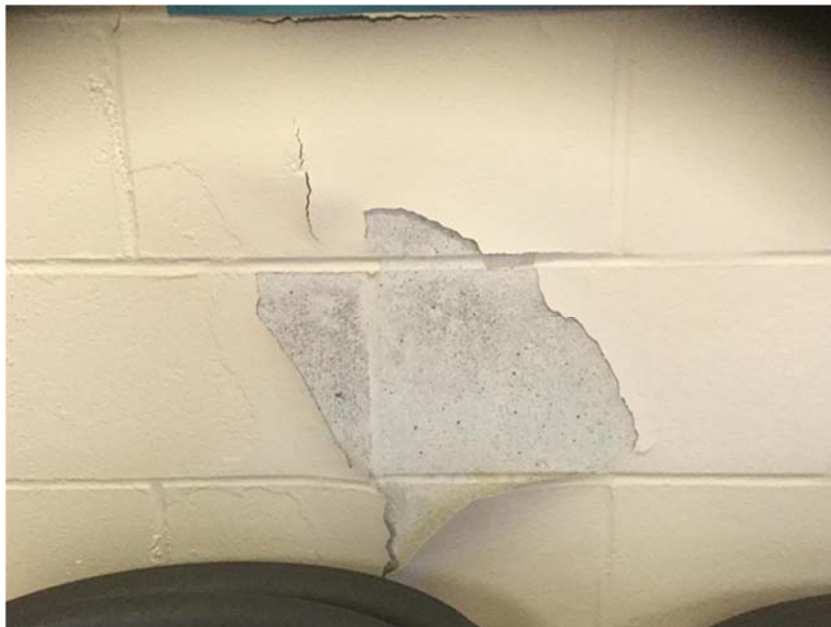
Photo 2: Typical peeling paint and efflorescence observed on the north and south CMU walls in the lower level meeting room.

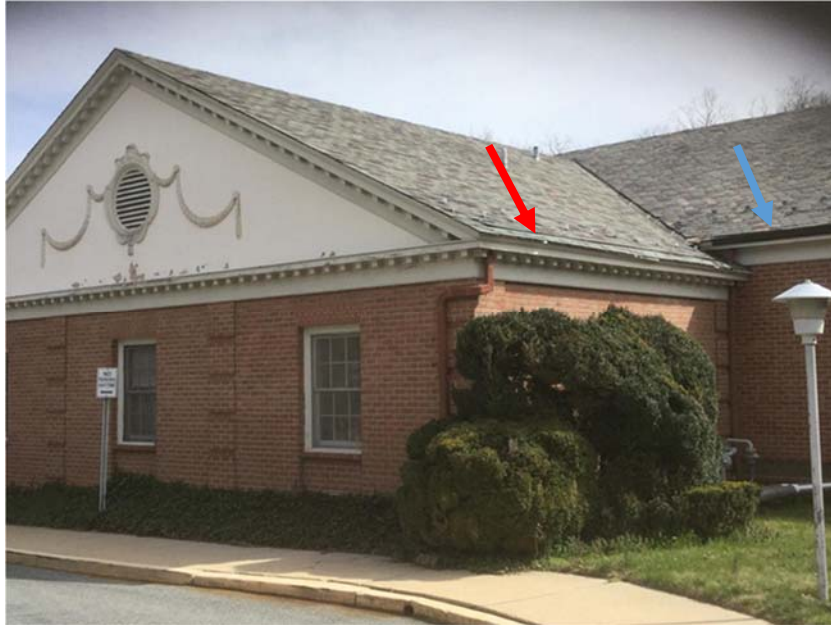
Photo 3: View of the southwest elevation. See Photo 4 for typical built-in gutter (red arrow).
See Photo 7 for typical hung gutter (blue arrow).

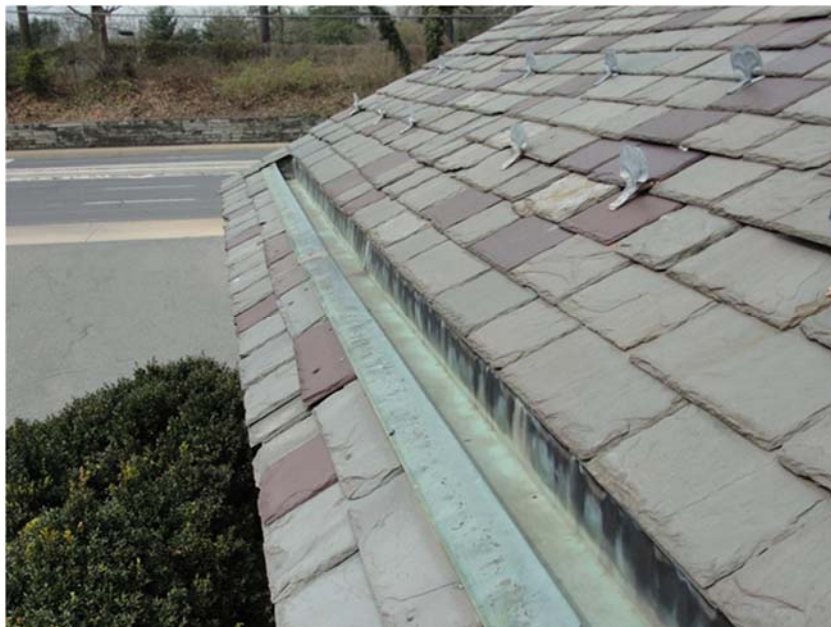
Photo 4: Typical copper built-in gutter assembly.
Isolated damaged slate tiles noted at this edge.

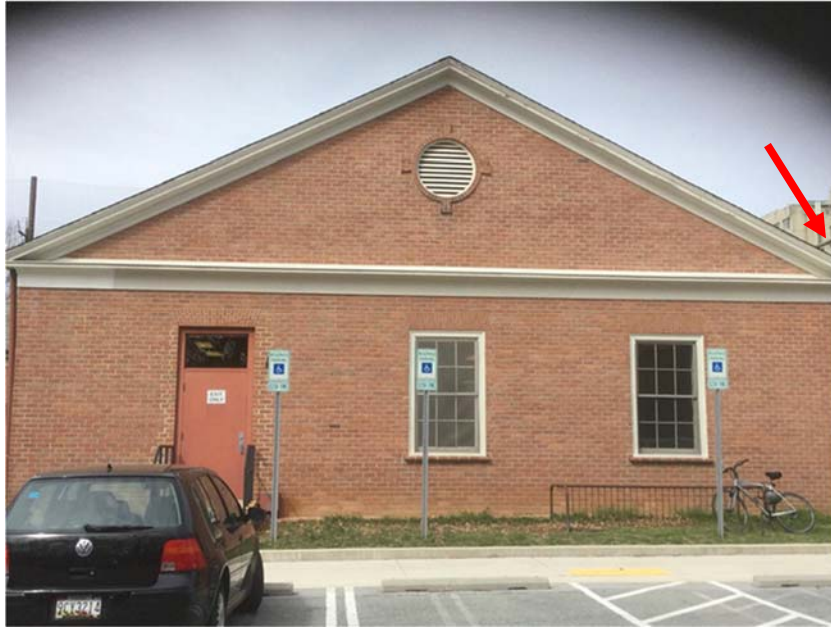
Photo 5: Partial view of the east elevation.
See Photo 6 for typical slate shingle displacement (red arrow).

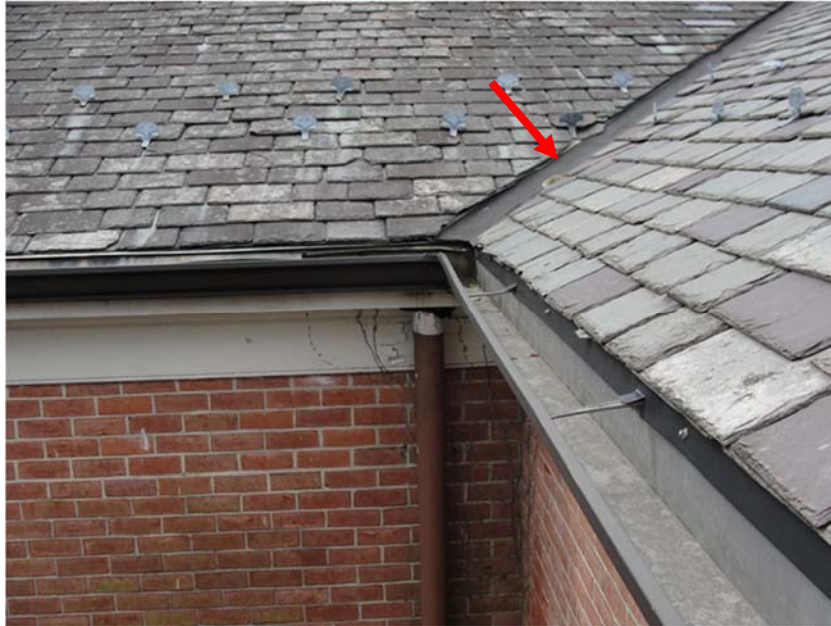
Photo 7: Typical sheet metal hung gutter assembly.
Note EPDM membrane repairs observed in valley (red arrow).

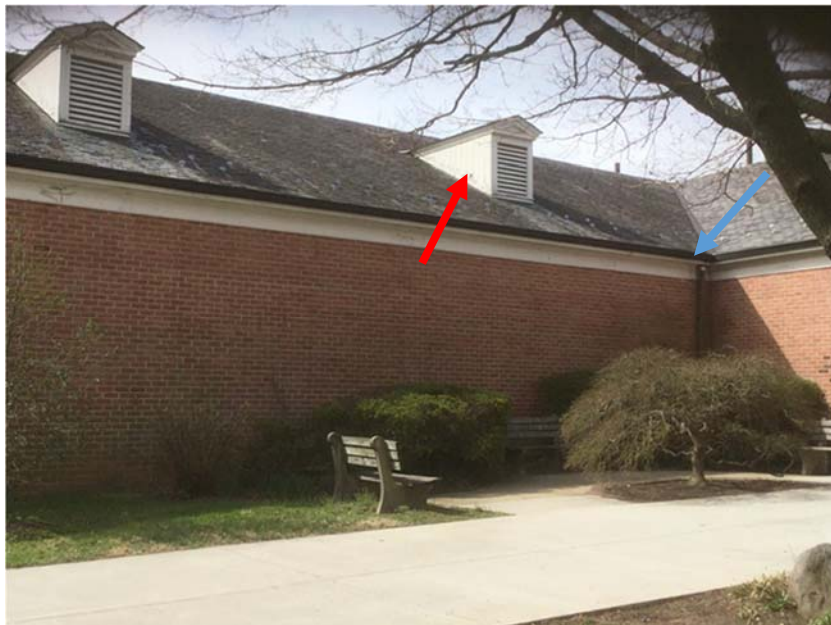
Photo 8: Partial view of the north elevation.
See Photo 9 (red arrow) and Photo 10 (blue arrow).

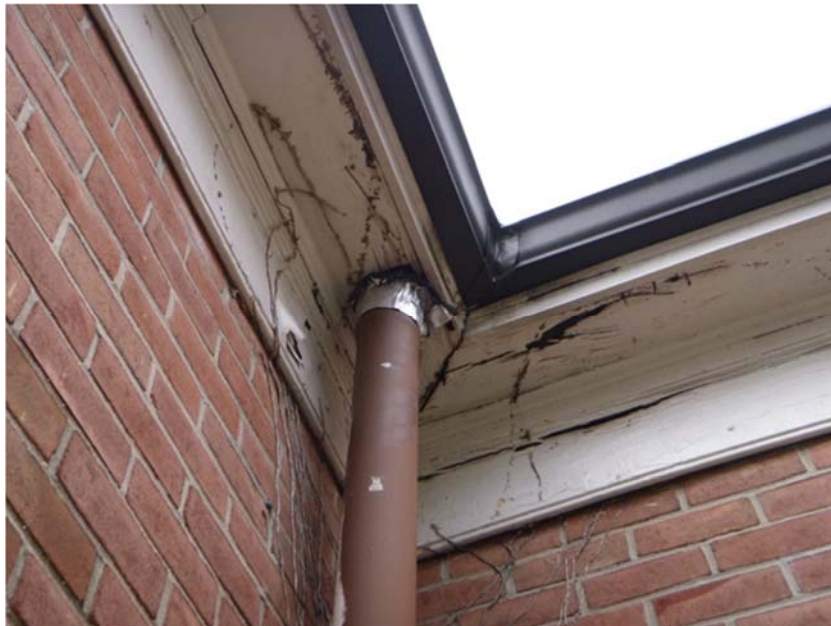
Photo 10: Downspout shown in Photo 8. Peeling paint and isolated rot noted throughout the fascia assembly. Note the repairs at the downspout.

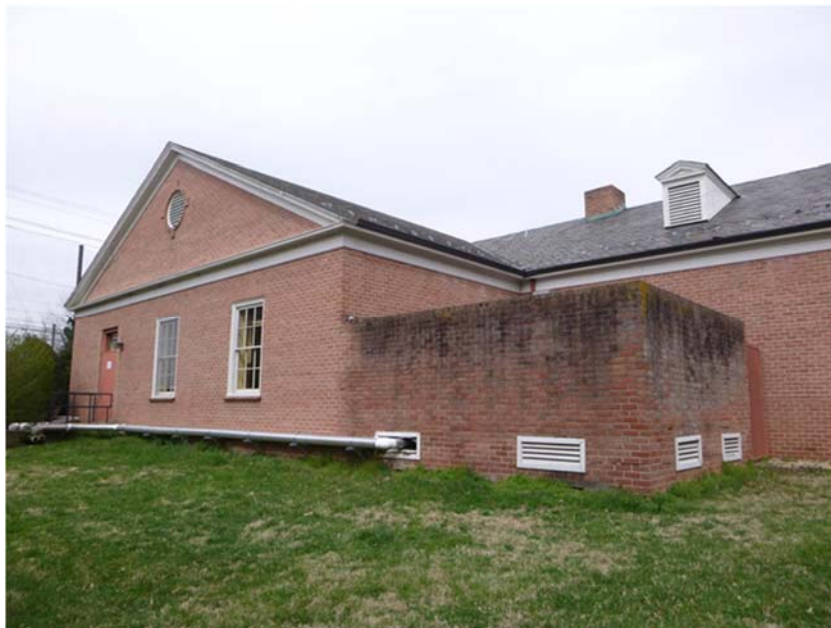
Photo 11: Partial view of the southeast elevation.
Note the staining on the screen wall. The mortar throughout is in generally deteriorated condition.

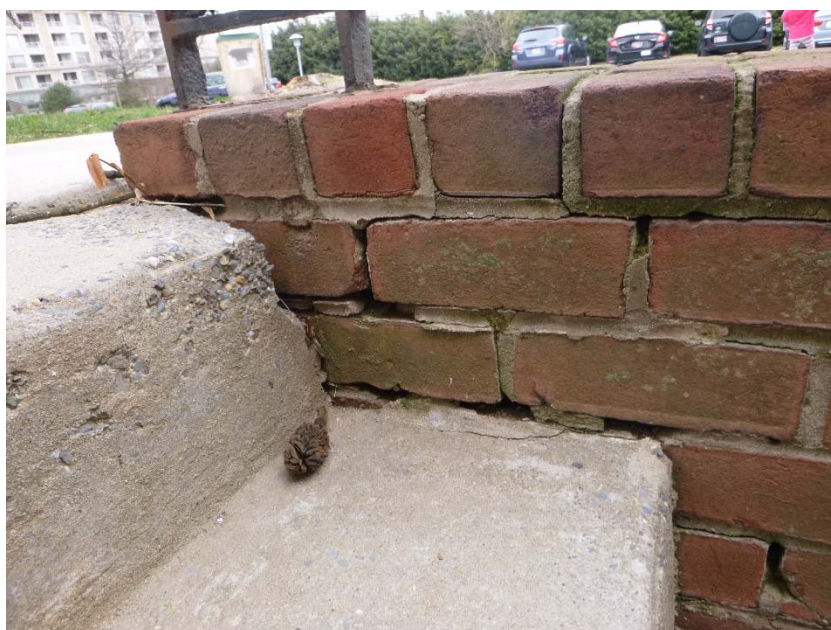
Photo 12: Deteriorated mortar on the north retaining wall.

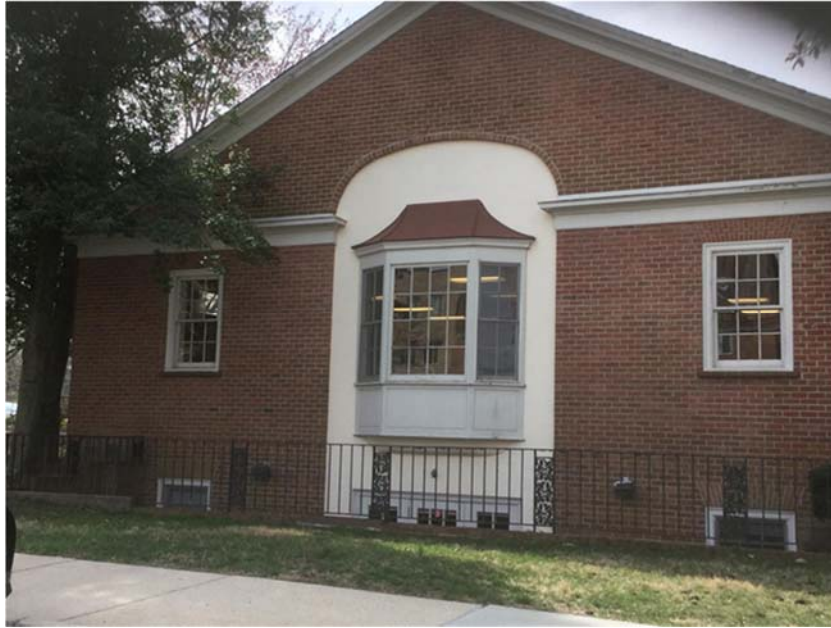
Photo 13: Partial view of the north elevation.
See Photo 14 for the below grade entrance.

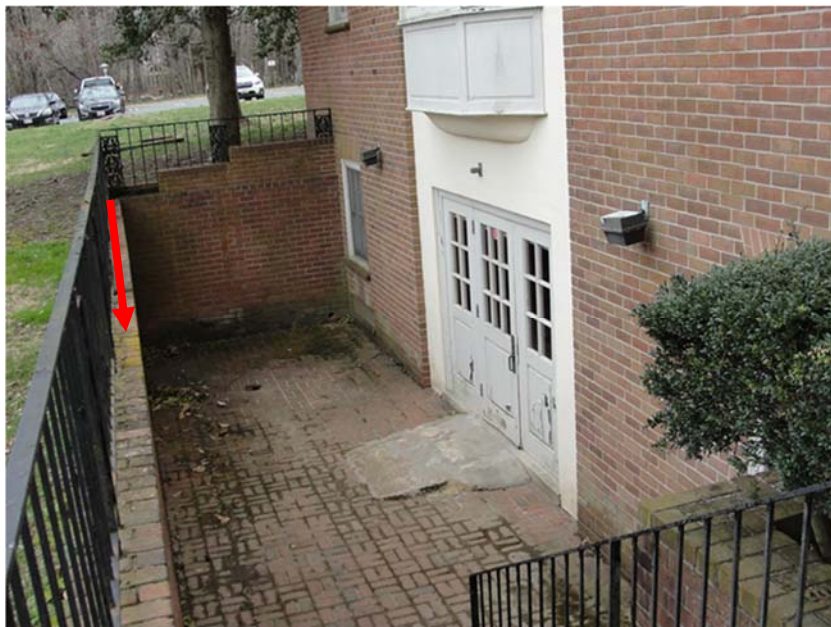
Photo 14: The below grade entrance into the lower level meeting room.
See Photo 12 for deteriorated conditions in the retaining wall (red arrow).

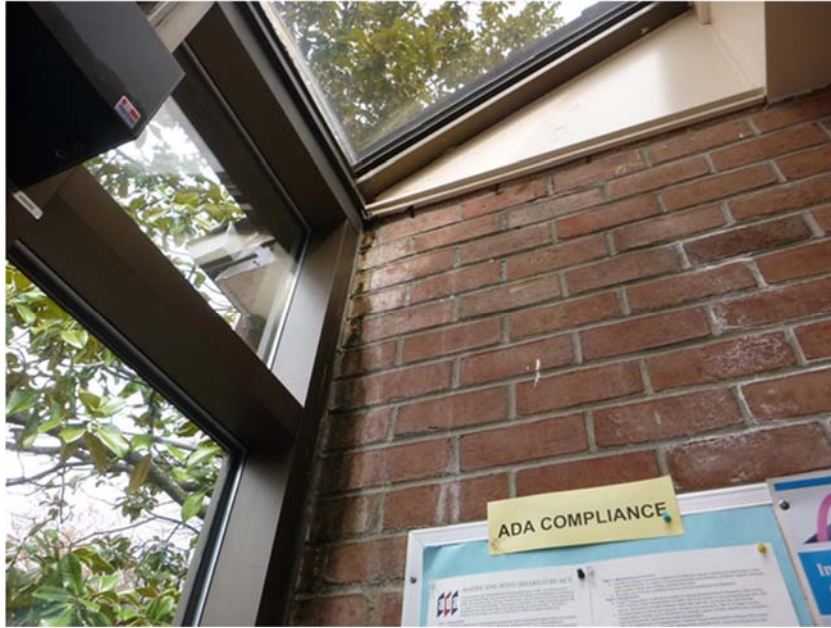
Photo 15: View of staining on interior brick, indicative of moisture intrusion from the curtainwall.

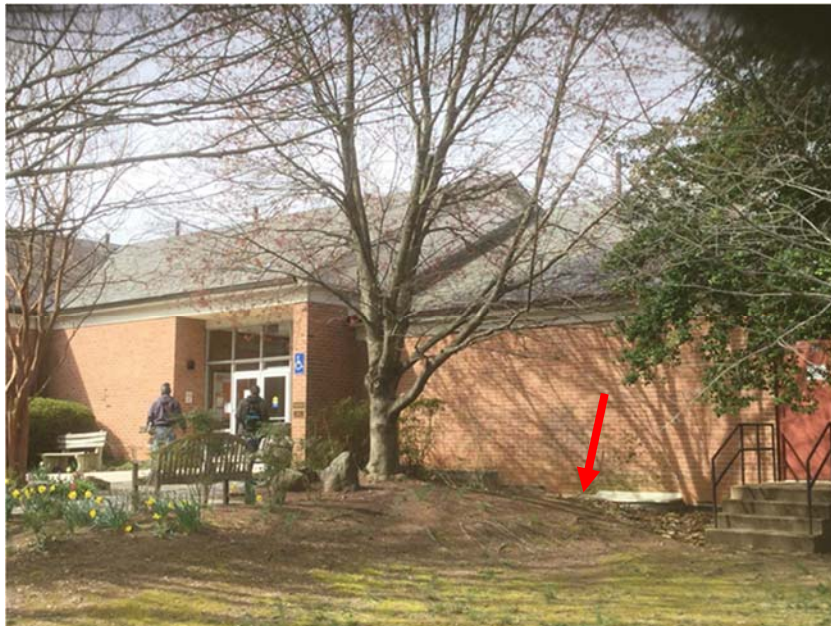
Photo 16: Partial view of the east elevation.
See Photo 17 for the observed below grade conditions (red arrow).

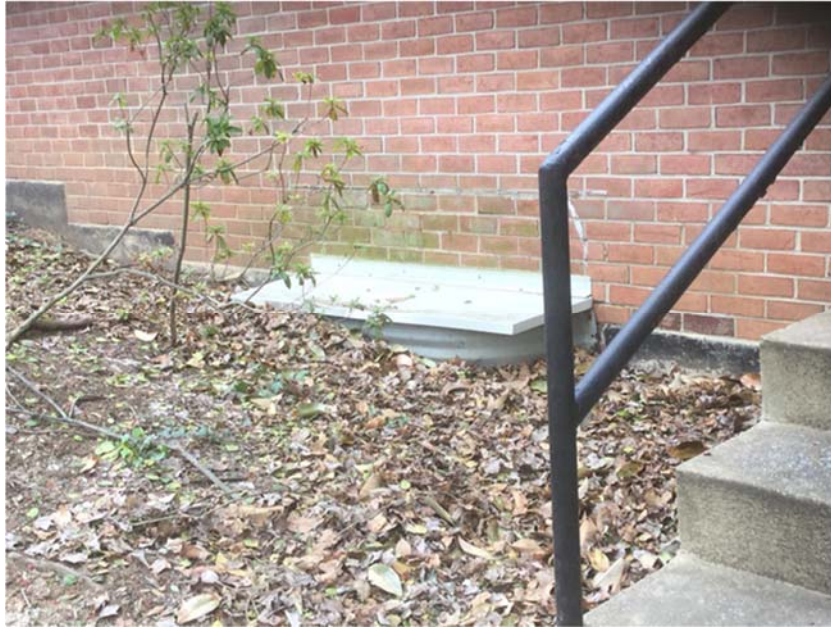
Photo 17: Parge coating with dampproofing was noted throughout the building exterior.

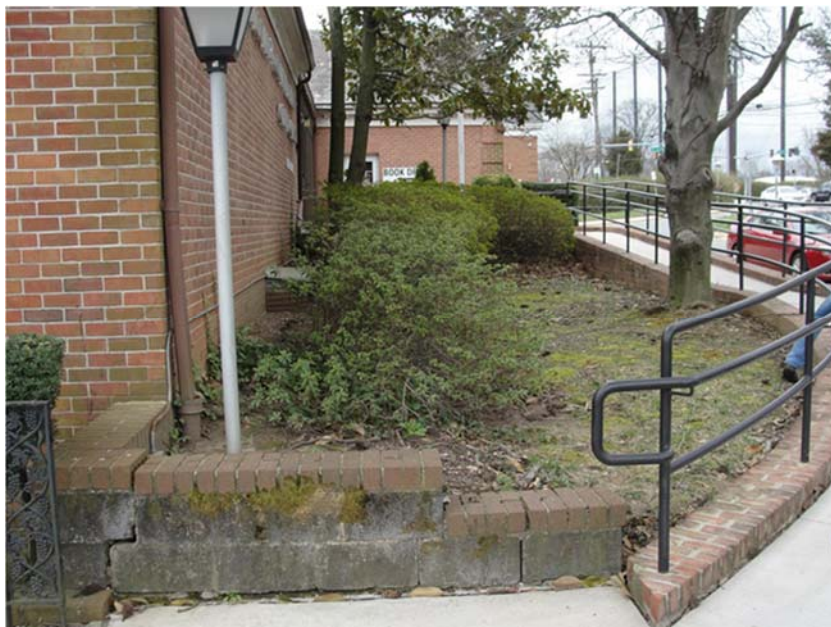
Photo 18: Note the garden wall and ramp prevent drainage of the landscaping area.
See Photo 2 for correlating defects on the meeting room walls.

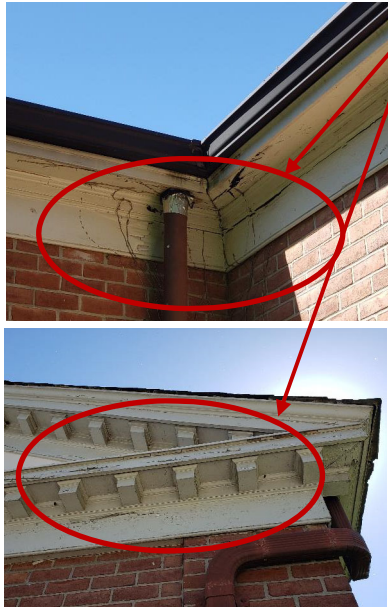
Condition of exposed painted wood trim, fascia and rake are poor throughout the building exterior.	●		
Recommendation:	All rotten wood to be replaced and weathered paint to be restored to match existing.

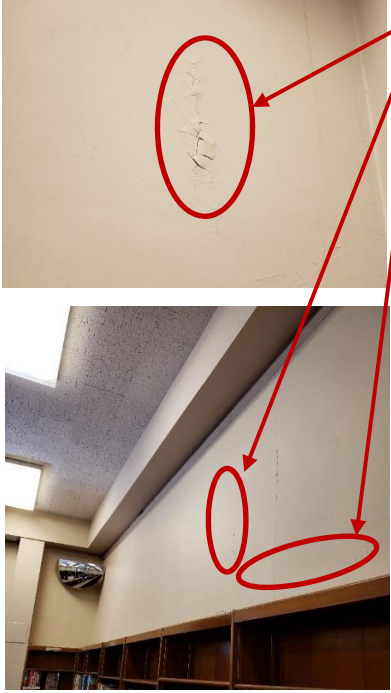
<p>#7-A, A1.3</p> <p>Roof</p> <p>Interior face of east wall of "Adults and Young Adults Room"</p>

<p>Signs of moisture damage.</p>	<p>●</p>		
<p>Recommendation:</p>	<p>Remove ceiling tiles at location of leakage and inspect the quality of all structural wood of the roofing frame. Investigate the source of leakage in the roof and mend peeling paint on the wall per architectural recommendations.</p>				
<p>#7-A, A1.4</p> <p>Roof</p> <p>Interior face of south wall of "Reference Room"</p>

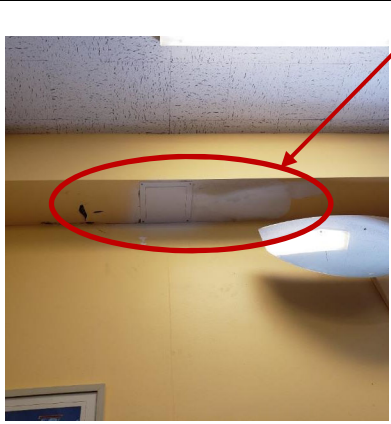
<p>Damaged paint on duct</p>	<p>●</p>		
<p>Recommendation:</p>	<p>Investigate source of moisture near air conditioning piping system. Repair damaged duct and paint per architectural recommendations. Refer to cost</p>

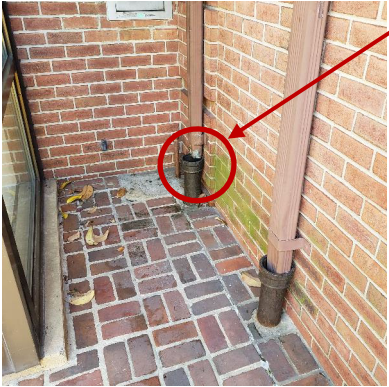
<p>Downspout not connected properly into the drain</p>	<p>●</p>		
<p>Recommendation:</p>	<p>Extend downspout properly into its designated drain.</p>				
<p>#7-A, A2.3</p> <p>Foundation / Waterproofing</p> <p>Northeast corner of the building</p>

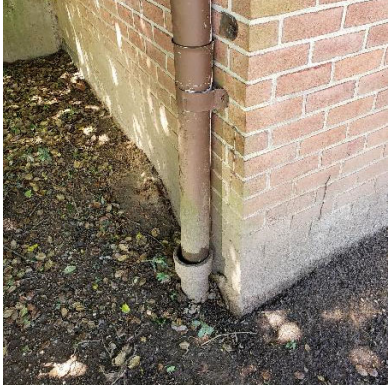
<p>Settled profile of the grade around down spout drain.</p>	<p>●</p>

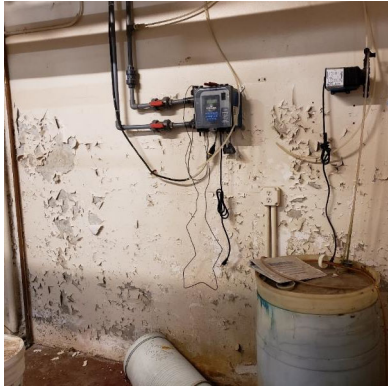
<p>#7-A, A2.4</p> <p>Foundation / Waterproofing</p> <p>Mechanical and Equipment Room</p>

<p>Peeling paint at interior face of East basement wall.</p>	<p>●</p>		
<p>#7-A, A2.5</p> <p>Foundation / Waterproofing</p> <p>Mechanical and Equipment Room</p>

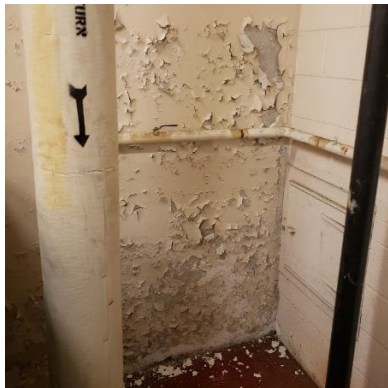
<p>Peeling paint at interior face of east basement wall.</p>	<p>●</p>		
<p>#7-A, A2.6</p> <p>Foundation / Waterproofing</p> <p>Mechanical and Equipment Room</p>

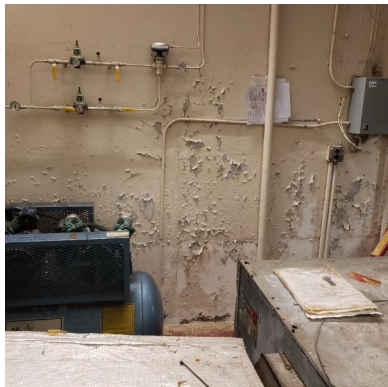
<p>Peeling paint at interior face of East basement wall.</p>	<p>●</p>		
<p>Recommendation:</p>	<p>Remove peeled paint from the existing concrete wall and prepare the surface per manufacturer's recommendation. Provide three coats of CrystalFlex 2K SuperStrong negative side basement waterproofing or equivalent product on the inside face of the concrete walls of the "Mechanical and Equipment Room" where water seepage was detected. Paint the final product with color matching the existing wall color considering the manufacturer's recommendations.</p>

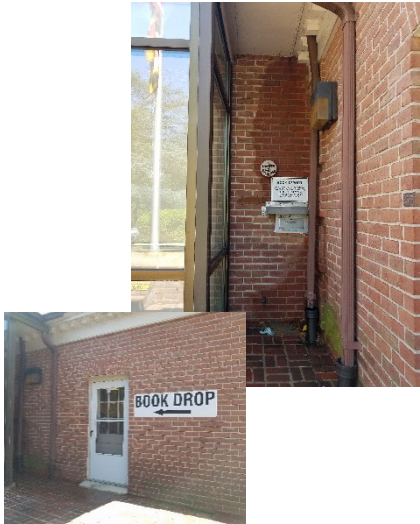
<p>Book Drop area.</p> <p>Note: Current setup is inefficient and non-ADA accessible. Exterior brick façade seems to get wet. Water seeps into the building interior through the book receiving tray, as a result books get wet.</p>

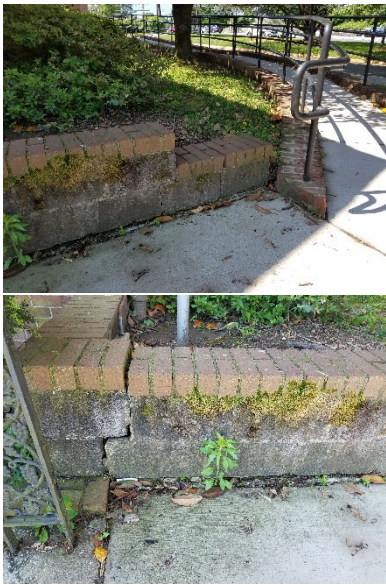
Cracked and settled Concrete retaining wall and moss buildup on wall. This landscaped area lacks drainage and is causing waterproofing issue for the basement level multi-purpose room.	●		
Recommendation	Removing the landscaped area to waterproof the exterior wall. Provide new landscaping post remediation efforts.				
#8-A, N2. Brick Retaining Wall

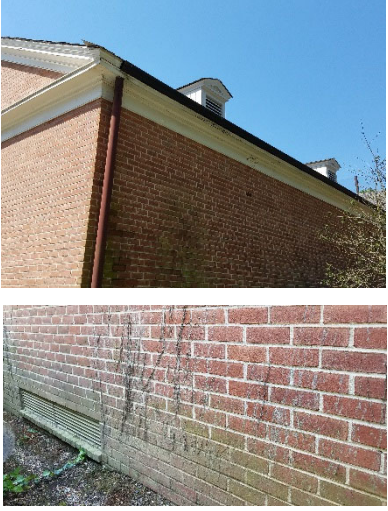
<p>Brick façade requires cleaning and repointing.</p>	<p>●</p>		
<p>Recommendation</p>	<p>Clean surface and treat mold growth, and repoint brick surfaces.</p>				
<p>#8-A, E9.</p> <p>Rain Leaders</p>

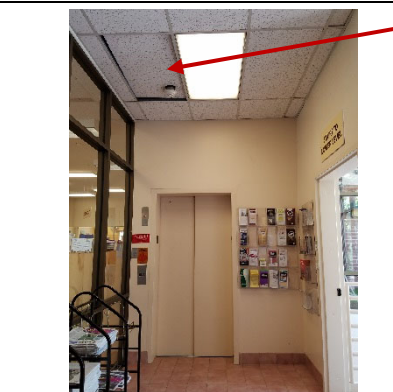
Ceiling tile out of place.	<input checked="" type="radio"/>		
Recommendation	Re-position ceiling tile within grid, as part of facility maintenance.				
#9-A, 101-A9. Flooring

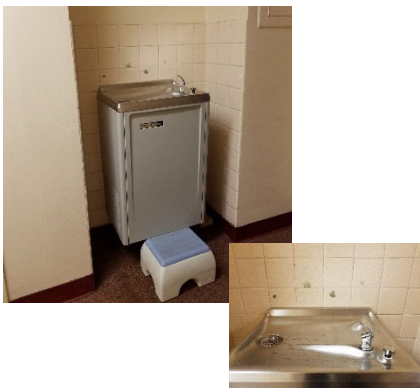
Drinking water fountain. Damaged wall tile.	●		
Recommendation	Replace with ADA accessible high-low type. Note that the existing space seems insufficient for new type. Recommend relocating the drinking foundation for proper code compliant ADA access clearances. Provide new wall tile to replace damaged tiles.

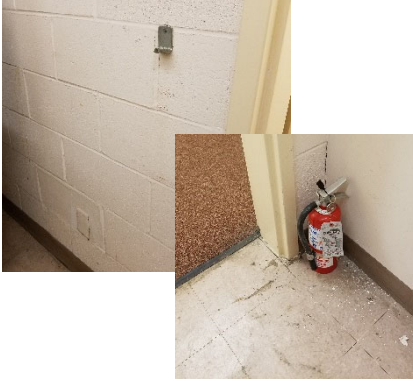
<p>Unused steel bracket on wall.</p> <p>Fire extinguisher placed on floor.</p>	<p>●</p>		
<p>Recommendation</p>	<p>Remove if not required. Provide new wall bracket to place fire extinguisher of wall in visible sight.</p>				
<p>#9-A, G107-A5.</p> <p>Interior Partitions</p>

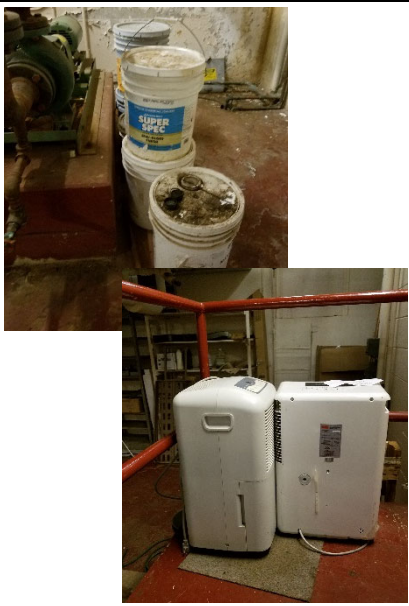
<p>Lose items stored in the Mechanical room.</p>			●
<p>Recommendation</p>	<p>Remove and clear floor areas around equipment and stair landing, as part of regular facility maintenance item.</p>				
<p>#9-A, G108-A8.</p> <p>Ceilings & soffits</p>

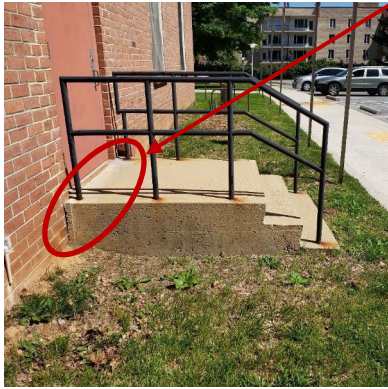
Gap between building enclosure and concrete stair landing.	●		
Recommendation:	Provide caulking all around the gap to prevent further growth of the gap opening.				
#10-B, B1.2 Mechanical and Equipment Room

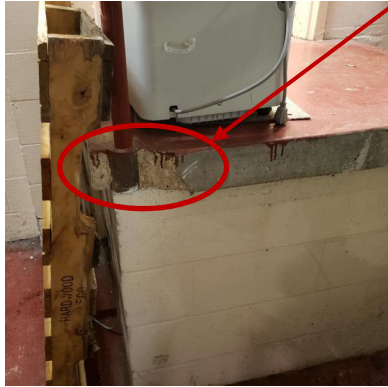
Damaged concrete stair landing.	●		
Recommendation:	Patch using Portland cement-based patching compound.

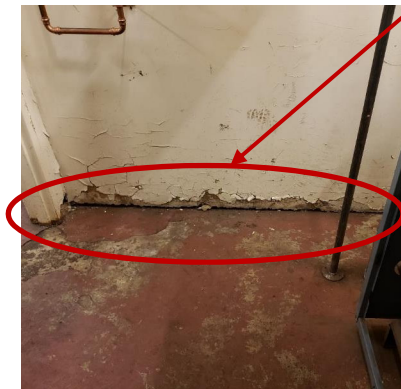
Damage to base of partition wall.	●		
Recommendation:	Patch the wall at the base using cement plaster and paint to match with the existing wall color.

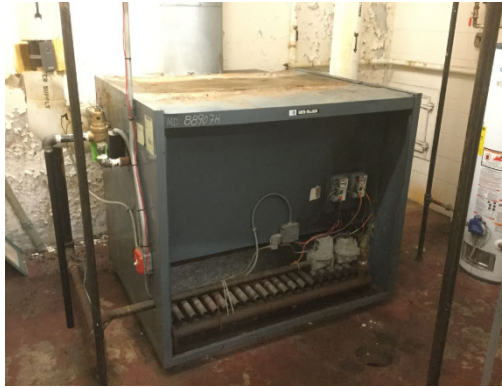
●		
Recommendations:	The boiler is in poor mechanical condition and past its expected service life. This boiler should be removed and replaced with two new high efficiency natural gas fired condensing boilers at 60% capacity (800,000 BTU) each for better heating control and redundancy. Further breakdown of exact replacement requirements can be found in category C1 of the cost estimate.

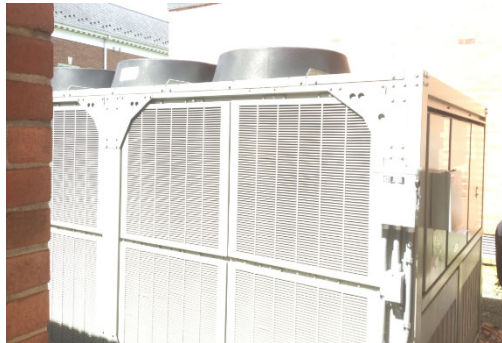
Recommendations:	The current outdoor chiller has a long service life and does not need to be replaced in the foreseeable future. Category C2 of the cost estimate reiterates no action is required for this system.

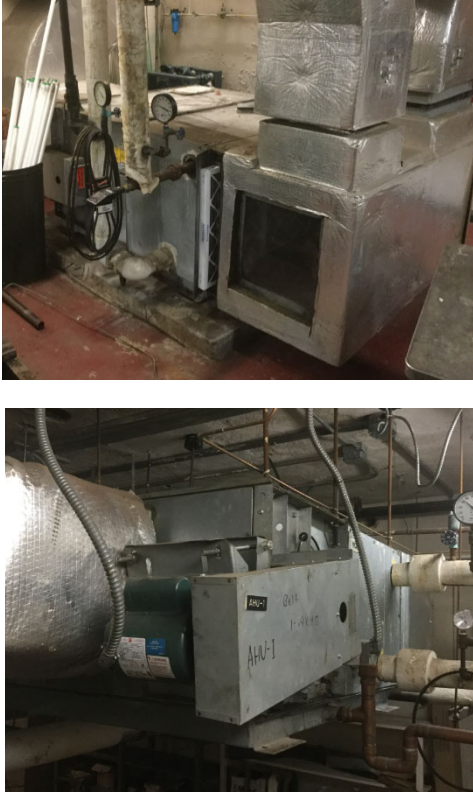
<p>#11-C, C3.3</p>	<p>The cooling system implements 8 unit ventilators and 10 fan coil units scattered throughout the library. These units are old and in many cases original to the building. However, all still appear in adequate physical and mechanical condition.</p>

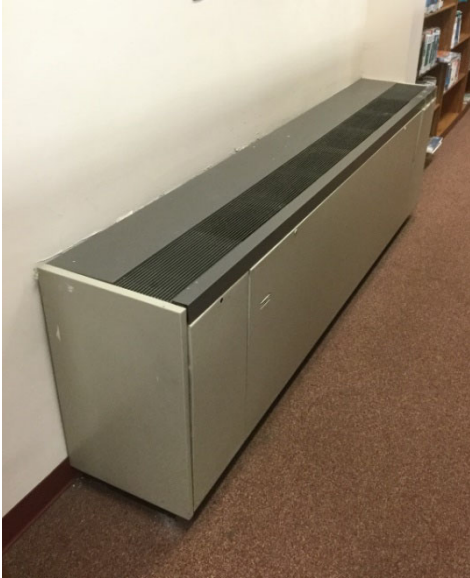
Recommendations:	<p>The building's air handling units are rapidly deteriorating and are recommended for immediate replacement. New air handling units should be constructed of 1-inch double-wall casing, MERV-13 filters and equipped with ECM motors for energy efficiency. Since the library contains a large number of FCUs and UVs, they require individual maintenance as needed. However, as a whole, these units should be replaced in the coming years and do not pose an immediate concern. All new units shall have stand-alone BACNet DDC controls and actuators. In addition, AHU's and UV's serving the Basement Level should be equipped with humidity sensors and reheat capability to address the smell of mustiness in the Basement Level. Further breakdown of exact replacement requirements can be found in category C3 of the cost estimate.</p>

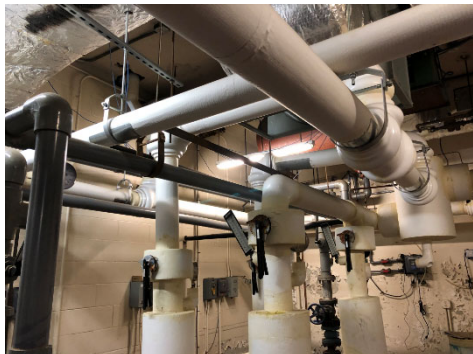
X		
Recommendations:	The system's circulating pumps and corresponding pipes and valves are aging but retain adequate operation. The shortcomings of the 2-pipe system could be contributing to the musty smell in the basement due to lack of dehumidification when chilled water is not available. These components and system should be updated to provide improved temperature control during the shoulder seasons and, most importantly, dehumidification capability during times of high humidity. Further breakdown of exact replacement requirements can be found in category C6 of the cost estimate.

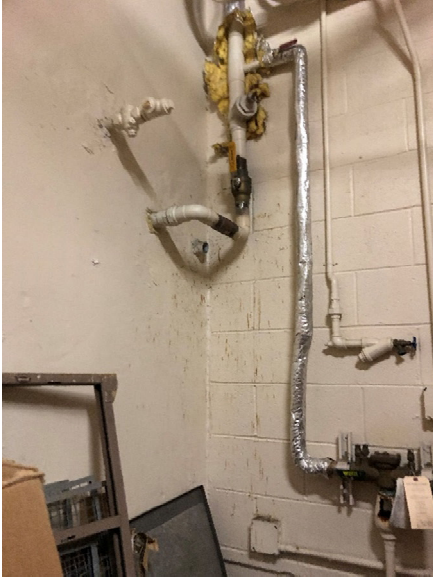
●		
Recommendations:	<ul style="list-style-type: none"> • New 2-inch Double Check Valve Assembly (DCVA, ASSE 1015) on the incoming water service. Class 1 recommendation. • Replace all existing domestic water piping throughout the entire structure. Extended renovation category (Class 3, 36-72 months) and may be undertaken in segments based on other renovations planned for the library.

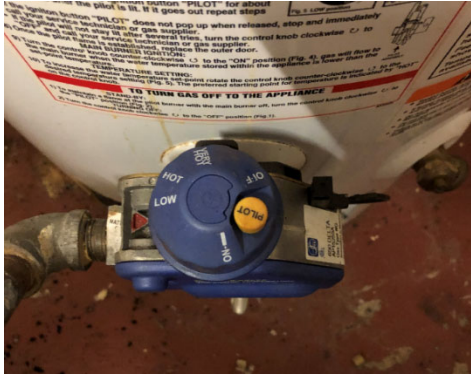
<p>Recommendations:</p>	<ul style="list-style-type: none"> • A new condensing gas fired water heater is recommended for replacement of the existing unit within the basement. The unit should be supplied with all new trim, valves, and controls. • Adjusting the water heater setting to “HOT” is recommended in order to increase the output temperature of the water heater.

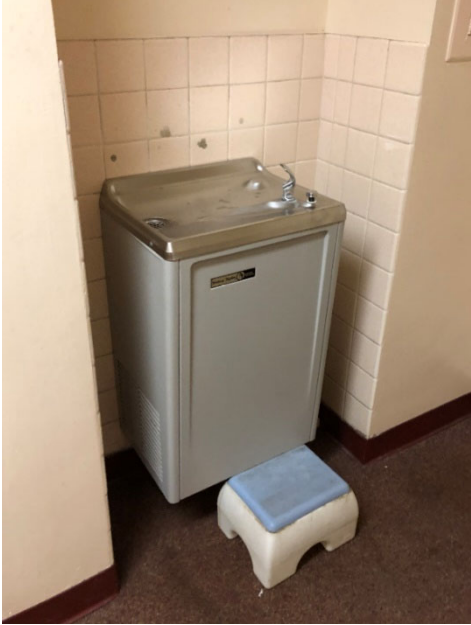
Recommendations:	<ul style="list-style-type: none"> • The first floor staff restroom should be fully renovated with a new toilet and lavatory. Priority Class 1. • Replace first floor pantry sink. Priority Class 2 • Replace basement pantry sink. Priority Class 2 • Replace mop sink. Priority Class 2 • Rearrange and upgrade basement group restrooms for ADA compliance. • Replace existing drinking fountain with new high-low unit and with bottle filler. 				
#12-D, D5 Sanitary Waste	Current force main piping passes ovetop existing electrical panels.

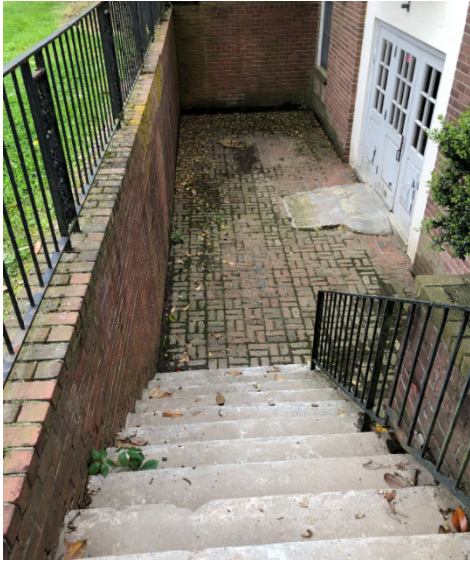
<p>Recommendations:</p>	<ul style="list-style-type: none">• Jet cleaning of the existing underground storm sewer is recommended. This is a Priority Class 1 recommendation.• Refer to the architectural portion of this report for proposed upgrades to the downspouts and gutters.• To coincide with the architectural recommendation of the north patio canopy, any provided gutter or downspout would be connected to a new cast iron boot which would tie to the site gravity storm sewer.• To coincide with the perimeter landscape and pavement upgrades as outlined in the architectural portion of this report, a new area and planter drain would be provided at the podium/ramp.• To coincide with the storefront upgrades listed in the architectural portion of this report, a new scupper or gutter system would be provided with a downspout and tie into the site storm sewer.• A new 3-foot diameter, 5-feet deep sump basin and duplex pumps at the north patio with controller and discharge piping connected to the gravity storm sewer. This is a Priority Class 2 upgrade.

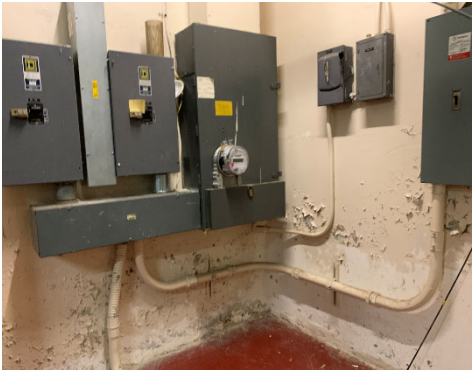
●		
#13-E, E1.2	Distribution panels are beyond their life expectancy and are recommended to be replaced.

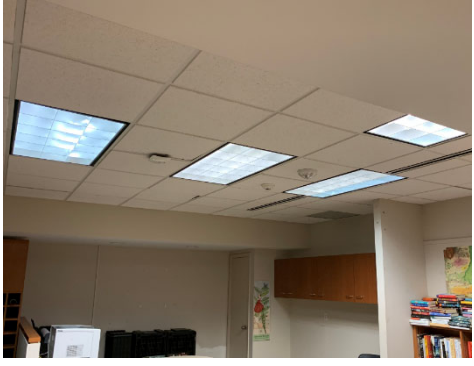
<p>●</p>
<p>Recommendations:</p>	<p>While the existing lighting system is in good operational condition, LED lighting shall be considered as the basis of design for all future fixtures in order to enhance energy savings. Existing controls to be demolished and provide automatic control including occupancy and daylight sensors. An occupancy sensor control system will be used with manual override switches to control all interior non-emergency light fixtures in the building. Further breakdown of exact replacement requirements can be found in category E3 of the cost estimate.</p>

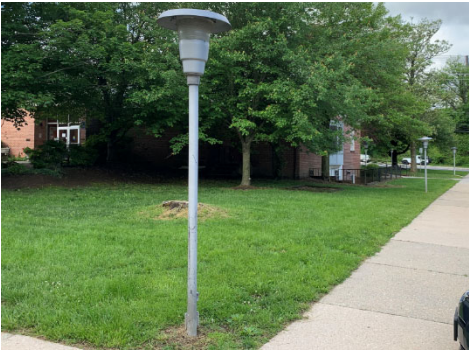
Recommendations:	Since the majority of the building mounted and all of the pole mounted fixtures appear to be original to the building, we are recommending they be replaced with more efficient LED exterior fixtures. Further breakdown of exact replacement requirements can be found in category E5 of the cost estimate.

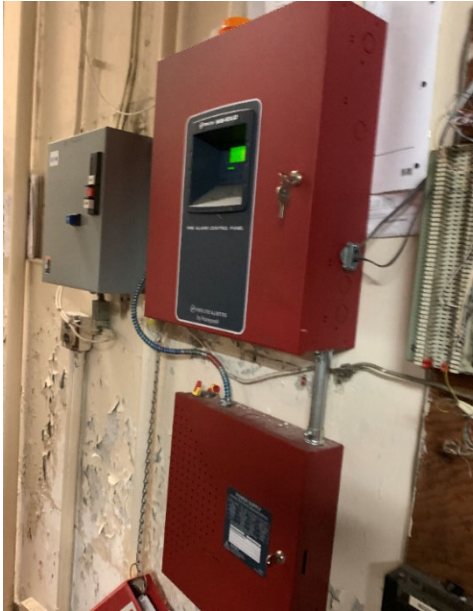
Combination of Audio and Visual fire alarm devices that are in good condition.
