CONDITION SURVEY
of
MONTGOMERY COUNTY
GARAGE 47/47A
at
7401 WAVERLY STREET,
BETHESDA, MARYLAND

DECEMBER 17, 2015

HAA Project No. 15-198

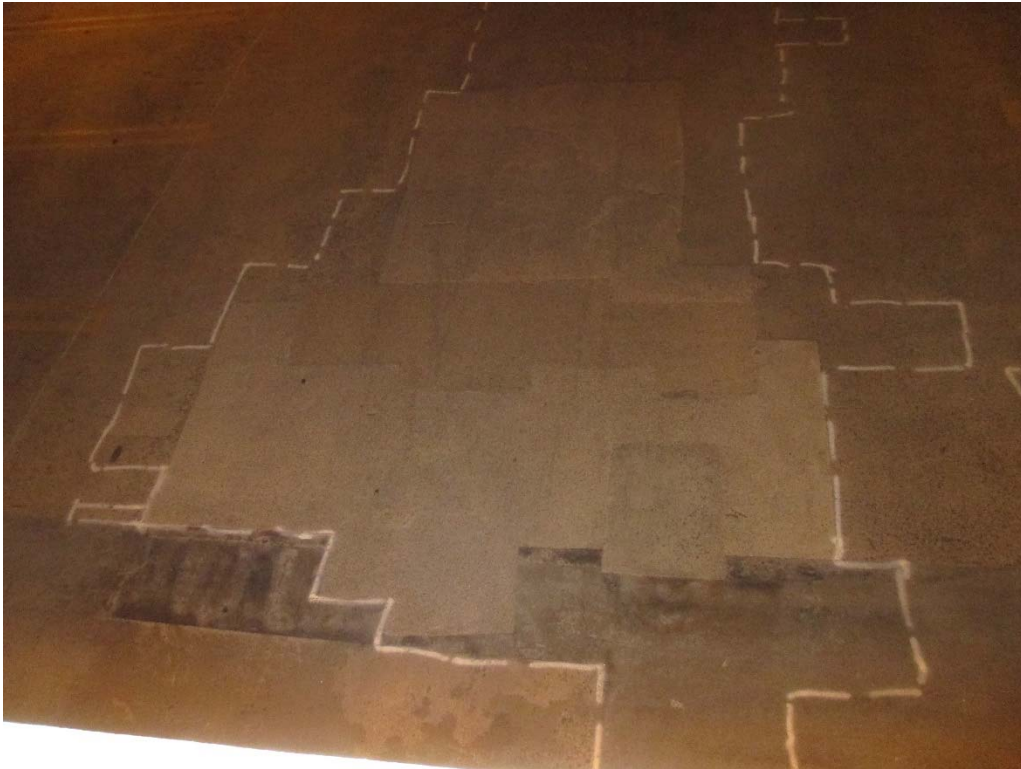
Photo No. 1

- **Slab Surface Damage:** Besides the failure of previous patches and the halo effect damage, many new delaminated or spalled surface areas were found throughout all levels of this phase of the garage (Photo No. 1). Moderate to severe scaling (i.e., loss of surface mortar and clearly exposed aggregates) were also observed, mainly at the top exposed floor (Photo No. 2). This scaling damage is usually caused by freezing and thawing effects and/or other construction related issues such as over-finishing or finishing while bleed water is on the surface. It is also worth noting that a membrane coating existed over some of the slab surfaces at some levels and, as a result, it is not possible to say for sure whether all of the areas of possible delaminated concrete detected using chain-drag and hammer sounding were actually concrete delaminations or only debonded areas of coating. The only effective way to tell for certain would be to completely remove the coating in suspect areas to evaluate the concrete underneath.

Typical Garage 47 Slab Damage

Area within white painted lines is delaminated concrete. Note the rectangular areas of different colors indicating previous slab repairs made at different times, most of which are now delaminated.

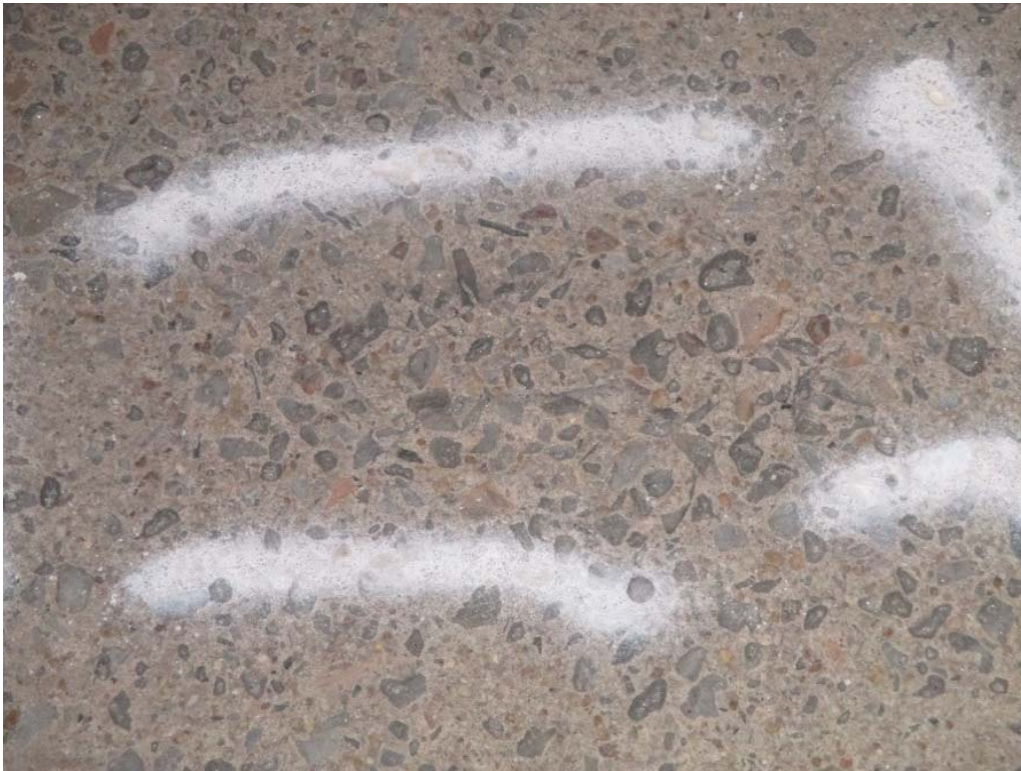
Photo No. 2

Typical Concrete Surface Scaling

Moderate to severe scaling was observed in some areas of the garage.
The area marked in white lines is delaminated.

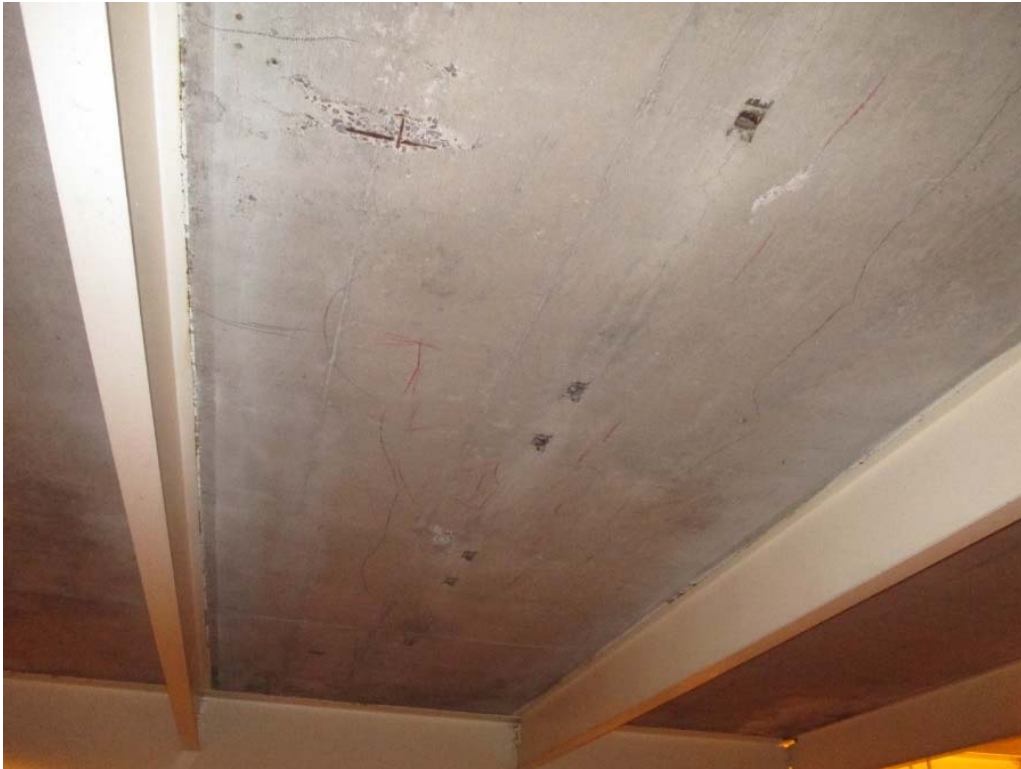
Photo No. 3

- **Slab Soffit Damage:** Areas of slab soffit spalling and delamination were also observed throughout all levels of this phase of the garage (Photos No. 3 and 4). It was noted that the

Typical Slab Soffit Damage – Garage 47

Detected spalling and deterioration area on the soft is marked in red.
Exposed rebar is visible where the concrete has spalled.

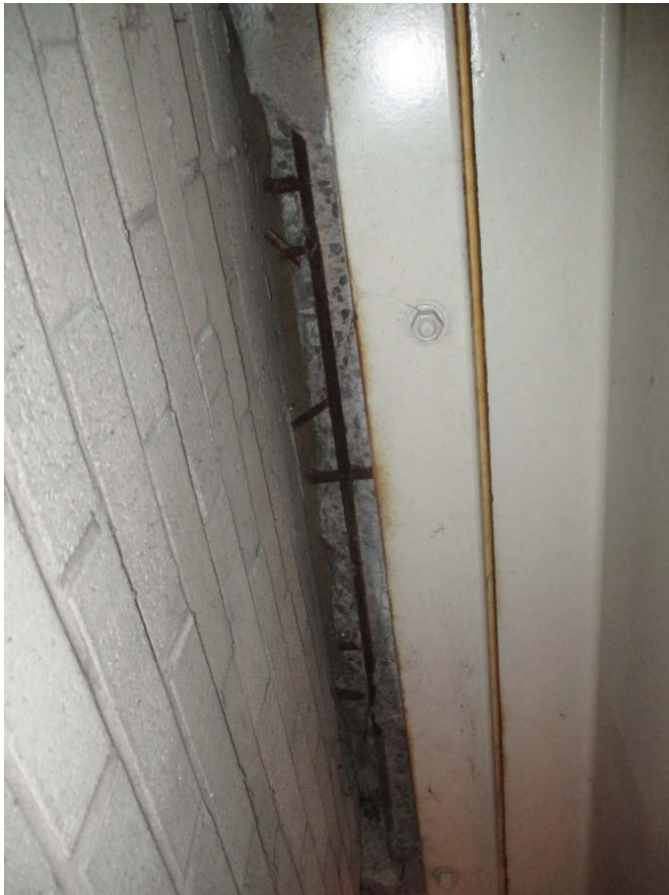
Photo No. 4

Slab Soffit Damage at Stair/Elevator Tower Areas – Garage 47

The soffit of the area between the stair/elevator tower edges and the adjacent beam had spalled concrete and exposed rebar.

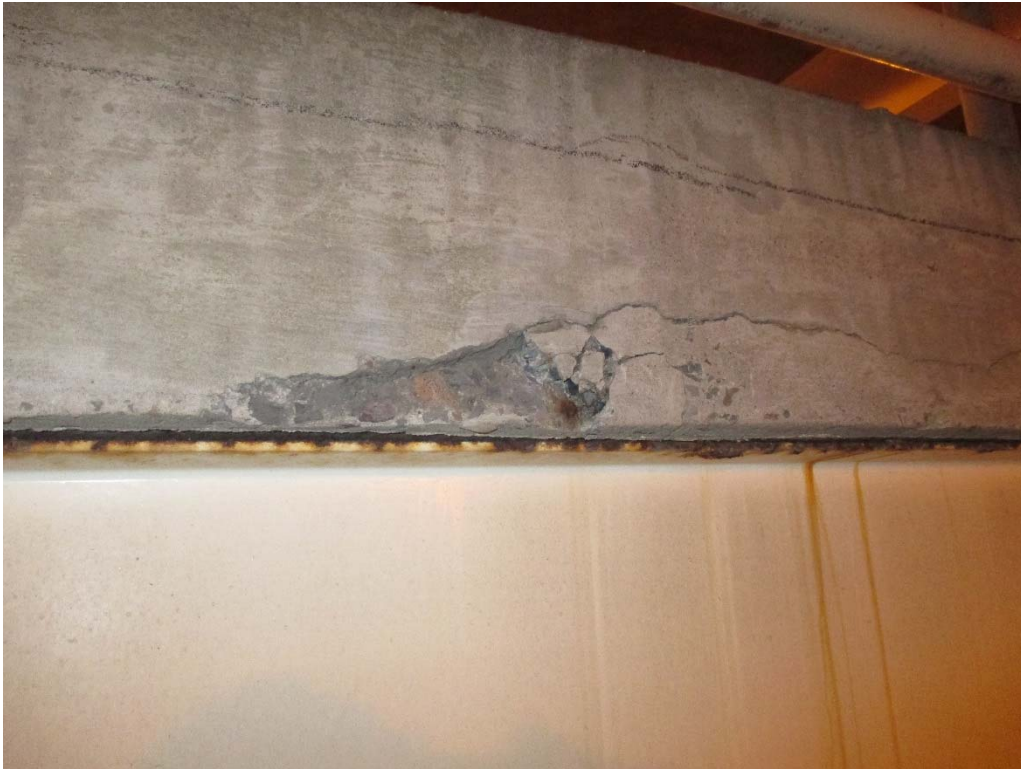
Photo No. 5

- **Slab Edge Damage:** The vertical sides of some slab edges had spalled or delaminated (Photo No. 5). The majority of this type of damage was observed at the interior sides of the ramp slabs. The top steel beam flanges that were directly below the slab in these areas had corroded at these locations.

- **Corroded Beam Flanges:** Many of the steel beams throughout this phase of the garage had minor corrosion visible along the edges of their top flanges (Photo No. 5).

Slab Edge Damage – Garage 47

The sides and corners of inner edges of ramp slabs has delaminated and spalled.
These slabs rest on corroded steel flanges.

- **Clean and Repaint Corroded Beam Flanges:** The current conditions of the corroded steel beam flanges do not affect the structural integrity of the garage. However, the rust should be cleaned from their surfaces and repainted for future corrosion prevention purposes.

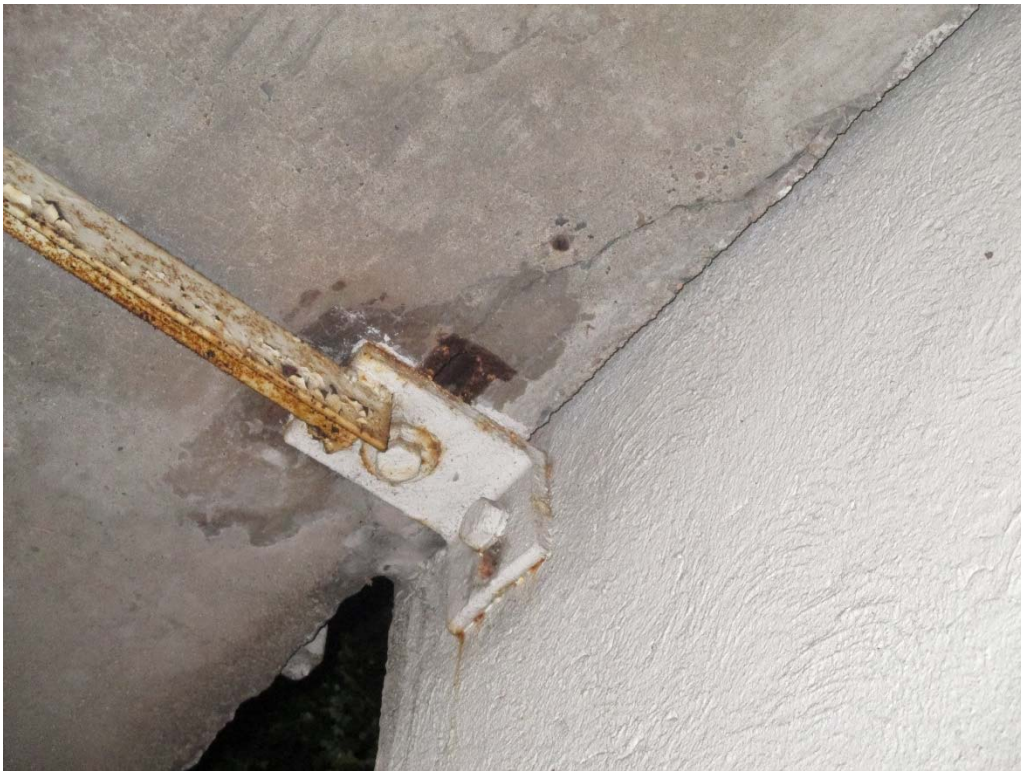
Photo No. 6

- **Precast Wall-to-Slab Connection Damage:** The south-side precast façade panels were connected to elevated slabs with bolted angles (Photo No. 6). The concrete slab around some of these angles is cracked and delaminated. Many of these angles also had visible corrosion on them.

Wall-to-Slab Connection – Garage 47

Some of the angles in the south-side precast facade panel-to-wall connections have rusted and surrounding concrete has spalled.

- **Repair Precast Wall-to-Slab Connection Damage:** If the damaged connections fail, the precast panels could fall off of the building. Therefore, all of the damaged connections should be repaired. If the concrete surrounding these connections has spalled, it should be repaired. If the damage is extensive, a new connection should be added in sound concrete near the existing connection.

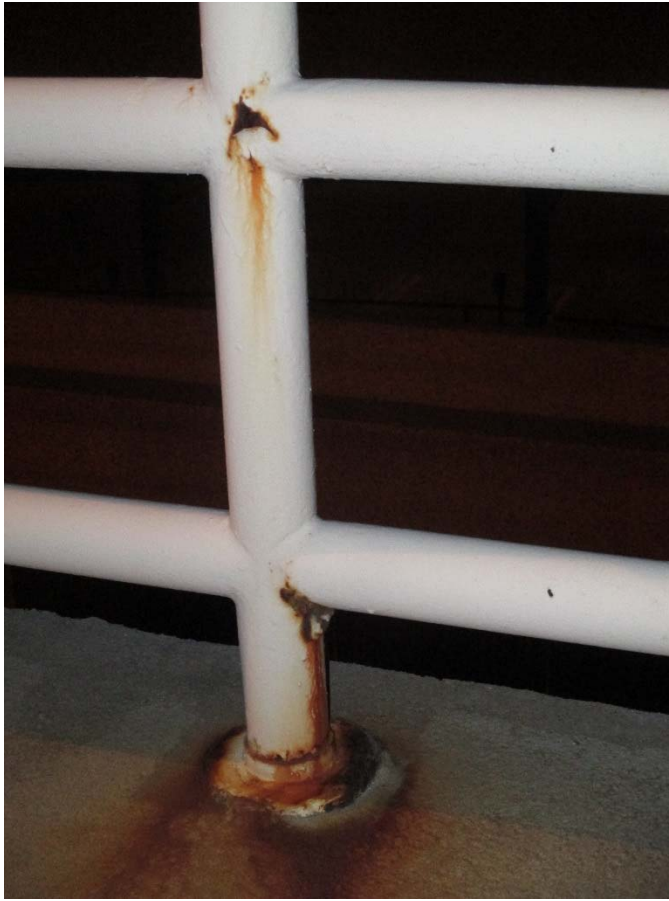
Photo No. 7

- **Guardrail Damage:** The base of some of the guardrails was heavily corroded and the posts and railings were also corroding at a few locations (Photo No. 7).

Typical Guardrail Damage – Garage 47

The bases of many guardrail posts are corroding and some corrosion is also occurring at the upper portions of the guardrails.

- **Guardrails:** Corrosion of the guardrails could cause the guardrails to fail and allow a person to fall of an elevated deck. All of the corroded guardrail elements should therefore be repaired, replaced and/or cleaned and painted to insure the structural integrity of the rail system. Sealant should be placed around the bottoms of all posts to try to deter future corrosion.

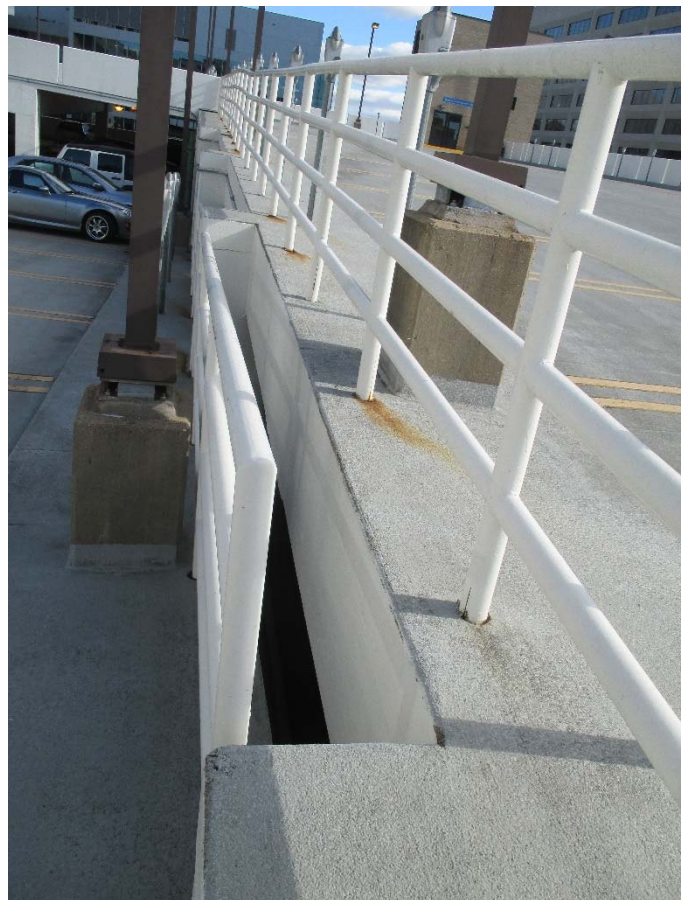
Photo No. 8

- **Guardrail Damage:** As noted above, the bottoms of the guardrails at the perimeter knee walls were corroding at many locations. The bottoms of the guardrail posts along the interior edges of the ramps were also corroding (Photo No. 8). There was no sealant around the bases of most of these posts. Some of the posts have split vertically along the seams of the pipe.

**Typical Guardrail Damage at
Garage 47A Ramp**

The bases of the guardrails embedded in the curb are corroding and some have split vertically along their welded seams.
Note that there is no sealant around the bottoms of the posts.

- **Repair Guardrails at Knee-Walls:** The guardrails throughout this phase of the garage are embedded into knee-walls at their base. Moisture has leaked into this embedment and has caused visible signs of corrosion at many locations and delaminated or spalling concrete at some locations. The concrete damage renders the guardrail ineffective in preventing a pedestrian from falling off of the edge. Therefore, the damaged concrete at these locations should be repaired. As part of these repairs a sealant should be added around the base of all posts that are embedded into the concrete to keep water out of the post embedment.

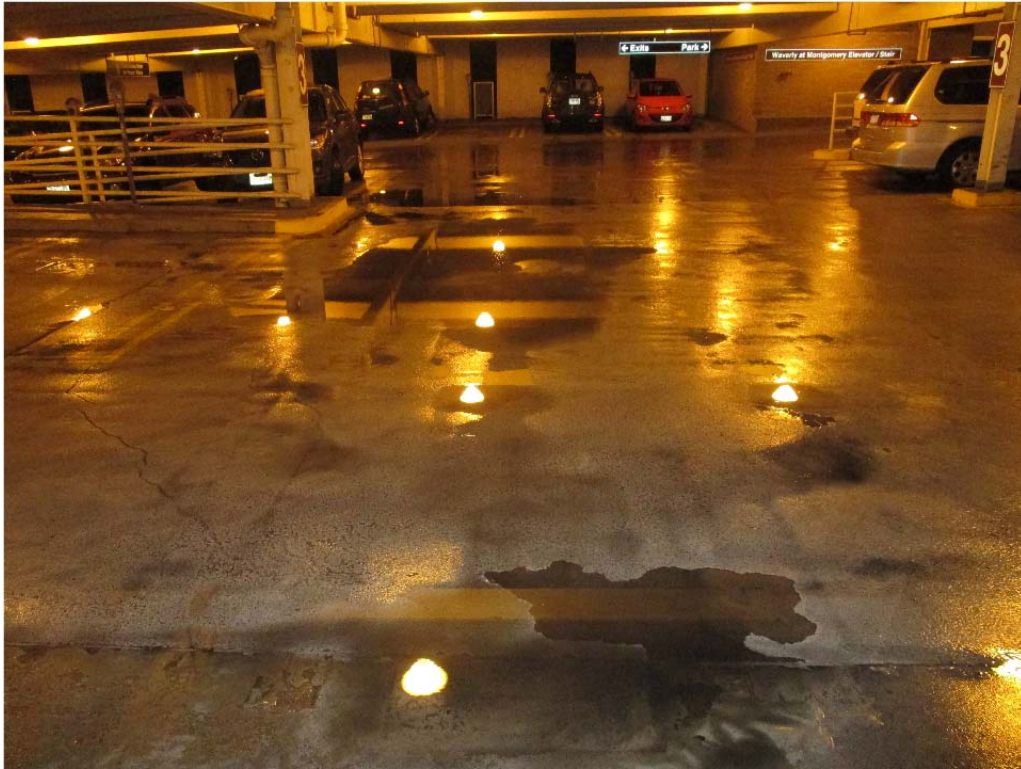
Photo No. 9

- **Leakage and Ponding:** The garage was revisited during a period of extended rain in order to better examine the location of leakage and ponding. The ponding locations are noted on the drawings for this phase and shown in Photo No. 9.

Areas of Ponding – Garage 47

Areas of ponding observed during extended periods of rain.

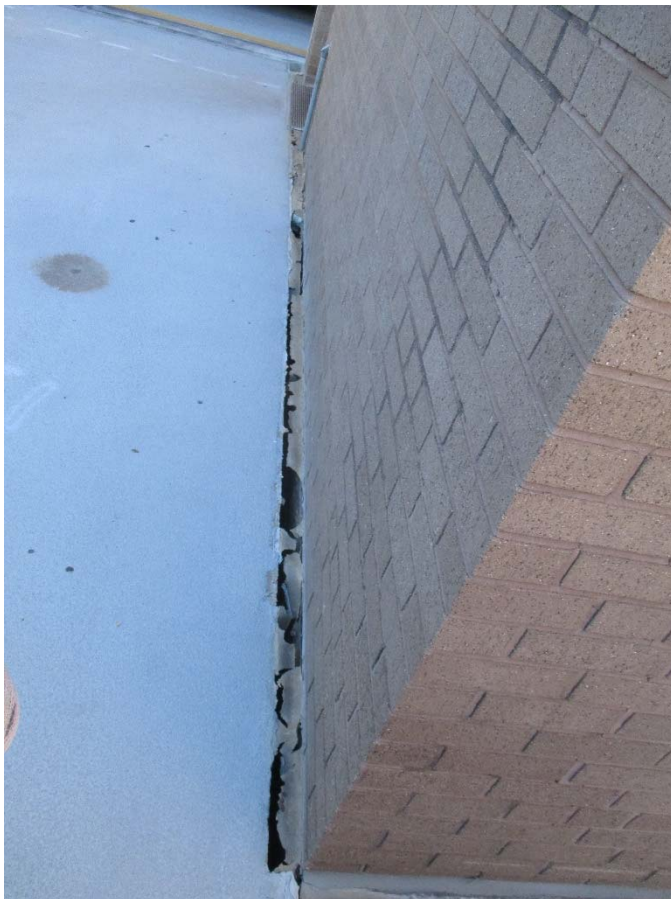
Photo No. 10

- **Expansion Joints:** The expansion joints around the perimeter of the north center stair tower were heavily damaged on Levels 3 and 4 (Photo No. 10).

Expansion Joint Damage at Stair Tower

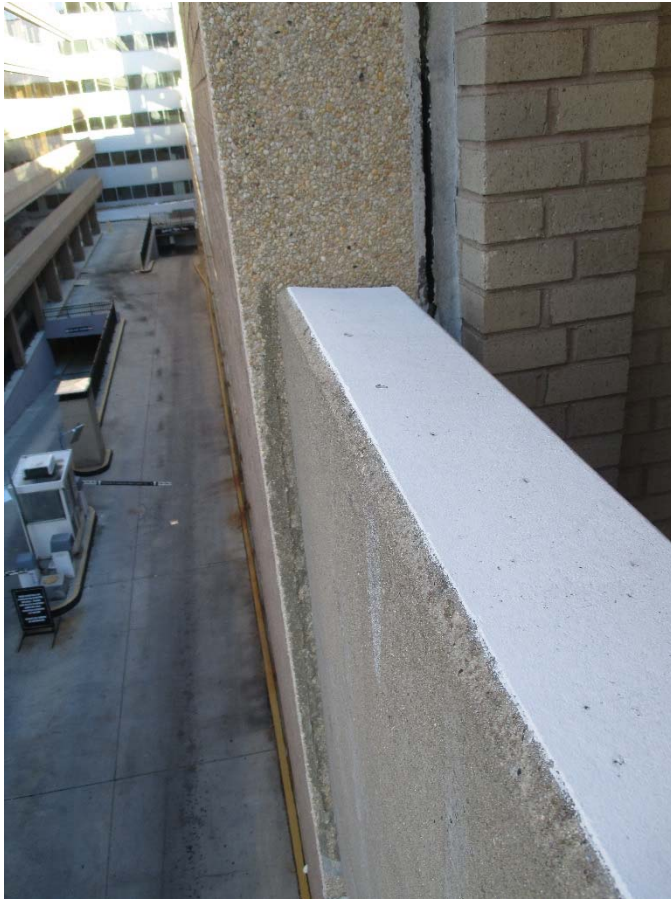
Photo No. 11

Exterior Wall Movement at North Center Stair Tower

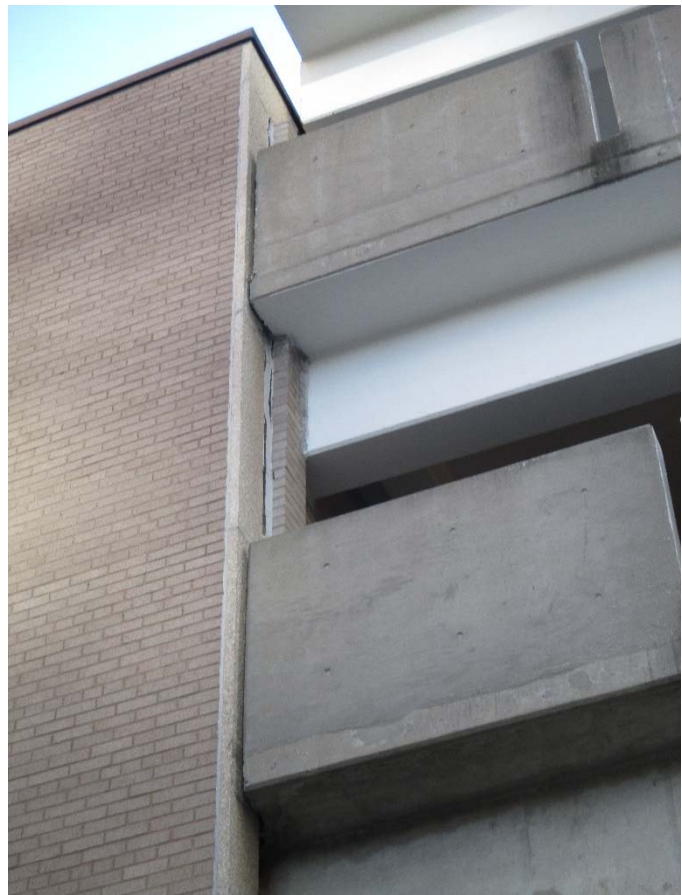
Exterior Wall Movement at North Center Stair Tower

Note the sealant in the vertical joint between the walls has torn open due to the outwards movement of the exterior wall.

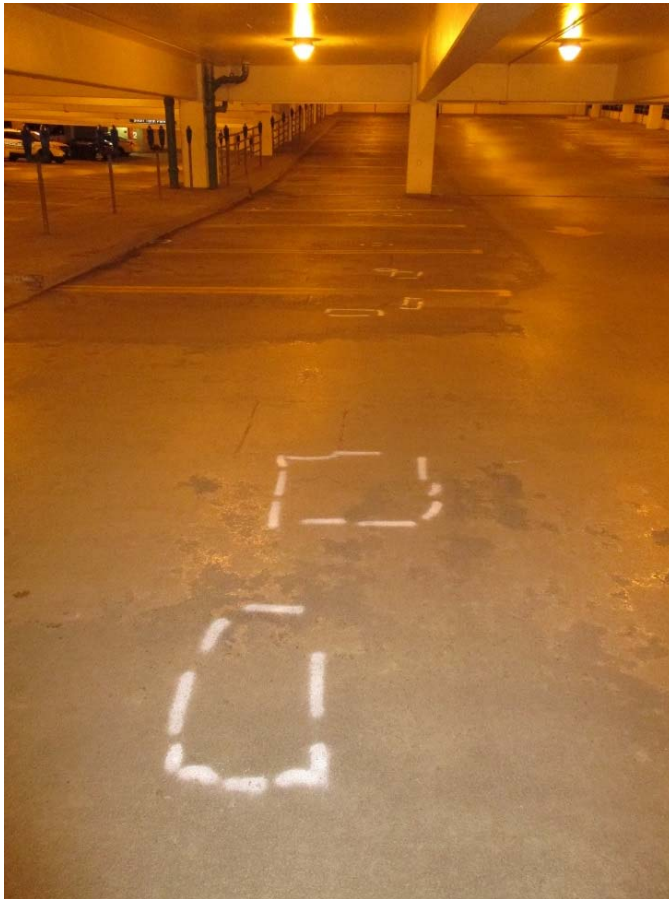
Photo No. 13

- **Slab Surface Damage:** Some minor areas of delaminated concrete were detected on all levels of this phase of the garage (Photo No. 13).
- **Slab Soffit Damage:** A few areas of delaminated concrete were found on the soffit of the Level 7 slab.
- **Concrete Beam and Column Damage:** One area of beam soffit damage and a few areas of column face damage (Photo No. 14) were found. Also some cracking on the face of a Level 7 column were observed but this area had not delaminated.
- **Knee-Wall Damage at Railing:** Delaminated and spalling concrete was found at numerous locations where the guardrail posts were embedded into the knee-wall along the north side of this phase of the garage (Photo No. 15). Rust stains at these locations indicated that the embedded ends of the posts and/or embedded metal sleeves at the post bases were corroding.

Slab Surface Delamination

Garage #47A: This phase generally had less delamination than the older phase (Garage #47). The white rectangles in the photo show the detected delaminated areas.

- **Damaged Slab Areas:** The extent and amount of damage in this phase of the garage is much less compared to Garage 47. As a result, partial-depth spot repairs are recommended for both the soffit and surface damage observed in this phase.

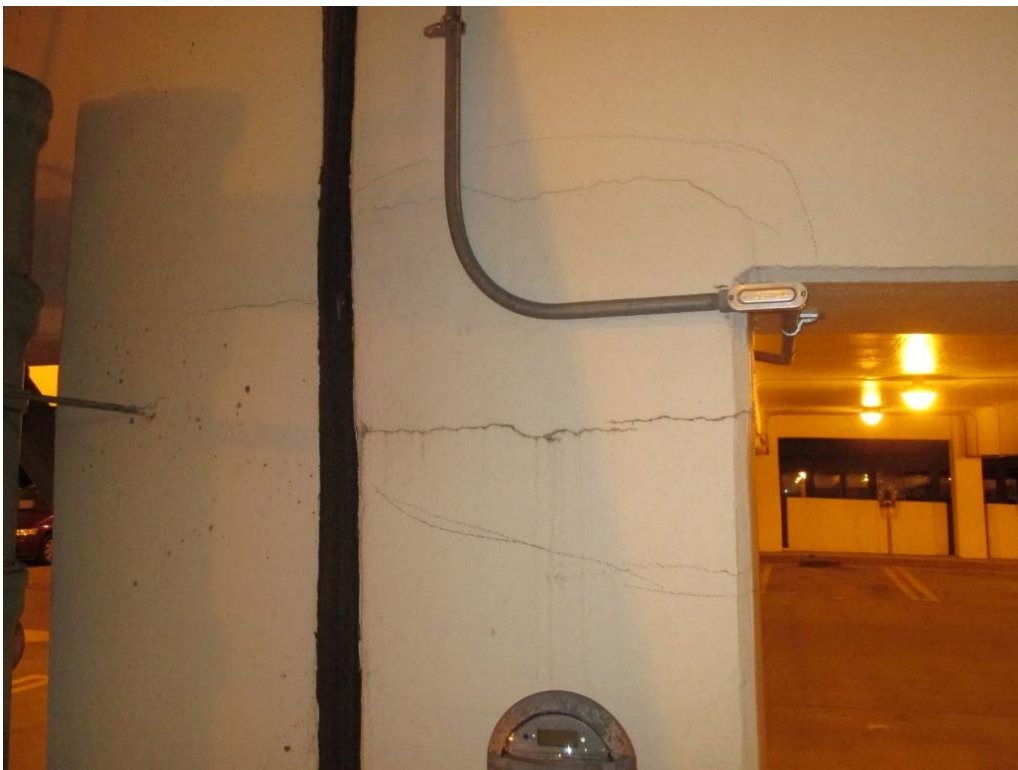
Photo No. 14

Concrete Column Face Delamination – Garage 47A

Concrete delamination was detected on the column face and marked with black chalk.

- **Concrete Beam and Column Damage:** The existing beam and column damage should be repaired.
- **Deck Coating:** To insure continued effectiveness of the coating in this phase of the garage, the new damaged areas of coating should be repaired and a new topcoat should be applied over the lower three (3) levels of the garage. Some consideration should be given to applying a coating to the few slab areas which are currently uncoated.

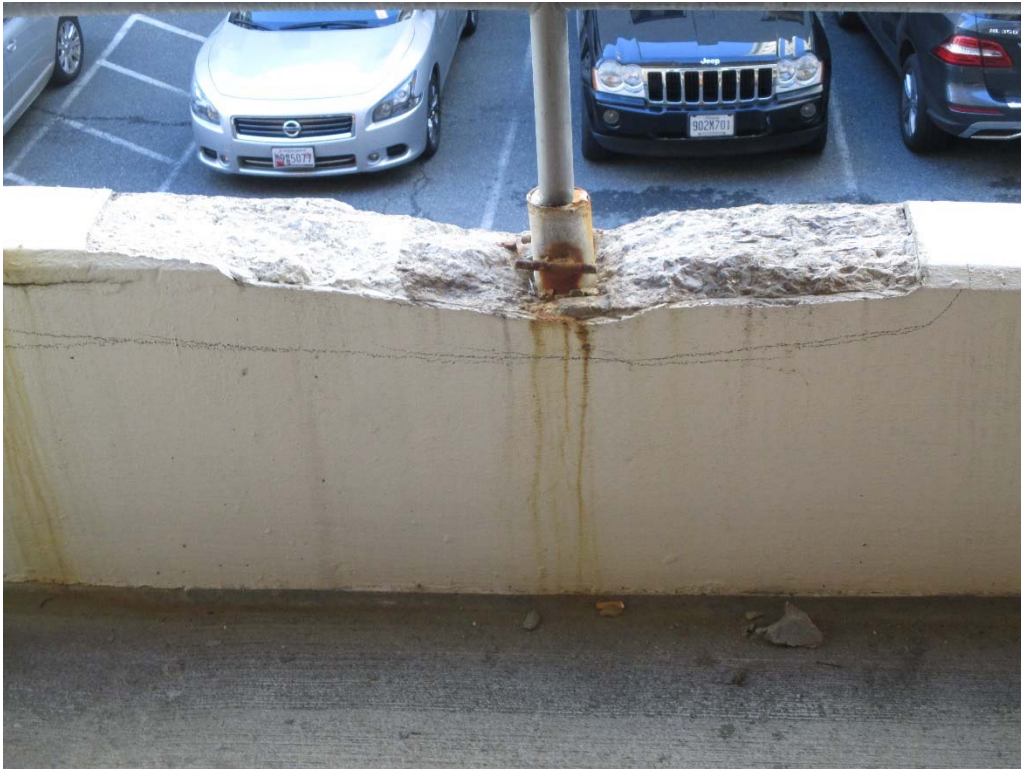
Photo No. 15

Concrete Knee Wall Damage – Garage 47A

The corrosion of the embedded guardrail post sleeve has caused the knee wall concrete to spall.

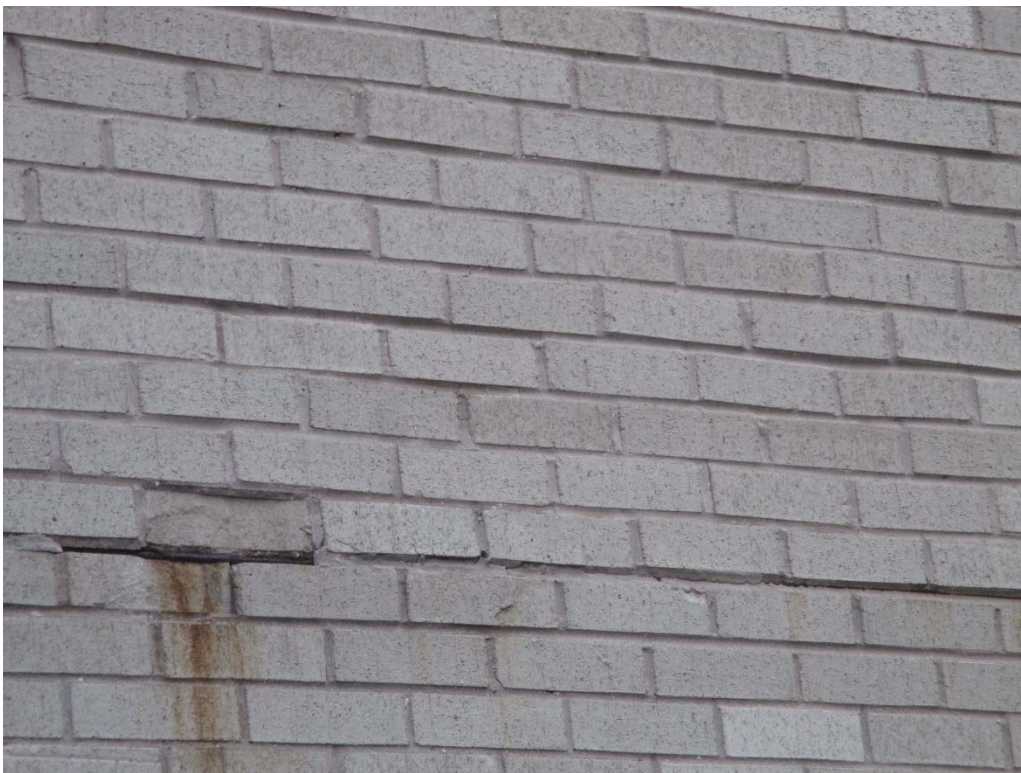
Photo No. 16

- **Stair/Elevator Tower Walls:** The apparent ineffective flashing and/or weeps placed in the brick walls at the ledger angles have allowed water to corrode the angles. The corrosion of these steel ledger angles causes the steel to expand. The expansion of the vertical legs of the angles pushes the brick outwards while the expansion of the horizontal legs of the angles pushes both upwards on the brick above the angle and downwards on the brick below the angle. Since no soft joint was

provided under the ledger angles, this vertical expansion of the horizontal angle legs causes the brick between the angles to be compressed, resulting in the observed spalling of the brick. The horizontal expansion of the horizontal angle legs also pushes out the mortar placed across the ends of the angles, causing it to crack and spall.

Typical Wall Damage at Ledger Angle

The mortar and brick are spalling along the ledger angle. Note the rust stains from the corroding angle.

These conditions should therefore be repaired by exposing, cleaning and repainting the ledger angles and then installing proper flashing, weeps and a soft joint when the brick is replaced.

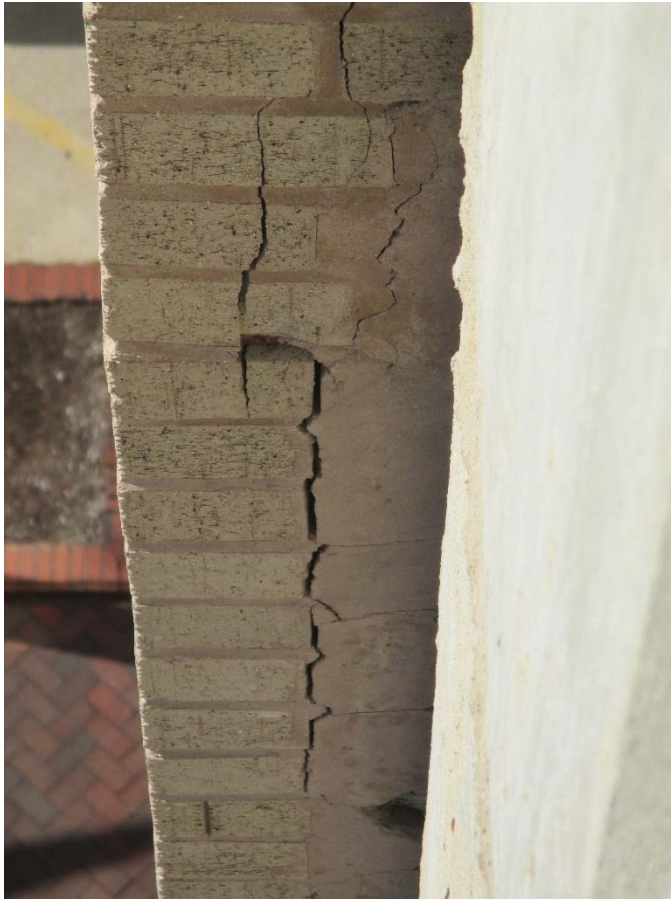
Photo No. 17

Typical Wall Damage at Ledger Angle

The brick is being pushed outwards by the corrosion of the ledger angle.

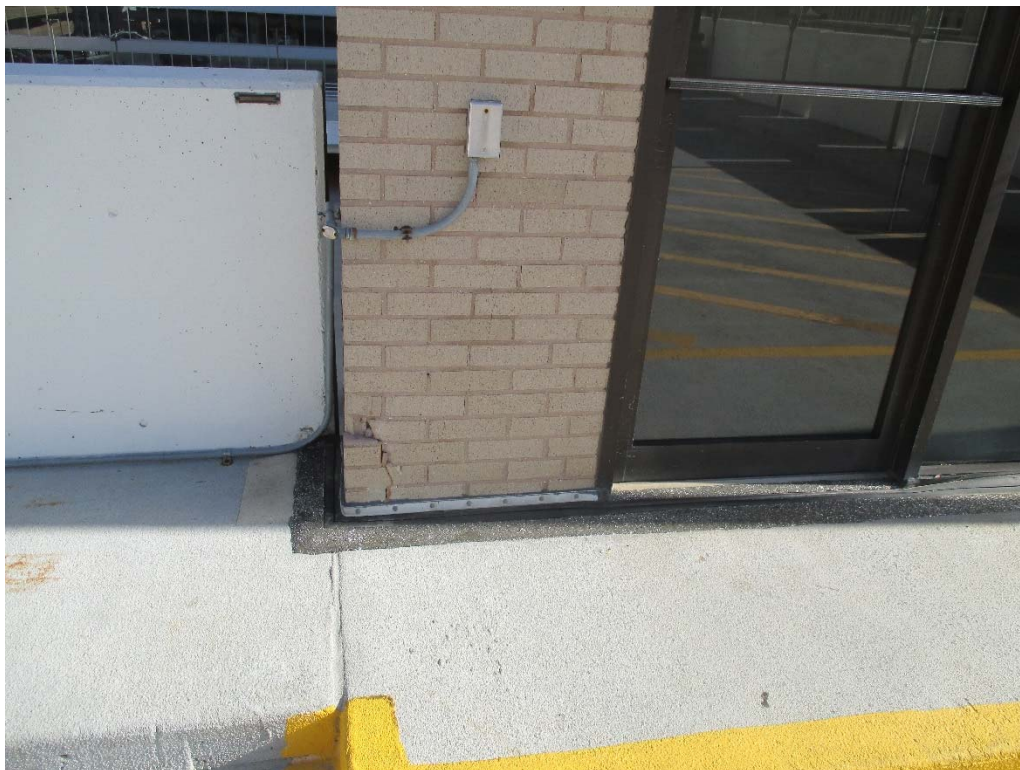
Photo No. 18

Typical Brick Wall Damage

The corner of the brick wall is spalling and cracked vertically.

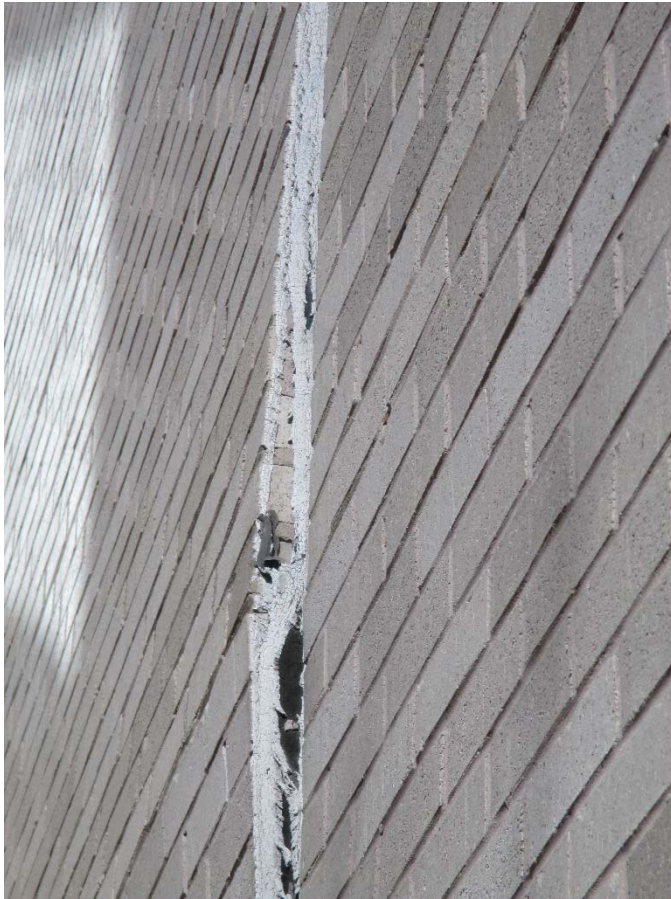
- **West Exterior Wall:** The bulged brick on this wall appears to be an advanced example of the corrosion-related ledger angle expansion discussed above. Due to the extent of the outwards movement of the brick, it appears that the brick is in imminent danger of falling off of the ledger angle. This area of the wall should therefore be rebuilt as soon as possible.
- **Stair Coatings:** There were no obvious concrete repairs made to the stairs prior to the application of the coating, so the need for the coating is not clear. However, since the coating is already present, the worn areas should be repaired in case the protection provided by the coating is required.

Photo No. 19
Bulging Brick at West Wall

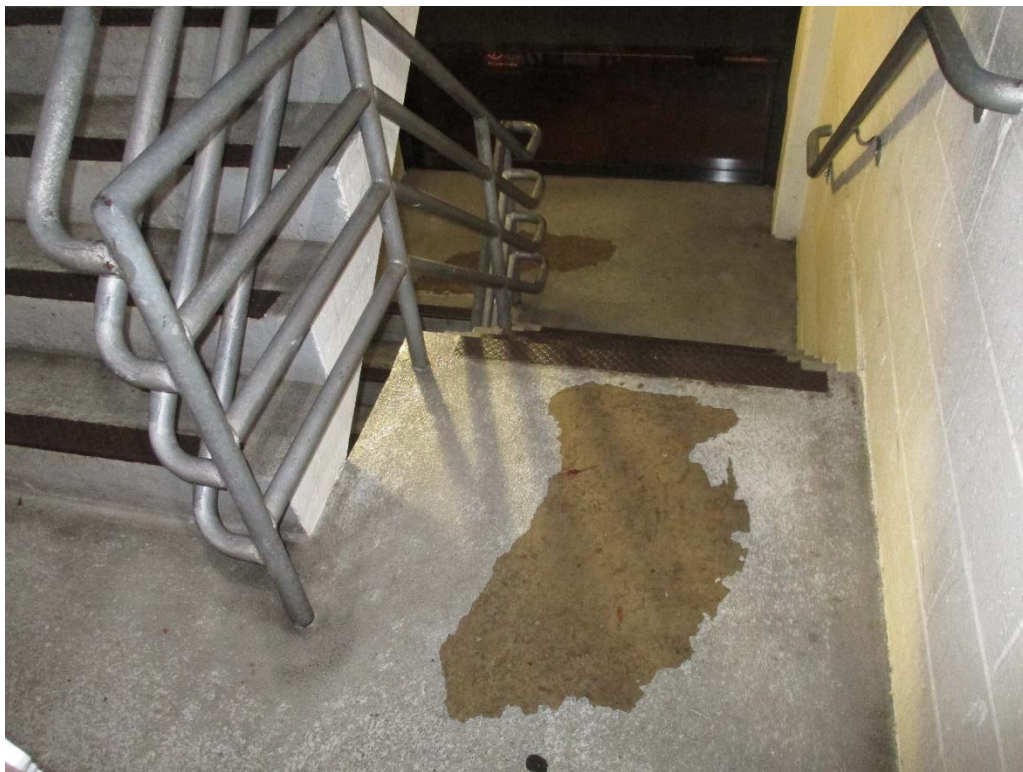
- **Stair Coatings:** A deck coating has been placed on the treads and landings of the stairs in this phase. It is typically in good condition above Level 3, but begins to exhibit worn and/or torn areas at various locations at the lower levels in all stairs (Photo No. 20).

Photo No. 20
Typical Deteriorated Stair Coating

Urethane coatings, however, are not typically applied to slabs-on-grade since moisture vapor coming up through the slab from the ground will typically cause the coating to fail as is evident at the ground floor at all three of these stairs. These slabs-on-grade also typically do not have much reinforcing steel in them to corrode, so there is no real need for a coating to prevent corrosion-related damage. For these reasons, we recommend that the remnants of the existing coating on the ground floor slabs just be removed and no new coating applied there.
