Pedestrian Road Safety Audit Public Document

MD 97 (Georgia Avenue) at Randolph Road

Montgomery County
July 2014

STV Incorporated
Baltimore, Maryland

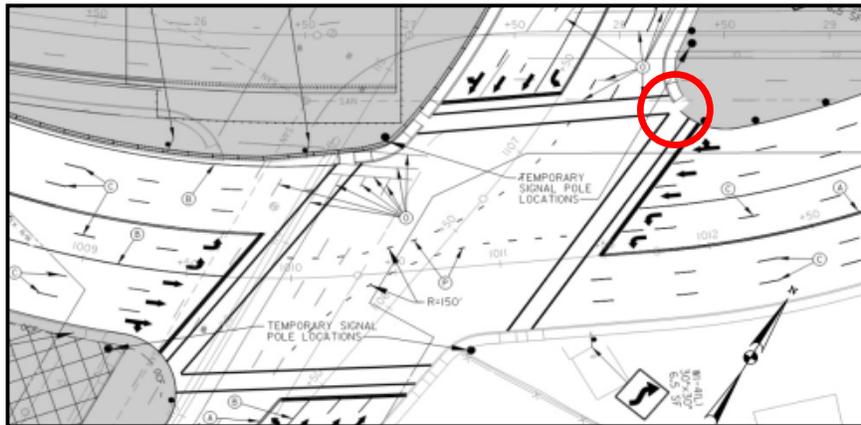
Figure 9: Discontinuity of Pedestrian Path – Phase 2A

Some of the pedestrian paths were obstructed and/or were not ADA accessible as shown on the plans. For example, as shown in **Figure 9**, the sidewalk on the northeast corner of the MD 97 at Randolph Road intersection did not extend around the radius of the curve. This may cause difficulty for the physically disabled to access the ramps and may lead pedestrians into the work zone. Therefore, it was recommended that the sidewalk be extended around the corner. Similar changes were recommended for any other obstructed or non-accessible pedestrian paths. In response, SHA added additional construction fencing and signs to clearly delineate the pedestrian pathway.

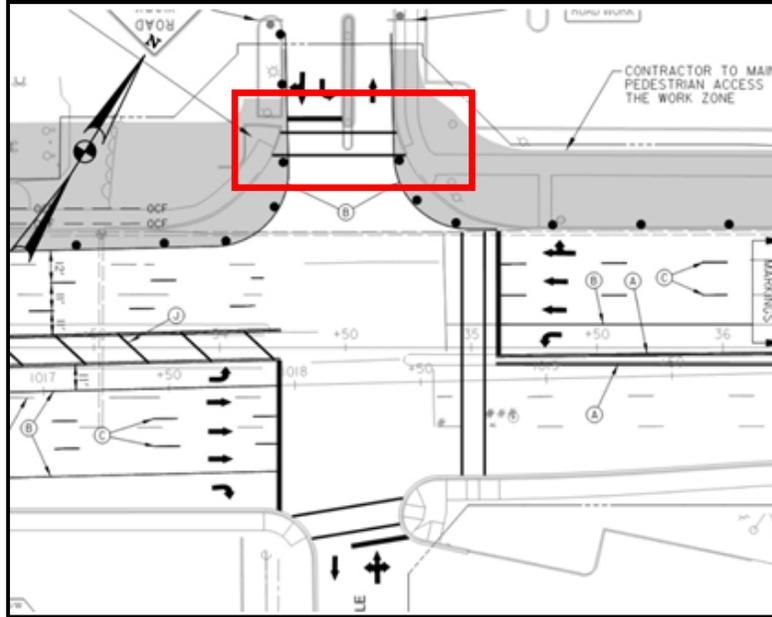
Figure 10: Inadequate Crosswalk and Pedestrian Related Signage

Crosswalks and pedestrian-related signage were not identified at some intersections and crosswalks. For example, during MOT Phase 2A at the Randolph Road at Glenmont Circle intersection, the pedestrian crosswalk on the north leg appeared to be too far removed from the intersection (**Figure 10**). With excess distance between the crosswalk and the intersection, westbound right-turning vehicles may not be aware of pedestrians in the crosswalk. It was suggested that “Watch for Pedestrians” or “Turning Traffic Yield to Peds” signs be installed on the westbound approach, and at any other similar location. In response, SHA added additional signs to notify vehicles of the presence of pedestrians.

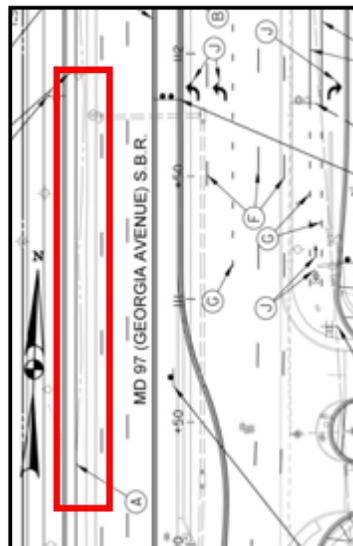
Figure 11: Lack of Bicycle-Related Markings

Some of the bicycle facilities were not marked appropriately. For example, pavement markings were not proposed for the southbound bike lane on MD 97 south of Randolph Road (Figure 11). As a result, motorists may not interpret the designated area as a bike lane and may not yield to bicycle traffic. It was recommended that “Bike Lane” pavement markings be installed along southbound MD 97 and any other designated bike lanes which were not marked. In response, SHA reviewed the pavement markings for bike lanes and ensured that all of the pavement markings for bike lanes conformed to SHA’s 2013 Bicycle Policy and Design Guidelines.

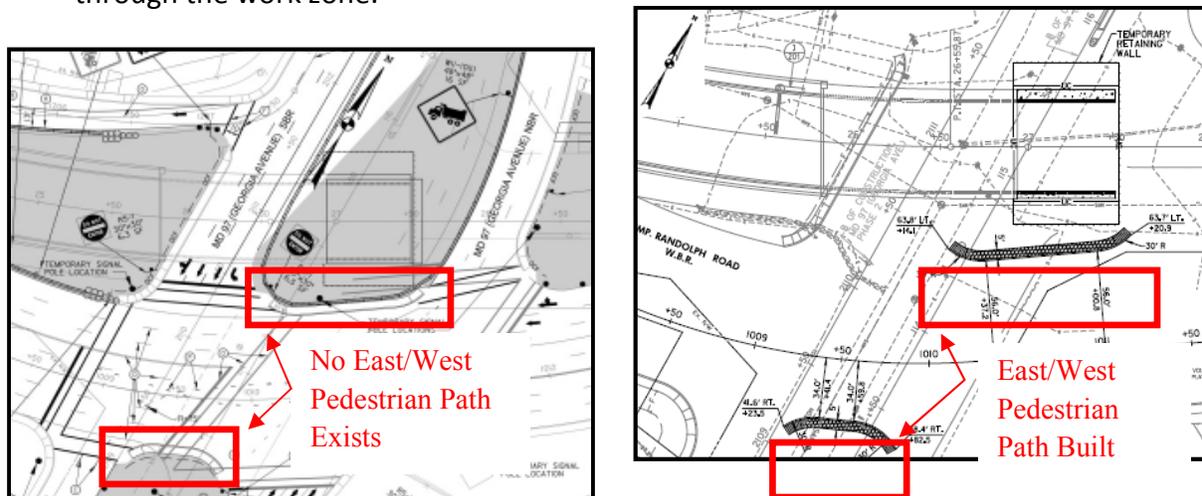
Figure 12: Sequence of Construction (MOT Phase 3 (Left) and Temporary Roadway Plan Phase 3A (Right))

The sequence of construction did not show when roadway, sidewalks, or other items were to be constructed in some locations. For example, Phase 3 of the MOT was not consistent with temporary roadway plans for Phase 3A at the intersection of MD 97 at Randolph Road (**Figure 12**). Both the north and south median sidewalks were being constructed in Phase 3A; however, MOT Phase 3 indicated the sidewalks were temporary for pedestrian crossings. Since the sidewalks were not constructed, pedestrian paths under MOT Phase 3 were not clearly defined for the east/west pedestrian path through the intersection. Therefore, it was recommended that the phasing of construction be modified to construct the north median first followed by the south median, so that there will be an east/west path available through the intersection. Any other locations with a similarly unclear path were also recommended for modification. In response, SHA reviewed the sequence of construction to ensure that the contractor will be maintaining pedestrian access through the work zone.

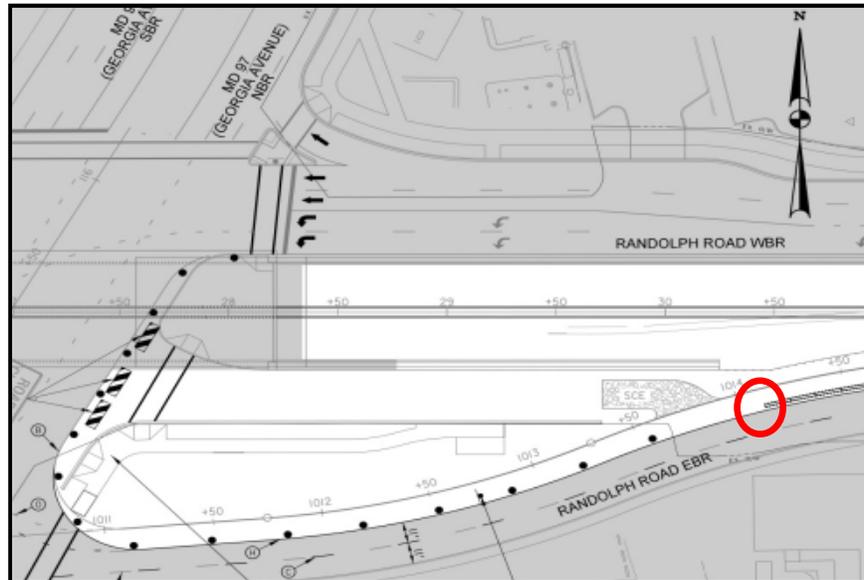
Figure 13: Inadequate Work Zone Protection

Adequate protection was not provided for some of the work zone areas. For example, during MOT Phase 5B, there was no crash cushion specified for the western end of the temporary concrete barrier east of the intersection of MD 97 at Randolph Road (**Figure 13**). It was recommended that an impact attenuator be installed at the end facing into the flow of traffic at this location. In response, SHA added an impact attenuator at this location.

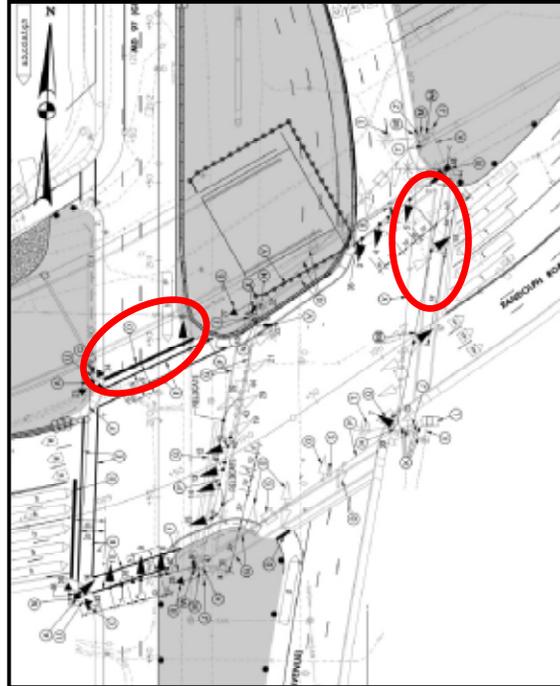
Figure 14: Need for Additional Signal Indicators

During MOT Phase 3, only one three-section signal head was provided on the near side of the intersection for all through movements at MD 97 at Randolph Road. Due to the curvature of the road and the distance of the traffic signal heads from the opposing intersection approaches, one near sided signal head may not be adequate (**Figure 14**). Therefore, it was recommended that a second near side signal head be installed for through movements on all approaches with curvature. In response, SHA agreed to add an additional near side signal head to the southbound approach.

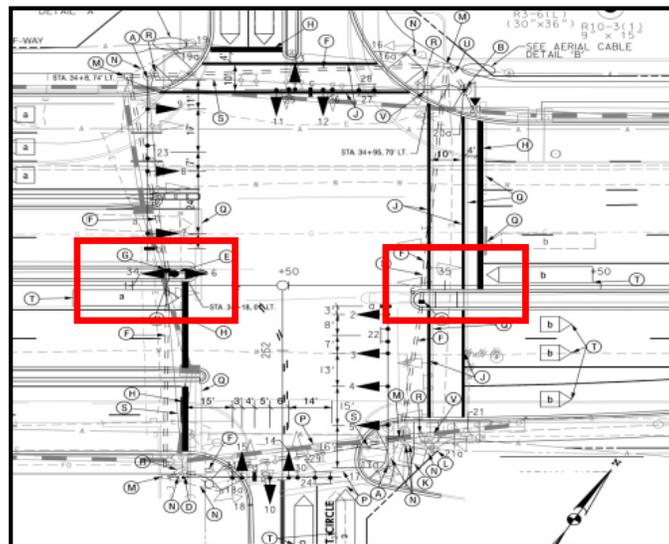
Figure 15: Inadequate Turning Radii

At the intersection of Randolph Road at Glenmont Circle, the proposed east and westbound U-turn radii appeared to be limited and may not have been adequate to complete a U-turn maneuver (**Figure 15**). It was suggested that U-turns be prohibited for the east- and westbound directions. In response, SHA altered the traffic signal phasing to include an exclusive east- and westbound left turn movement, removing the need to prohibit U-turn maneuvers.

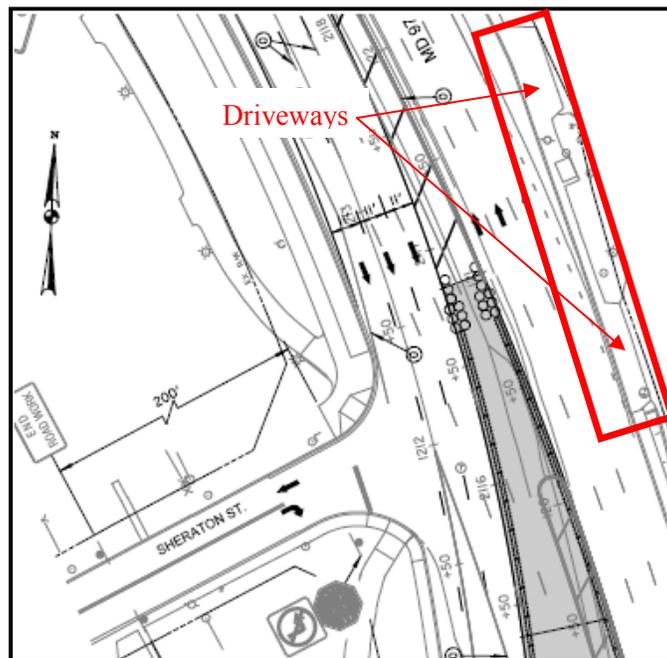
Figure 16: Lack of Signage for Left-Turn Prohibitions

Movement prohibition signage informs drivers of illegal and unsafe turning movements. Lack of appropriate movement prohibition signage or confusing signage may impact safety. For example, the driveways on the east side of MD 97 north of Sheraton Street did not have signage restricting left turns exiting the driveways (**Figure 16**). Since the existing median along MD 97 will be removed during some construction phases, vehicles from the driveways could attempt to make left turns onto southbound MD 97. In order to prevent this maneuver, it was suggested that “No Left Turn” signs and/or “Right Turn Only” signs and “One Way” signs be installed to guide vehicles exiting these driveways. In response, SHA added the additional movement prohibition signage at this location.

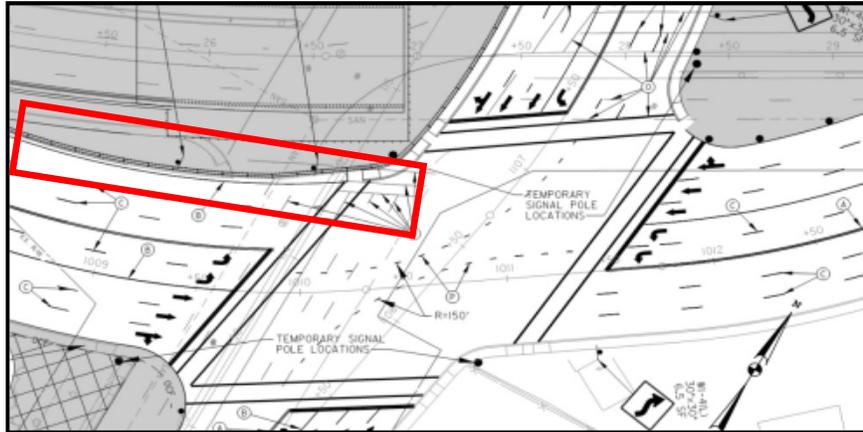
Figure 17: Lack of Pedestrian Detour Signage

Without appropriate signage, roadway and sidewalk closures may lead to pedestrian and/or driver confusion. One such situation was found on MOT Phase 2A plans at the intersection of MD 97 and Randolph Road. No pedestrian detour signage was proposed between MD 97 (Georgia Avenue) and Judson Road north of Randolph Road, where the

sidewalk will be closed. Without pedestrian detour signage, pedestrians may attempt to cross at an unmarked location and travel through the construction zone to reach Judson Road (**Figure 17**). “Sidewalk Closed” signs were recommended at this location, along with pedestrian detour signs on the northwest corner of the MD 97 and Randolph Road intersection leading pedestrians to access Judson Road from Sheraton Street. Any other similar sidewalk closures and pedestrian detours were recommended for additional signage. In response, SHA added additional signage to detour pedestrians in the westbound direction.

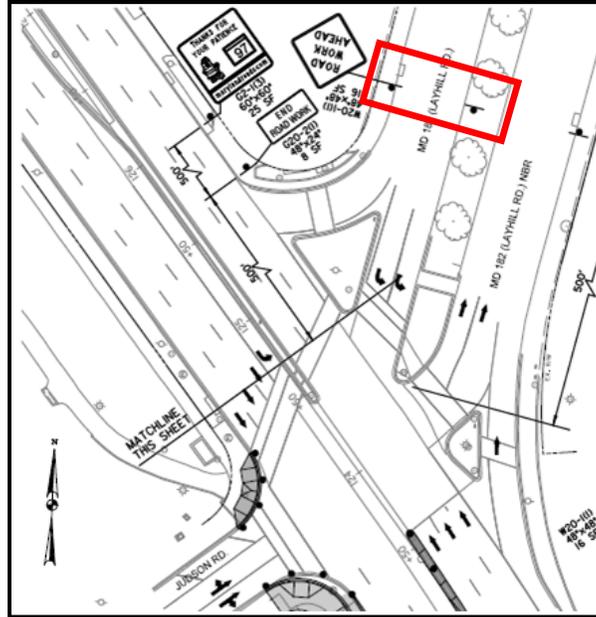
Figure 18: Work Zone Signage Location

During MOT Phase 1A, the “Road Work Ahead” sign proposed on the westbound approach of the Layhill Road intersection with MD 97 appeared to be too close to the intersection (**Figure 18**). This may not have given adequate advanced notice regarding the work zone for motorists, in particular the westbound left-turning vehicles, to be prepared for the change in conditions. The “Road Work Ahead” sign on the westbound approach was recommended to be moved further ahead of the intersection. In response, SHA identified the offset dimension from the intersection to the sign and added clarification on the sign in the median of Layhill Road.

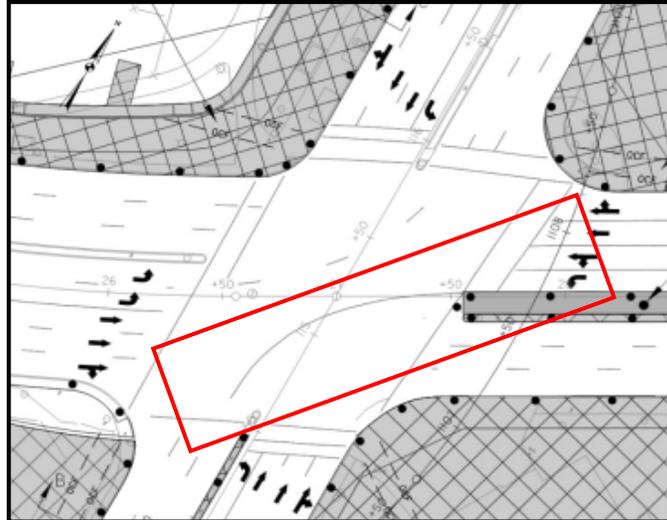
Figure 19: Example of Lack of Pavement Markings

During MOT Phase 1B at the intersection of MD 97 at Randolph Road, no temporary lane line extension markings were provided for the westbound dual left-turn lanes (**Figure 19**). Without designated lane markings, there was potential that two westbound left turning vehicles in adjacent lanes could collide. Therefore, it was recommended that lane line extension markings be installed through the intersection to provide positive guidance for the westbound left-turning movements. In response, SHA added temporary lane extension pavement markings for the westbound dual left turn lanes.

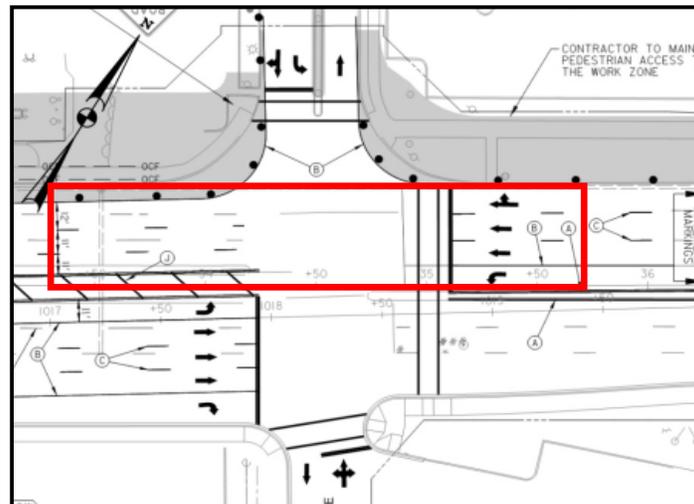
Figure 20: Lack of Pavement Markings for Lane Shift

During MOT Phase 2A the westbound through lanes shift slightly through the intersection of Randolph Road at Glenmont Circle (**Figure 20**). An unexpected shift in lanes can lead to side swipe collisions. It was suggested that lane line extension markings be installed through the intersection for the westbound through lanes. In response, SHA reviewed the alignment of westbound through movements and determined that lane line extension markings were not necessary.

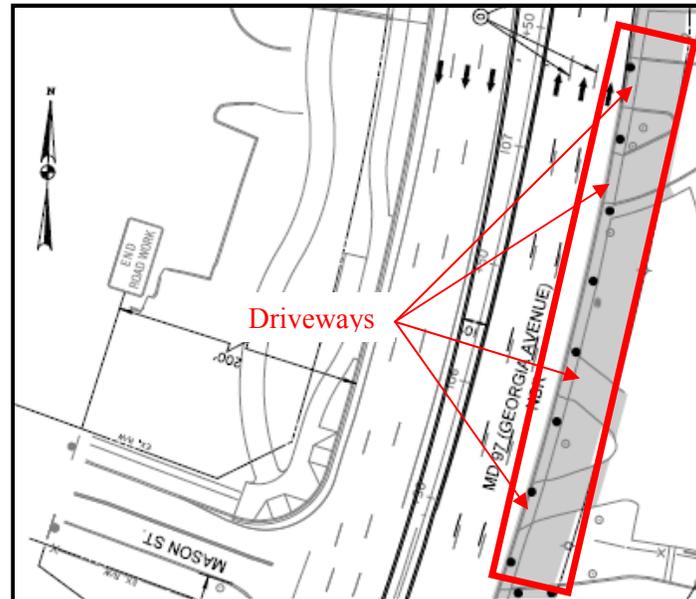
Figure 21: Lack of Driveway Access

Access to commercial properties and driveways was not clearly defined during some of the MOT phases. For example, the commercial driveways on the east side of MD 97 north of Mason Street were shown as part of the work zone area during MOT Phase 4A (**Figure 21**). Drums to delineate access to all commercial businesses were recommended throughout the work zone for this and any other similar areas. In response, SHA added additional drums to identify driveways and maintain access.

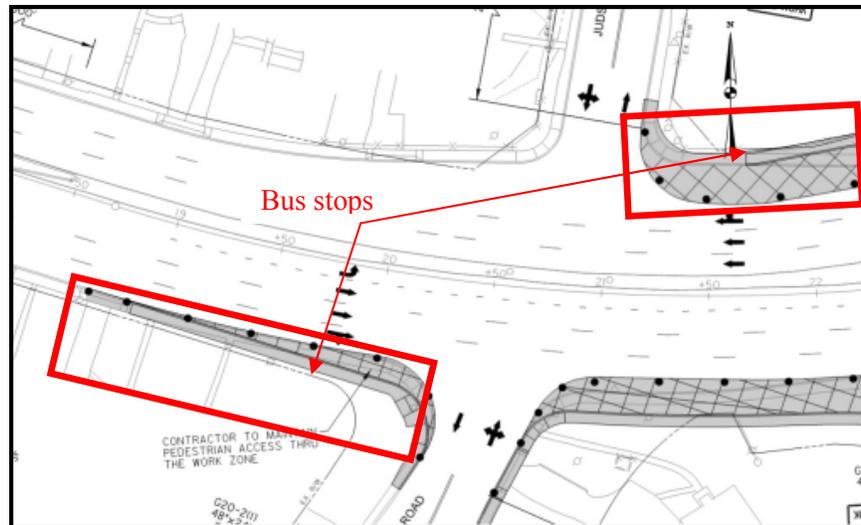
Figure 22: Accessibility Issues to Bus Stop

Based on a review of the design plans, several bus stop locations were impacted by the work zone. However, it was not clearly identified if and how these facilities would be maintained. As an example, during MOT Phase 1A on Randolph Road near Judson Road, there are existing bus stops located in the work zone (**Figure 22**). Improper or inadequate waiting areas and paths may block the sidewalk for pedestrians, and riders wanting to board the bus may have to traverse the construction zone. It was recommended for this location and any other similar locations, that waiting areas and clear access to/from the bus be provided. In response, SHA coordinated with Montgomery County and WMATA, and all temporary and permanent bus stops have been modified as necessary to provide appropriate access.

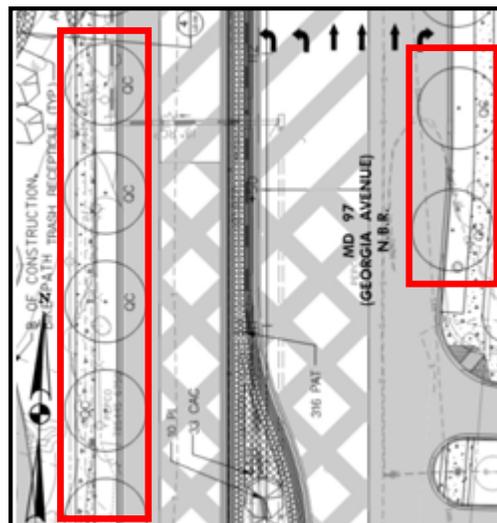
Figure 23: Landscaping Interference with Pedestrian/Vehicle Operations

Some of the landscaping and lighting details on the design plans appeared to potentially interfere with pedestrian/vehicular traffic operations. For example, the proposed trees in the landscaping plans along north- and southbound MD 97 appear to be in close proximity to the roadway (**Figure 23**). Given the proportion of large vehicles using this roadway, trees may be struck by trucks, potentially leading to sudden avoidance maneuvers and damage to street trees. Therefore, it was recommended that appropriate species of trees and foliage be chosen to minimize encroachment on the roadway, and/or consider the feasibility of relocation (or removal) of the proposed trees to avoid interference with large vehicles for this and any other similarly situated plantings. In response, SHA reviewed the proposed tree placement and changed the placement to reduce encroachment on the roadway.
