Old Georgetown Road Pedestrian Road Safety Audit Montgomery County, Maryland

Prepared For:
Department of Transportation
Montgomery County, Maryland

November 2014

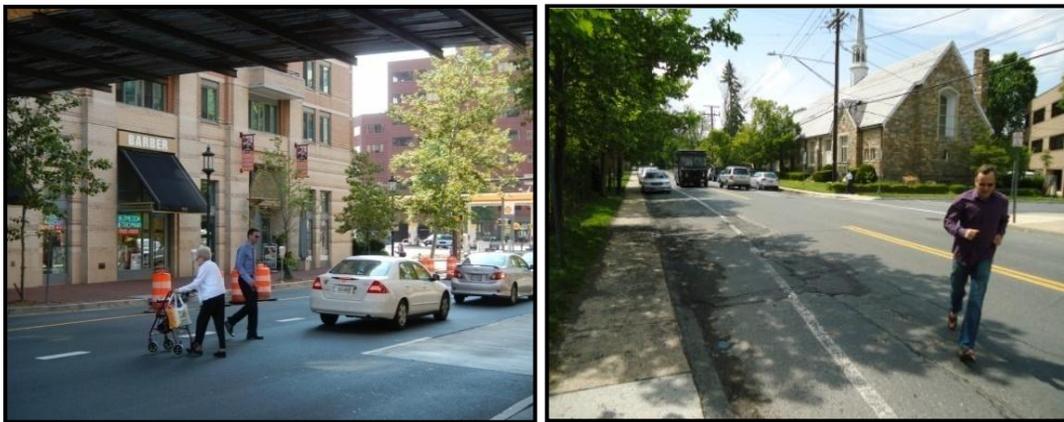
Figure 12: Uncontrolled Midblock Crossings

Uncontrolled midblock crossing activity was observed at multiple locations throughout the study area and was identified as a contributing factor to several pedestrian crashes. The location of various land uses, location of bus stops, distances between marked crossings, signal cycle lengths, and the lack of street furniture or planter boxes contribute to midblock crossings.

Left: Pedestrians crossing midblock on Old Georgetown Road near the pedestrian bridge.

Right: Pedestrian crossing Wilson Lane east of the intersection.

The audit team recommends the installation of pedestrian and bicycle warning signage at midblock locations in addition to the installation of continuous planter beds with barriers/fencing with landscaping in sidewalk areas along Old Georgetown Road to reduce the amount of uncontrolled midblock crossing activity. Further, the potential to provide designated midblock crossings at select locations should be coordinated with MDSHA. In order to promote the use of the pedestrian bridge that crosses Old Georgetown Road, the need for trailblazing signage within the Montgomery County parking garage directing patrons to use the bridge should be evaluated. Lastly, a pedestrian education program should be considered at adjacent land uses as well as coordination with the Montgomery County Police Department to ensure appropriate levels of enforcement.

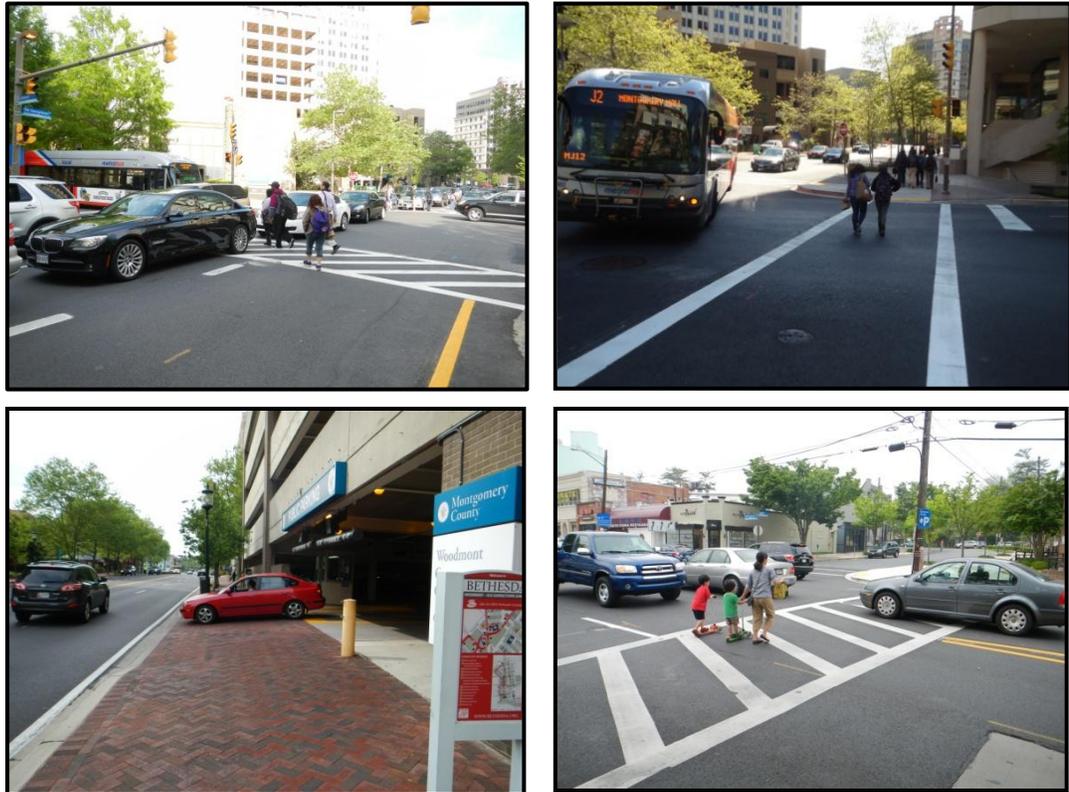
Figure 13: Pedestrian-Vehicle Conflicts

Pedestrian-vehicle conflicts, not including those involving uncontrolled midblock crossings, often involve vehicles turning at the intersection and nearby access points. In many locations, drivers appeared to place more focus on finding acceptable gaps in traffic to make their maneuver than to potential pedestrian and bicycle activity. A combination of factors including frequency of turning movements, pedestrian volume, vehicle speeds, signal phasing/timing settings, and sight distance limitations also contribute to conflicts.

Upper-left: Conflict between pedestrians in Old Georgetown Road crosswalk and northbound queued vehicles encroaching on the crosswalk. Upper-right: Conflict between pedestrians in crosswalk and a northbound left-turning bus. Lower-left: Vehicle exiting Woodmont Corner Garage and waiting for an acceptable gap in Old Georgetown Road traffic. Lower-right: Pedestrians crossing at crosswalk through traffic on Old Georgetown Road.

The PRSA team identified a number of suggestions to reduce pedestrian-vehicle conflicts including but not limited to installing signage to improve driver awareness of pedestrians at intersections; installing high visibility crosswalks where necessary; installing pavement markings to provide additional guidance to motorists; and considering potential geometric roadway improvements to reduce pedestrian crossing distances, improve pedestrian refuge spaces, and/or reduce vehicle turning speeds. Potential signal improvements to be evaluated and coordinated with MDSHA include traffic signal reconstruction to improve signal head visibility, signalization at the intersection of Old Georgetown Road at Cordell Avenue, restriction of select turning movements during peak periods, and the implementation of lead pedestrian intervals.

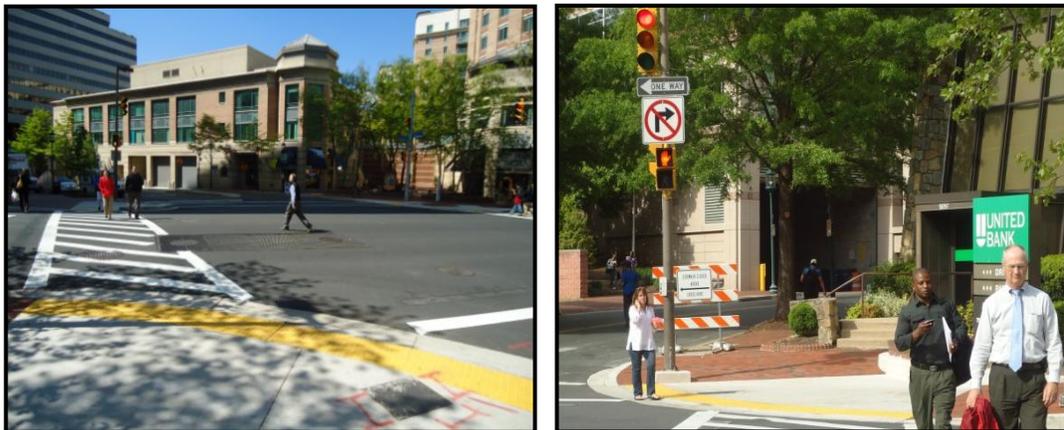
Figure 14: Limited Pedestrian Compliance with Signals

Pedestrians were frequently observed violating pedestrian signals throughout the study area. In many instances, pedestrians were observed crossing during Don't Walk intervals. Pedestrian confusion at intersections with unique signal phasing may have contributed to the violation of pedestrian signals.

Left: Pedestrian crossing diagonally through the intersection. Right: Pedestrians crossing during the Don't Walk phase.

In order to improve pedestrian compliance with signals, the PRSA team recommends coordinating with MDSHA to pursue installing APS with education signs, audible messages and push-buttons that indicate when the pedestrian call is actuated. Also, it is recommended that community-based educational efforts be considered in addition to ensuring that appropriate levels of enforcement are provided to deter pedestrians from violating signals.

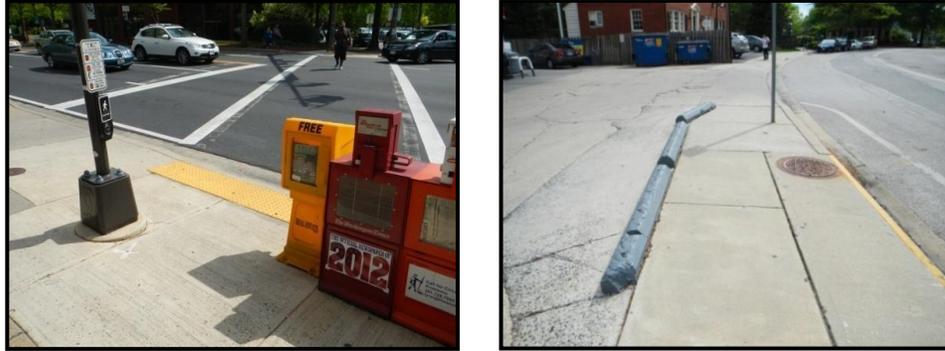
Figure 15: Pedestrian Facility Limitations

A number of issues related to pedestrian facilities were observed during the audit. Examples include a lack of detectable warning surfaces, narrow effective sidewalk widths caused by obstructions, crosswalk skew, and congested median refuge areas.

Left: Newspaper distribution bins blocking the south leg pedestrian crossing. Right: Parking curb on the south side of Moorland Lane.

In order to comply with the Americans with Disabilities Act (ADA) requirements, it is recommended that detectable warning surfaces be installed, where necessary. Objects that currently block pedestrian sidewalks and crosswalks should also be removed to provide a clear path of travel without obstructions.

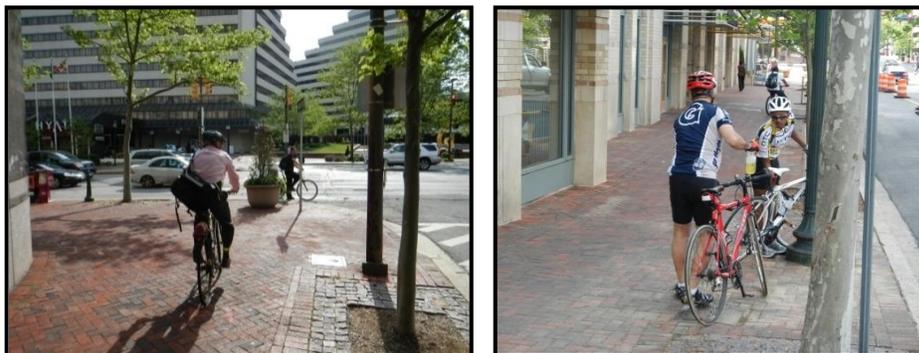
Figure 16: Bicycle Facility Limitations

The team observed many cyclists riding on the sidewalks throughout the study, and it was noted during the stakeholder meetings that this is largely due to the lack of bicycle facilities. Although bikes are not prohibited on sidewalks, the behavior presents a safety issue for both cyclists and pedestrians. During the field review, cyclists were observed both on sidewalks and within the roadway.

Left: Bicyclist activity along the sidewalk. Right: Bicycles chained to poles on the northwest corner of the intersection.

In order to reduce the number of bicyclists utilizing sidewalks, it is recommended that the potential to incorporate bicycle facilities along Old Georgetown Road be evaluated with applicable stakeholders. Signage and pavement markings should also be installed to designate shared roadway status between vehicles and cyclists. Lastly, bicycle racks should be installed along Old Georgetown Road to provide short-term parking for bicyclists.

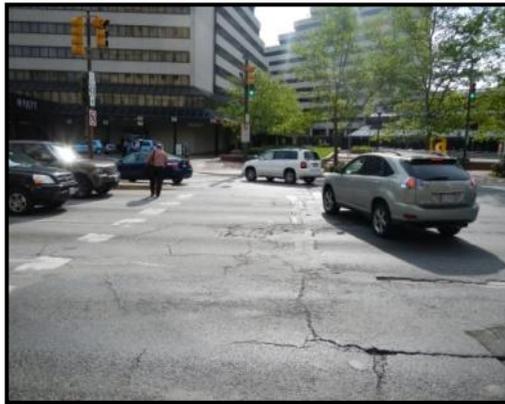
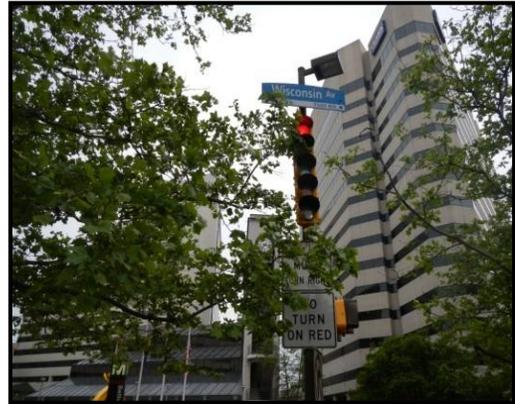
Figure 17: Bicycle Facility Limitations

A number of conditions potentially contributing to pedestrian safety issues that could be resolved through maintenance improvements were observed. Such issues include deteriorating pavement and pavement markings, faded signage, overgrown vegetation, and a non-functioning pedestrian signal head.

Left: Pavement conditions within the intersection of Old Georgetown Road at Wisconsin Avenue/East West Highway. Right: Overgrown trees near the signal head for East West Highway approach.

The safety concerns listed above can be improved with periodic maintenance measures including replacing faded signage when necessary, trimming overgrown vegetation around signal heads, restriping faded and missing pavement markings and crosswalks, and replacing non-functioning pedestrian signal heads. To improve areas with deteriorated pavement, the feasibility and constructability of resurfacing should be considered.

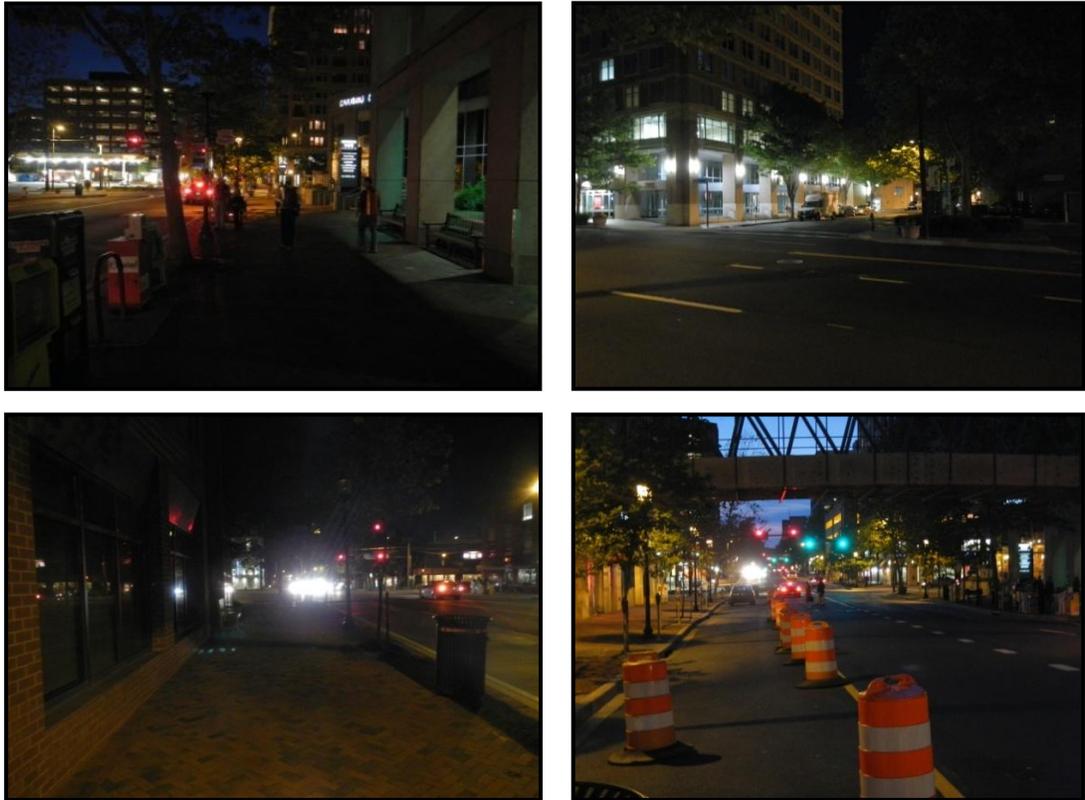
Figure 18: Lighting Conditions

During the study period, four pedestrian crashes occurred during dark conditions while the street lights were on. Limited lighting conditions may reduce visibility of pedestrians near unsignalized crosswalks, uncontrolled midblock crossing locations, and along sidewalks. During the nighttime site visit, the team observed insufficient lighting in multiple areas throughout the study area.

Upper-left: Lighting Conditions at Woodmont Avenue/ Old Georgetown Road. Upper-Right: Lighting Conditions at Fairmont Avenue/ Old Georgetown Road. Lower-left: Lighting Conditions at Wilson Lane/ Arlington Road/ St. Elmo Avenue/ Old Georgetown Road.

Lighting throughout the study area can be improved with the replacement of non-functioning lamps. The audit team also recommends that the need for additional street-lighting be evaluated.
