Randolph Road Pedestrian Road Safety Audit Montgomery County, Maryland

Prepared For:
Department of Transportation
Montgomery County, Maryland

September 2011

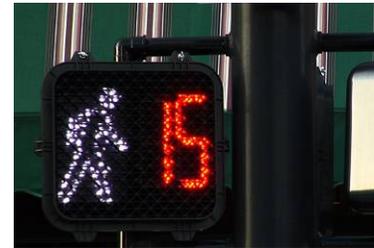
- *Countdown pedestrian signals:* Pedestrian countdown signals are provided at the intersections of Randolph Road at Selfridge Road and Colie Drive. Countdown pedestrian signal research has shown that pedestrians easily understand how the signal works, that more pedestrians start during the clearance phase, and that fewer people initiate walking late in the clearance phase. Studies have also shown that fewer pedestrians remain in crosswalks during the steady “Don’t Walk” phase where countdown signals are used. Countdown pedestrian signals have also been found to reduce pedestrian injury crashes and improve pedestrian compliance to traffic controls in several national studies.

Photo of a countdown signal
