Department of Transportation
Division Traffic Engineering and Operations
Montgomery County, Maryland

SCHOOL WALKING AREA ANALYSIS

Location: Kensington Parkwood Elementary

Study Date: 06/27/2019

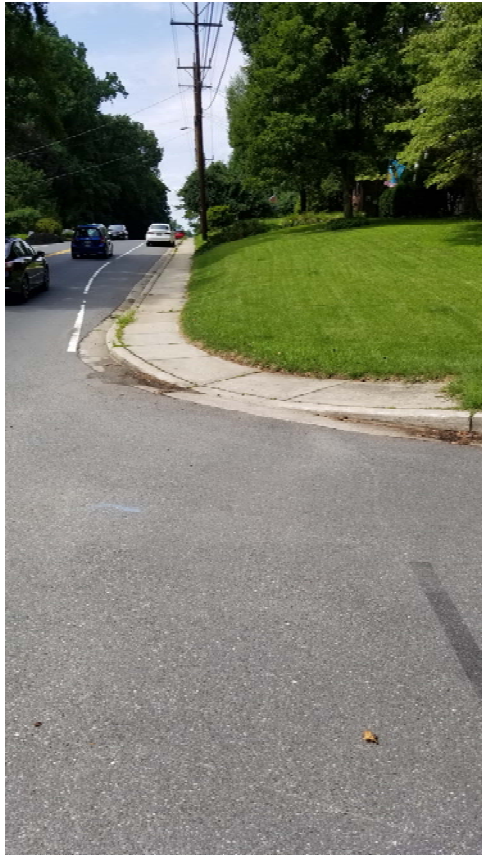
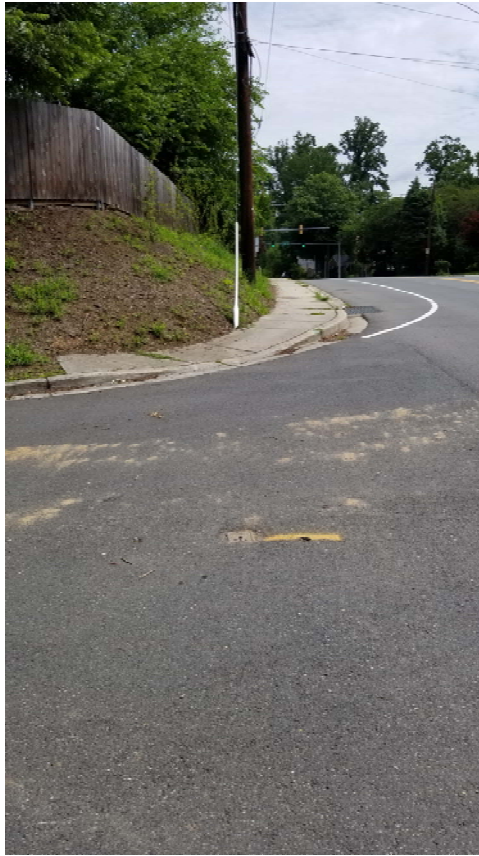
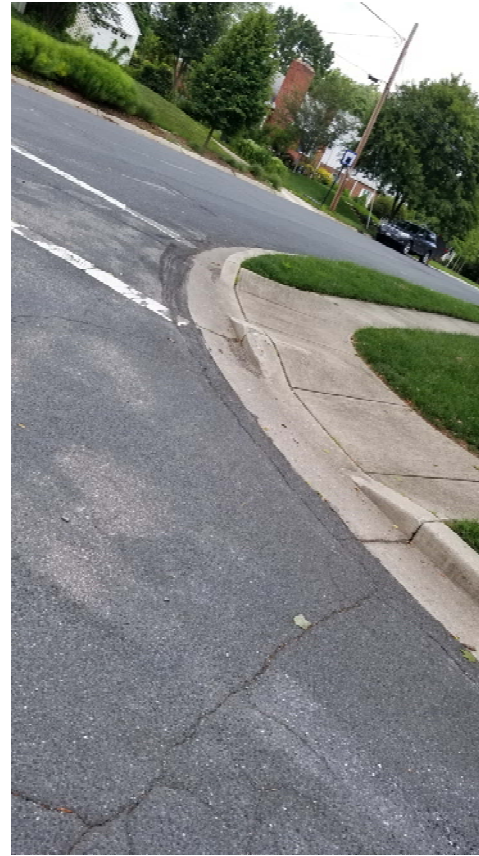
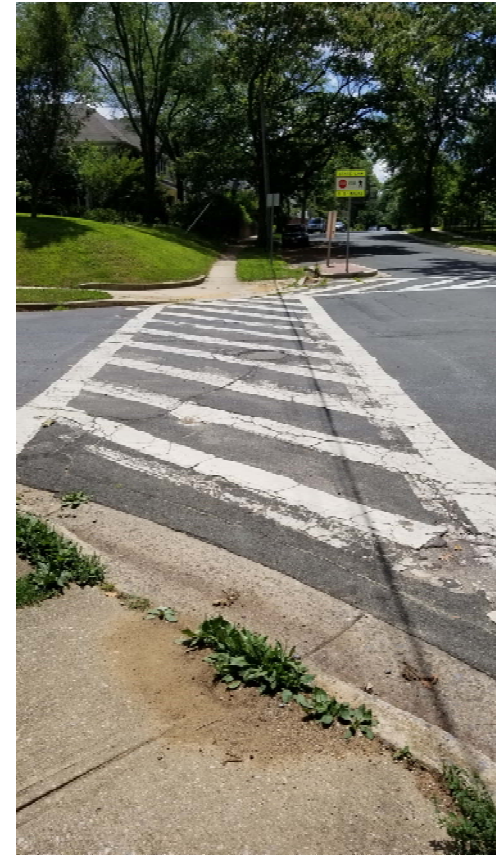
Non-compliant ADA ramps (with and without crosswalks) found throughout the walking area.

It is therefore recommended that new sidewalk be installed on streets without existing sidewalk through the county's new sidewalk program. Various ADA ramps throughout the walking area are not up to ADA standards. ADA ramp improvements are recommended where proper sidewalks exist, and ramps can meet construction standards.

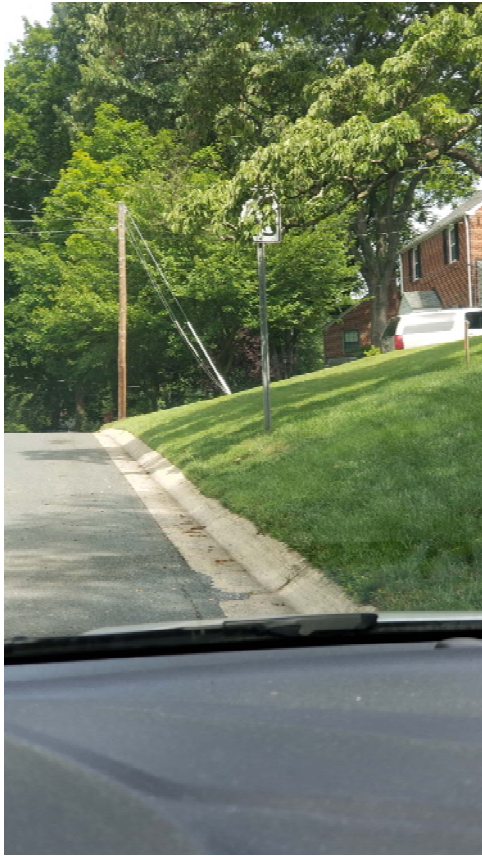
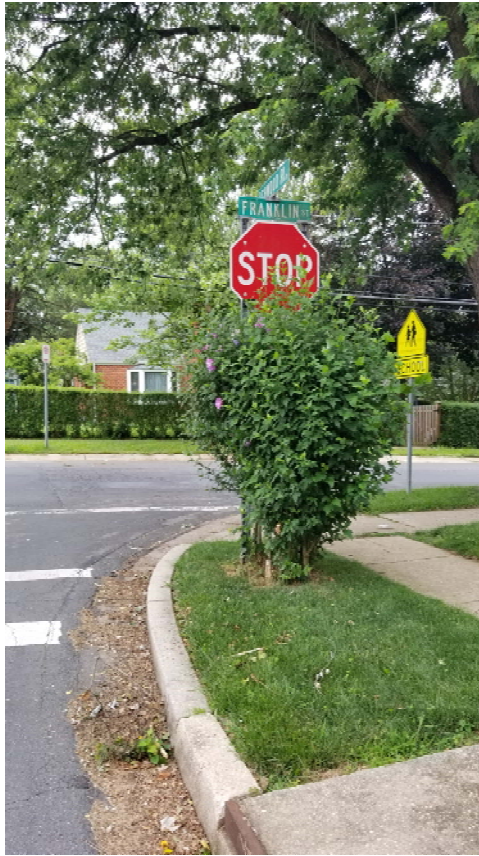
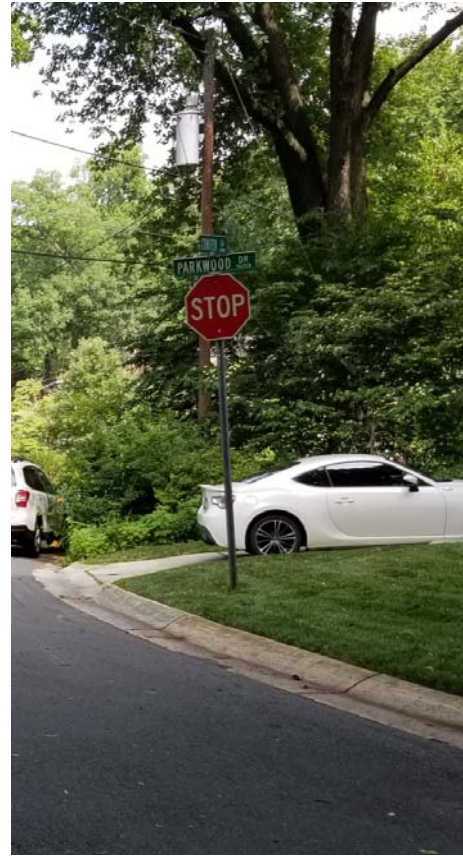
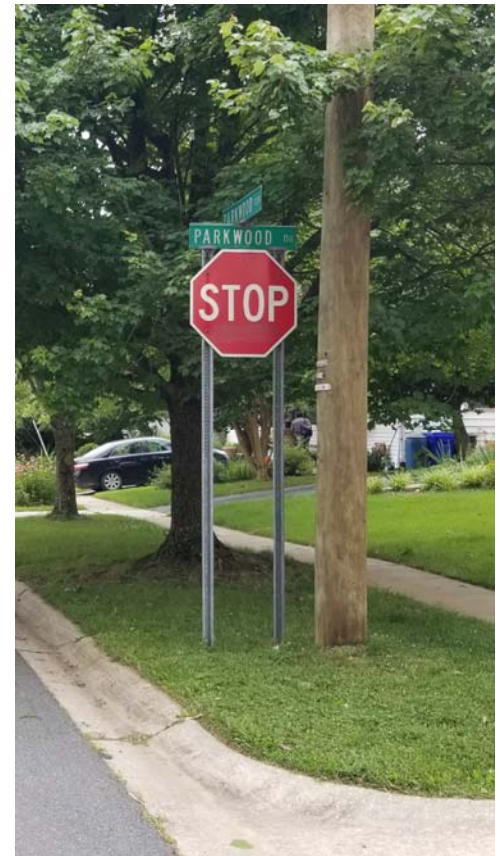
Inadequate signing found throughout the walking area
