# SCHOOL-RELATED CRASH REVIEW

**Location:** Watkins Mill Road at Stedwick Road

**Crash Date:** February 26, 2024

**Local Case No.:** 240009398

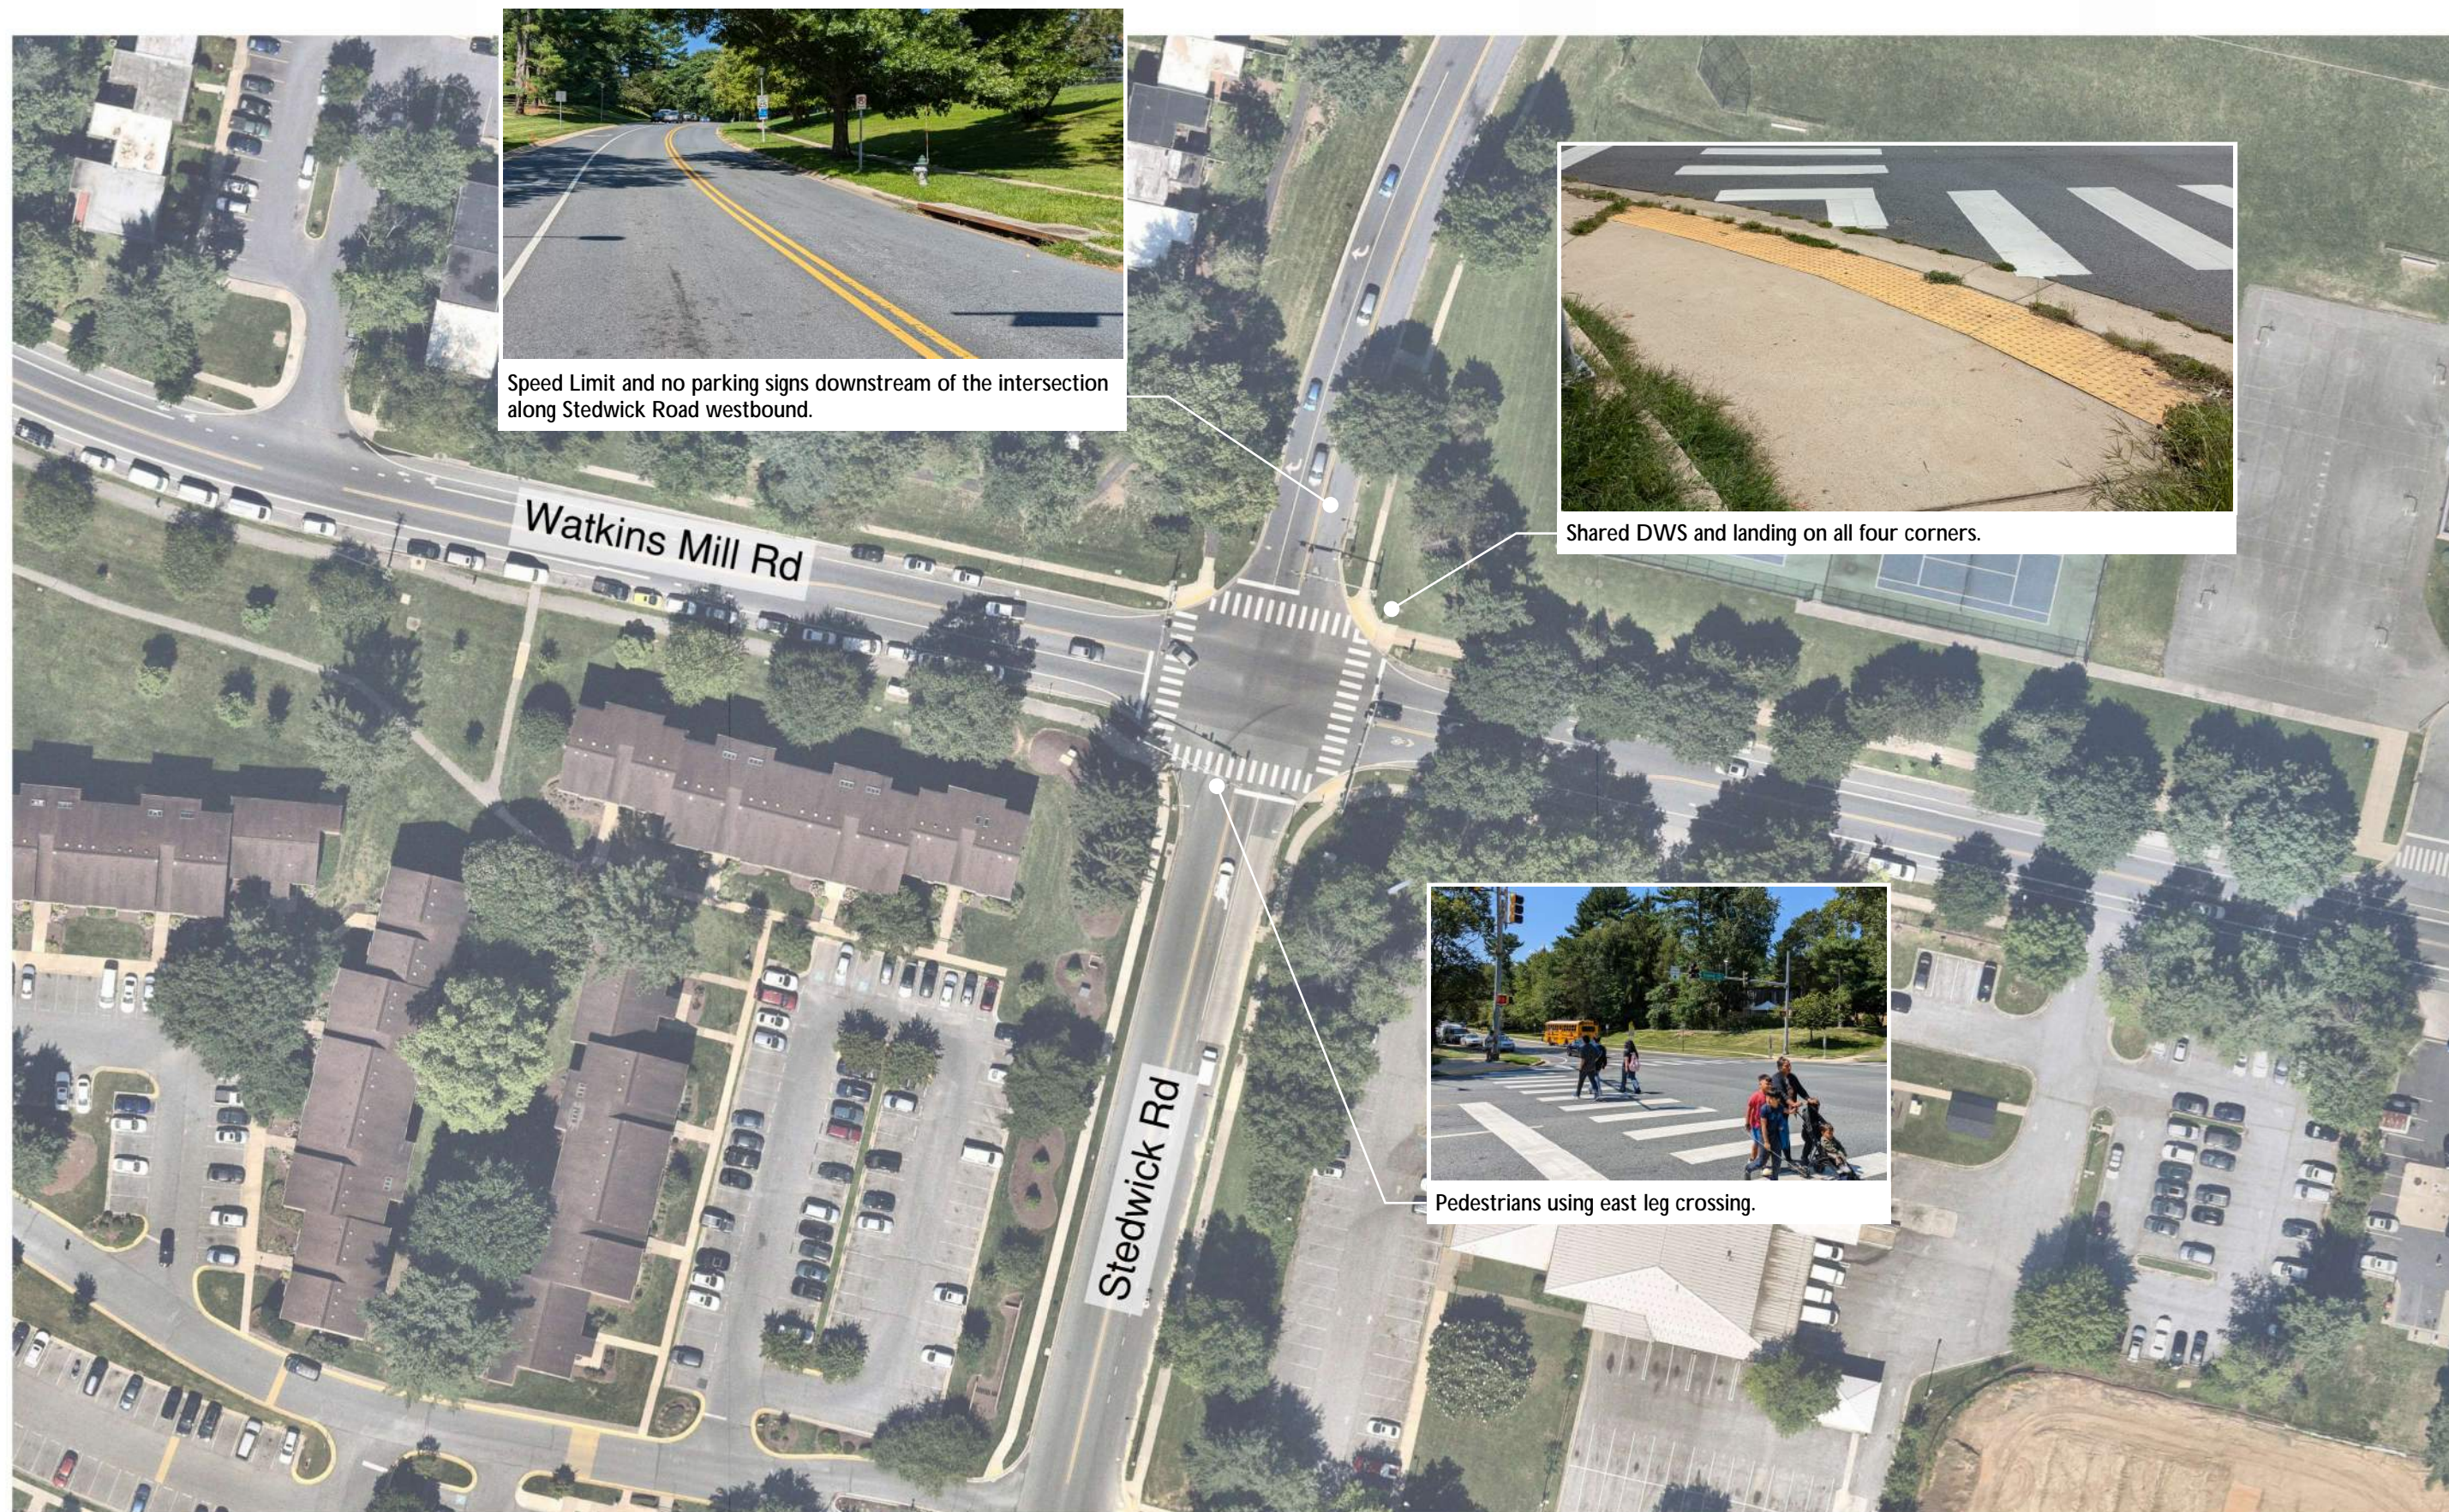
Figure 1 - Watkins Mill Road Corridor Observations

In the southbound direction, a static 35 MPH speed limit sign is located approximately 1,800 feet north of the subject intersection. Additionally, a high-intensity beacon (HIB) with a speed limit posting of 25 MPH is located approximately 1,500 feet north of the subject intersection. In the northbound direction, a static 35 MPH speed limit sign is posted approximately 1.0 mile south of the subject intersection. An HIB with a speed limit posting of 25 MPH is located approximately 150 feet north of the subject intersection. On-street parking restrictions vary between Stedwick Road and Club House Road. Refer to **Figure 1** in the attachments for additional details of the Watkins Mill Road segment.

The Watkins Mill Road corridor was reviewed between MD 355 (Frederick Road) to the south and Cove Ledge Court to the north. This corridor was evaluated to identify potential infrastructure, maintenance activities, and road-user behaviors that contribute to increased safety risk at and in the vicinity of the school-related crash location. Please refer to **Figure 1** for additional information such as curb restrictions, traffic control device placement, and road user behaviors.

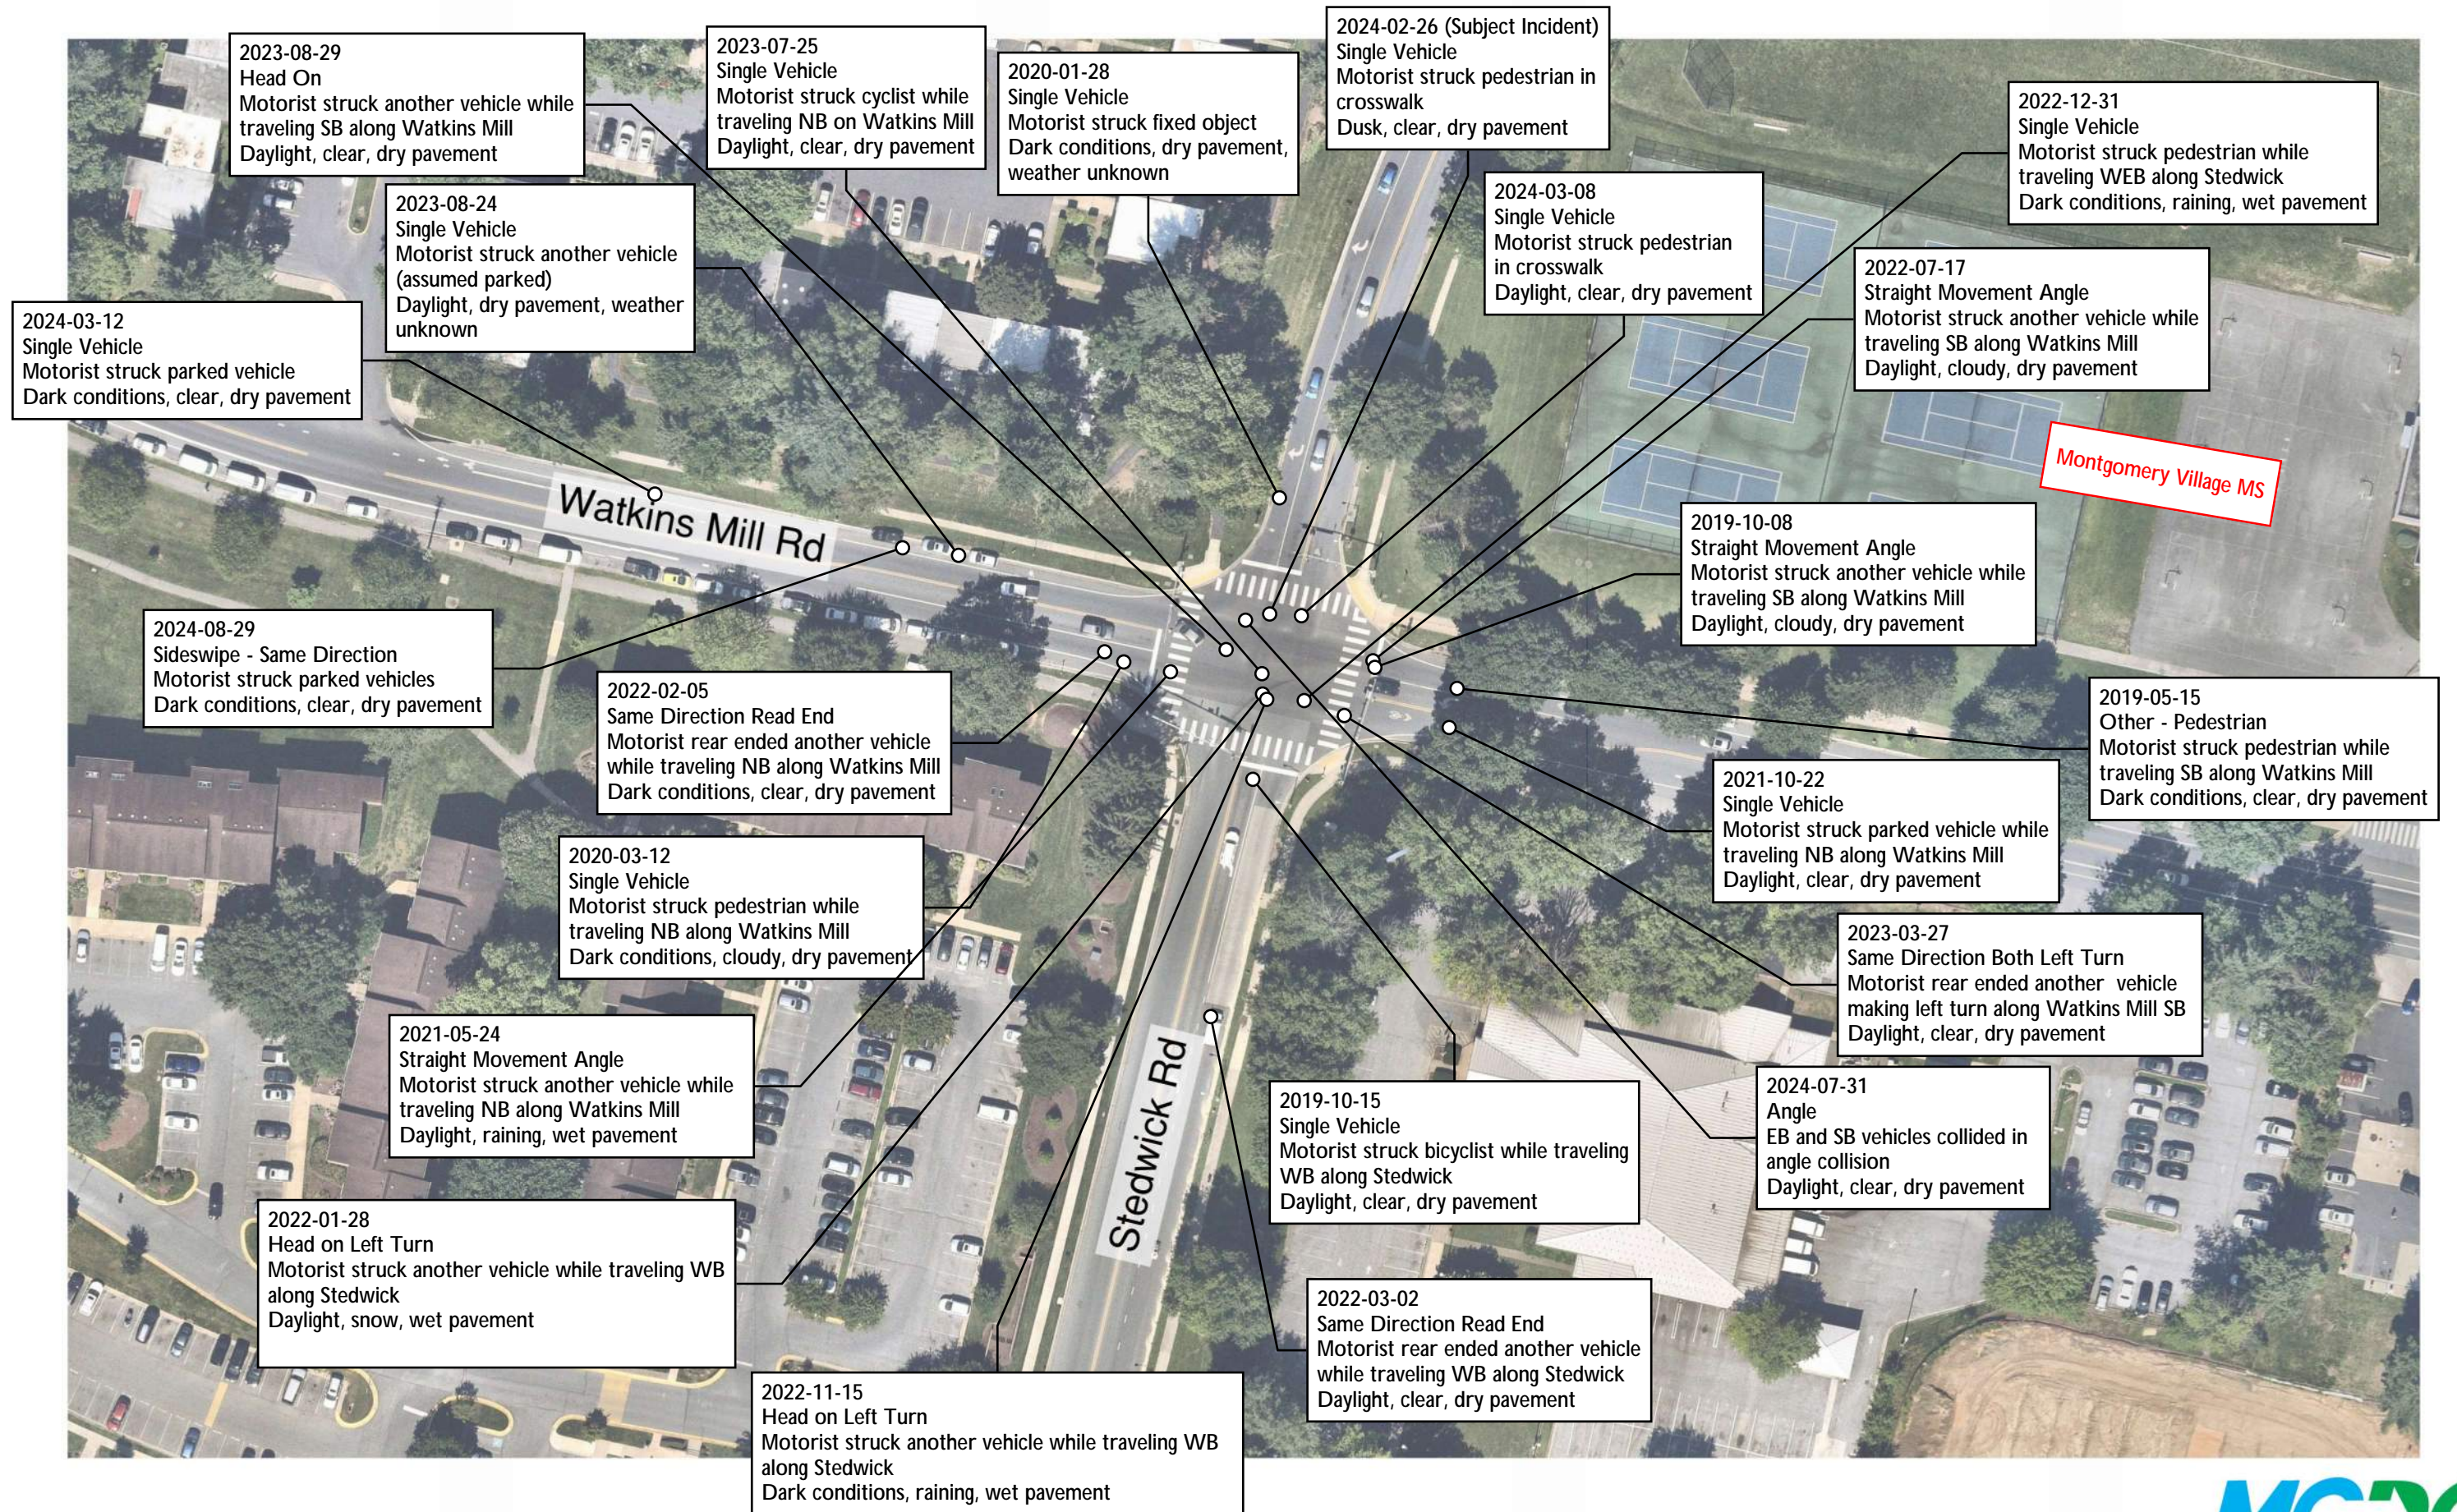
Figure 3 - Crash History (2019-2024)

Crash data obtained from dataMontgomery shows twenty-two (22) incidents occurred within the influence of the Watkins Mill Road at Stedwick Road intersection, between May 2019 and September 2024. Six (6) collisions involved pedestrians and two (2) involved bicyclists. Thirteen (13) of the collisions resulted in injuries. The incidents are illustrated on **Figure 3**.
