SCHOOL-RELATED CRASH REVIEW

Location: Watkins Mill Road at Stedwick Road

Crash Date: March 8, 2024

Local Case No.: 240011196

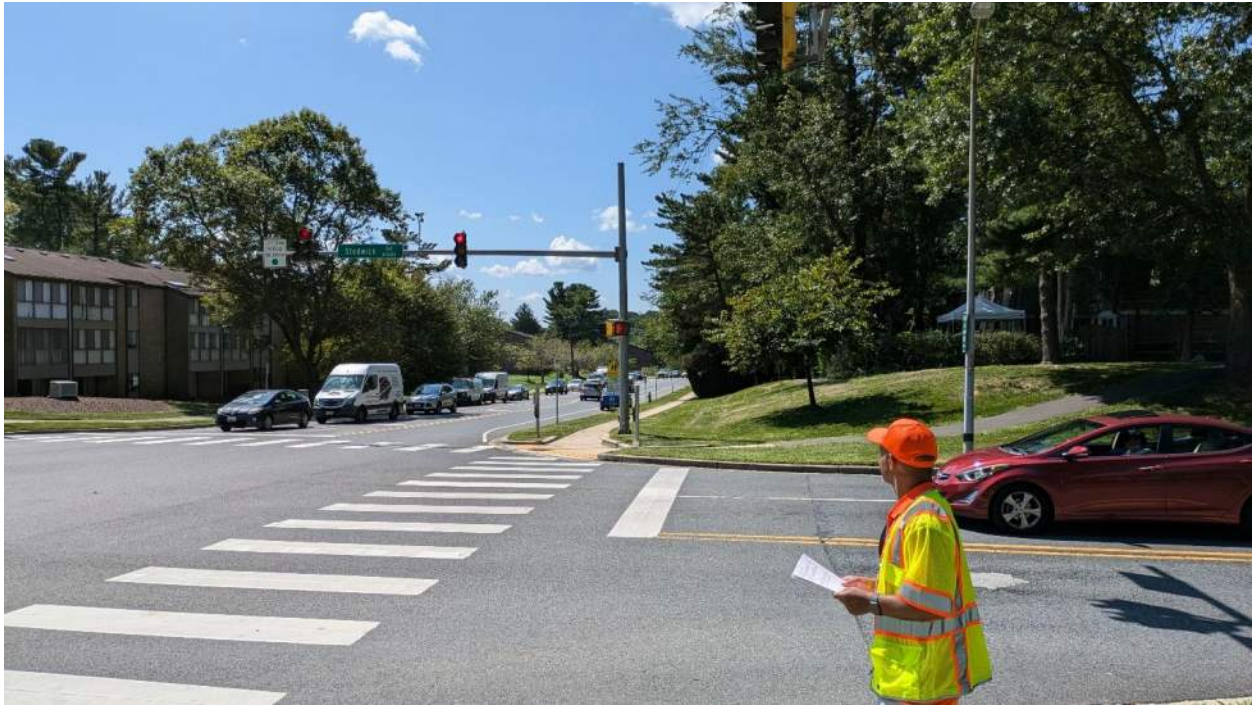
Photo 1. West leg of intersection where crash occurred, looking east along Stedwick Road.

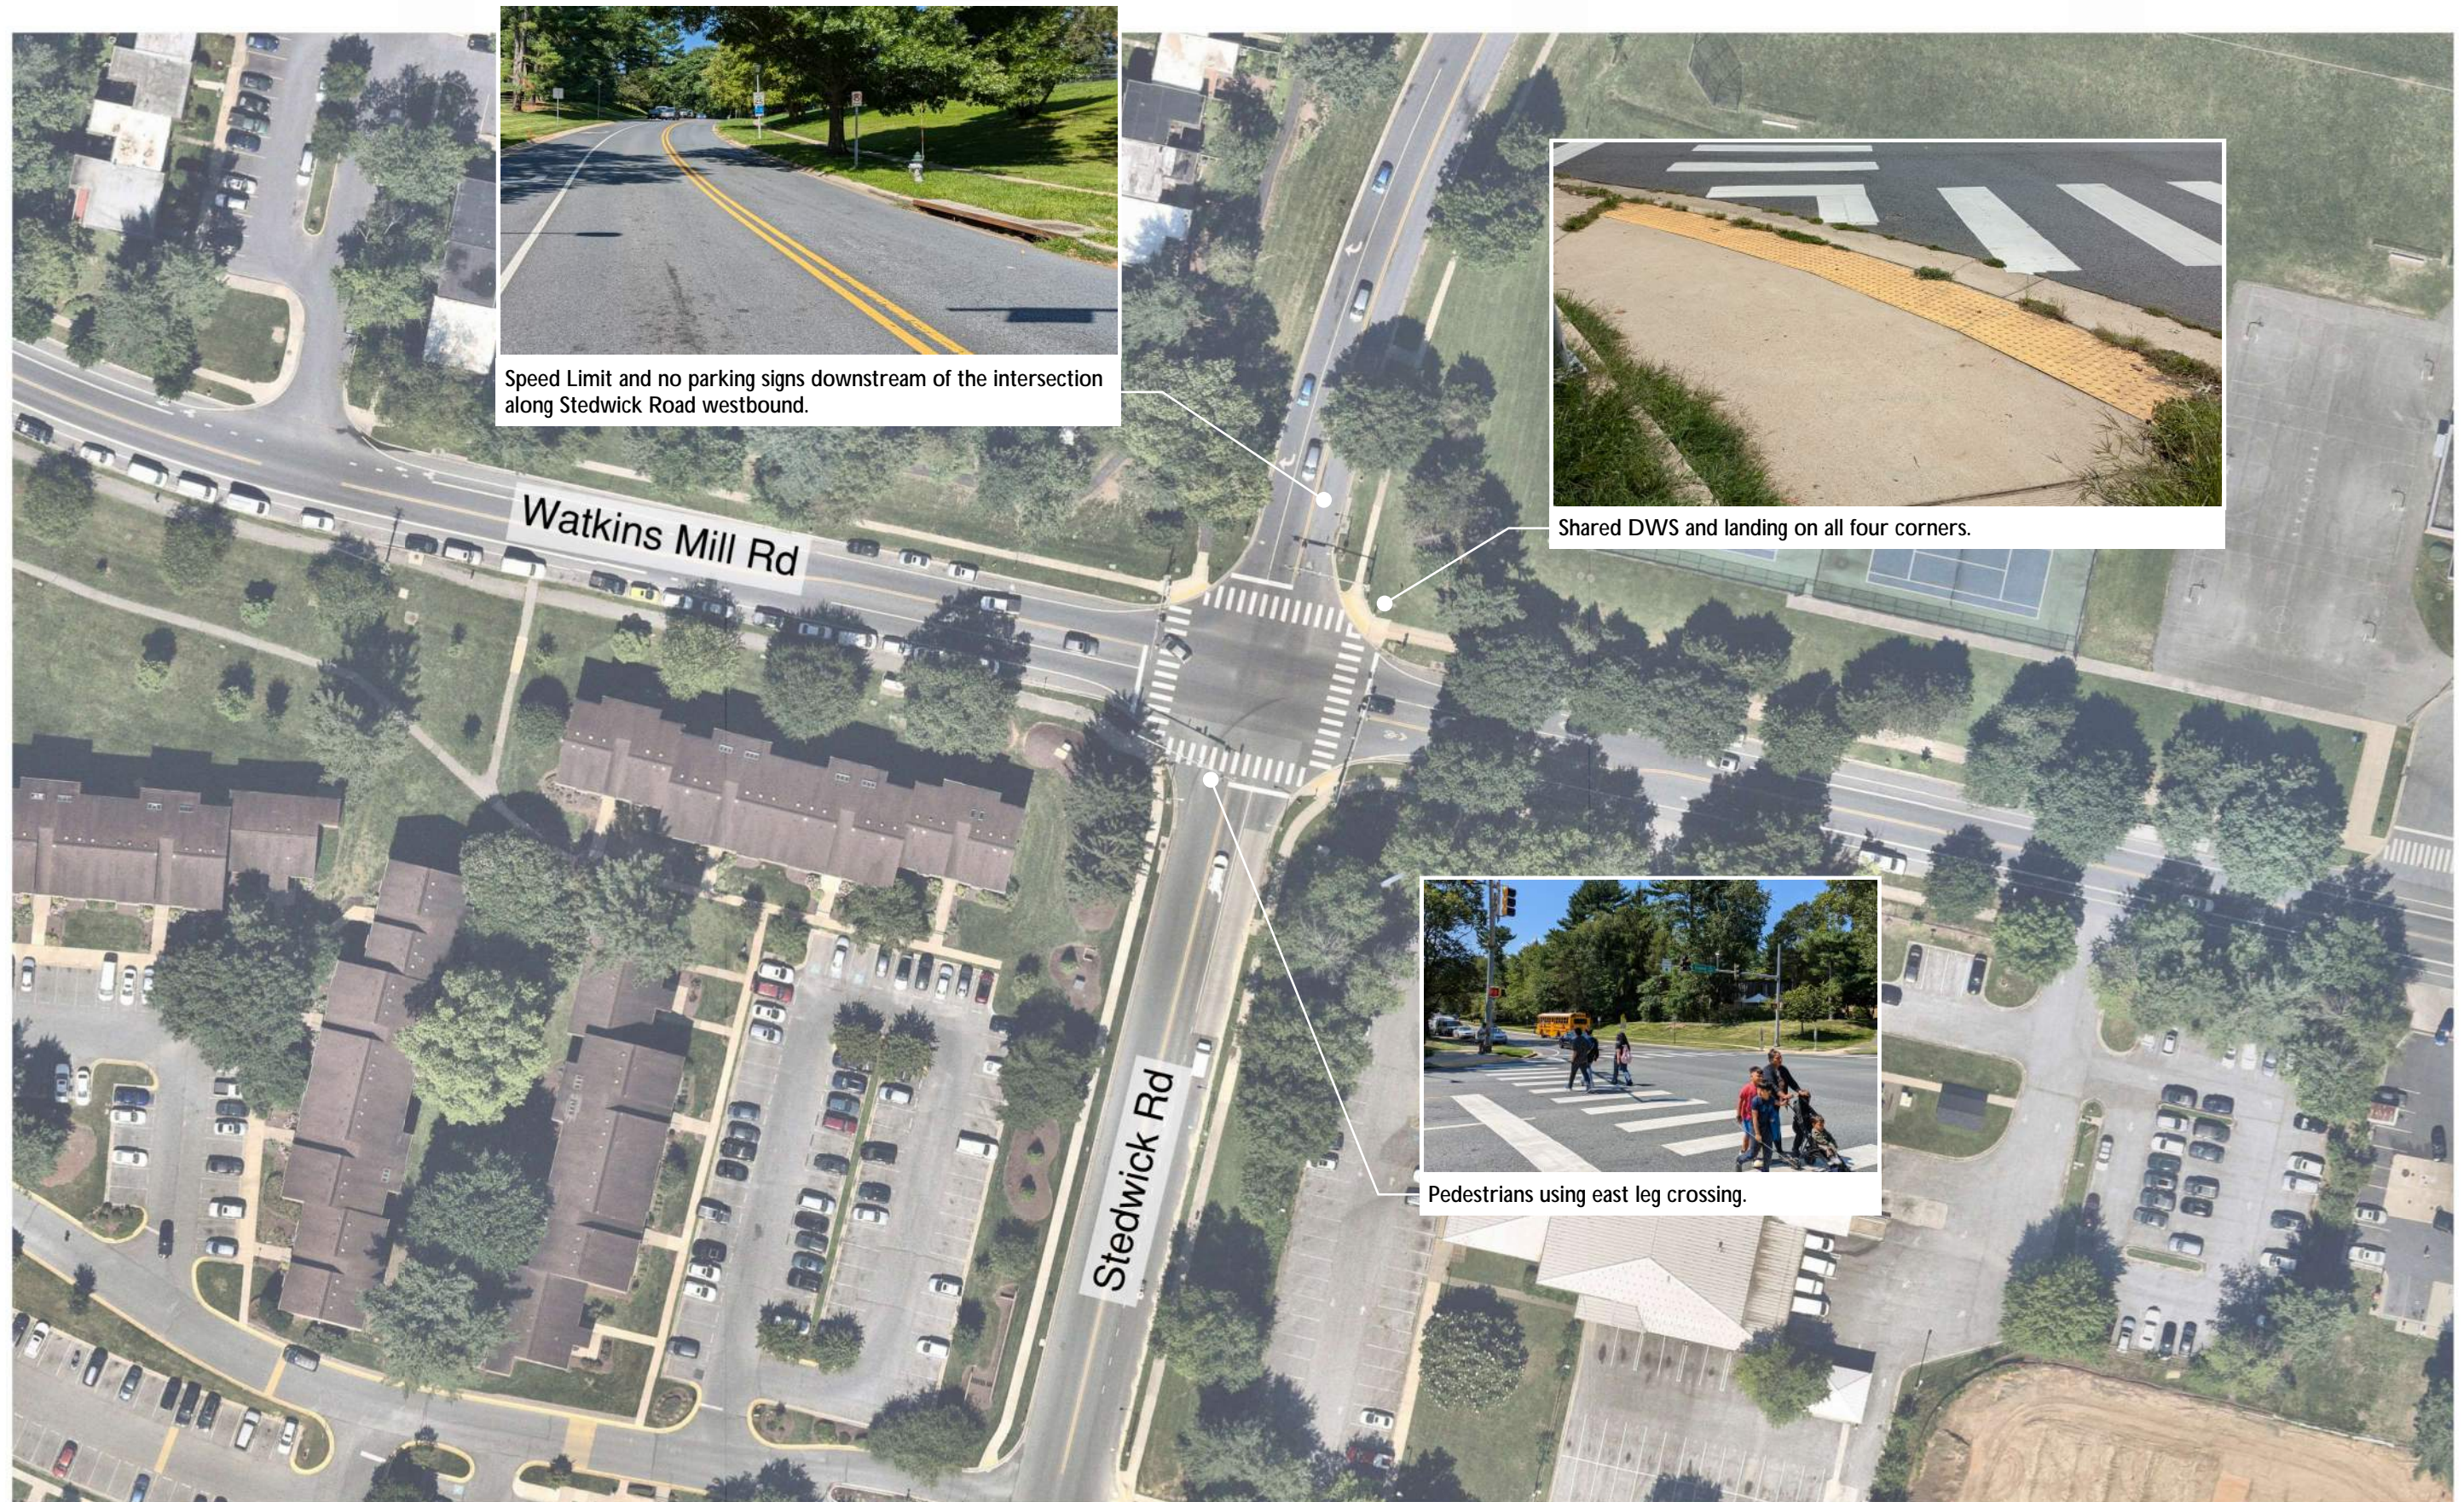
Figure 1 - Watkins Mill Road Corridor Observations

In the southbound direction approaching the school, Watkins Mill Road has a static 35 MPH speed limit sign approximately 1,800 feet north of the subject intersection and a School HIB Flasher with a posted speed limit of 25 MPH approximately 1,500 feet north of the subject intersection. The northbound direction has a static 35 MPH speed limit sign posted approximately 1.0 miles south of the subject intersection and a School HIB Flasher with a posted speed limit of 25 MPH approximately 150 feet north of the subject intersection. On-street parking restrictions vary between Stedwick Road and Club House Road. Refer to **Figure 1** in the attachments for additional details of the Watkins Mill Road segment.

The Watkins Mill Road corridor was evaluated to identify potential infrastructure, maintenance activities, and road user behaviors that contribute to increased safety risk at and in the vicinity of the school-related crash location. The Watkins Mill Road corridor was reviewed between MD 355 (Frederick Road) to the south and Cove Ledge Court to the north. Please refer to **Figure 1** for additional information.

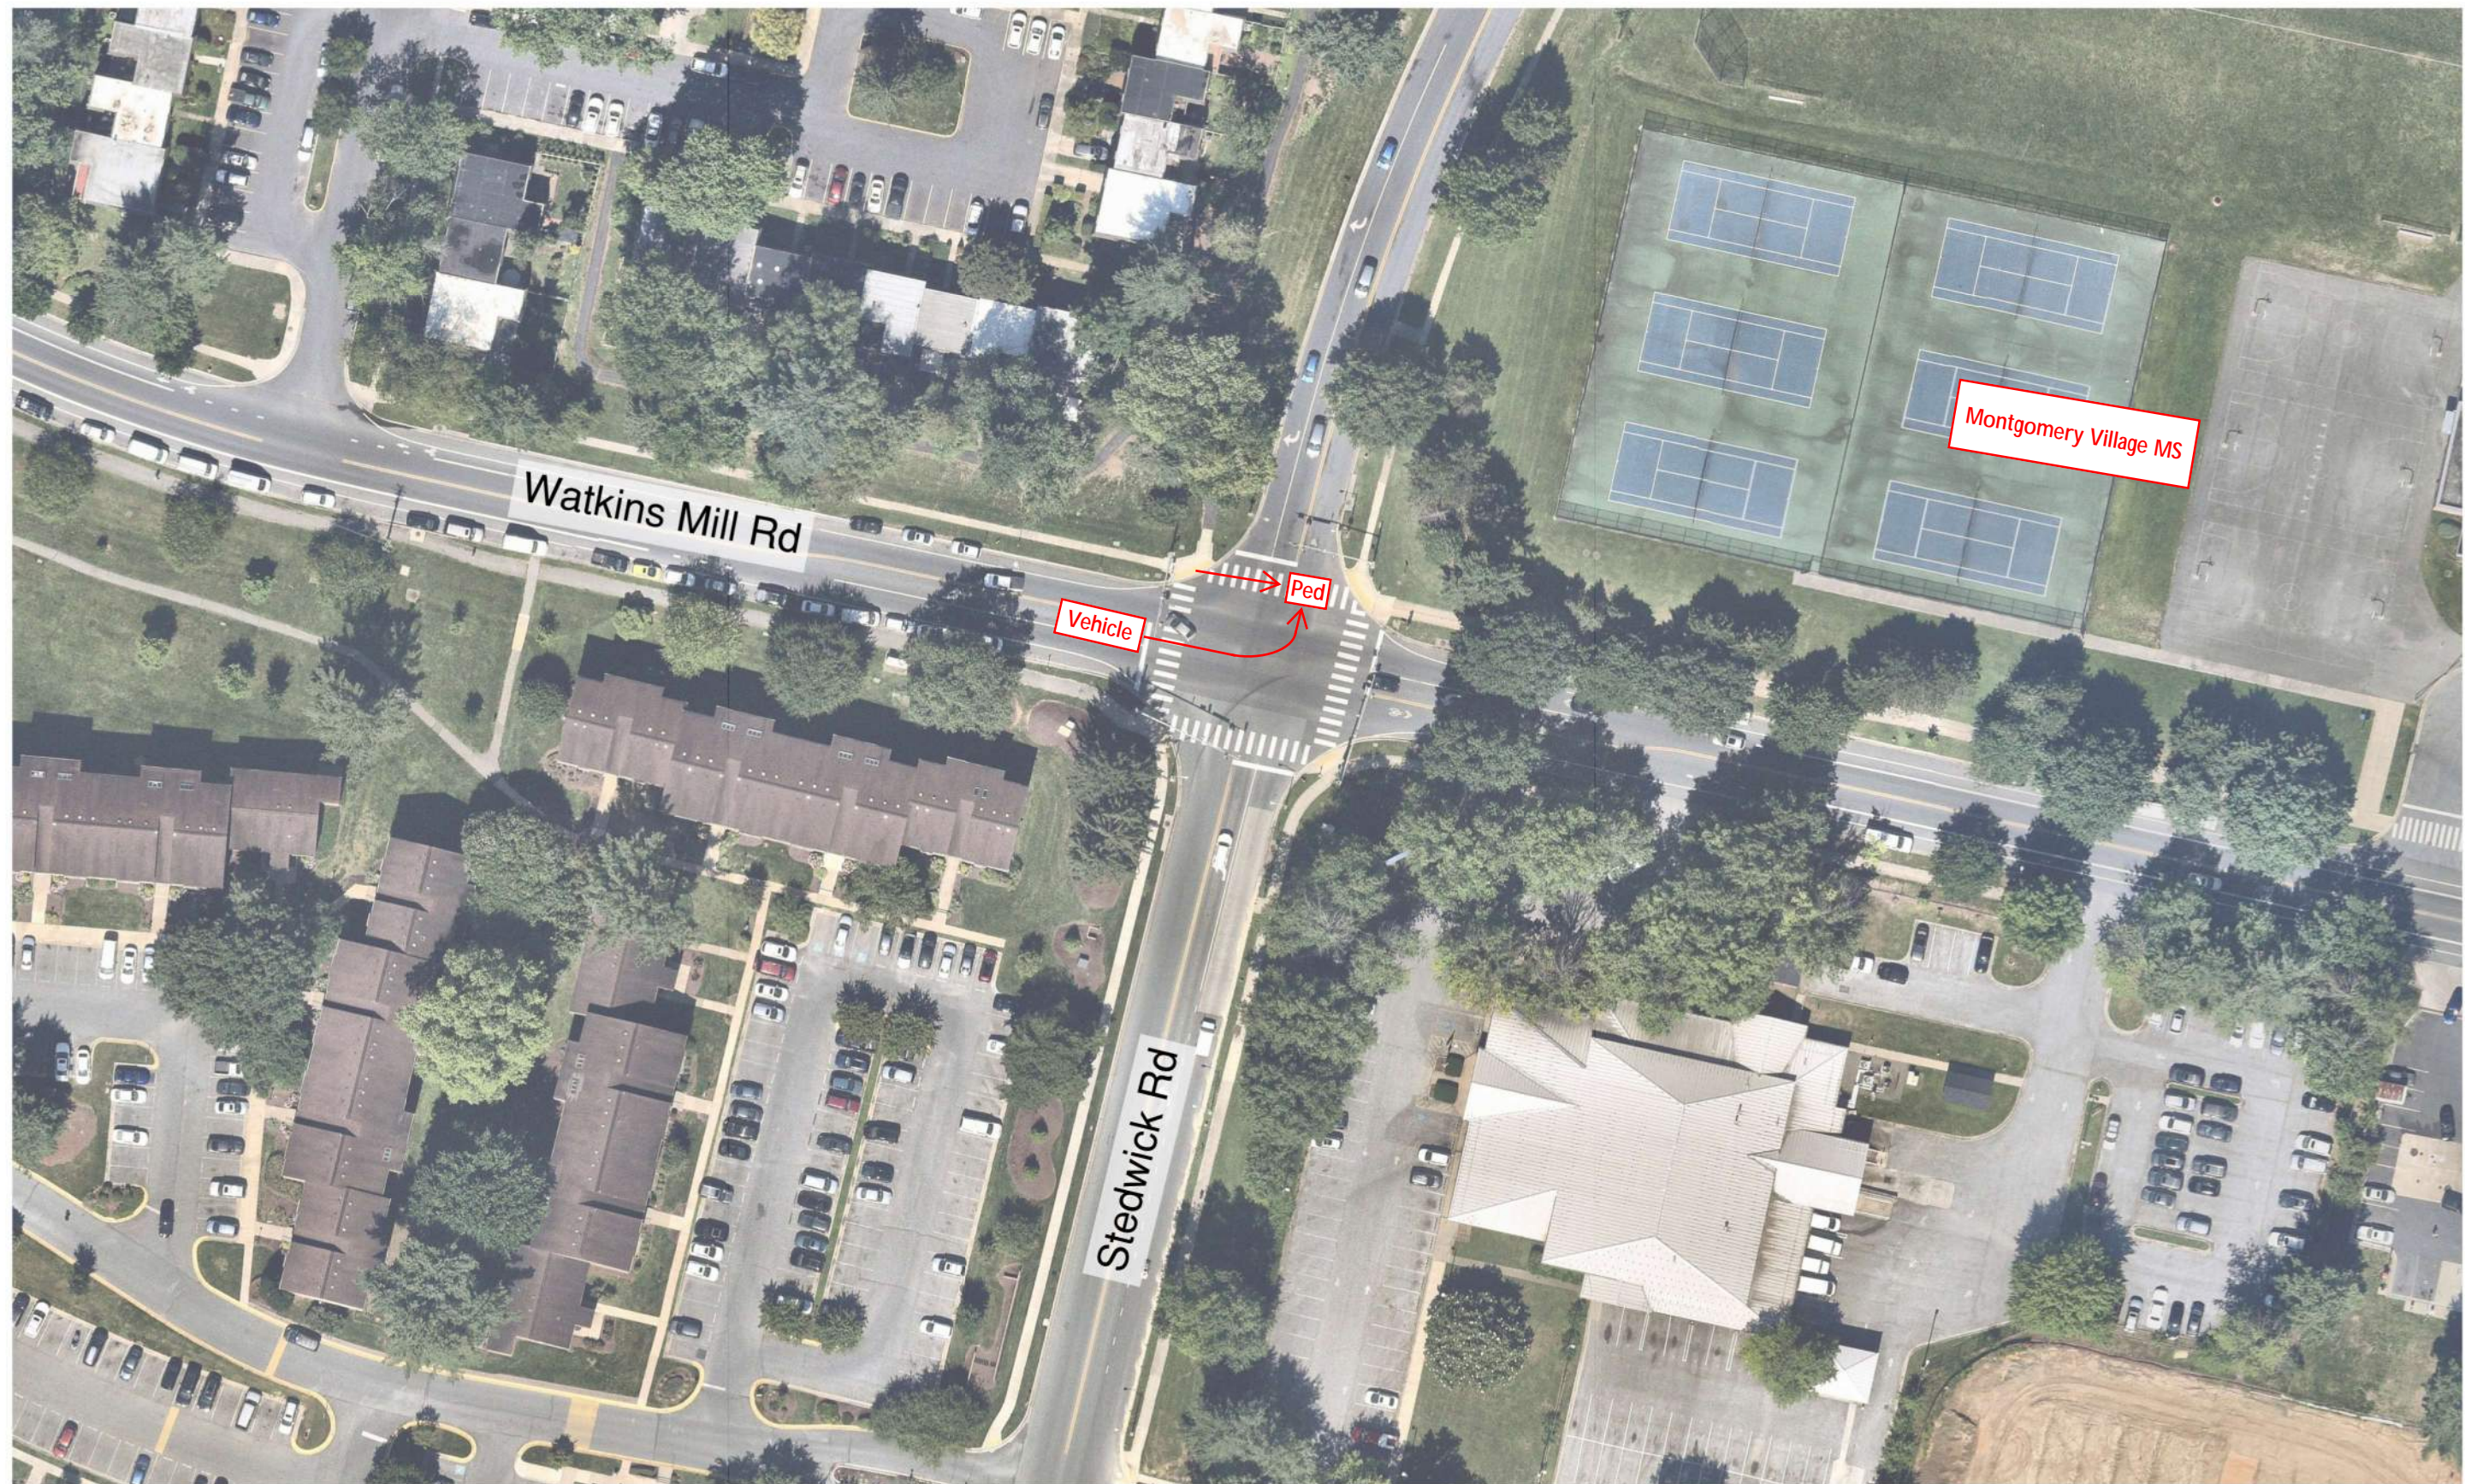
Figure 2 - Crash Diagram

On Friday, March 8, 2024, at approximately 8:00 AM, a pedestrian was traveling across the west leg of the intersection in the crosswalk with a do not walk signal. A motorist traveling northbound along Watkins Mill Road, with a green signal, began making a left turn onto westbound Stedwick road and struck the pedestrian in the crosswalk. The crash report noted that the pedestrian had his head down and was looking at his phone just prior to the collision. Weather conditions were clear, the roadway surface was dry, and it was daylight. The pedestrian suffered minor injuries.

Figure 2 illustrates the crash location and direction of pedestrian and vehicle travel.

1. Consider installation of centerline hardening to slow left-turning vehicles and increase visibility of pedestrians in the crosswalk. This forces motorists to focus on the conflicting crosswalk in addition to opposing thru traffic.
2. Consider revising signal phasing to address confusion and conflicts resulting from Exclusive/Permissive to Exclusive.

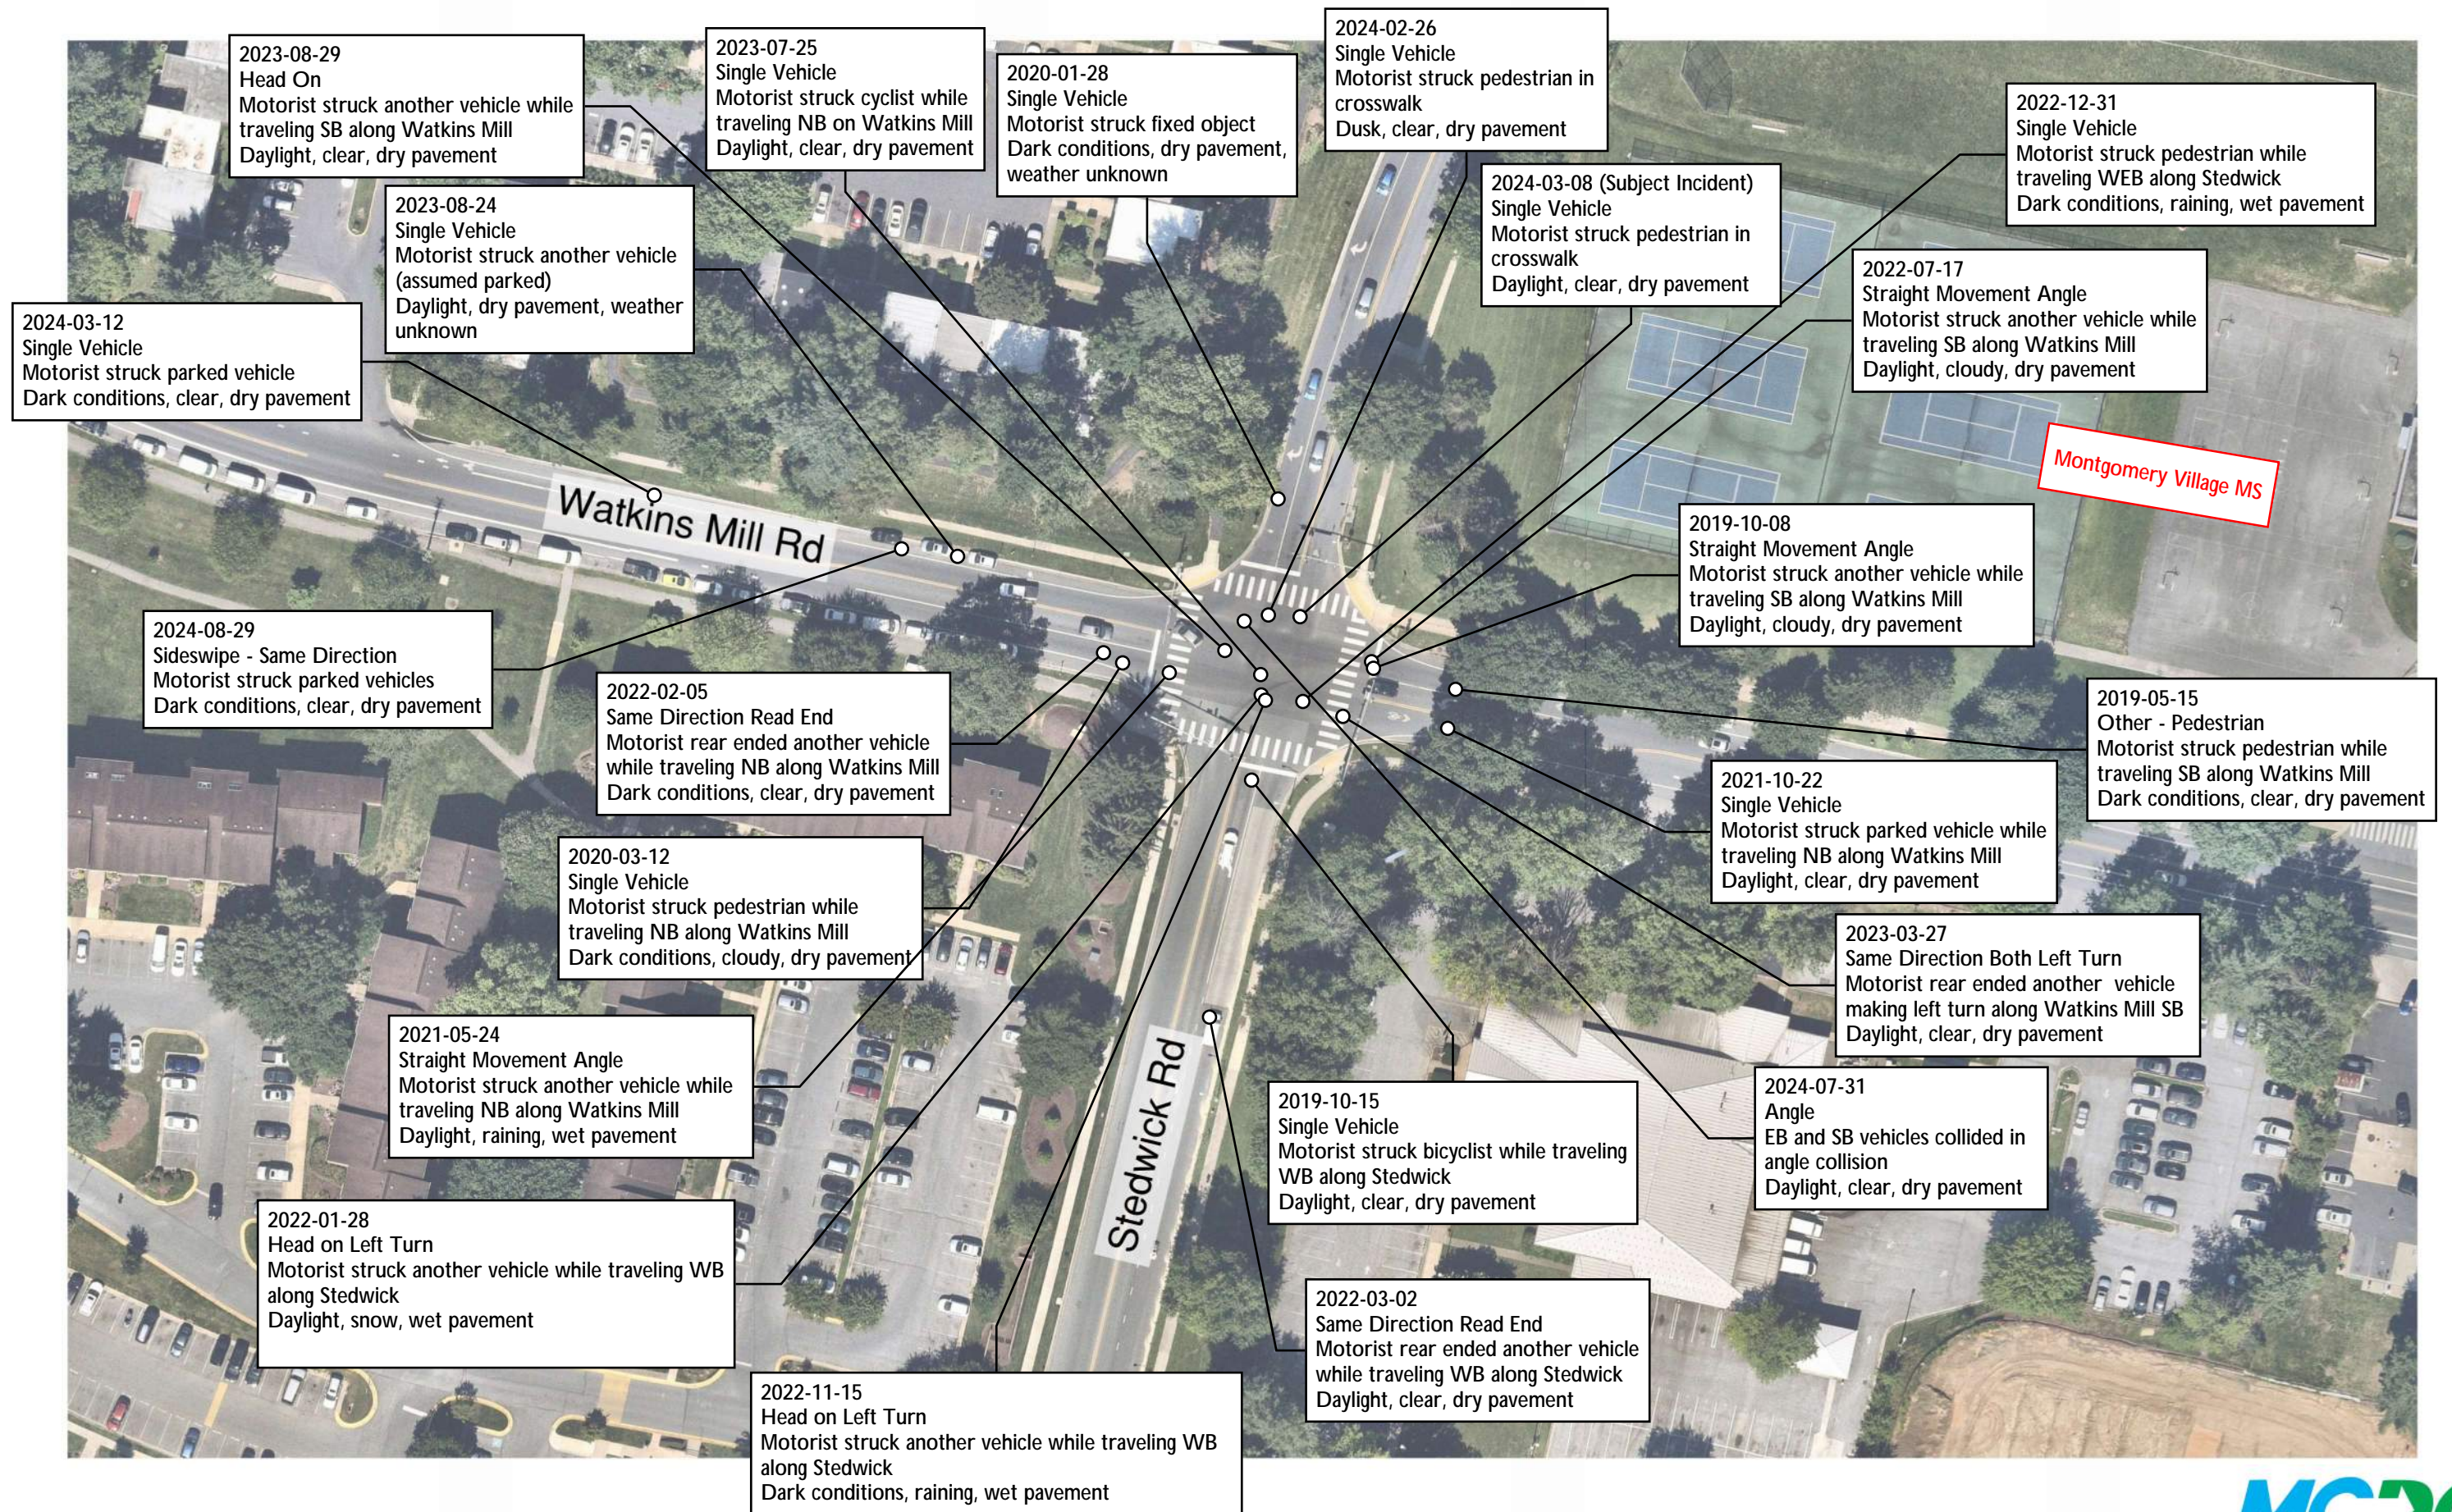
Figure 3 - Crash History (2019-2024)

Crash data obtained from dataMontgomery provides information for twenty-two (22) incidents that occurred within the influence of the Watkins Mill Road at Stedwick Road intersection between May 2019 and September 2024. Six (6) collisions involved pedestrians and two (2) involved cyclists. Thirteen (13) of the collisions resulted in injuries. The incidents are illustrated on **Figure 3**.
