SCHOOL-RELATED CRASH-INFRASTRUCTURE REVIEW

Location: Royal Crown Dr at Observation Dr

Crash Date: October 16, 2024

Local Case No.: 240049487

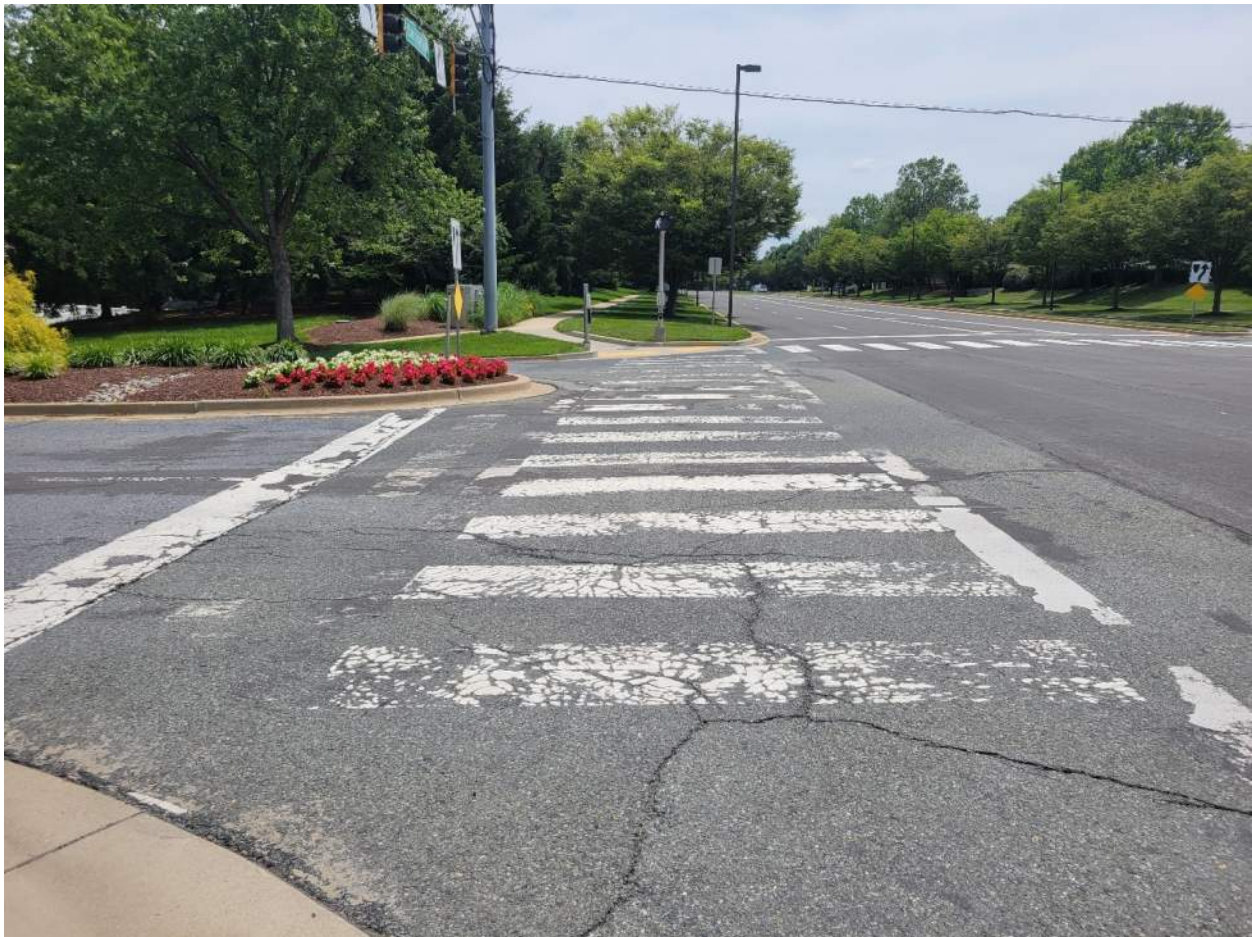
Photo 1. Taken from northwest corner looking eastbound along Observation Dr at the north leg crossing. Poor pavement marking condition.

1. Recommend refreshing the continental crosswalk pavement markings for all legs.
2. Recommend realigning ramps to guide pedestrians perpendicular to the roadway instead of into the center of the intersection.

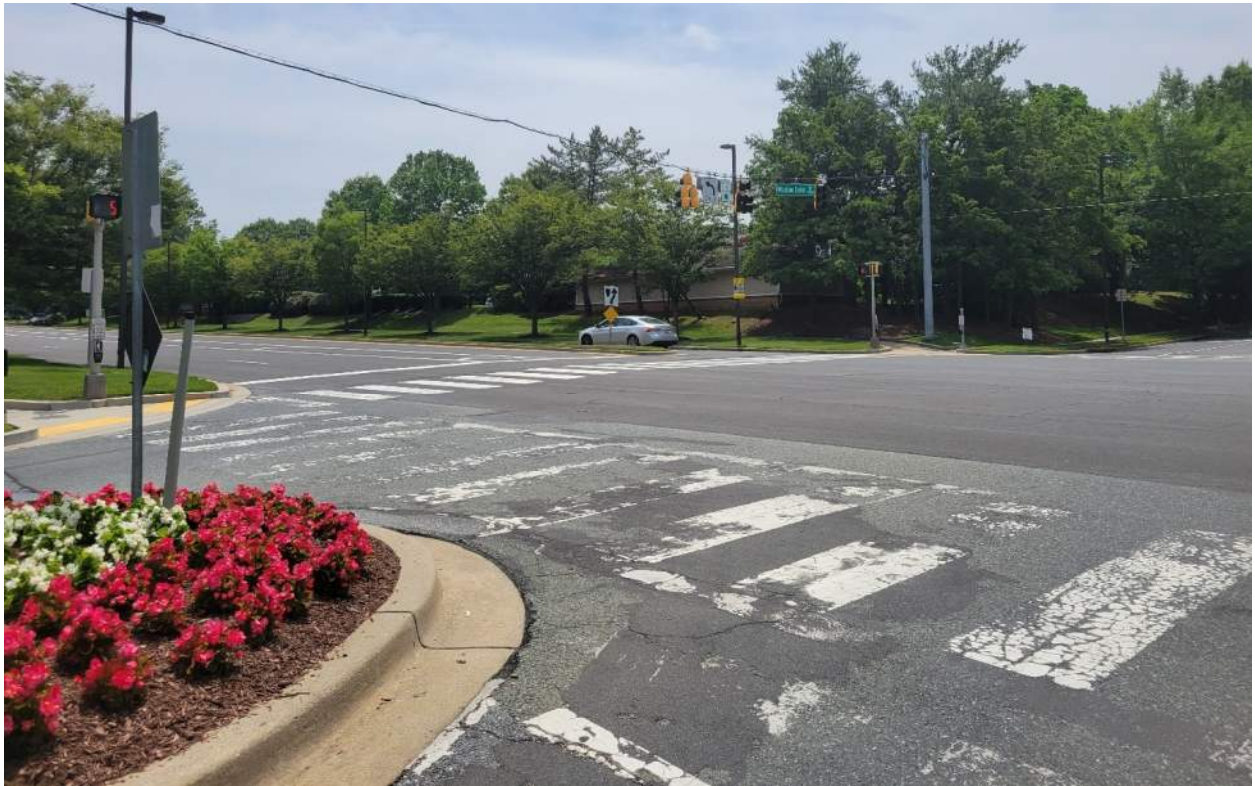
Photo 2. Taken from northwest corner looking at the east leg crossing at the approximate crash location. No pedestrian refuge crossing Observation Drive.

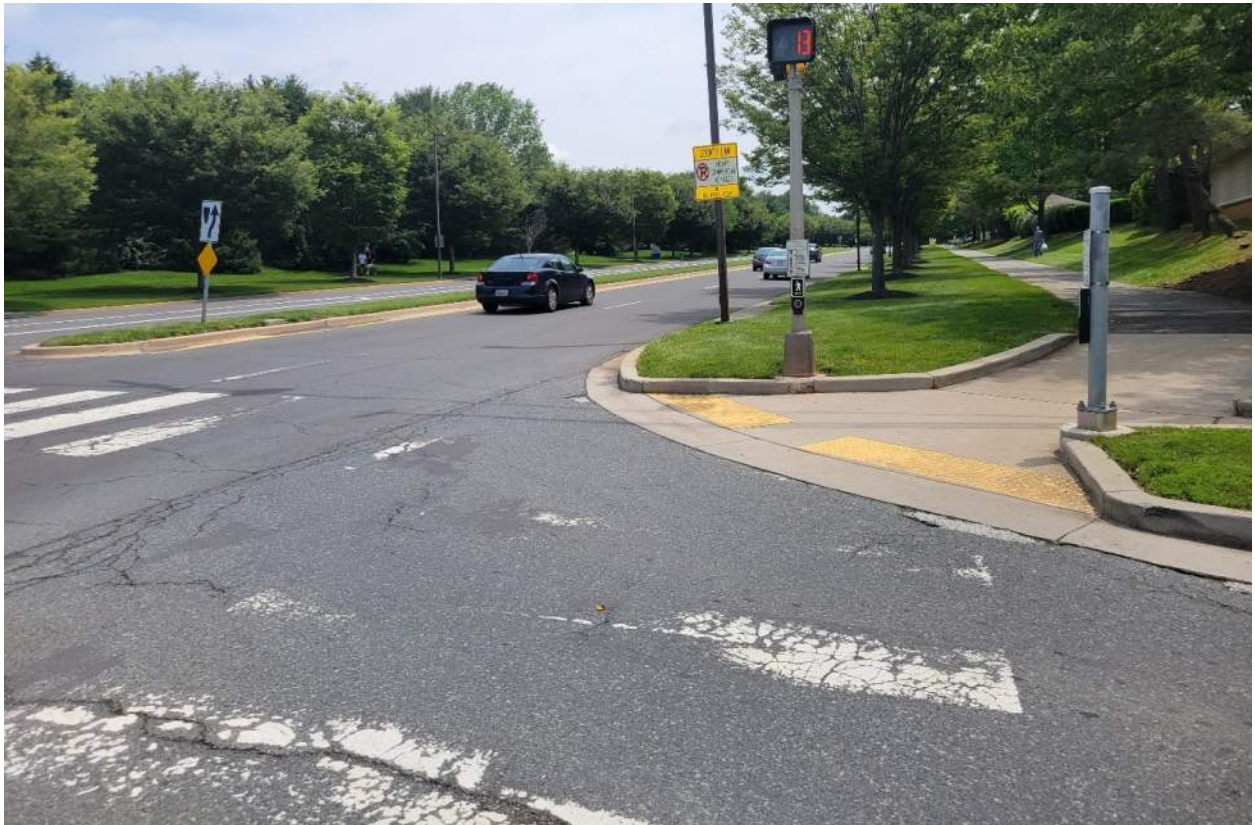
Photo 3: All pedestrian ramps consist of two detectable warning surfaces that do not guide motorists perpendicular to the roadway.

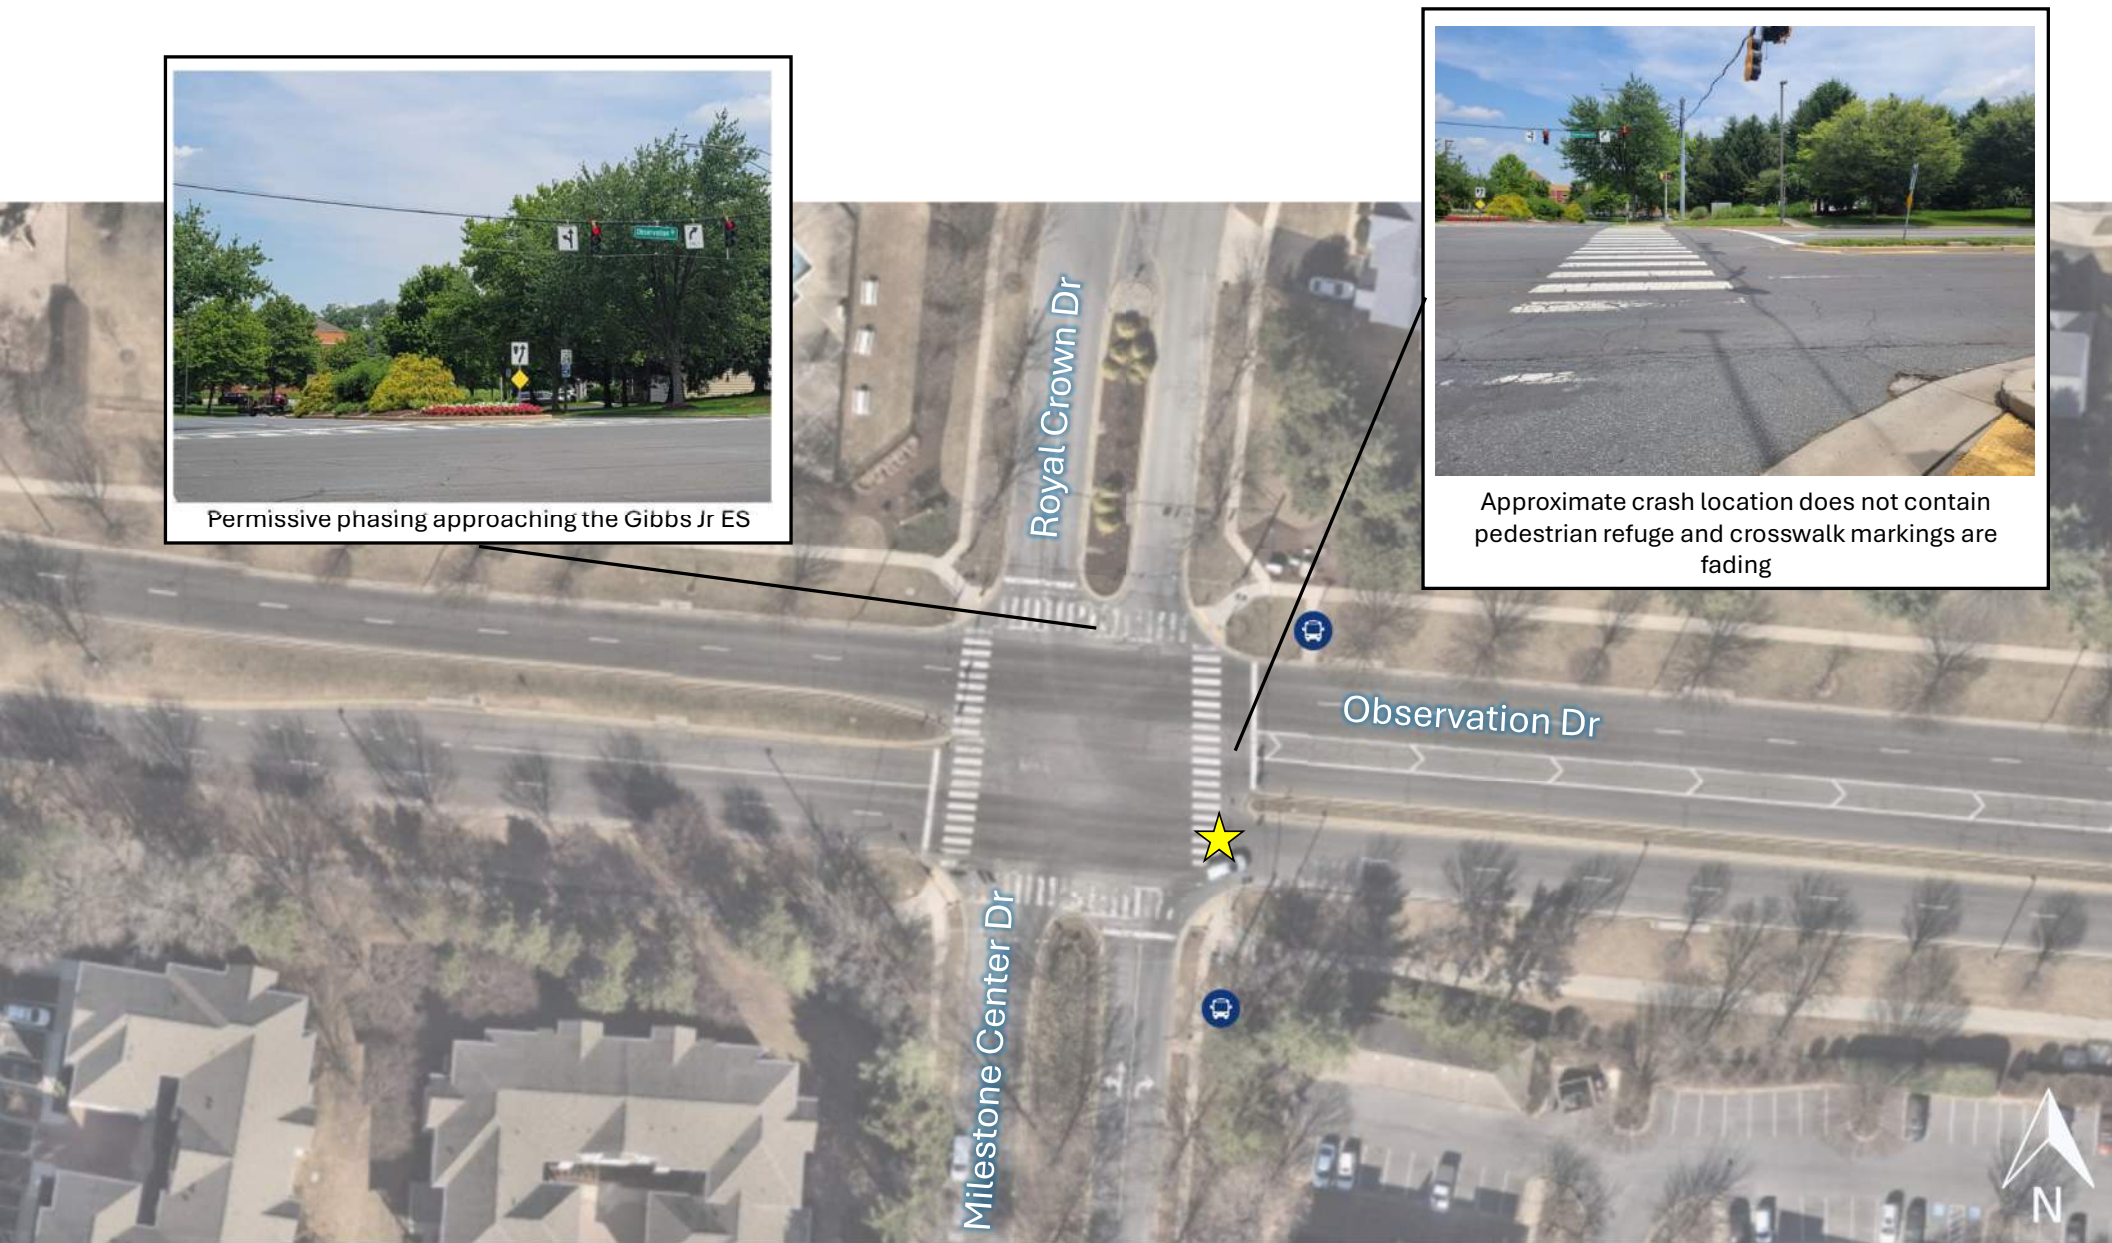
Figure 1 – Observation Drive at Royal Crown Drive Intersection Observations

The Observation Drive corridor was evaluated to identify potential infrastructure, maintenance activities, and road user behaviors that contribute to increased safety risk at and in the vicinity of the school-related crash location. The Observation Drive corridor was reviewed between Found Stone Road to the west and Ridge Road to the east. Please refer to **Figure 1** for additional information.

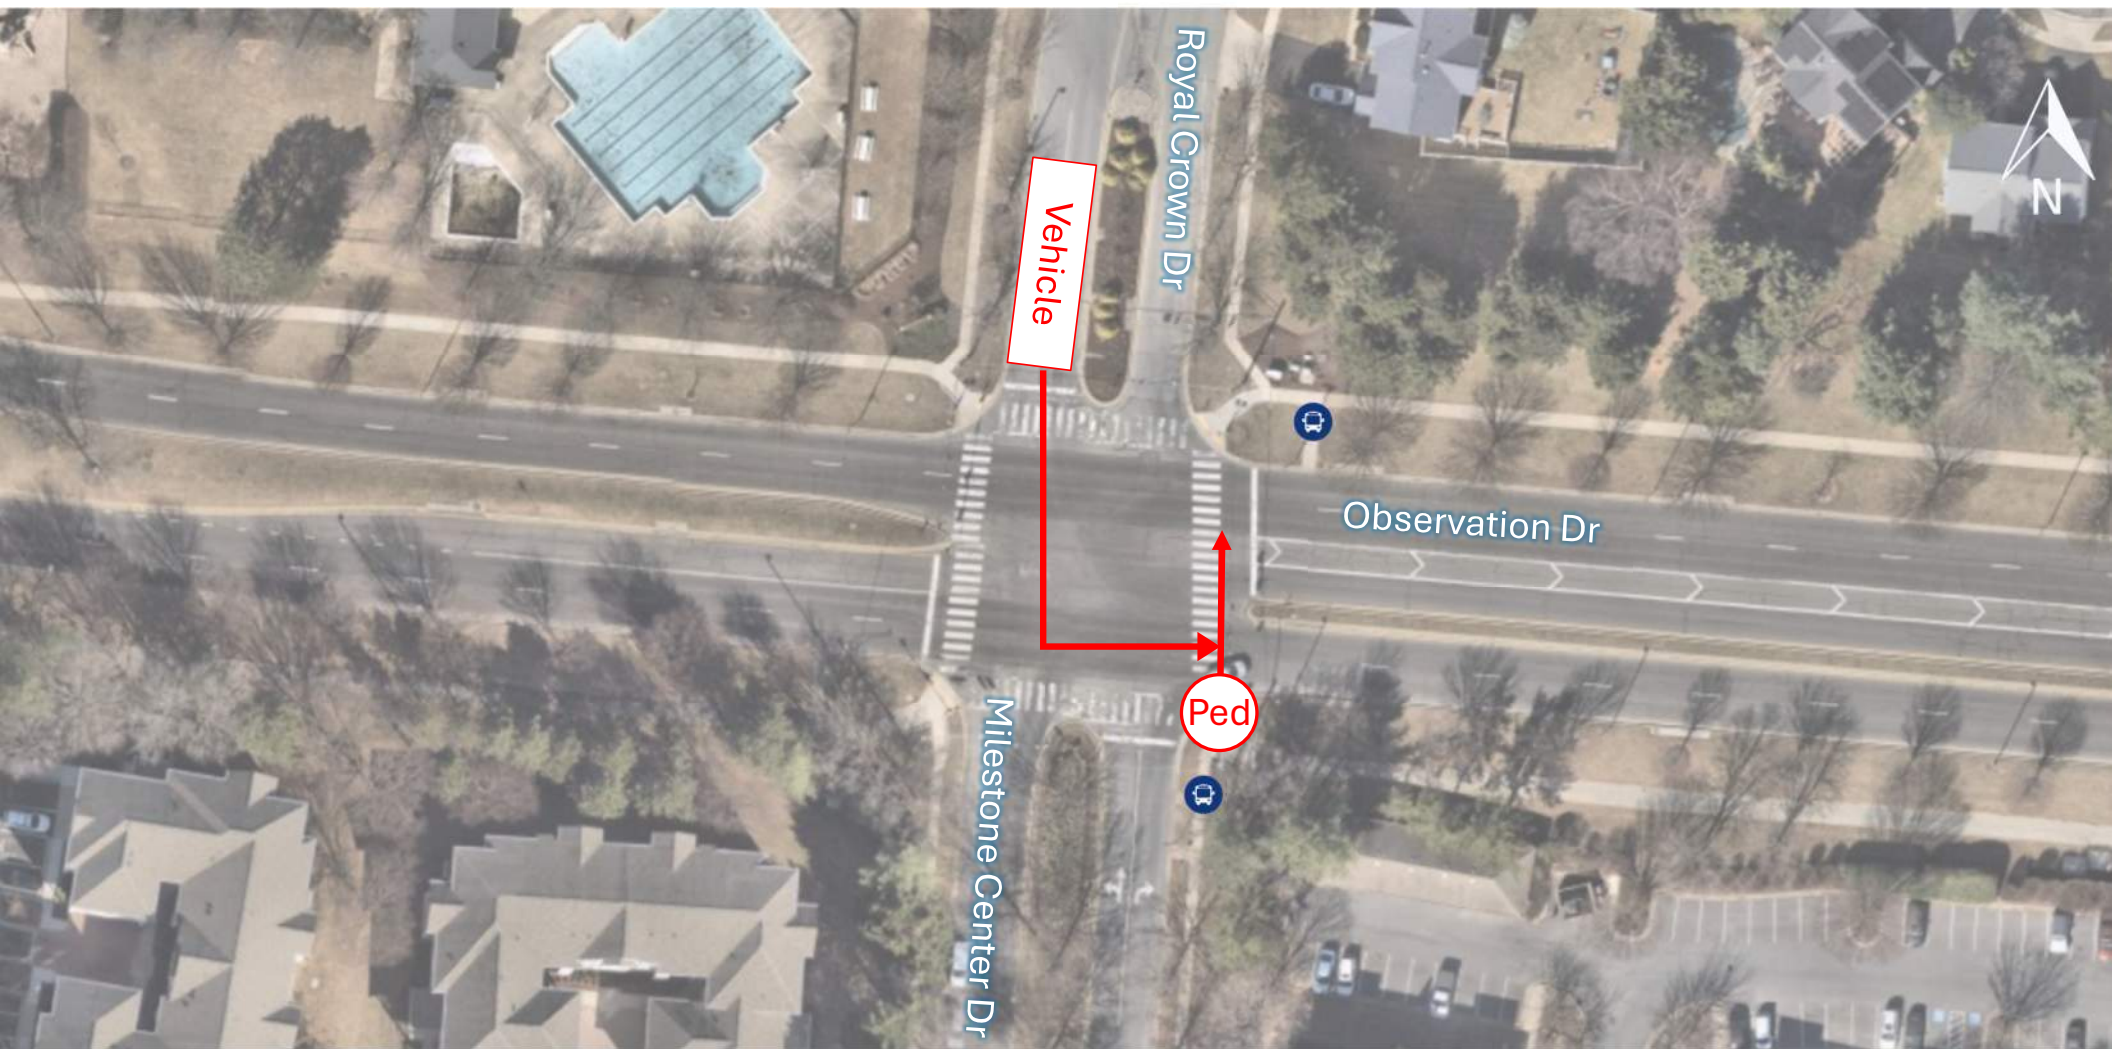
Figure 2 – Crash Diagram

On Wednesday, October 16, 2024, at approximately 3:46 PM, a pedestrian was in the crosswalk on the east leg of Observation Drive when a motorist making a left turn from Royal Crown Drive onto Observation Drive struck the pedestrian. The crash report indicated the subject location occurred within a marked crosswalk. The pedestrian suffered a suspected minor injury. The driver was found at fault for failing to yield right-of-way. Daytime weather conditions were clear, and the roadway surface was dry.

Figure 2 illustrates the crash location and direction of pedestrian and vehicle travel.

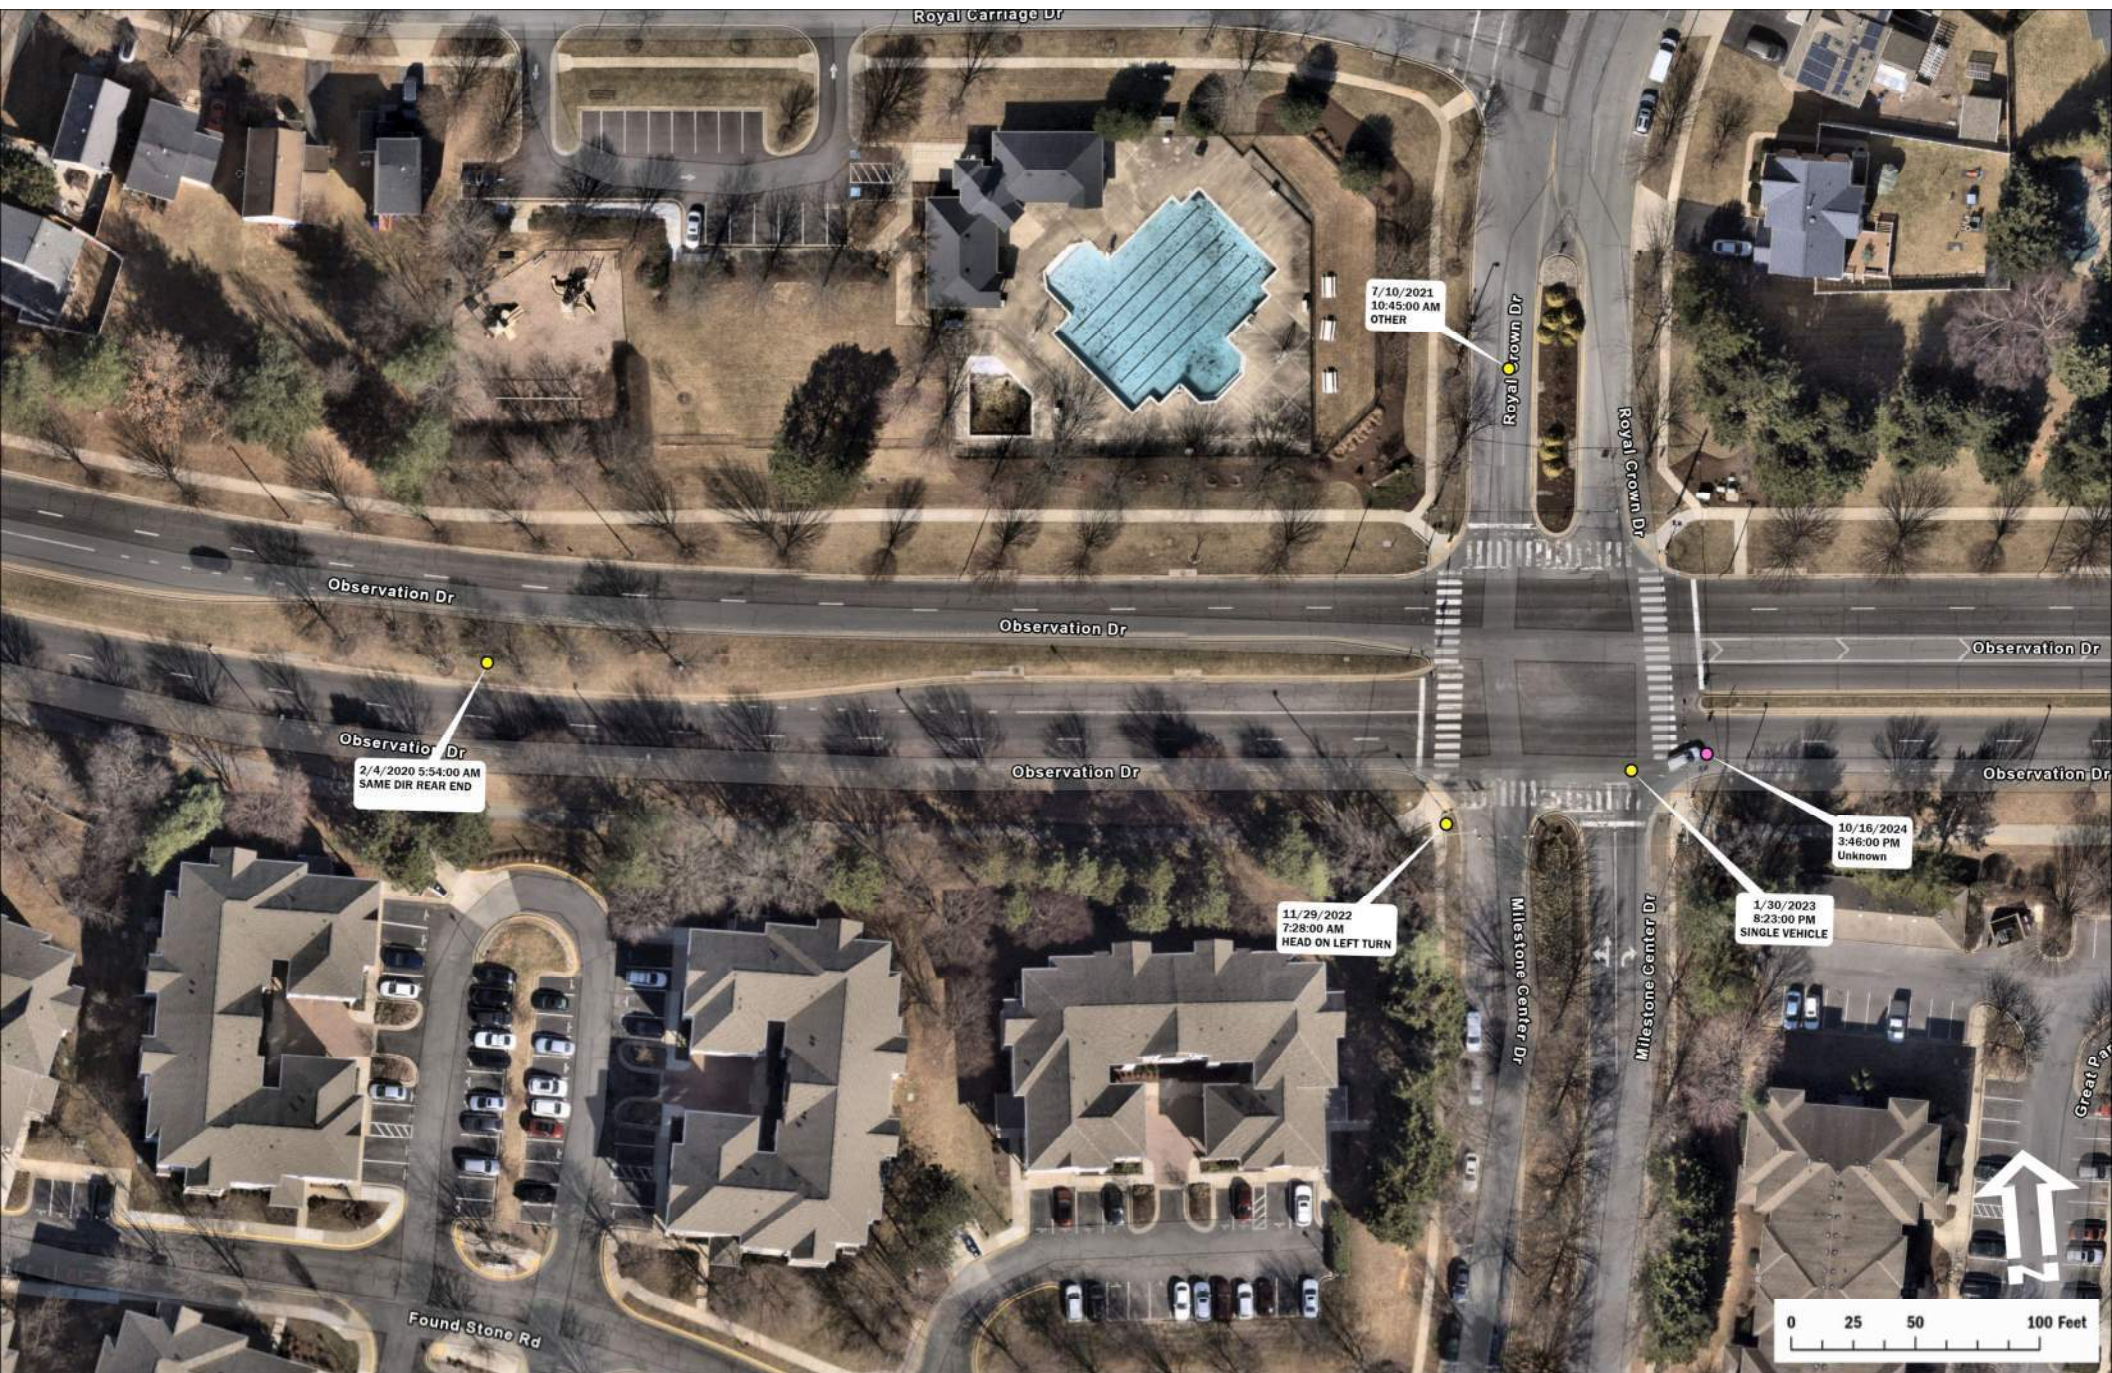
Figure 3a – Crash History west (2020-2024)

All incidents are illustrated on Figure 3a and Figure 3b. Figure 3a shows crashes at the subject location and west, whereas Figure 3b shows crashes at the subject location and east.
